# *Large ASE in the US: ASE-Rs, Trends, etc.*

Presented by Rachel Stagliano, Federal Aviation Administration

ASE Technical Interchange Meeting

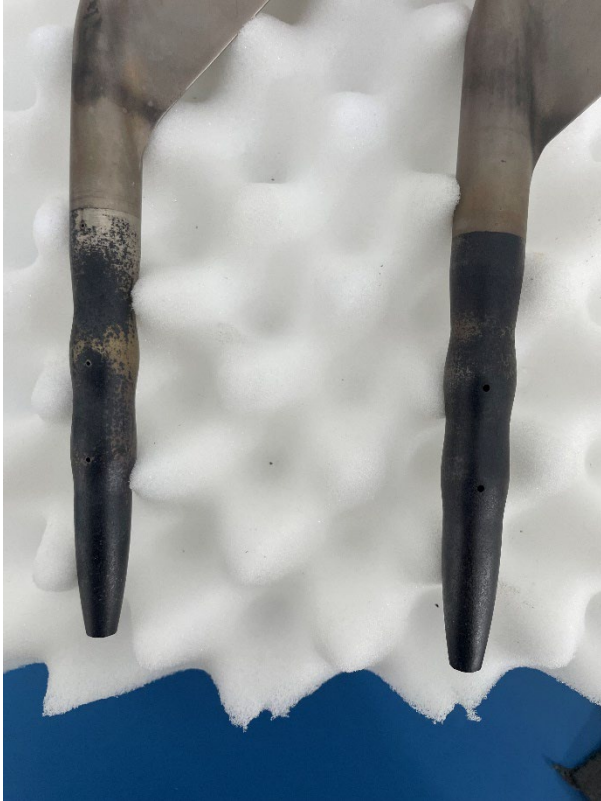
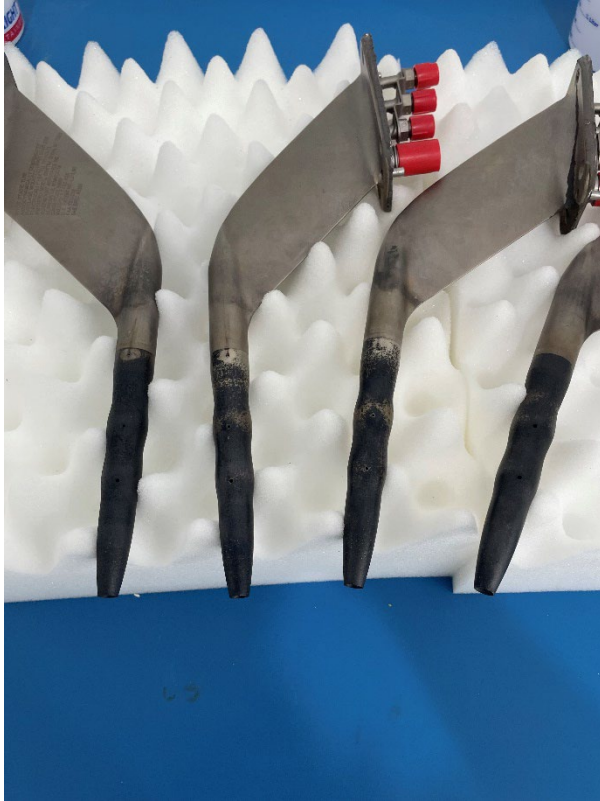
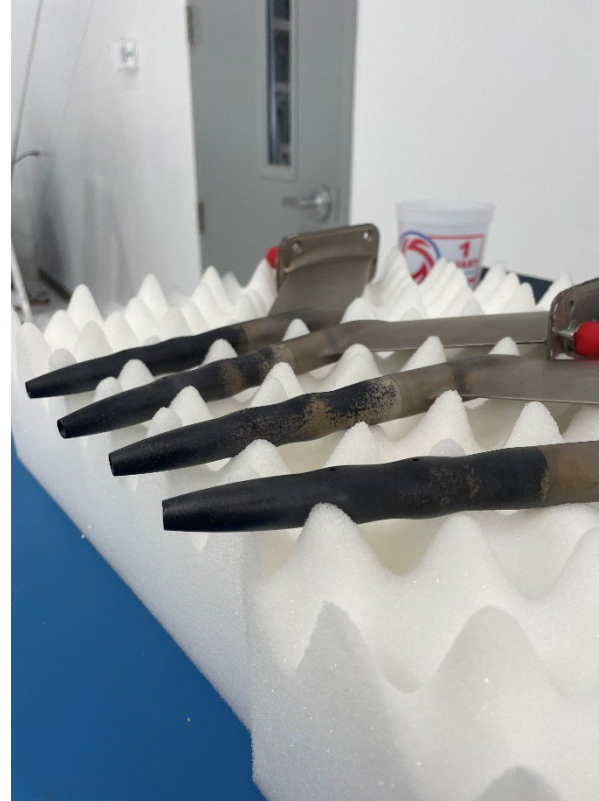
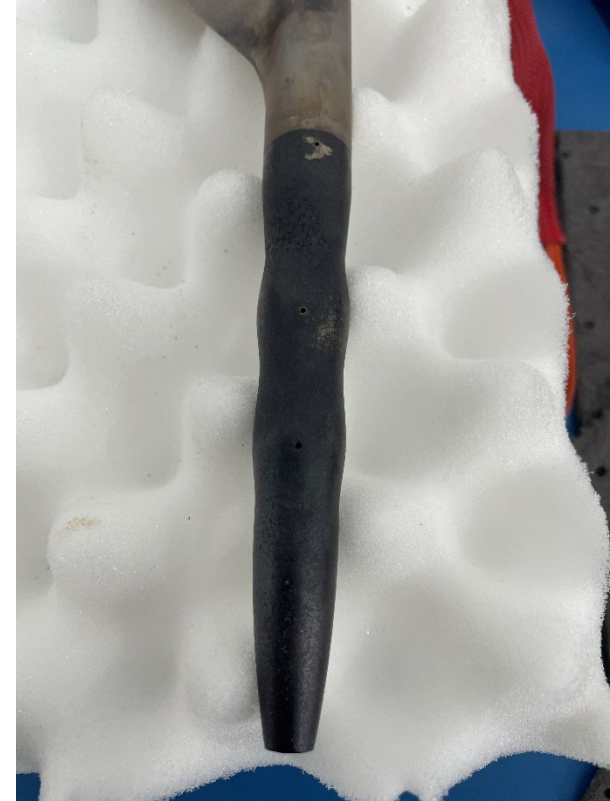
# Probe Corrosion

**Corrosion or Erosion:** Deterioration in pitot tubes and static vents.
