| Flight Procedures Cover Page | Task Action:<br>P-NOTAM | Task Type:<br>IAP | Estimated Chart Date:<br>04/17/2025 | APWS Task ID:<br>35EC9E9D51734727855C0C7034E08087 | APWS Project ID:<br>79EC0732E6C84B5AB8D99C7722227959 |
| Procedure:<br>LOC RWY 1R AMDT 4D | | Enroute:<br>NO | Specialist:<br>Copeland, Guy | | Agreement Number: |

TAMPA, FLORIDA

LOC RWY 1R  
TAMPA INTL (TPA)

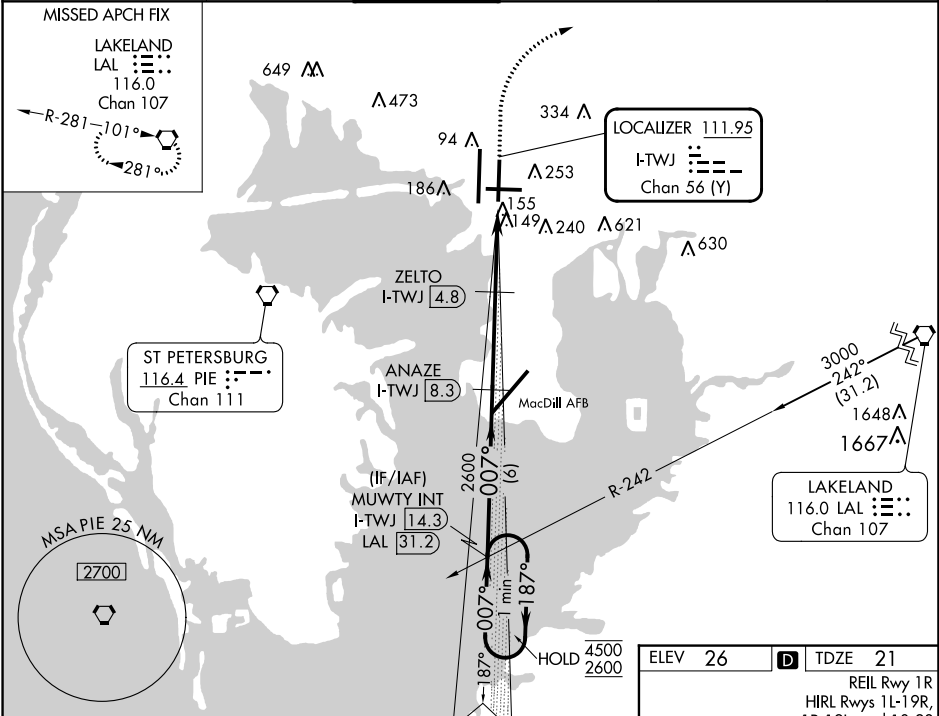
| DME required.<br>⚠ | | MISSED APPROACH: Climb to 500 then climbing right turn to 2000 direct LAL VORTAC and hold. | |

| VGSI and descent angle not coincident<br>(VGSI Angle 3.00/TCH 71). | 500 | 2000 | LAL |
| One Minute<br>Holding Pattern | ↑ | ↪ | ⬡ |

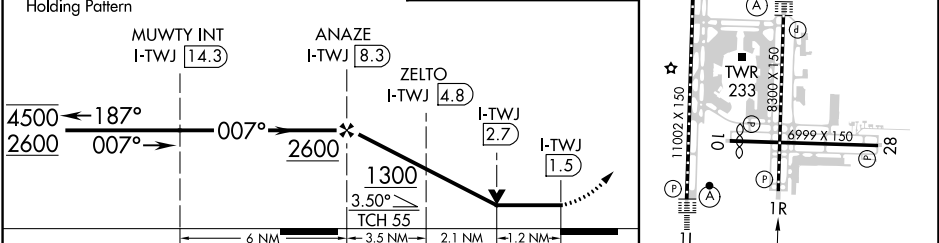
| LOC/DME I-TWJ<br><b>111.95</b><br>Chan <b>56</b> (Y) | APP CRS<br><b>007°</b> | Rwy Idg<br>TDZE<br>Apt Elev | <b>8300</b><br><b>21</b><br><b>26</b> |

| FAF to MAP 6.8 NM | |
