# **Engine Titanium Consortium - Phase III**

## **Project 1 – Nondestructive Evaluation (NDE) of Manufacturing Induced Anomalies**

## **Project 2 – Thermal Acoustic Studies of Engine Disk Materials**

### **Quarterly Report**

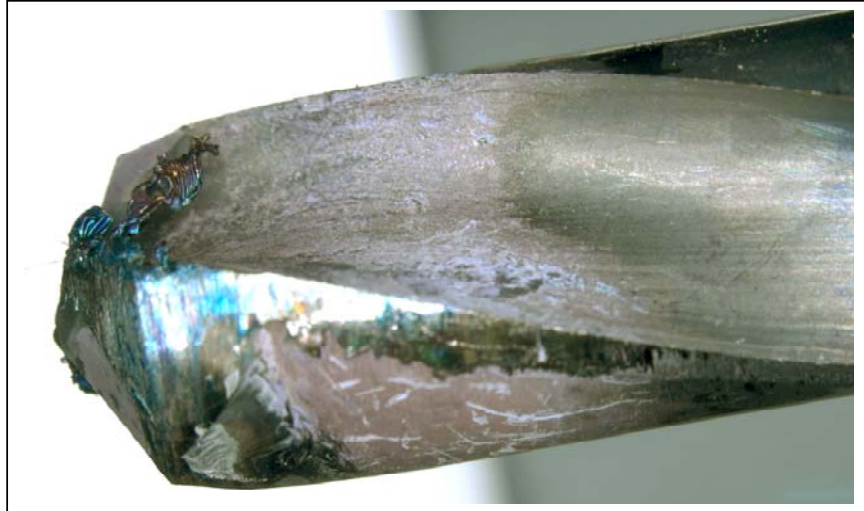
Figure 10. Example of a tool with significant adhered material. This tool was used to fabricate Type 6 anomalies in In718.

Figure 10 below. Figure 11 provides surface photographs of a smeared hole showing the Type 6 anomaly with micrographs shown in Figure 12 and Figure 13.

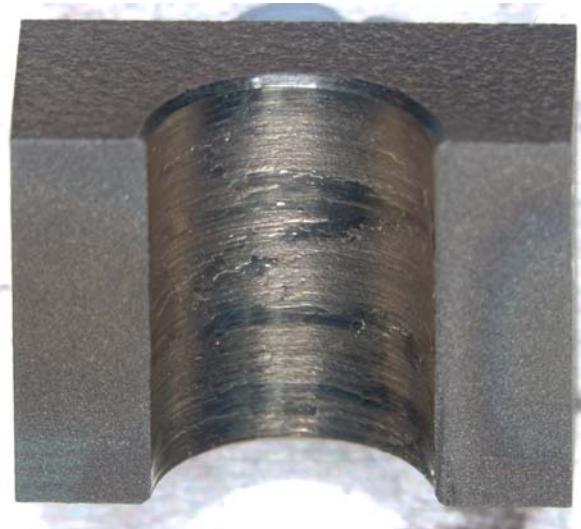
Figure 11. Surface photographs of smeared hole material – Type 6 anomaly.

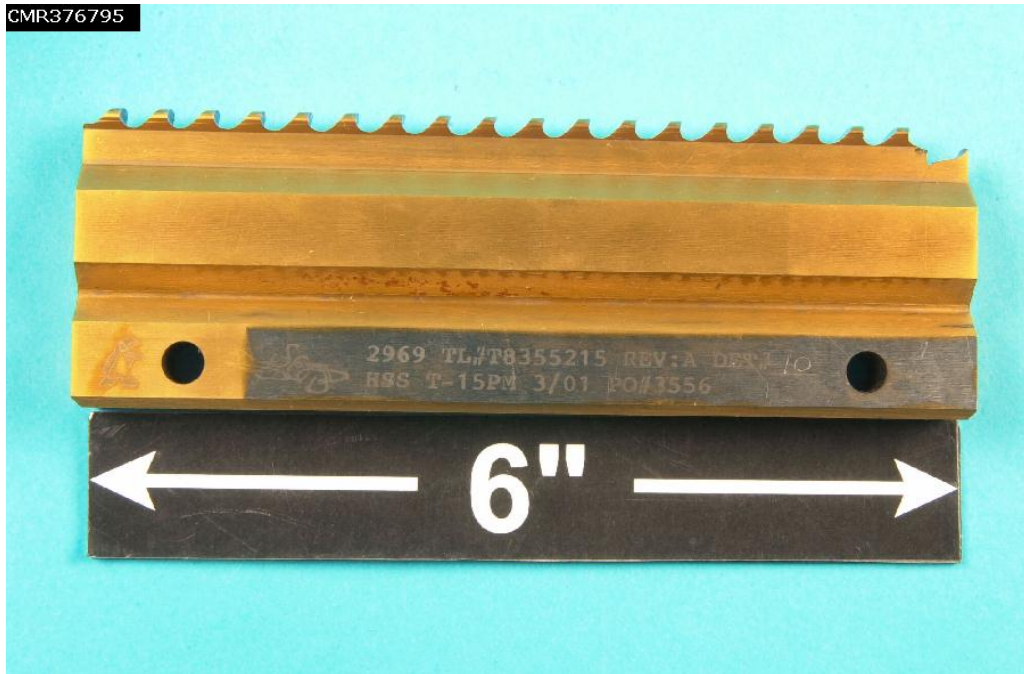
Figure 29. Typical Crown Cutter Tool.

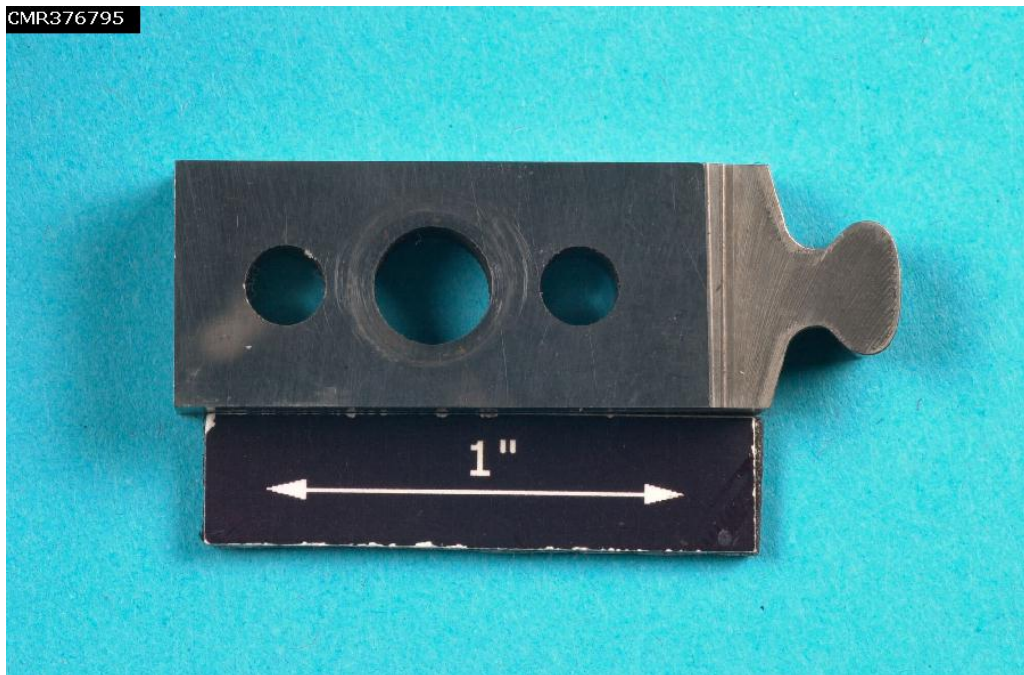
Figure 30. Carbide Insert Form Cutter.

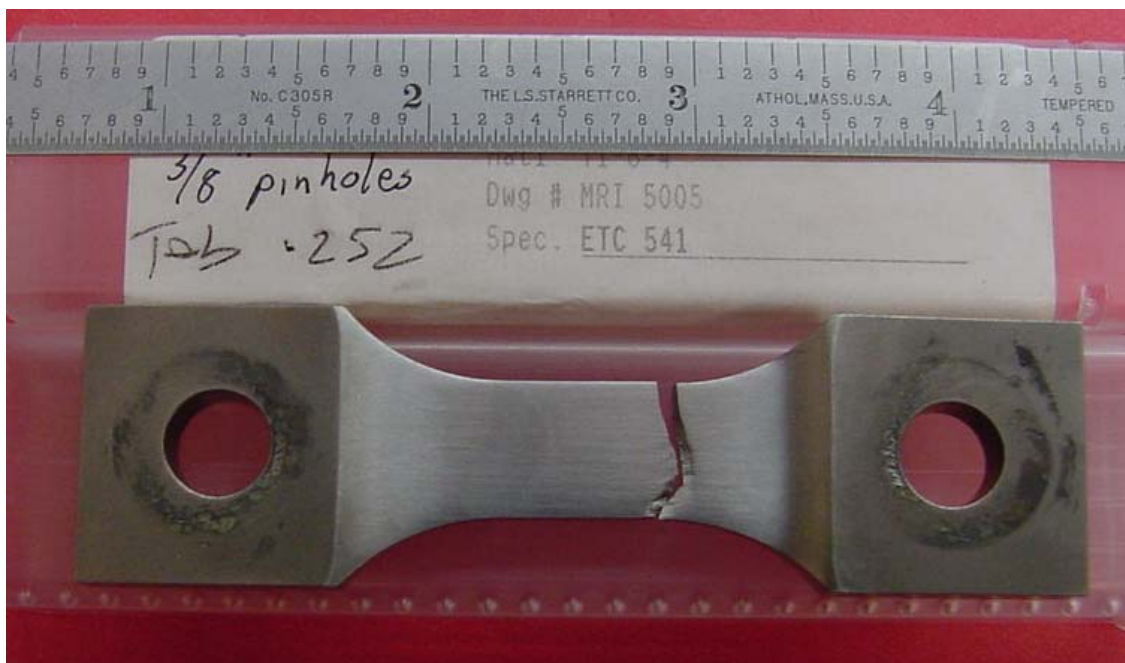
Figure 4. Pinned HCF specimen with edge radius transition failure.

The pinned specimen designed to eliminate possible slippage failed at Metcut at the edge of the radius transition (Figure 4). There was also a failure of the pins during the test. The midlife failure of the pins and the clevises lead to question validity of the results. It was decided to break the corner edges of six samples and test those at ISU.
