# MANHIRP

Integrating Process Controls with Manufacturing to  
Produce High Integrity Rotating Parts for Modern  
Gas Turbines

Presentation to RISC/RoMan

19<sup>th</sup> January 2005

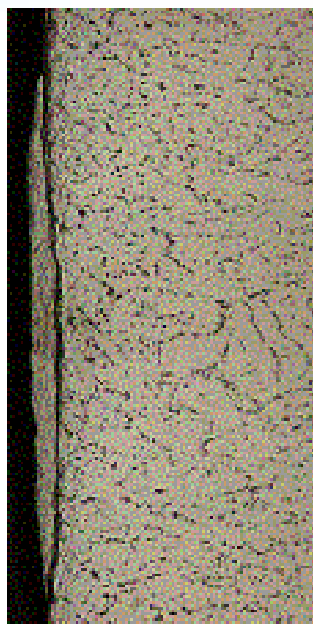
**(a): isolated smearing; (b) continuous smearing; (c) heat affected zone.**

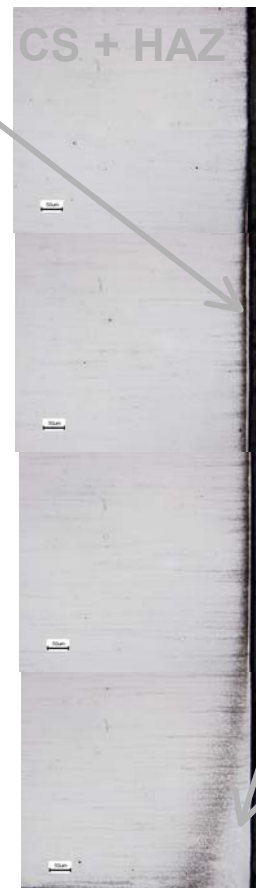
IS + CS

## • The three types of microstructural anomalies

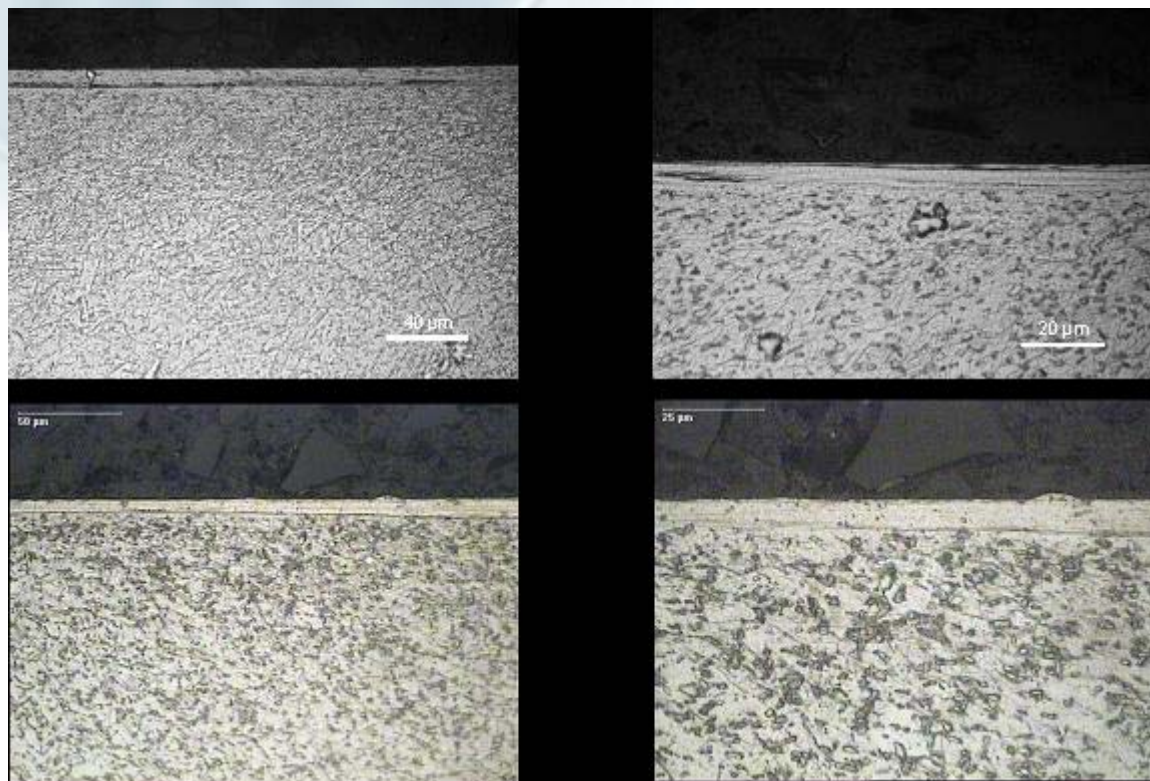
**Metallographic** sections showing amorphous layers produced in the preliminary Batch 2 specimens.

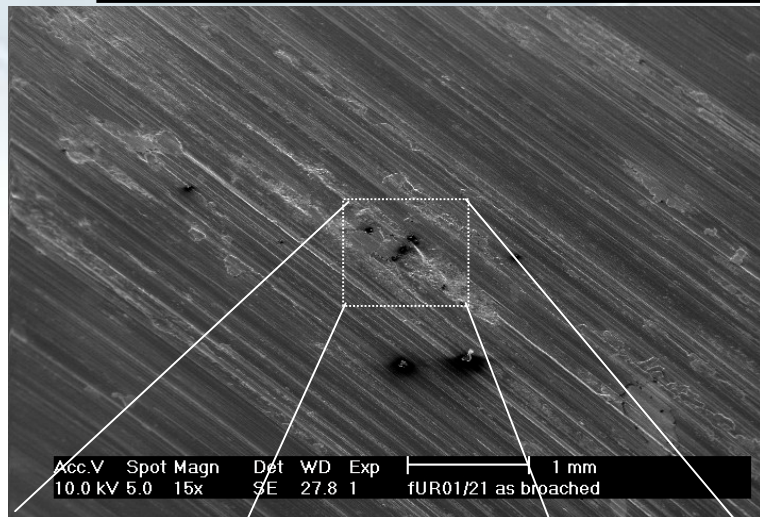
Severity of fatigue deficit will depend on location (very few found at the key stress position).
