Bipartisan Infrastructure Law (BIL) Airport Traffic Control Tower (ATCT) Replacement

David Wayne Hooks Memorial Airport (DWH) ATCT Draft Tiered Environmental Assessment (EA)

Harris County, Texas

October 2024

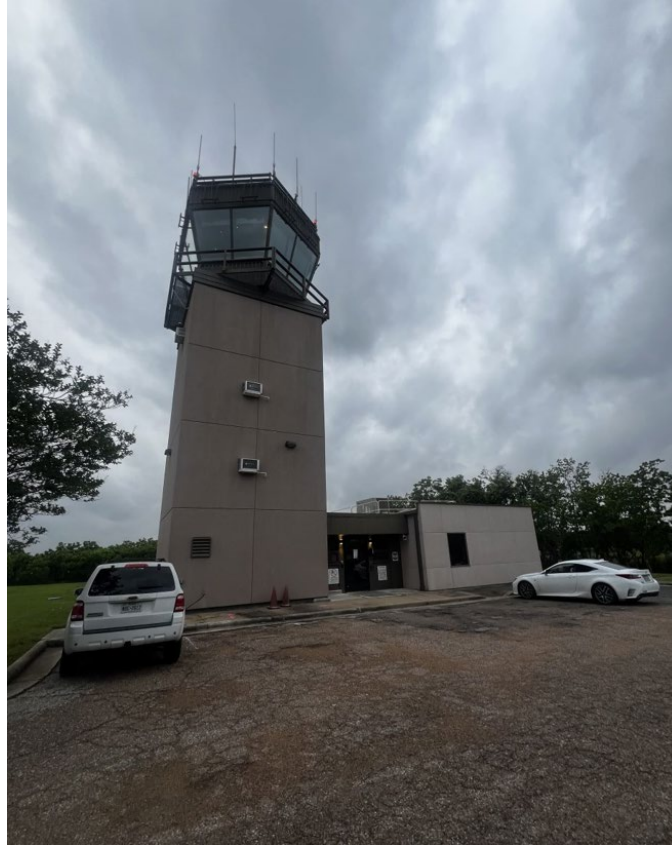
Figure 1-2. Photo of Existing Hunt/AVCO ATCT at DWH

Constructed in July 1979, the existing FAA-owned DWH ATCT is a Hunt/Aviation Corporation (AVCO) design (see Figure 1-2), Tier 2, Level 5 facility. The ATCT has a cab size of 225 square feet with the cab floor at 40 ft above ground level (AGL) and a base area of 1,040 square feet. The ATCT operates daily from 7:00 am to 10:00 pm (FAA, 2024). When the tower is closed, the airspace converts to a Class G airspace from the surface to 700 feet AGL and Class E airspace above that until Class B airspace is reached. The existing ATCT is located in the center of the airport property, west of the runways at 30°04'01.2" N, -95°33'21.4" W (see Figure 1-1).

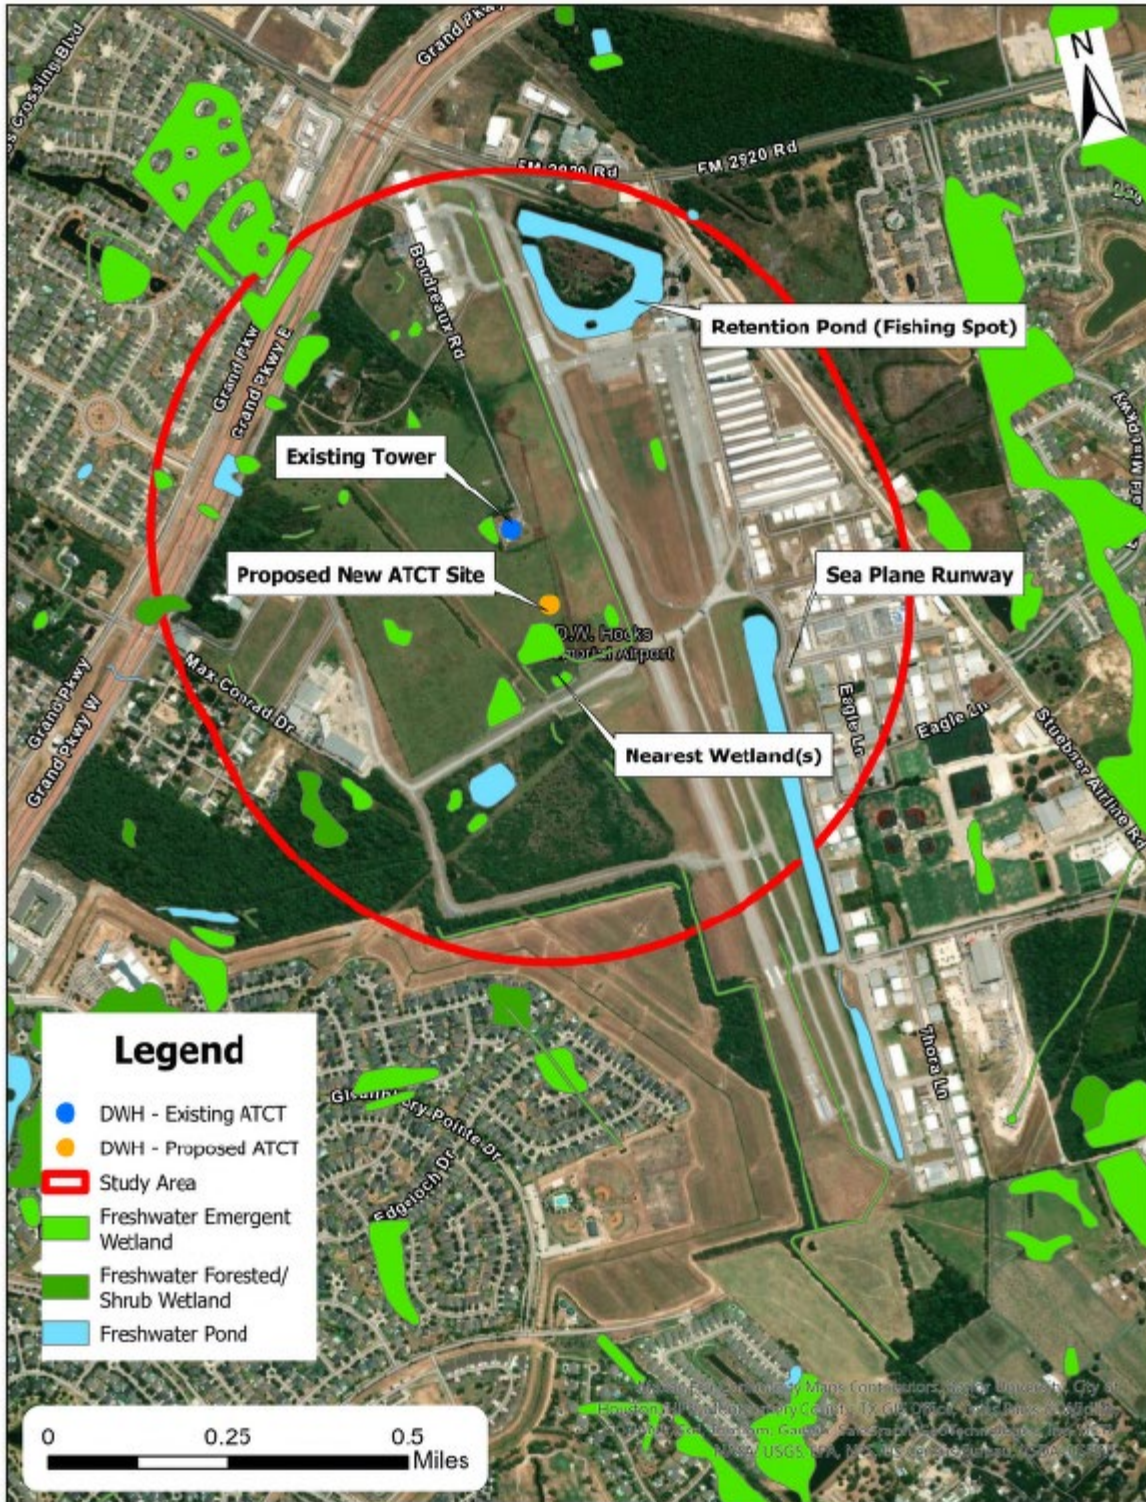
Figure 4-3. Aerial Image of National Wetland Inventory Wetlands and Surface Water Features near DWH Airport

Approximately 0.38 miles northeast of the proposed new ATCT site is an 8.66-acre wetland designated as a freshwater pond, which is also identified on the National Wetland Inventory (NWI), shown on Figure 4-3. DWH manages a 7.51-acre freshwater pond as a sea plane runway approximately 0.28 miles southeast of the proposed new ATCT site (EPA, 2024). Surface water and wetland features are shown in Figure 4-3.

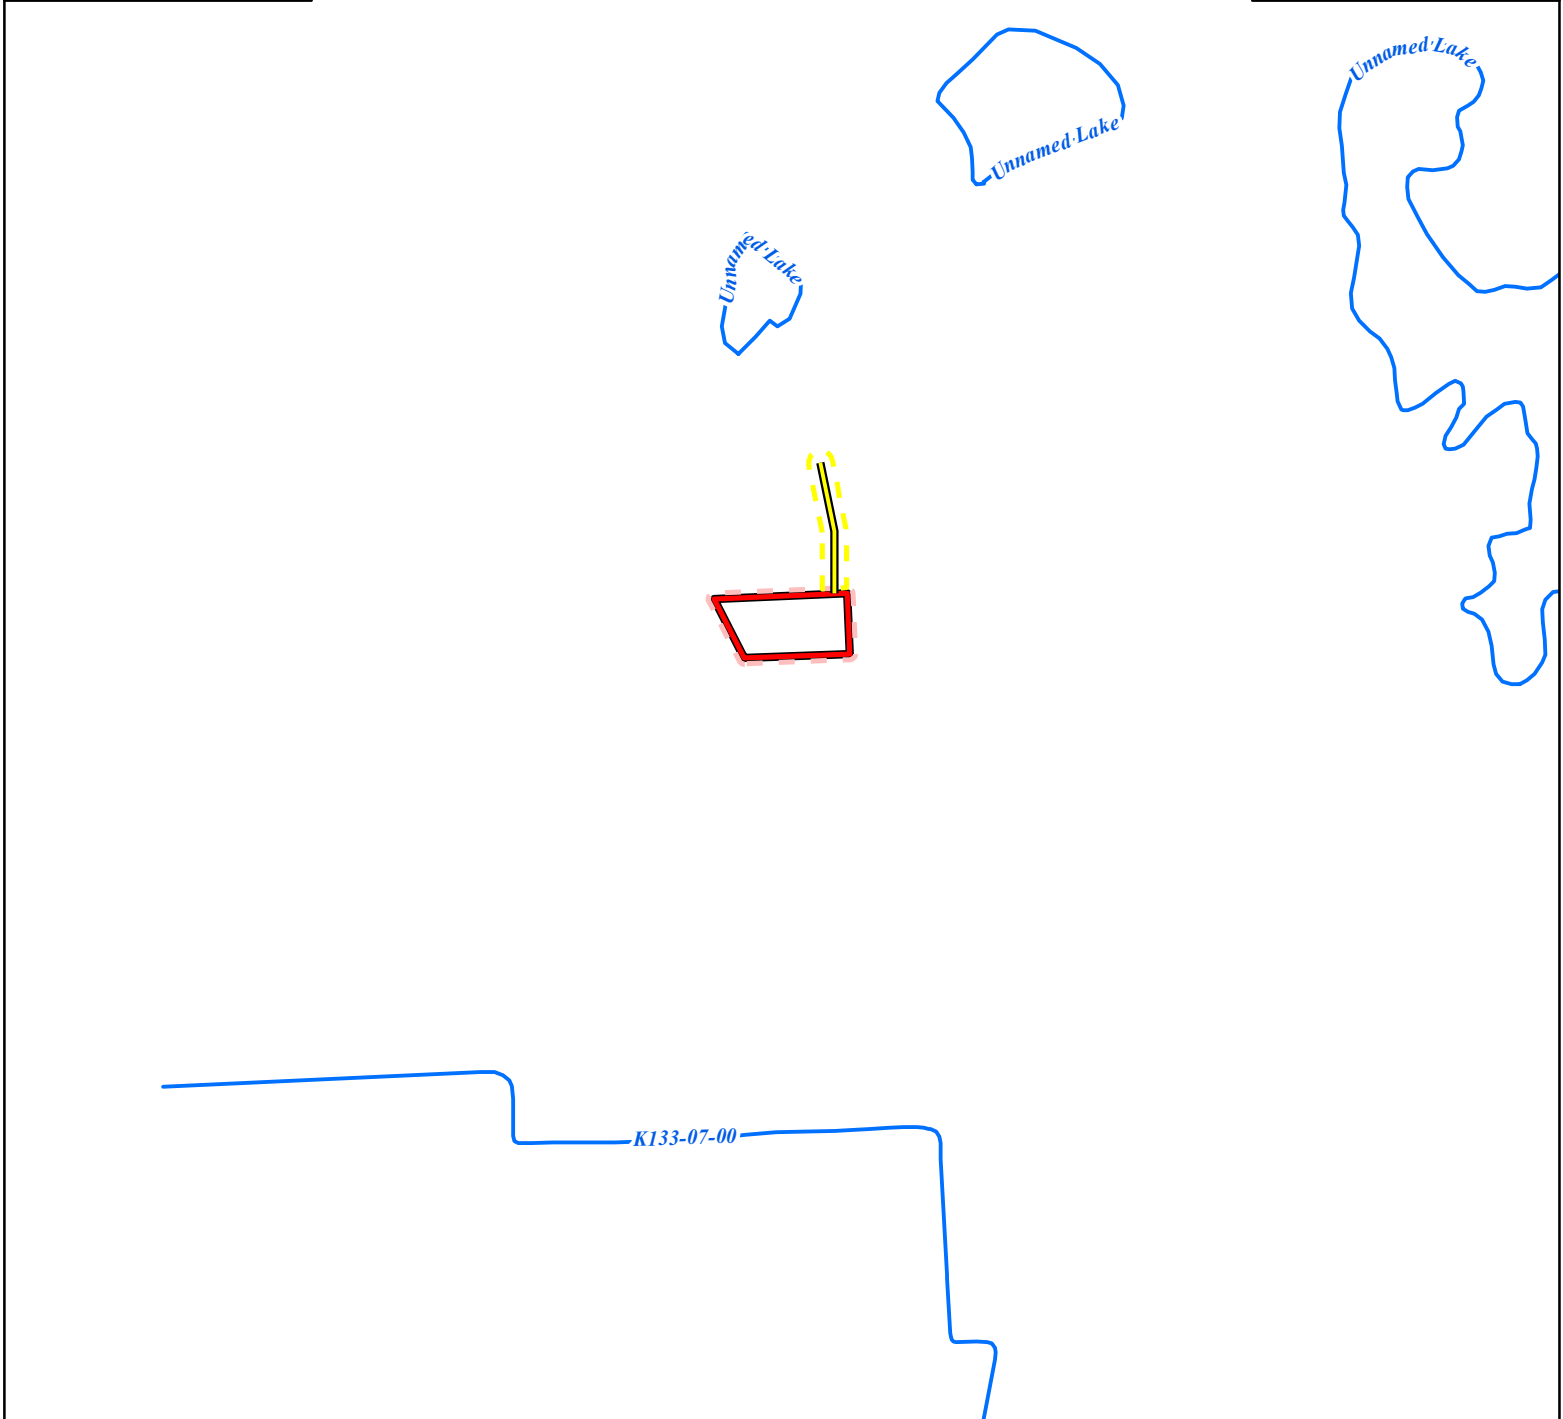
Figure 03 - FEMA Map

- Project Area
- Project Area Buffer (25')
- Proposed Access Road Centerline
- Access Road Buffer (50')
- Streams (FEMA)
- 100-yr Floodplain (FEMA)

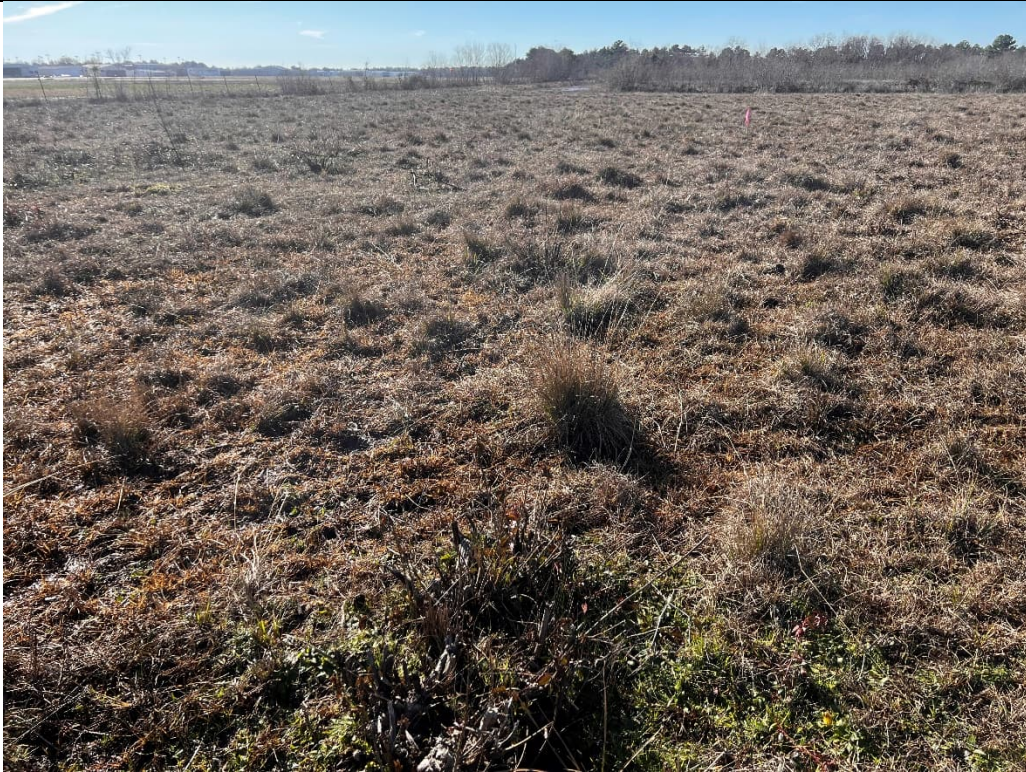
Photograph 1. View of an upland area, SP01, within the ag field. View is facing south. Photo taken January 29th, 2024. (30.065523, -95.555478)

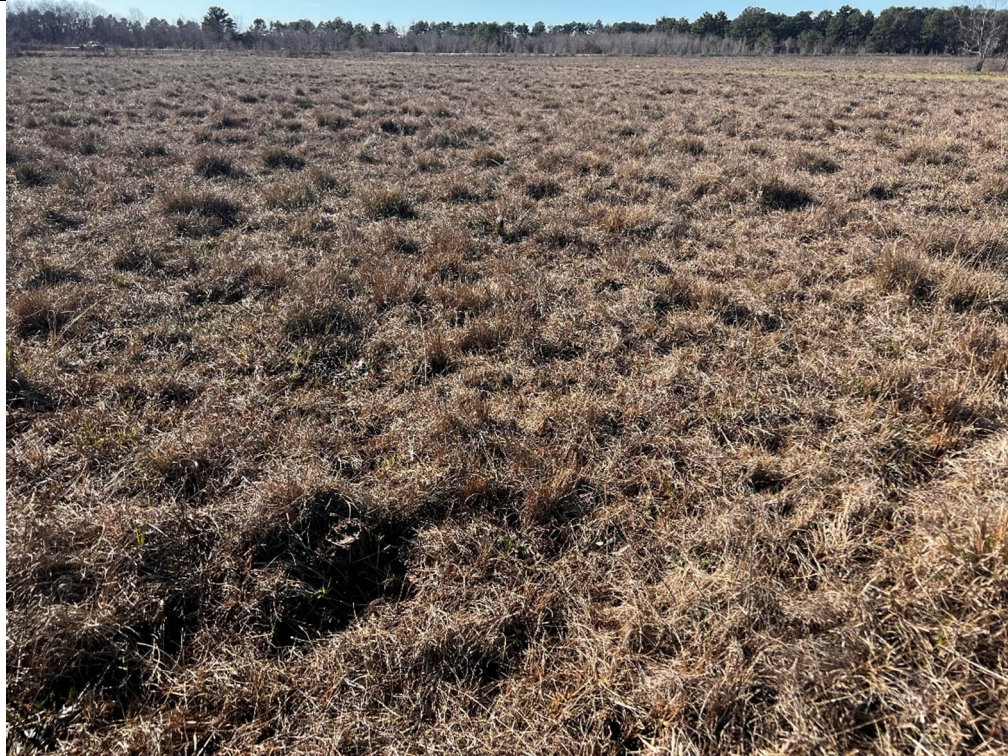
Photograph 2. View is of an upland area, SP02. View is within the ag field, facing southwest. Photo taken January 29th, 2024. (30.065374, -95.556640)

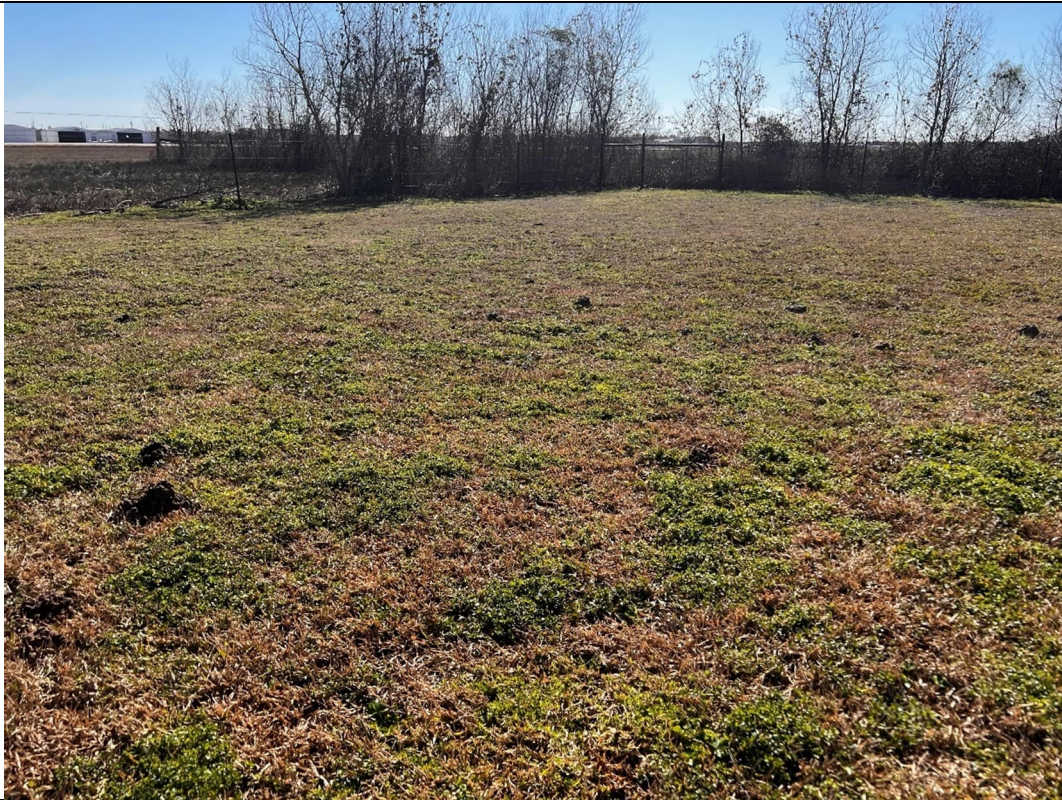
Photograph 3. View is of an upland area, SP03. View is within the existing ATCT location, facing south towards the ag field. Photo taken January 29th, 2024. (30.066890, -95.555587)

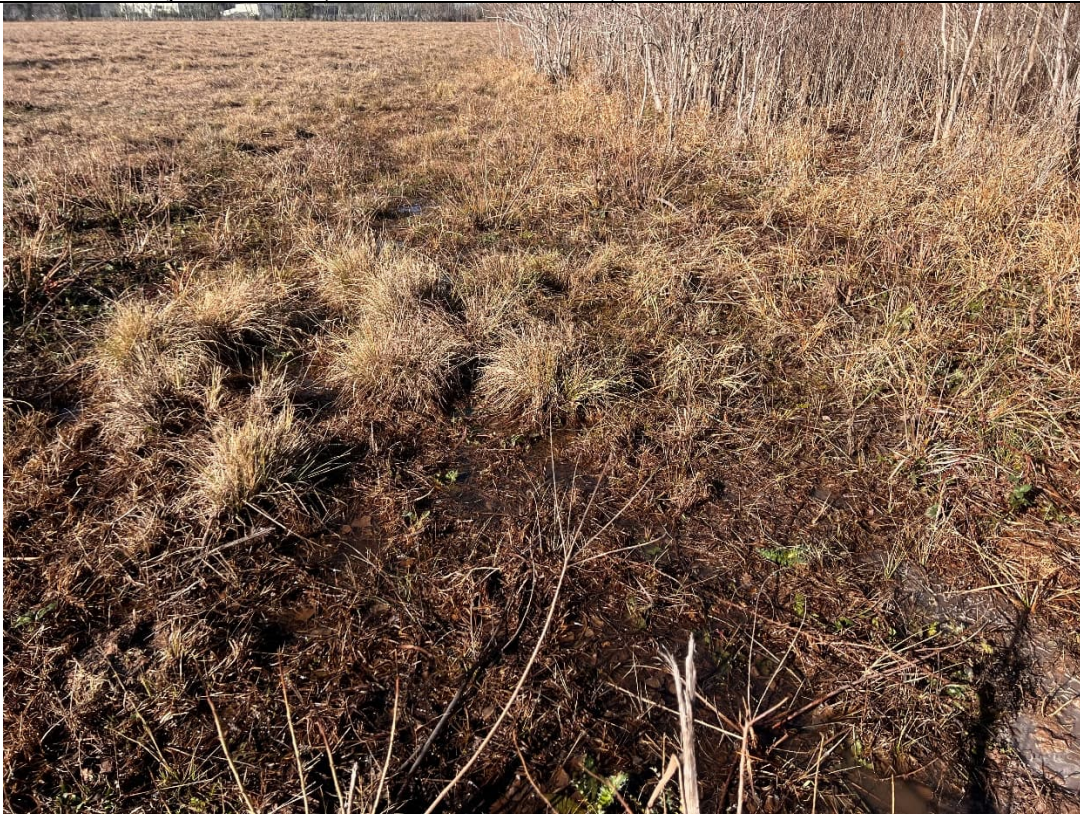
Photograph 4. View is of emergent wetland, PEM01. View is facing west. Photo taken January 29th, 2024. (30.066550, -95.555594)

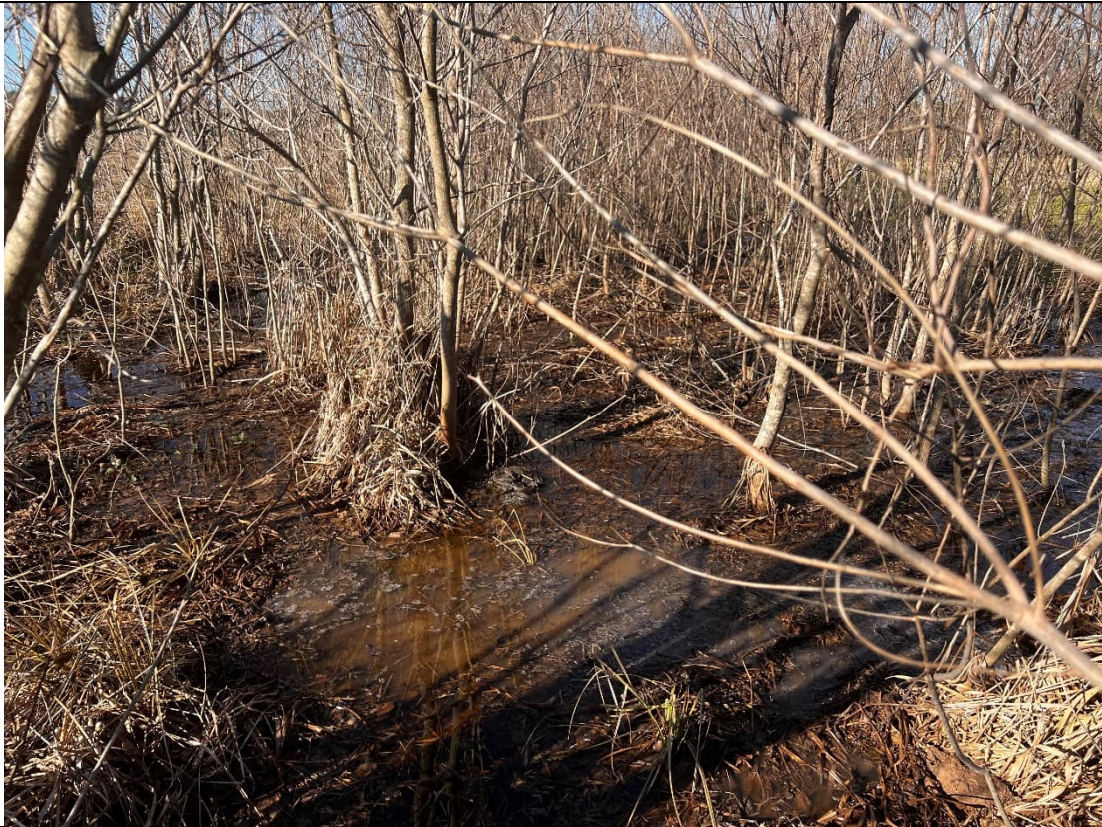
Photograph 5. View of scrub-shrub wetland, PSS01, located just north of PEM01. View is facing west. Photo taken January 29th, 2024. (30.066595, -95.555606)

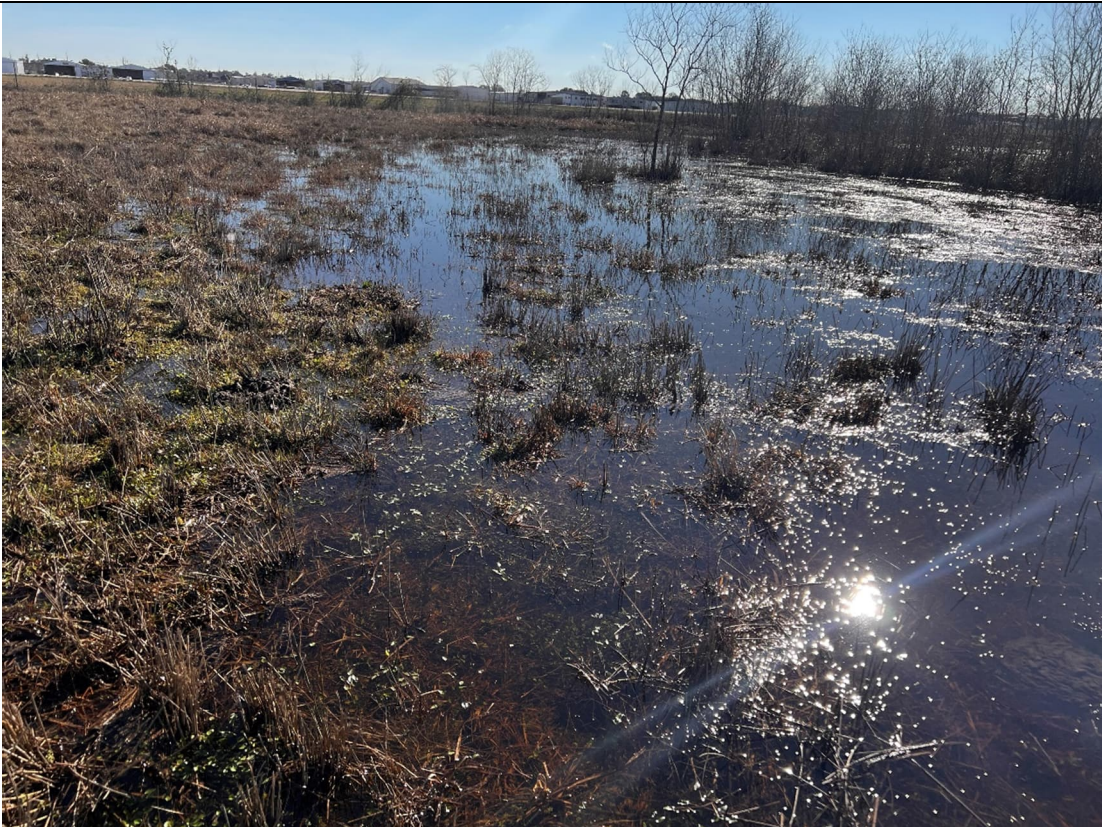
Photograph 6. View of emergent wetland, PEM02, located at the southernmost end of the survey boundary. View is facing east. Photo taken on January 29th, 2024. (30.064908, -95.555801)

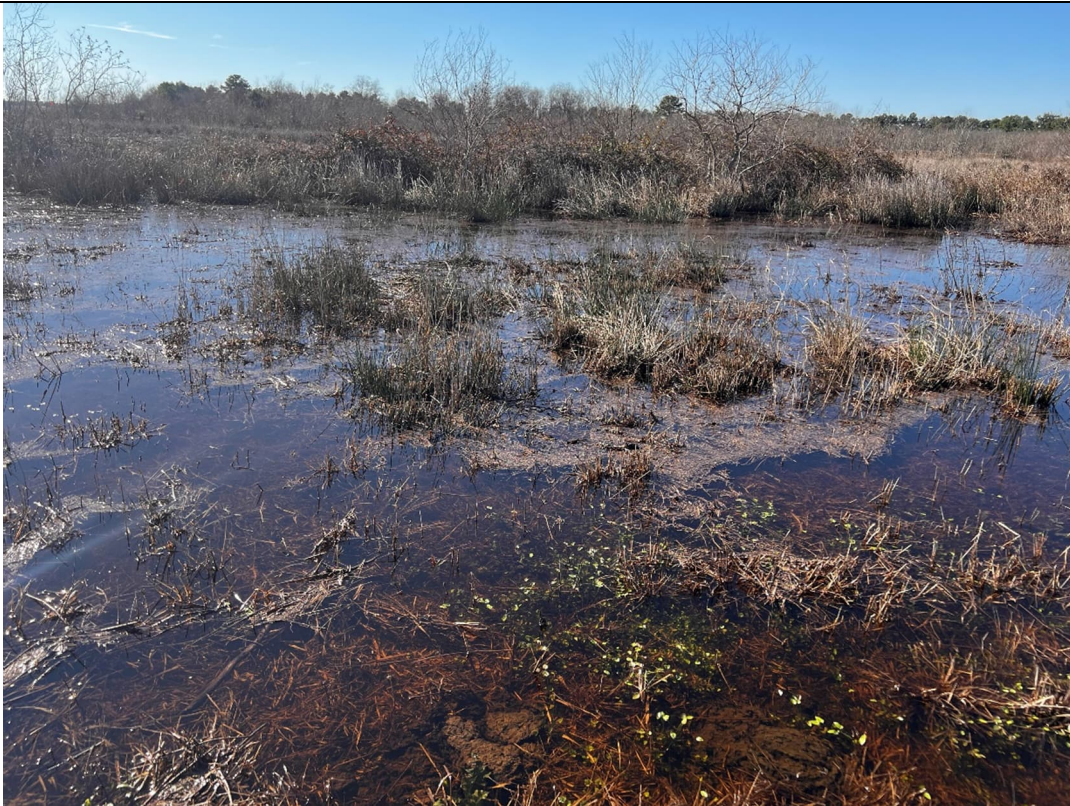
Photograph 7. View of emergent wetland, PEM02, located at the southernmost end of the survey boundary. View is facing south. Photo taken on January 29th, 2024. (30.064908, -95.555801)

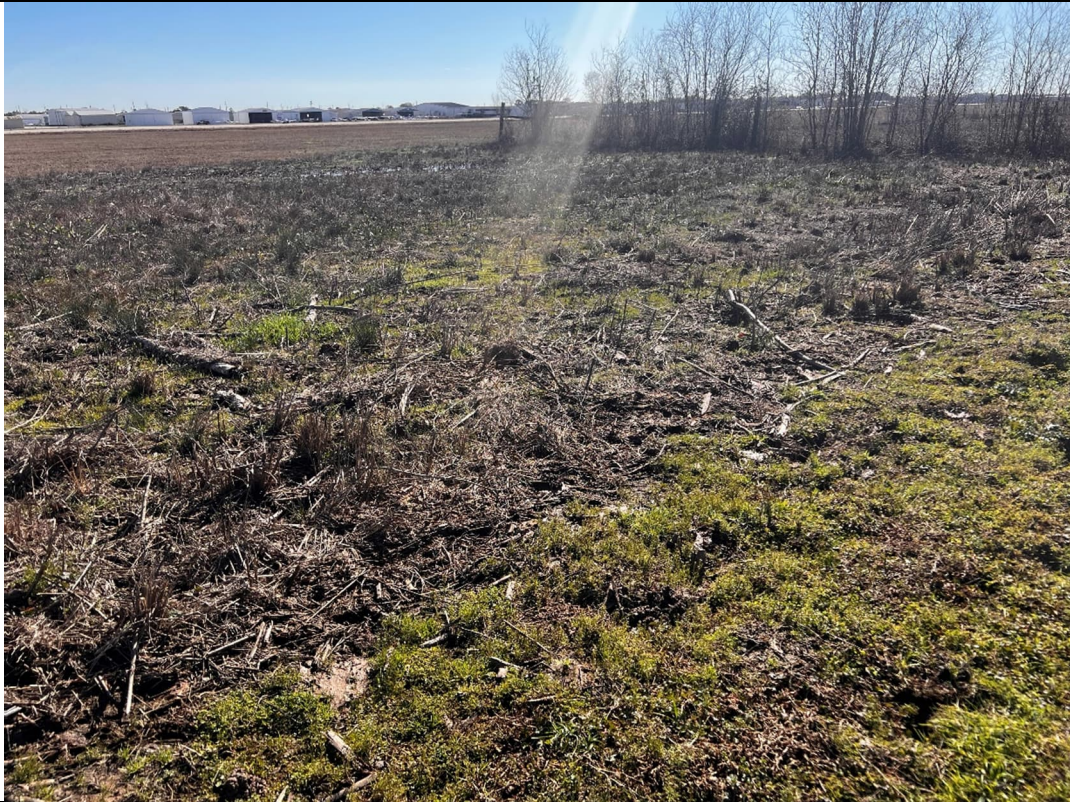
Photograph 8. View of emergent wetland, PEM03 located just east of the existing ATCT. View is facing southeast. Photo taken on January 29th, 2024. (30.066715, -95.555427)
