**Federal Aviation
Administration**

DOT/FAA/AM-06/10
Office of Aerospace Medicine
Washington, DC 20591

Vaporized Hydrogen Peroxide (VHP®) Decontamination of a Section of a Boeing 747 Cabin

Final Report

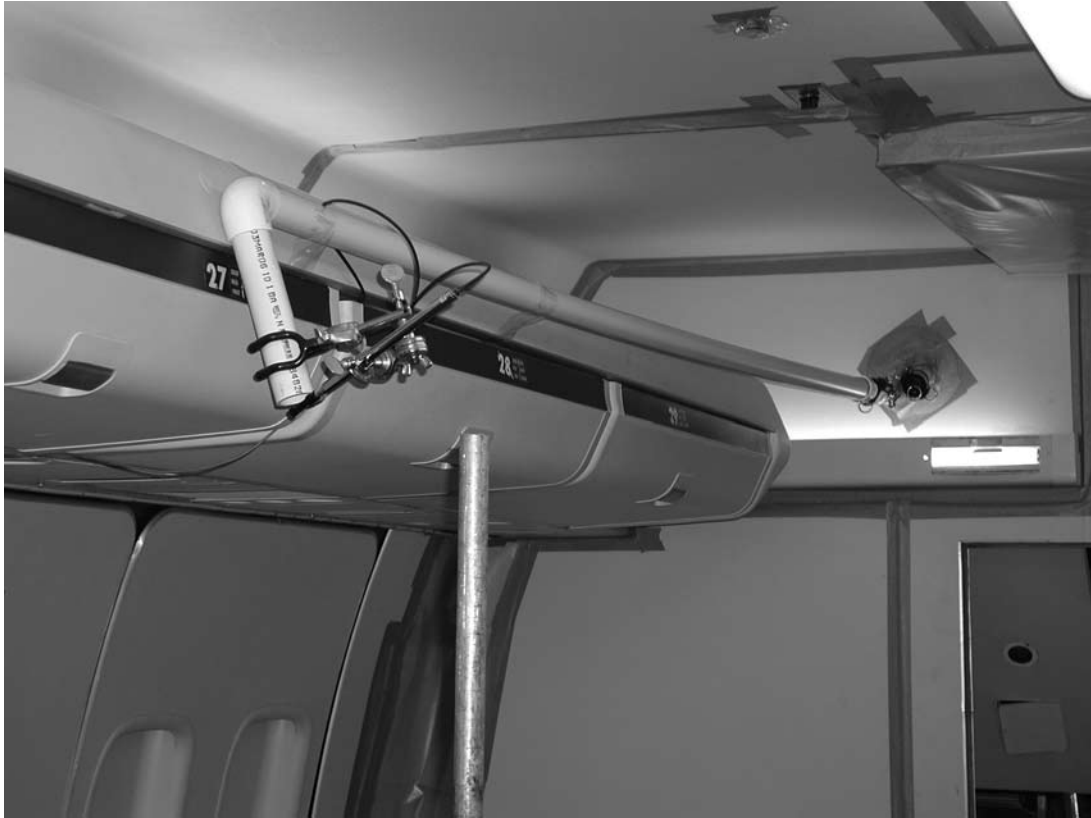
Figure 2. Photograph showing an overhead luggage rack, VHP vapor introduction piping, and hotwire anemometer.

VHP Process Quantification Methods: Two methods were used to quantify the VHP concentrations in the cabin test section during the experiments. Near-infrared spectrophotometers (Hydrogen Peroxide Vapor Monitor, Guided Wave Inc., El Dorado Hills, CA) provided a real-time measurement of the VHP concentration in the range of 0.1 to 50 mg/l. The second VHP concentration measurement was accomplished using Chemical Indicators, (Steris Corp., 5960 Heisley Rd, Mentor, OH), which provided a simple, non-quantified color change indication that VHP vapor was present at the indicator location. CIs were paired with biological indicators, as described below. In addition, an estimate of VHP vapor delivery into the cabin could be derived from the velocity of the flow stream and the cross sectional area of the inlet tube. Hot wire anemometers were placed in the middle of the VHP inlet and the velocity recorded. The resulting

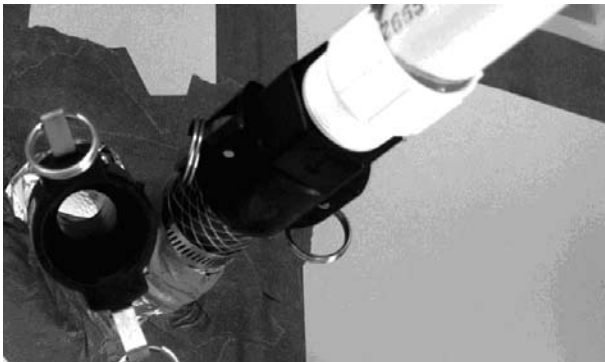
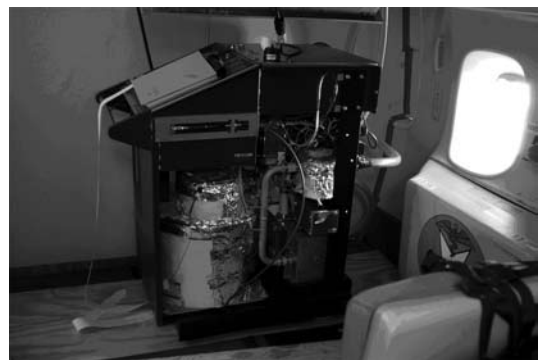
Figure 3. Photograph 1 showing the bulkhead penetration of the VHP Inlet pipe and VHP Return (open connector) into the test section of the AERF. Photograph 2 showing the STERIS model 1000 VHP.

VHP Generation: The VHP process was introduced into the cabin at four locations. Two generators (STERIS VHP 1000) were each located at either end of the cabin segment, outside of the test area itself. The generators are completely self-contained bio-decontamination systems with the ability to dehumidify, generate VHP vapor, and aerate sealed enclosures. The inlets and outlets of the generators passed into the cabin segment through openings in the bulkheads. Figure 1 also shows where the

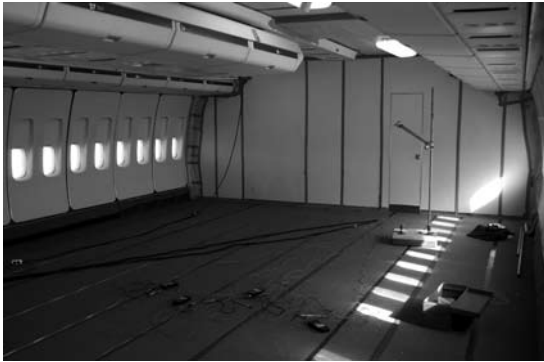
Figure 4. Photographs showing the 747 AERF section with the seats removed and bulkheads isolating the test section of the aircraft. Photograph 1 is a view of the Forward bulkhead, and Photograph 2 is a view of the Aft bulkhead.

Test Facility: The AERF at the FAA/CAMI was utilized as the test facility. For these tests, a passenger cabin segment just aft of the entrance door in front of the wing was utilized. The segment is 32 feet long with a volume of approximately 5000 cubic feet. The test section was separated from the rest of the cabin by two bulkheads built specifically for the purpose of segmenting sections of the AERF. Tape and plastic sheeting was used throughout the cabin to minimize VHP leakage during the testing. The test section is shown schematically in Figure 1.

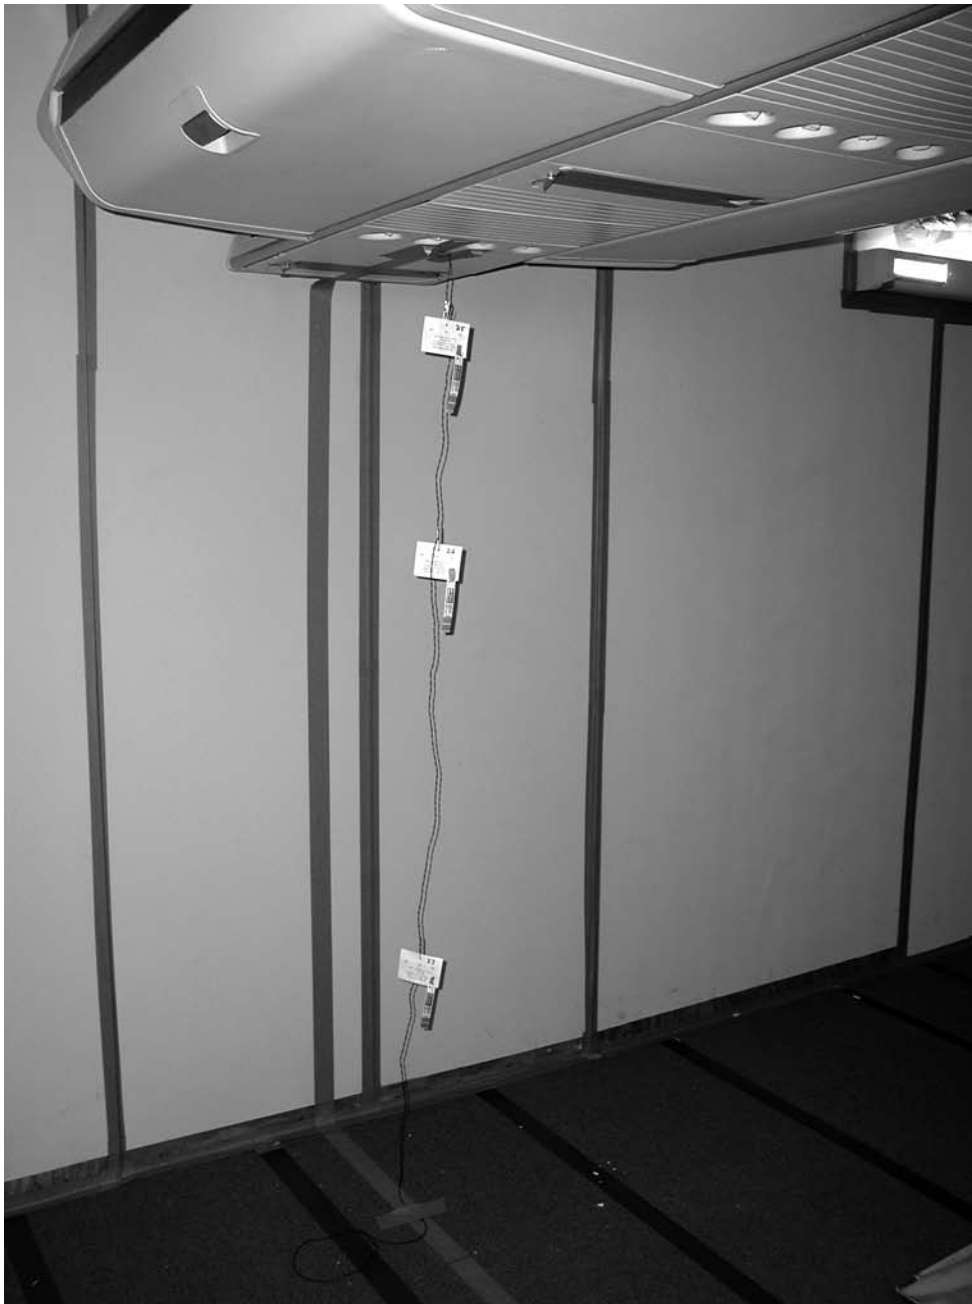
Figure 6. Photograph of BIs and CIs (positions no. 25 – 27, as shown in Figure 7 and identified in Table I) attached to wire in preparation for testing.

Biological Indicators (BIs): BIs were used to provide functional assessments of the VHP level present in the cabin. The biological indicators were tri-pack stainless steel coupons inoculated with approximately 10⁴, 10⁵, and 10⁶ colony forming units (CFU) with *Geobacillus stearothermophilus* spores packaged in sub-divided Tyvek®* envelopes (Apex Laboratories, Inc.). The CI and BI packets were distributed throughout the cabin segment using wires with paper clips located at positions to give the desired height for each BI/CI set. The CI/BI locations were numbered sequentially (1 – 53) and located in the cabin segment as shown in Figure 7. In addition to the BIs exposed during the testing, two indicators that were not exposed to VHP treatment were cultured as a positive growth control. Following each test the BIs were left sealed in their Tyvek envelopes, packaged separately from the controls, and transported to STERIS laboratories for analysis.
