DOT/FAA/AM-08/4
Office of Aerospace Medicine
Washington, DC 20591

Field Evaluation of Whole Airliner Decontamination Technologies – Wide-Body Aircraft With Dual-Use Application for Railcars

February 2008

Final Report

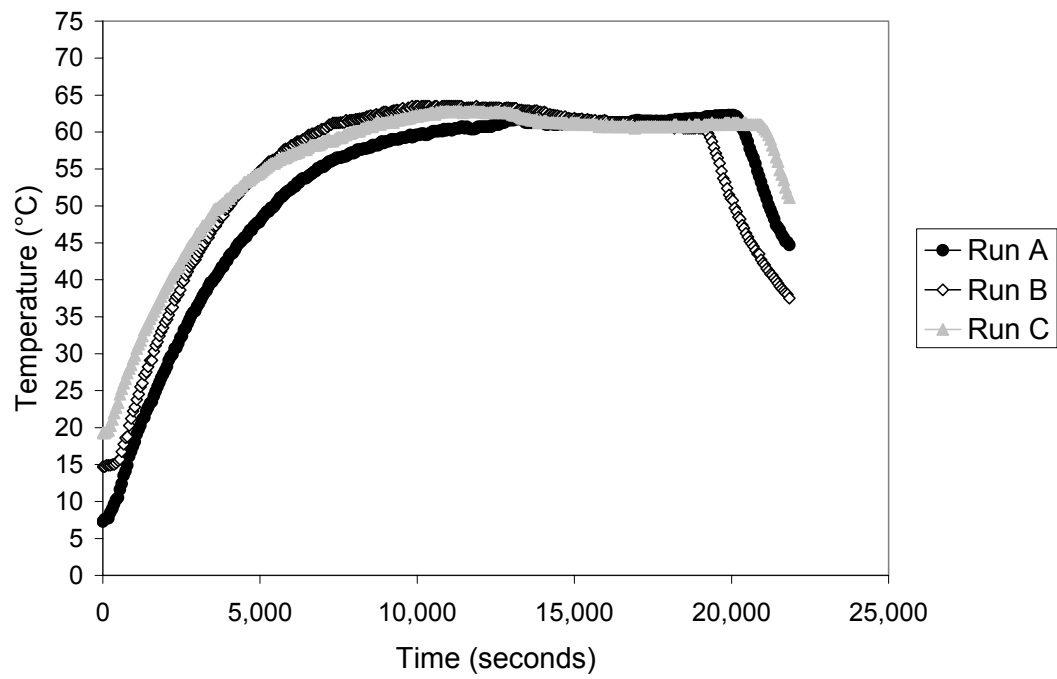
Figure 1. Profile from an armrest towards the rear of the cabin

It proved possible to heat the majority of the 747 cabin to close to 60°C and hold fairly near to this temperature for an extended period with the use of two thermal decontamination units (Figure 1). However, in some cases regions, it was not possible to hold at 60°C for 2 hours, as stipulated in the protocol (Figure 2). Surface temperatures in other locations (e.g. adjacent to the inlet) were found to exceed 65°C, with a maximum temperature of 71°C being observed where the incoming air stream impinged on the cabin (Figure 3). The two thermal decontamination units appeared to be well matched to the thermal mass of the 747, whereas a single unit had a rather larger heating capability than that required for a DC-9.

Cabin temperature on multiple cabin surfaces exceeded the desired 60°C. This was due to one of the two units having to be operated at 65°C and the second at 85°C, due to on-site power limitations. It must be noted that the present trials were conducted on a very tight schedule and budget. It is likely that given a longer lead time, more proving runs, and additional resources, the temperature control issues can be addressed.

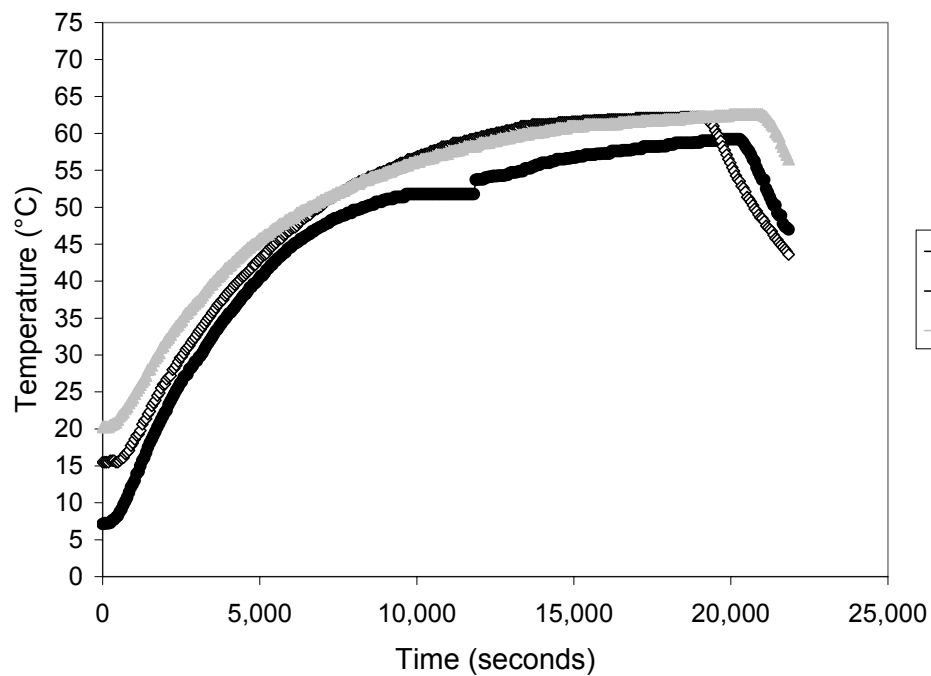
Figure 2. Profile from an armrest towards the front of the cabin

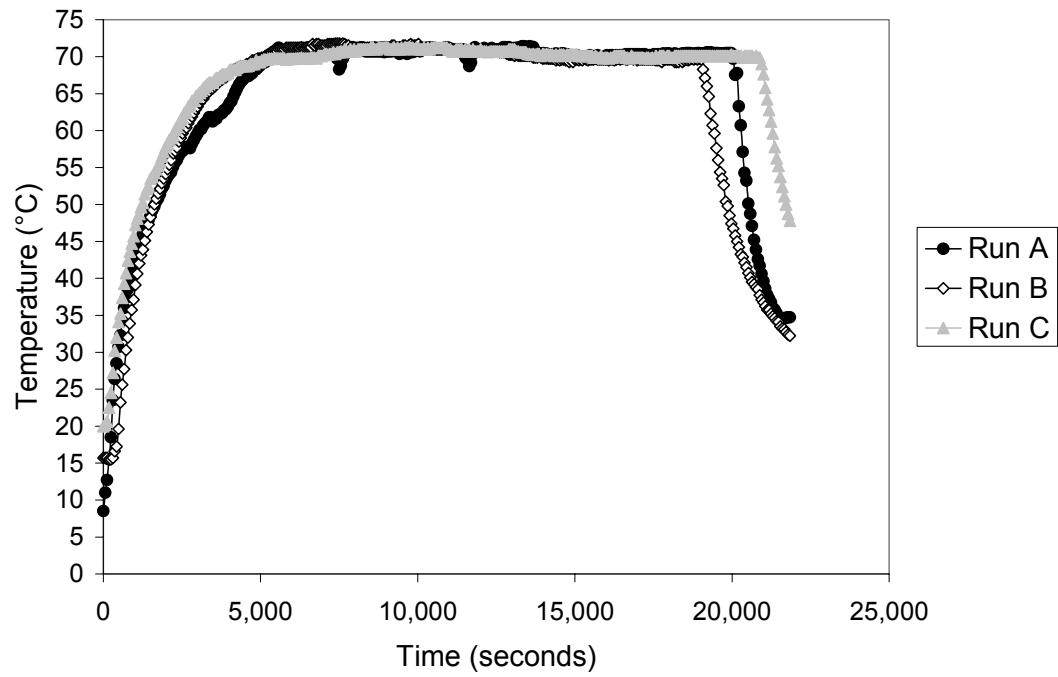
Figure 3. Profile from an overhead area adjacent to inlet
