DOT/FAA/AM-98/13

# **A Human Factors Perspective on Human External Loads**

May 1998

Final Report

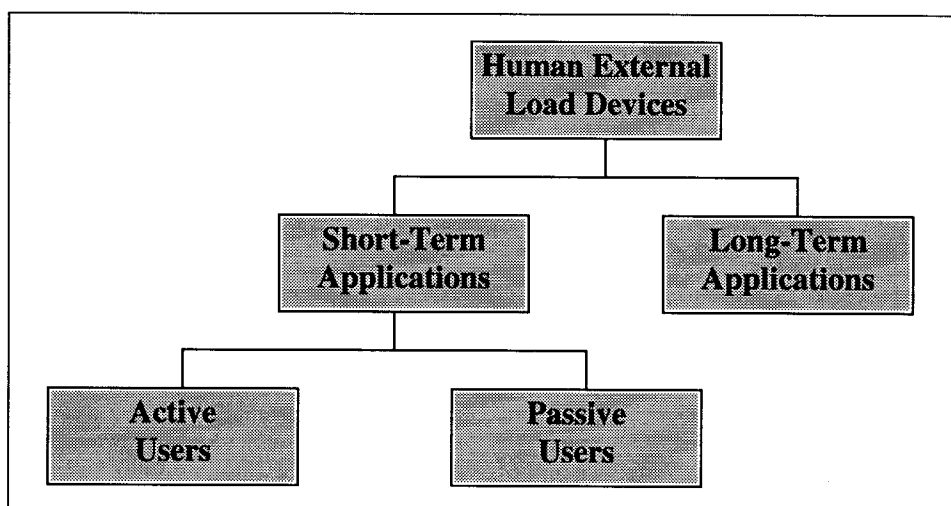
**Figure 1.** Categorization of Human External Load Suspension Devices.

Short-term applications of HEL include rappelling, short hauling, and rescue operations. Devices used in such applications are directly attached to the user for the duration of the activity, which usually involves transporting the user to a near location. This category can be further subdivided into active users and passive users according to the level of involvement of the user in the HEL operation. In the case of the active user, the passenger must actively participate in the lifting operation, such as maintaining a grasp on a center bar or hoist rope for balance. These short-term, active-user devices can be used if the user is capable of the necessary performance. On the other hand, passive-user devices are used in rescue operations to transport injured or impaired personnel who are unable to assist in their own rescue. Examples of such devices include rescue baskets and stretchers. Typically, rescue personnel are required to assist passive users in order to position the user in the HEL device. Figure 1 is a graphic illustration of the HEL device categorization scheme.

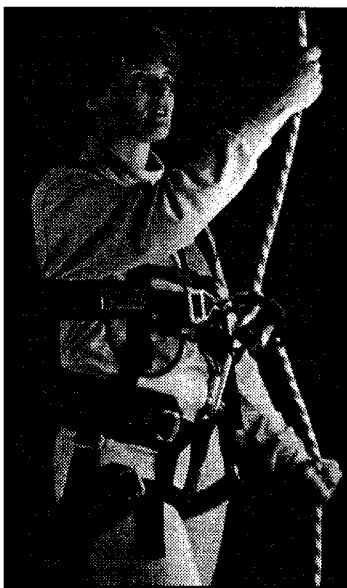
**Figure 5.** Pro Series Full Body Harness (CMC Rescue Equipment).

Full-body harnesses (FBHs) represent a combination of sit harnesses and chest harnesses. While there are numerous variations of the basic design of the harness, all full-body harnesses include leg loops, shoulder straps, and either a waist belt, a chest belt, or both. The design of the various components resembles that described for the sit and chest harnesses. Figure 5 is an example of the CMC Rescue Equipment (2) full-body harness. Most full-body harnesses are fully adjustable, although some are individually sized and are available with quick-release buckles for fast, easy donning. Again, some manufacturers utilize 2 in. nylon webbing while others incorporate 3 in. webbing with padding into the harness. One manufacturer, Surety Manufacturing and Testing Ltd. (3), incorporates a redundant safety system into the harness by including plastic components which ensure that the hardware is properly positioned. The design of full-body harnesses is such that it assists the user in maintaining an upright, seated posture while suspended from the helicopter.

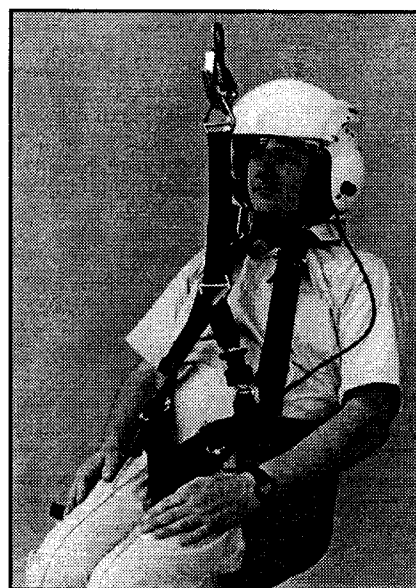
**Figure 6.** Full Body Seat Harness (Lifesaving Systems Corporation).

Other modifications to the basic design of the full-body harness are worth mentioning. One modification is the addition of a mesh vest to the shoulder straps to provide additional comfort and visibility. Another manufacturer, Lifesaving Systems Corporation (4), has developed a full-body hoisting harness that is an entire torso suit. The webbing is attached to a nylon mesh suit that has a large range of adjustability. The suit helps to distribute the load across the entire torso, minimizing localized pressure points. The suit is also manufactured in orange, which dramatically improves the conspicuity of the user. The last substantial modification identified was the addition of shorts to the full-body harness, called the full-body seat harness. This fully-adjustable harness (Figure 6) combines the features of a full-body harness with a seat harness by incorporating a contoured seat in place of the leg loops and waist belt. The seat is connected to shoulder straps at the waist. The tether point-of-attachment is at the top of an inverted "Y" that connects to the seat at each hip and is connected to the shoulder straps via an additional strap. This harness provides a high degree of mobility and freedom of the hands and is perhaps the most comfortable working platform available in harnesses. The full-body seat harness is applicable to extended duration operations. A different version of this same device is the rescue

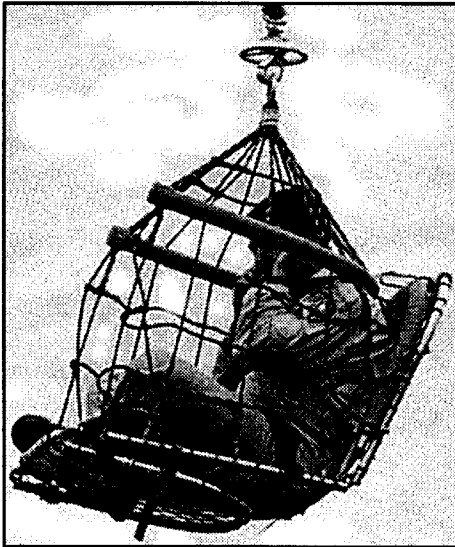
**Figure 8. Stretcher Rescue Net (Billy Pugh Company).**

Rescue nets are another device developed for the transport of individuals. The series of rescue nets manufactured by Billy Pugh Co., Inc. (7) follow the basic design of a suspended cage made of a flexible cabling with one open side. The nets are designed such that gravitational forces locate the occupant to the rear of the cage. Rescue nets are available in models that fold for storage, as well as models that can be used in a chair mode or a stretcher mode. Figure 8 illustrates a rescue net in the stretcher mode. Rescue operations comprise the majority of the applications of the net, although transport of personnel is also possible. However, the user sits in the net without any additional restraints or harnesses. Also, given the nature of the flexible netting, movement within the net is somewhat cumbersome.

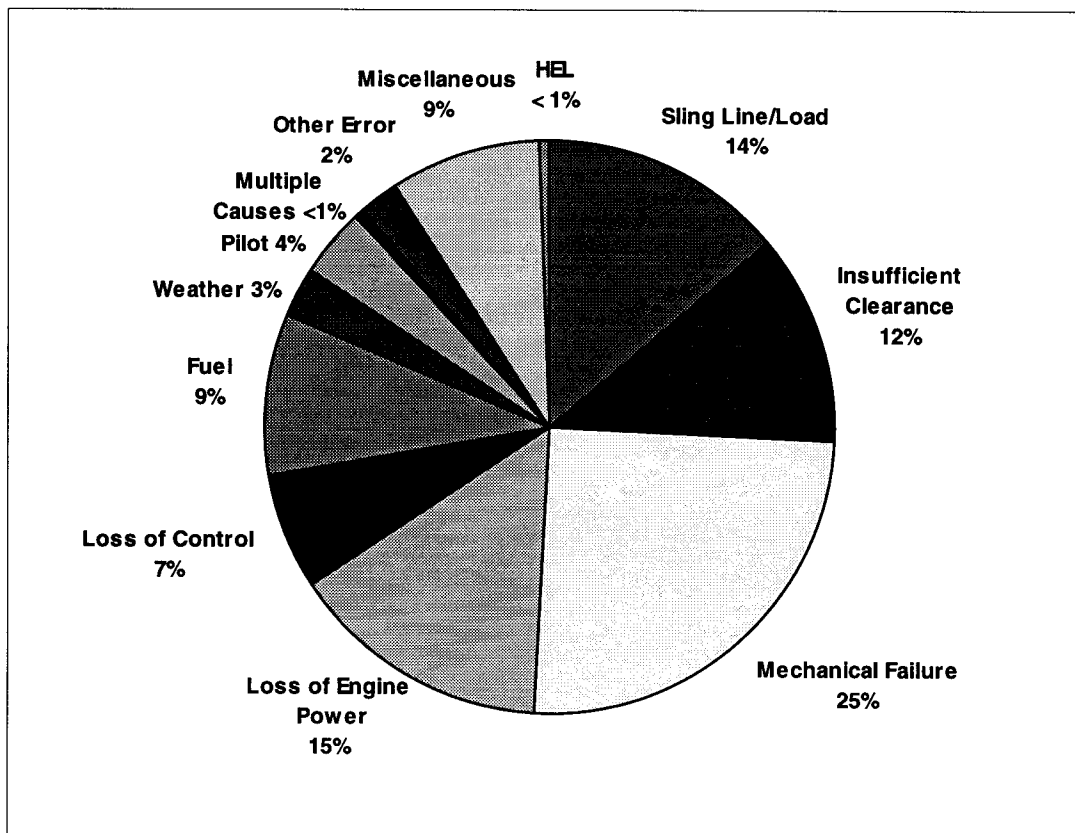
**Figure 12.** Categorization of Rotorcraft Accidents/Incidents by Cause (N=616).

A histogram detailing the number of external load rotorcraft accidents/incidents by cause is presented in Figure 11. Figure 12 presents the categorization as a percentage of total accidents/incidents. As shown in both figures, mechanical failure was involved in the largest number of accidents. One hundred fifty-four (25%) helicopter accidents resulted from some form of mechanical failure; mechanical failure implied failure of the airframe, a component, or system due to material fatigue. Loss of engine power was the second most common cause, contributing to 90 events, or 15% of all rotorcraft accidents. Engine power was lost either totally or partially and was typically due to specific mechanical failures and malfunctions of the engine.

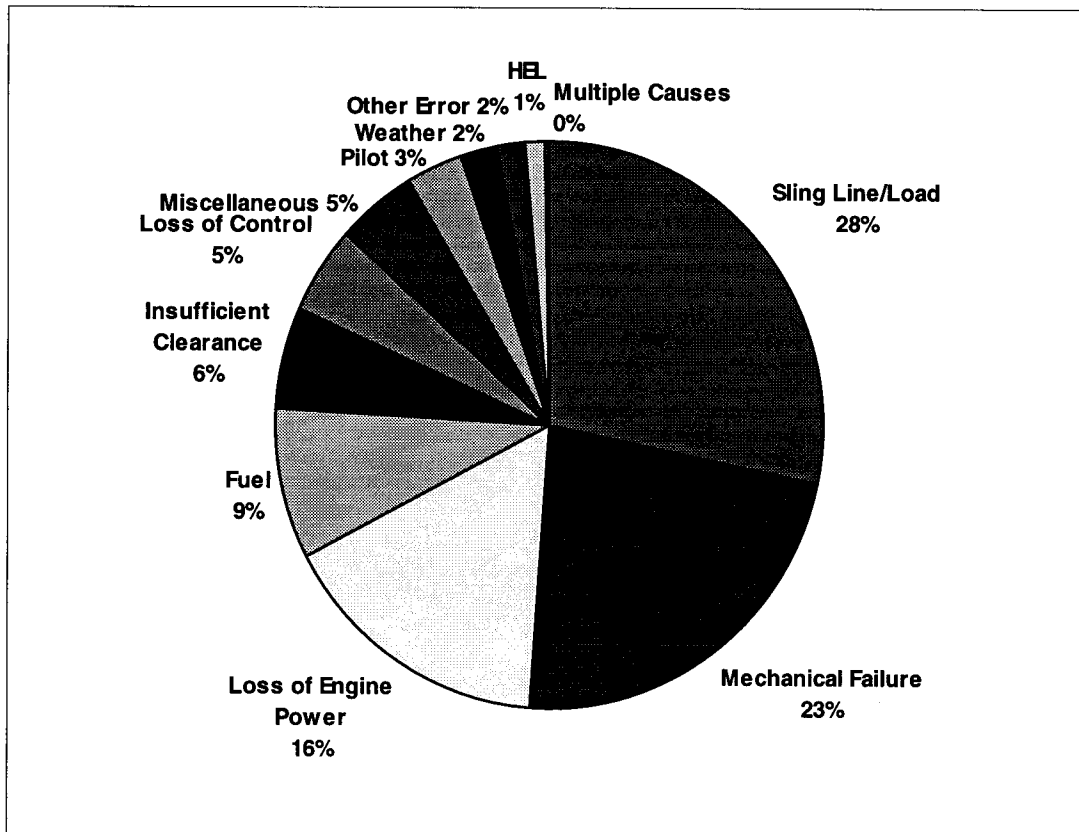
**Figure 14.** Categorization of Rotorcraft Accidents/Incidents During External Load Operations by Cause (N=301).

Figures 13 and 14 display the categorized data for the number and frequency, respectively, of accidents/incidents occurring during external load operations. The charts show that the predominant cause of external load accidents (85 accidents or 28%) was problems with the sling line/load. Specifically, 28 accidents were attributed to failure to maintain sufficient clearance for the sling line or load. The typical scenario in these accidents was that the load, cargo hook, or cargo basket was dragged along the ground and became snagged on an environmental obstruction. In most cases, these were initiating events that led to the accident's direct causes, including the line rebounding into the rotor, the load falling and hitting a member of the ground crew, failed load release, or losing control of the helicopter. Twenty-four accidents involved the sling line becoming tangled in the tail or main rotor. Often, these accidents were due to turbulent winds, shifting loads, unweighted lines, inappropriate line tension, incorrect line length, failed emergency release, or other inappropriate operations. These accidents were the most critical, as evidenced by the highest frequency and severity of injuries. In 16 events, the weight of the load exceeded the maximum rated capacity of the helicopter. The remaining 17 events involving the sling line or load were distributed among excessive load swing, broken sling line, and sling line caught on the skid.
