# THE "STALL BARRIER" AS A NEW PREVENTIVE IN GENERAL AVIATION ACCIDENTS

September 1966

FEDERAL AVIATION AGENCY  
Office of Aviation Medicine

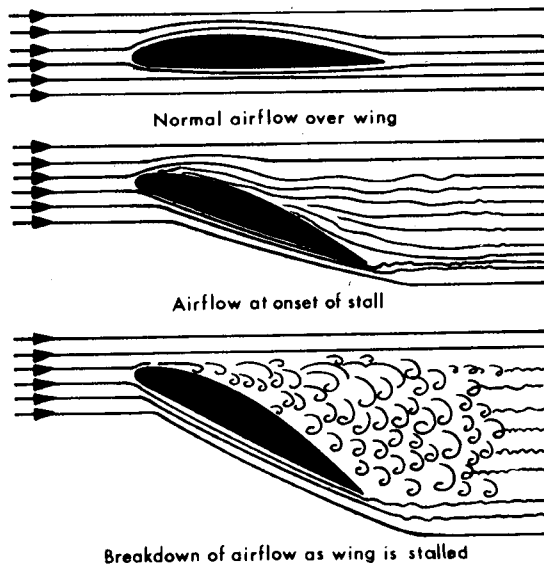
FIGURE 1. The breakdown of airflow as a wing is stalled is shown. The stall warning system provides a small vane at a point on the leading edge of the wing. Just prior to a shift in airflow over the wing which heralds an impending stall, the small vane is pushed upward completing an electrical circuit.

All subjects found that just prior to the onset of a stall, the stick was pulled firmly forward, preventing the stall. The timing in all cases was precisely coordinated with the actuation of the stall warning vane on the left wing.

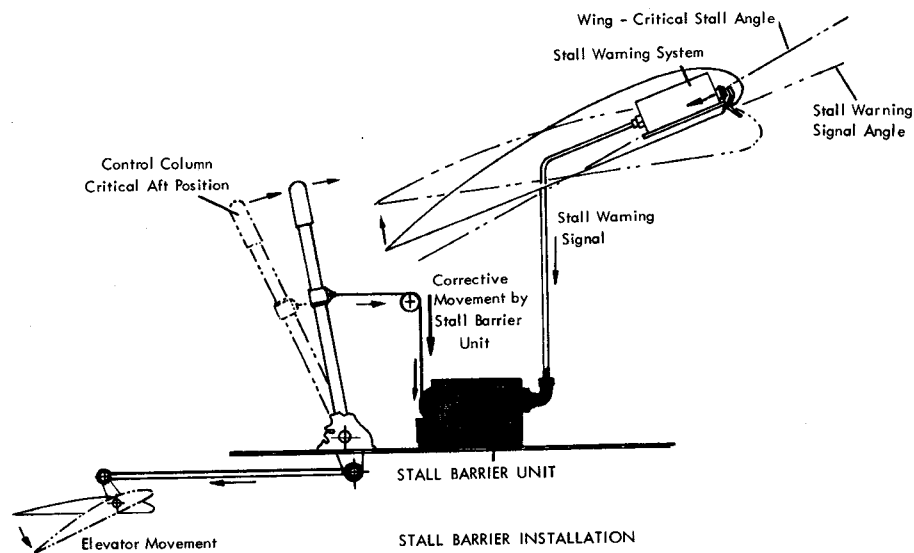
FIGURE 2. The "Stall Barrier" is shown diagrammatically. When the control column is far enough aft to place the aircraft in danger of stalling, the stall warning system is activated and the servo motor in the Stall Barrier pulls the column forward. The stall is thus averted.

In order to validate this approach to the problem, a small electric servo unit was installed in the cockpit of the Beechcraft T-34B aircraft operated by the Civil Aeromedical Research Institute. A cable from the drum of the servo unit was connected to the stick. The magnetic clutch of the servo was wired into the airplane's conventional stall warning system (present in almost all light aircraft) so that as the stall

warning is triggered by a high angle of attack, the magnetic clutch is energized. The stick is then pulled forward until the angle of attack of the wing is restored to a normal flight range, at which point the stick is released. A rheostat was installed enabling the stick-pull force to be varied between 5 and 90 pounds.
