**DOT/FAA/TC-14/23**

# **Development of a Firefighting Agent Application Test Protocol for Aircraft Fuselage Composites, Phase I—GLARE**

August 2014

Final Report

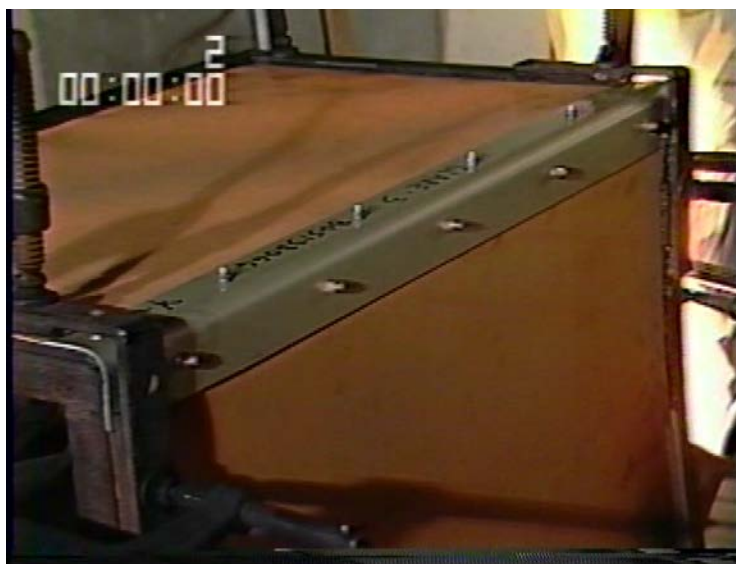
Figure 2. Cessna GLARE Cargo Liner Corner Test Setup

the Oil Burner Test for Cargo Liners method, which uses the Park Oil burner in a vertical configuration with a 2-gallon-per-hour fuel spray nozzle. The videos show the test beginning when the burner slides into the test frame after a 2-minute preburn. The test ran for 5 minutes. The corners were made of either GLARE 3-3/2 or GLARE 1-3/2, with a smooth 90° bend. An unknown thickness and brand of conventional phenolic cargo liner was fastened to the inside surface of the corner to make the top and side panels. Screw fasteners held the cargo liner to the corner. Figure 2 shows the test setup. There was no temperature data available from these tests, as they were pass/fail burnthrough tests.

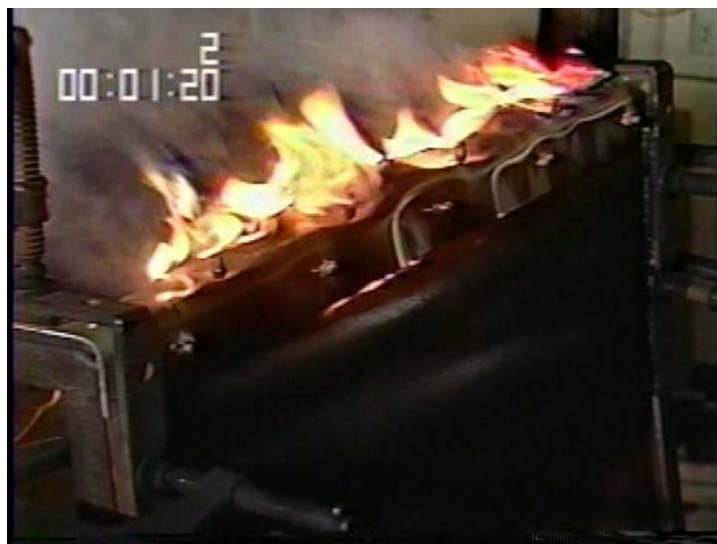
Figure 3. Cargo Liner Corner Test 2 of GLARE 3-3/2

Figure 3 shows a series of screen captures from the GLARE 3-3/2 Test 2 video, showing the test start, buckling and smoking, and sample ignition.

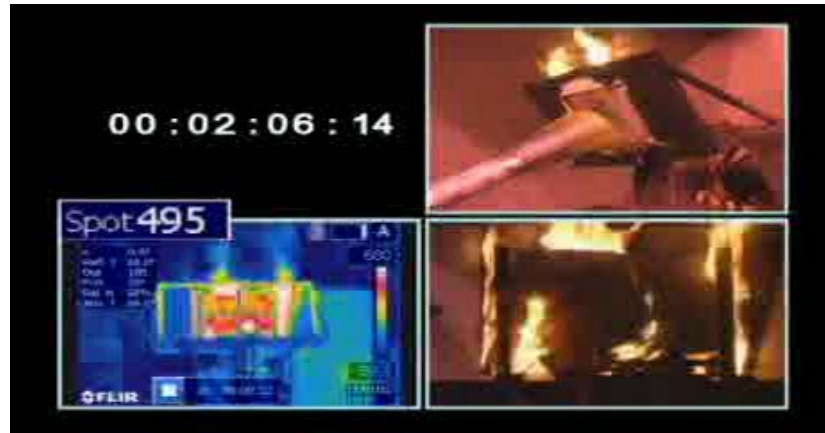
Figure 19. Test 1—1 Second After FAA NextGen Burner was Turned off

None of the flat panel tests achieved sample burnthrough. There was smoke ignition and resin off-gassing on the back during each 8-minute burnthrough test. Test 1 was stopped after 2 minutes 5 seconds due to severe burning of the sample. The sample ignited 43 seconds after

the test began. The flame stopped for 9 seconds at approximately the 1-minute mark before reigniting. Figure 19 shows the amount of free burning 1 second after the FAA NextGen Burner was turned off. After Test 1, the decision was made that the remaining two burnthrough tests would not be stopped early despite how much back burning occurred.

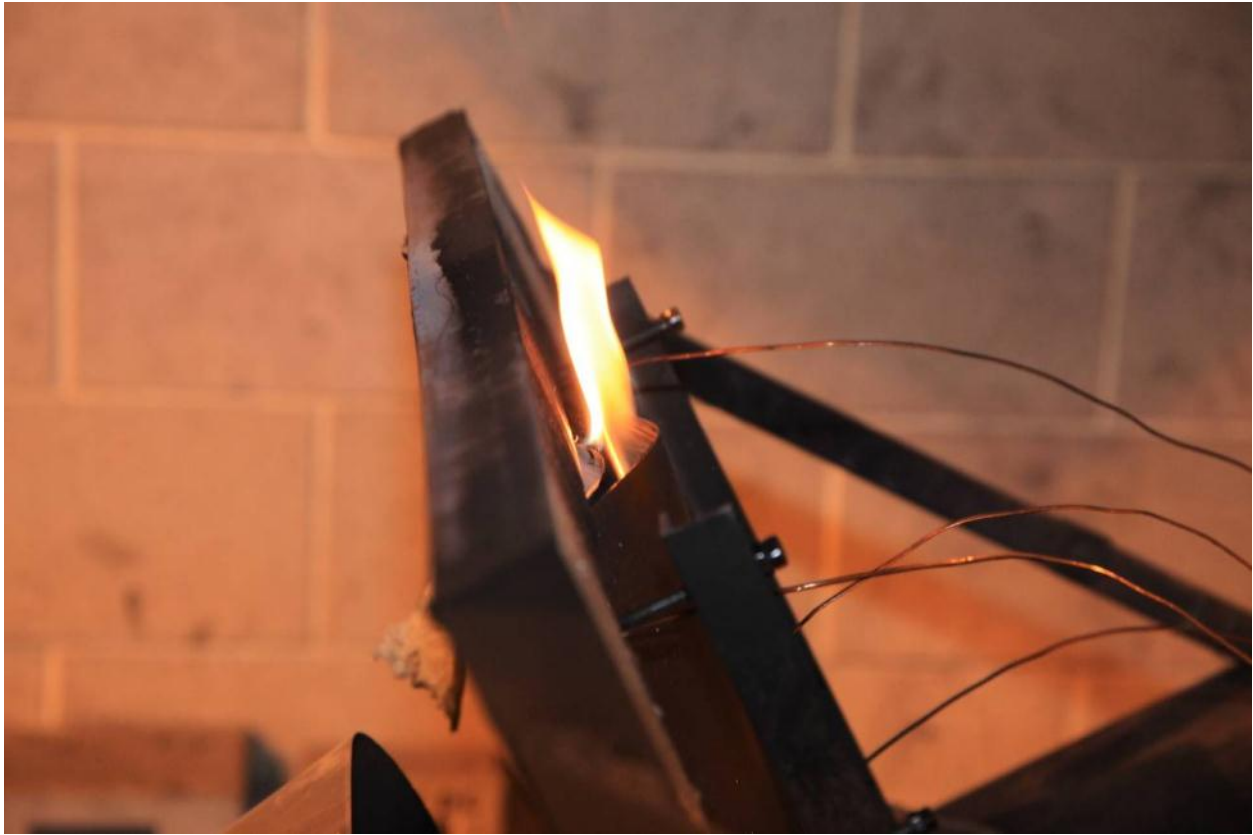
Figure 26. Chimney Effect in Test 6

Each sample bowed in the center, generally creating a chimney-like effect. Figure 26 shows the chimney effect created after the pop during Test 6. Burning continued at the chimney opening in Test 6 for 53 seconds after turning off the FAA NextGen Burner.

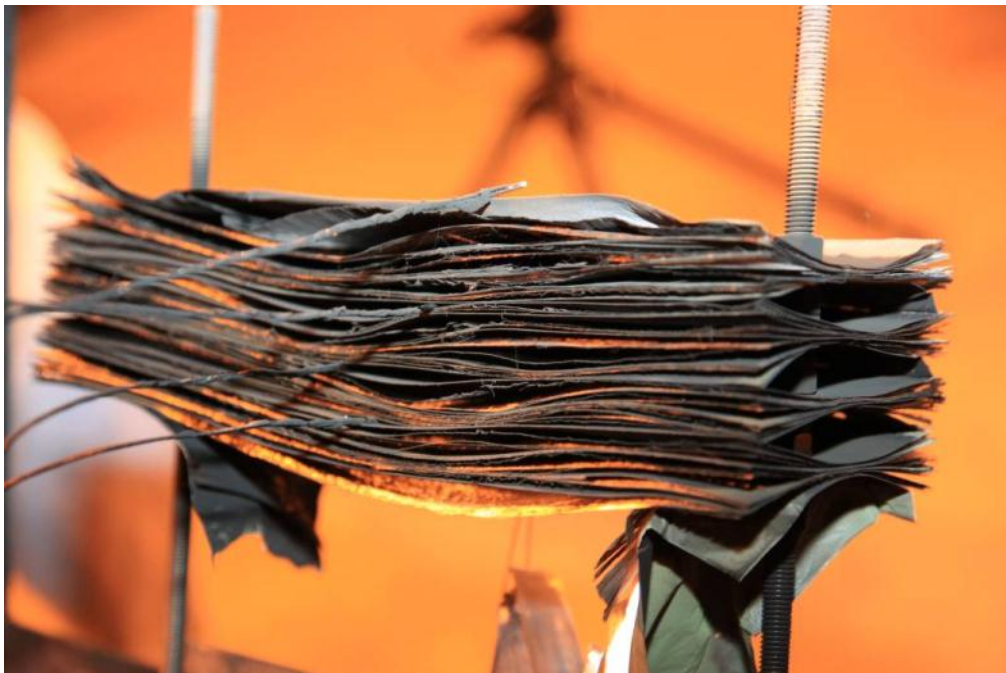
Figure 30. Delaminated Sample After Test 11

The layered tests expanded the assessment of smoldering by creating a configuration that gave the best opportunity to radiate heat between layers. The CFRP tests showed that some smoldering occurred, mainly in the corners, but very high-temperature smoldering occurred during the layered tests [4]. The GLARE tests did not exhibit smoldering. Tests 10 through 12 exposed the GLARE for 1 minute. After exposure, all four pieces in the layered configuration were completely delaminated. Even the flat panel tests had completely come apart, as discussed in section 5.1. Figure 30 shows the delaminated sample after Test 11.
