**DOT/FAA/TC-15/2**

# **Evaluation of Aviation Rumble Strips**

January 2015

Interim Report

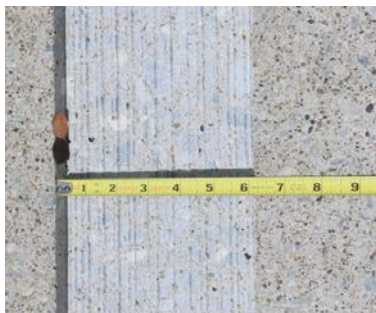
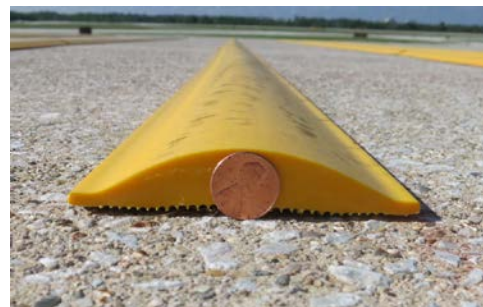
Figure 2. Rumble Strip Configuration Design

(a) Sawcut Rumble Strip Configuration

(b) Raised Rumble Strip Configuration

(c) The 6" Wide Sawcut Rumble Strip

(d) The 4" Raised Rumble Strip Profile

This research constructed a test facility at the Purdue University Airport with both sawcut (figure 2(a) and (c)) and raised rumble strips (figure 2(b) and (d)). The raised rumble strips were constructed first because of their flexibility for empirically assessing alternative spacing in a short time.

The seven rumble strips in the sawcut installation are shown in figure 2(a). R1 and R2 were 8 in. wide, R3 and R4 were 6 in. wide, and R5, R6, and R7 were 4 in. wide. Sawcut rumble strips were used rather than milled rumble strips because the focus of the project was GA airports, and equipment to install sawcut rumble strips was much more readily available than equipment to install milled rumble strips. Milling machines remove a larger area of pavement at a time than sawcutting machines; however, they are larger and more costly. A photograph of a portion of the 6" wide sawcut R3 rumble strip is shown in figure 2(c) (all dimensions nominal). The center-to-center spacing between installed stripes for both the sawcut and raised rumble strips was 3 ft, 3 ft, 2 ft, 2 ft, 1 ft, 1 ft' (as shown in figure 2(b)), but the raised rumble strips were all 4 in. wide (figure 2(d)).

The completed test bed included a 20-ft-wide sawcut rumble strip configuration followed by a 24-ft-wide raised rumble strip configuration (the raised rumble strips came in 6-ft modules). The width was increased relative to the 1980 design to allow all landing gear for most GA aircraft to traverse the rumble strips. The sawcut and raised rumble strips sections were separated, so the residual acceleration from the first section was unable to impact the second section for most GA aircraft.
