PASSIVE COLLISION ALERT SYSTEM (PCAS) DEMONSTRATION PROGRAM—FINAL REPORT

UtopiaCompression Corporation

New Mexico State University Physical Science Laboratory

Date: 9/2/2021

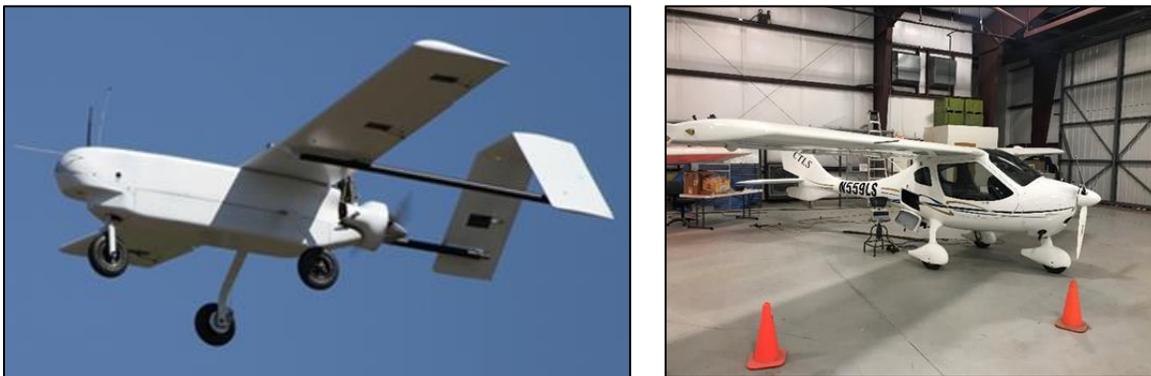
Figure 1: Ownship MLB Bat-4 (left) and Intruder CTLS (right)

The first of four flight test events took place at the NMSU FTC from 7/8/2020 to 7/14/2020. Due to the embedded computer issues described above we used a laptop computer running the refactored/ROS PCAS software stack in single-camera configuration with 40° FOV. Figure 1 shows the ownship MLB Bat-4 and the CTLS intruder.

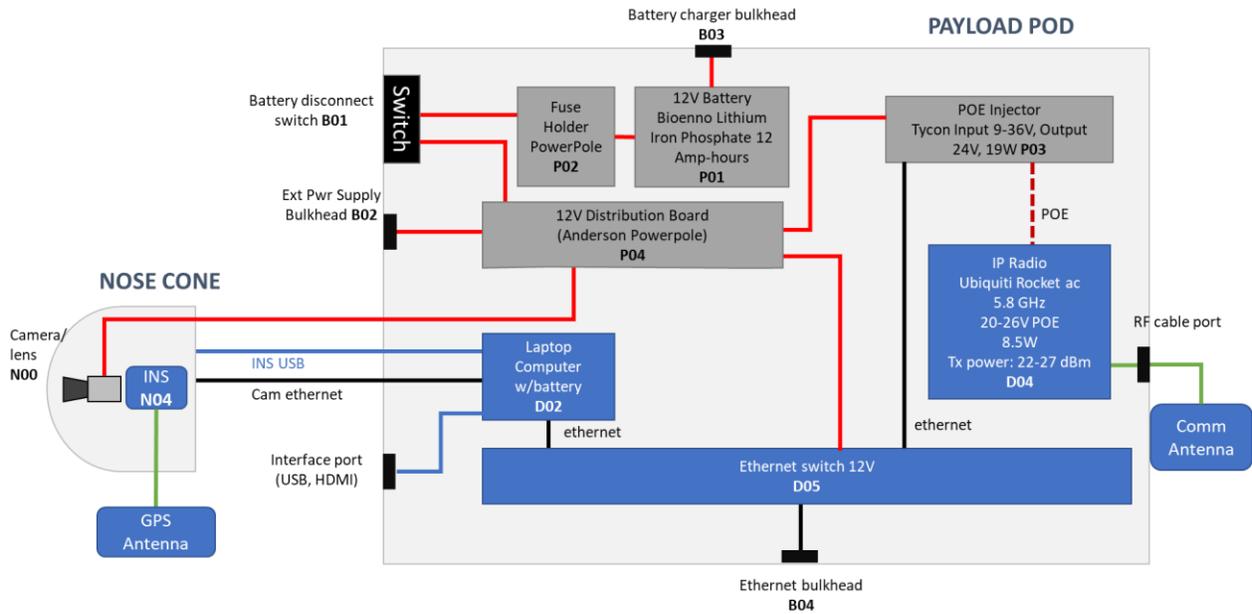
Figure 2: Payload + Nose Cone Block Diagram

The payload configuration is shown in Figure 2 and is described in detail in the FT1 post-event report. The camera was the VLG-40C gigabit ethernet (GigE) camera manufactured by Baumer,

Ltd, with a 40° FOV lens. The camera interfaced directly with the computer's network card build into the motherboard.

Payload, nose cone, and vehicle integration and ground testing was done on 7/8 and 7/9/2020. All components were installed into the payload pod and nose cone. Additionally, as shown in Figure 2, several bulkheads, switches, and ports were installed allowing ease of access while the vehicle is on the ground. An L-bracket was fabricated to install the camera/lens in the nose cone. The GPS antenna was installed on the top of the fuselage and the RF radio antenna was installed on the underside of the payload pod. Some of the integration activities are shown in Figure 3. Figure 4 shows the integrated payload sans computer.

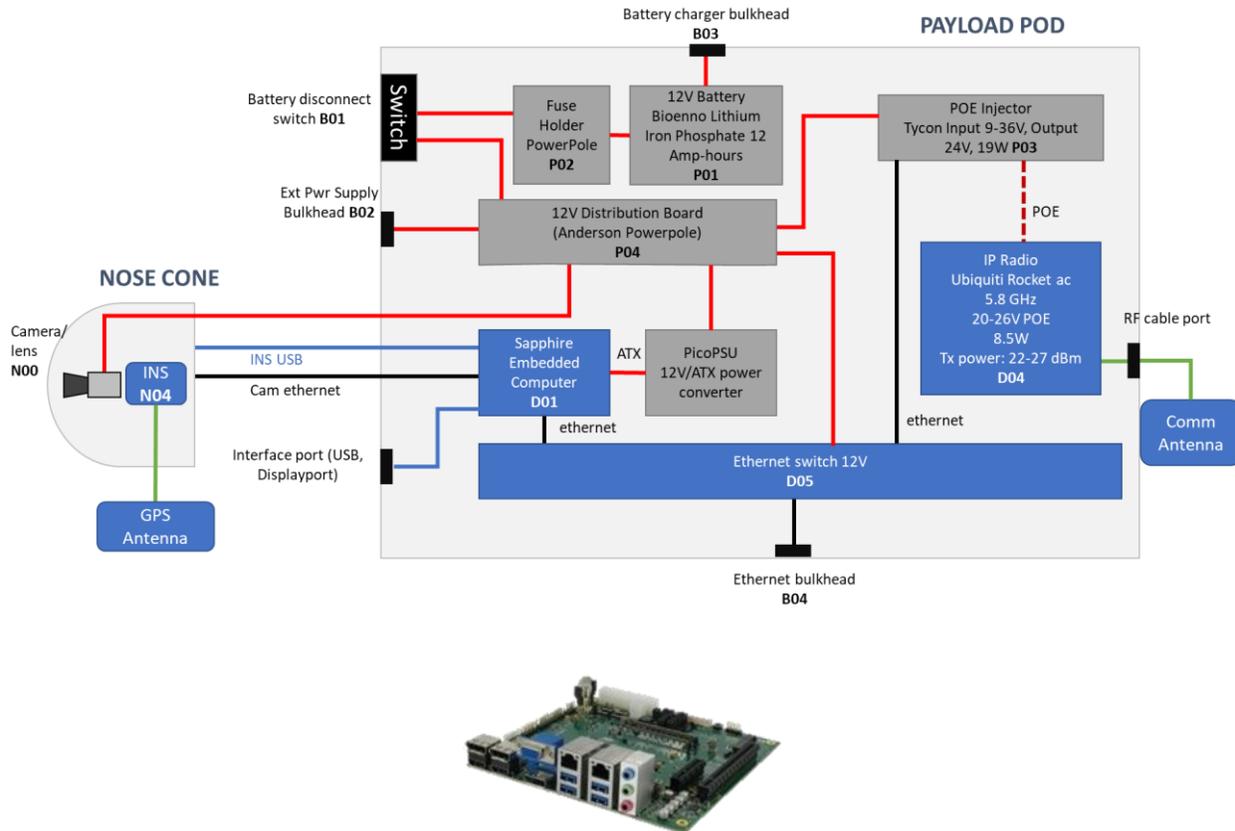
Figure 5: Payload + Nose Cone Block Diagram and Sapphire Embedded Computer

The second flight test took place from 10/12/2020 to 10/16/2020. This test was similar to FT1, but this time, the single-board embedded computer was used instead of the laptop. The payload configuration is shown in Figure 5. Importantly, the autoexposure algorithm was used in this test to provide a consistent image quality sufficient for detection of the intruder. Recall that this algorithm was not used in FT1, which degraded the detection performance.

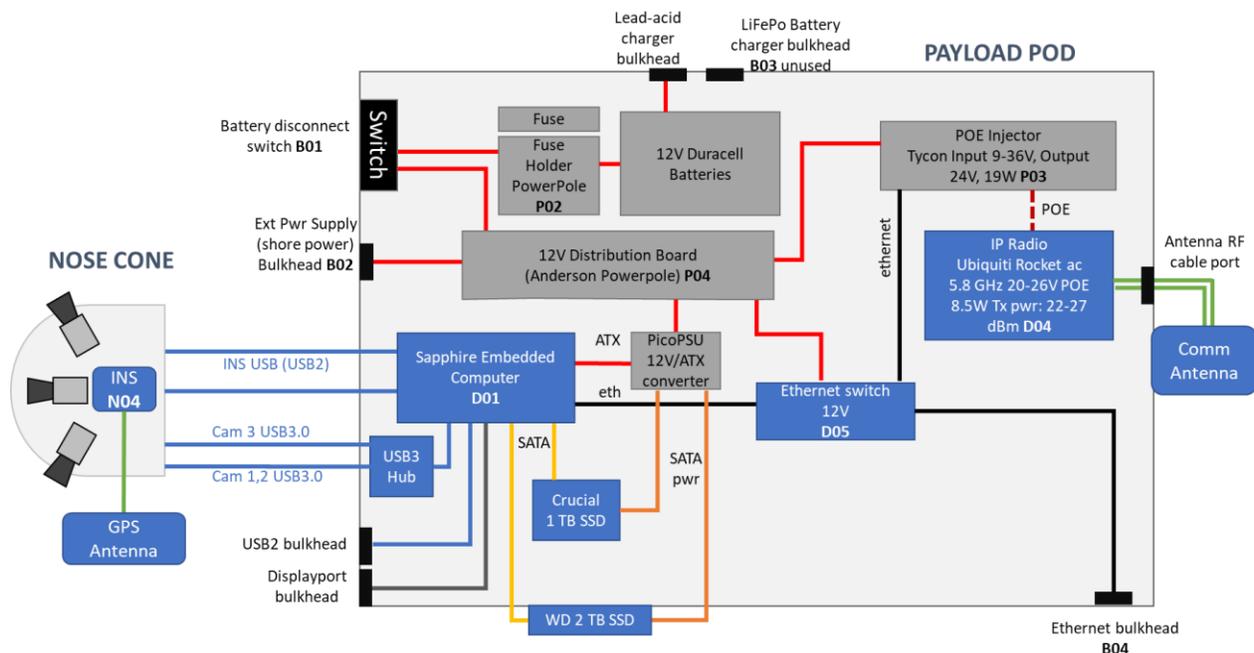
Figure 6: Payload + Nose Cone Block Diagram

In Flight Test 3, the decision was made to use three cameras. As mentioned earlier, we chose USB3 cameras for their high data rate and ability to transmit high resolution images at a fast frame rate. As we also mentioned above, the loaner Merlin-Falcon computer has only two USB3 ports and we believed this would preclude using three cameras simultaneously. However, using a USB3 hub, we were able to capture data from all three cameras at a frame rate of 10 fps. Figure 6 shows the configuration for FT3. For more details, refer to the FT3 post-event report.

Payload, nose cone, and vehicle integration and ground testing was done on 3/10/21—3/12/21. All components were installed into the payload pod and nose cone. A new mounting plate was fabricated for the three-camera system. The aircraft was deemed safe to fly at this time and the aircraft was transported to the Jornada test range for flight activities planned the week of 3/15/21.

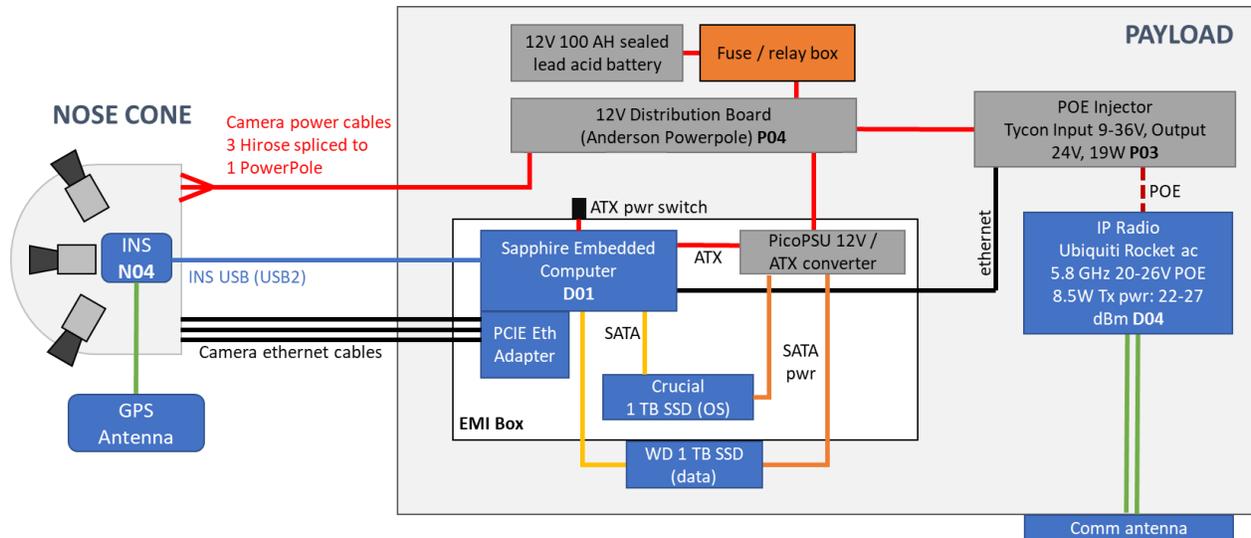
Figure 8: Payload + Nose Cone Block Diagram

In FT4, we tested the 3-camera PCAS system using GigE cameras. We used three Baumer VLG-40C cameras and purchased new lenses giving each camera an 86.26° FOV. The cameras were mounted such that a total FOV of 238.8°. The single-board computer has two Ethernet ports on the motherboard, one of which is used for the IP radio. Thus a PCI network interface card was added for each camera to connect to. Note that using an Ethernet switch did not work due to collisions. Instead, three separate ports (on the card) were configured each on a separate subnet. This enabled the three cameras to work simultaneously.

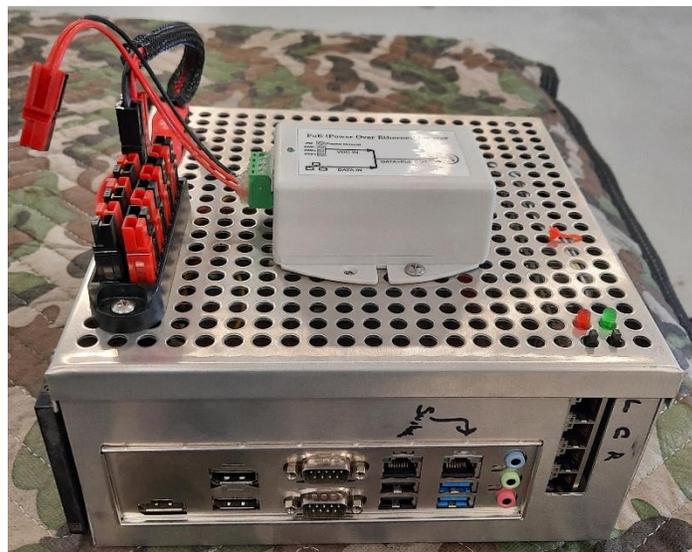
Figure 9: EMI enclosure

Bat-4 integration was done on 6/21/21—6/25/21. This activity is detailed in the FT4 post-event report. Due to bad weather as well as previous commitments by NMSU in late June and early July, the continued FT4 activities were deferred to the week of 7/12/21. At that time, the payload was integrated onto the Aerostar UAV. The payload diagram is shown in Figure 8. The EMI enclosure which houses the computer, power supply, ethernet adapter card, and one SSD hard drive (with the operating system) is shown in Figure 9.
