MITSUBISHI MU-2 AIRPLANES; Availability of Special Certification Review

Subject: ACTION: Mitsubishi MU-2 Special Certification Review (SCR) Program

SPECIAL CERTIFICATION REVIEW OF MITSUBISHI MU-2

FINAL REPORT

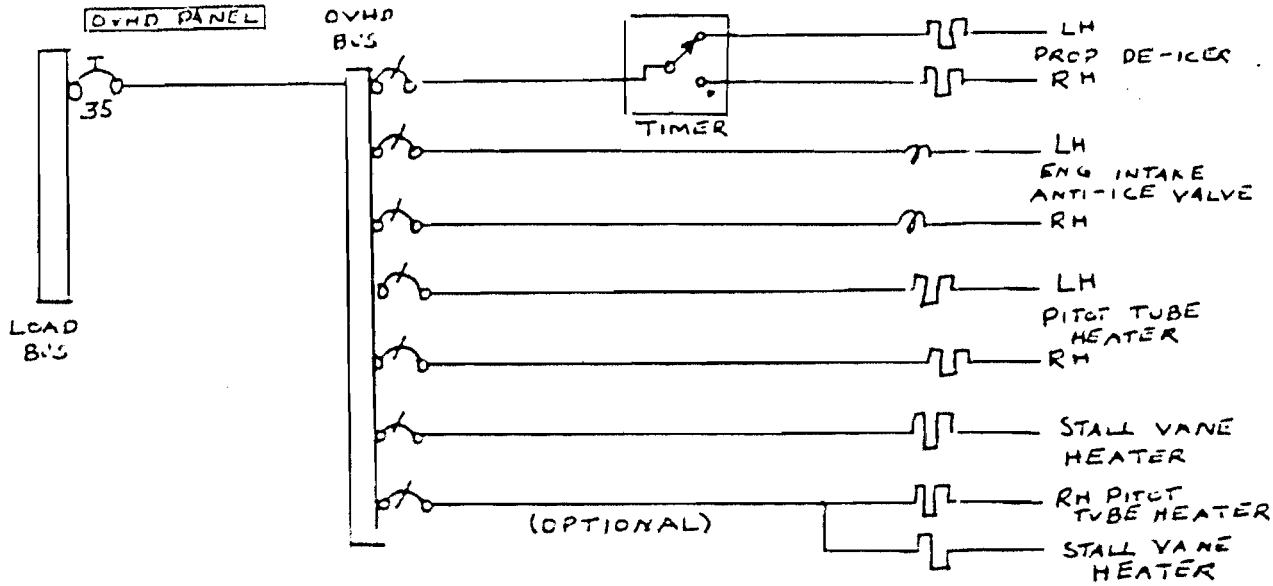
1. LH/RH propeller deicer heaters.
2. LH/RH engine intake anti-ice valves.
3. LH/RH pitot tube heaters.
4. Stall warning vane heater.

B. A failure mode and effects analysis of the circuit follows:

b. If the above systems are not being operated, there will be no effect on the operation of the airplane (e.g., not in icing conditions) but the failure will not be annunciated to the pilot.

c. If the failure occurs during icing conditions while these systems are being operated, it can be detected by observing the absence of current on the PROP DEICER current meter and the extinguished ENG HEAT INTAKE lights on the overhead panel. Since these systems should be monitored when entering icing conditions and during icing conditions, their absence should alert the pilot to vacate the icing area as soon as possible.

C. A single failure (a fault of the OVHD circuit breaker can cause a loss of all of the previously reviewed Deice loads. MIL HDBK 217D lists the Mean Time Before Failure of a circuit breaker as 5×10^5 operating hours.

The combination of circuit breaker reliability, circuit protection for each switch/circuit breaker controlled load and the power monitoring capability provided by the PROP DEICE current meter and ENG INTAKE heat lights were and are considered adequate in meeting the CAR 3.681, 3.690, and 3.691 requirements. In addition there is no adverse service history showing this installation to be unsafe. The power monitoring capability of this system is designated in the following photograph of the OVERHEAD PANEL.

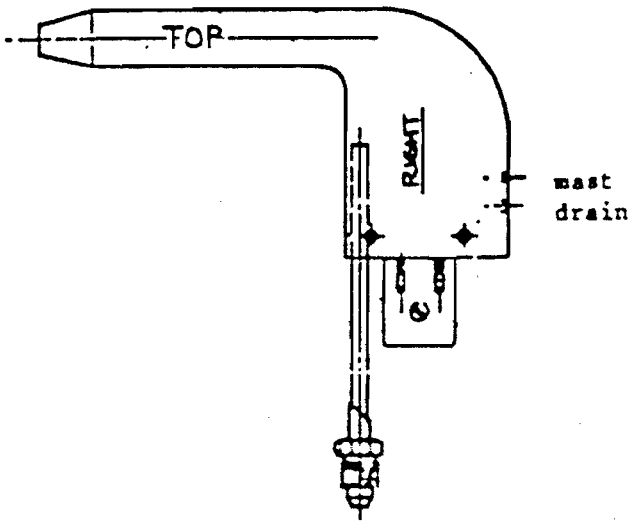
PH 506 Pitot head

Subsequent investigation has revealed it is possible for moisture to collect and freeze within the pitot mast casting and not properly drain out of the mast drain.

This is caused in part by the horizontal mounting of the pitot tube assembly. In addition, the lower heat (PH 506 L or R) pitot tubes do not incorporate a heater in the mast as does the higher heat pitot tube (PH 1100 R or L). Since the higher heat pitot tube utilizes a mast heater, the collected moisture does not have an opportunity to freeze and obstruct the pitot pressure.

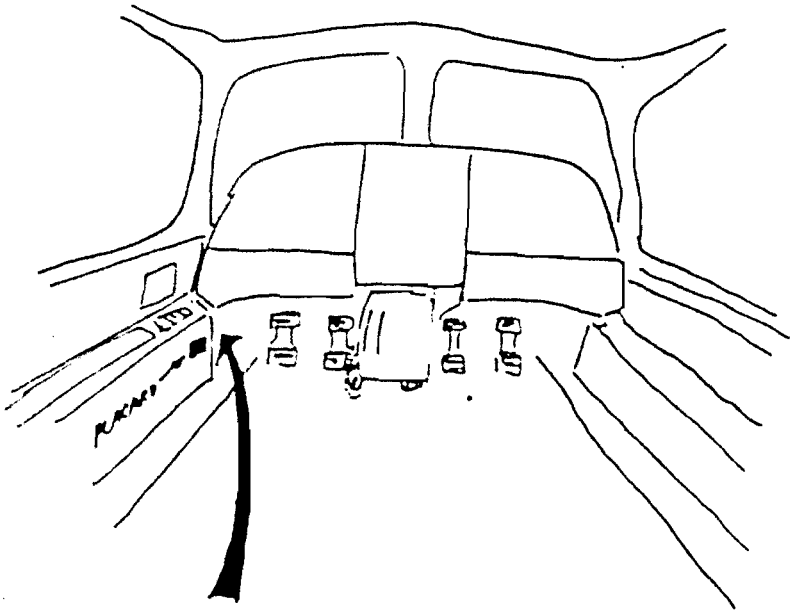
Field Approved Alternate Static Source Selector Location

The other alternate static system that may be installed on the MU-2 was a "field approved" installation. The location of this alternate static source selector is on the left side panel close to the left-hand corner of the lower instrument panel. See sketches of the installation.

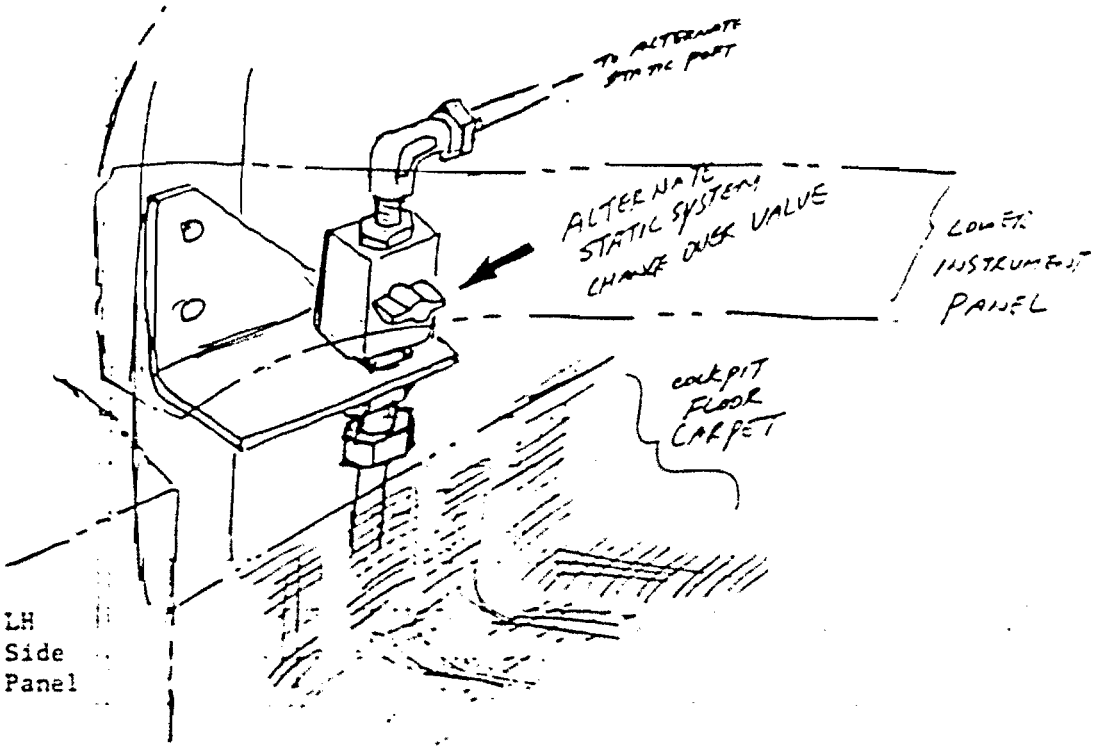
Additional Field Approved Alternate Static Source

The field approved alternate static source selector could possibly be installed on the following 21.29 MU-2s:

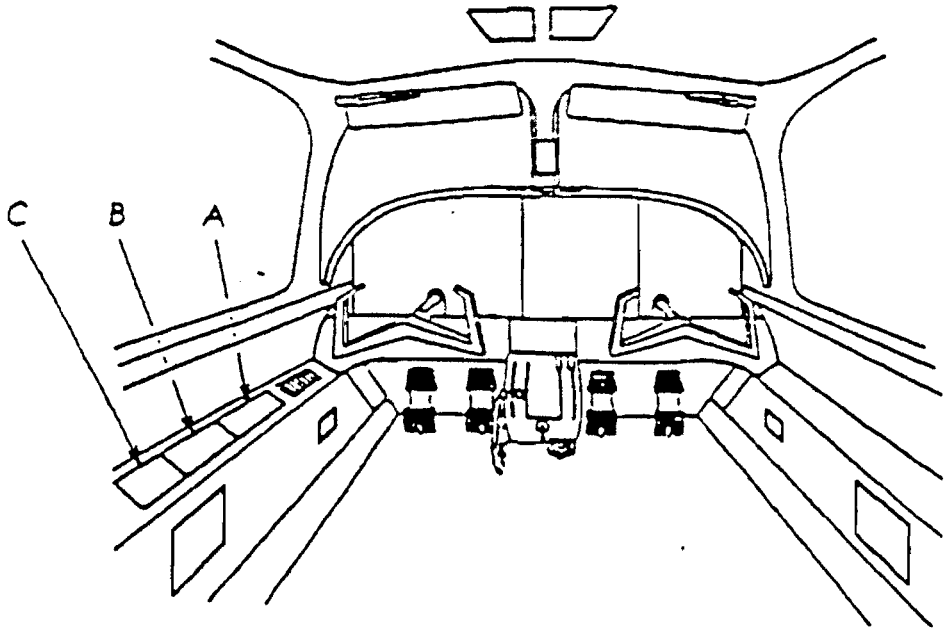
FIG 1. Circuit Breaker Panel Arrangement (See TABLE 1)

As shown on following pages, all circuit breaker panels are proper marking and grouping.

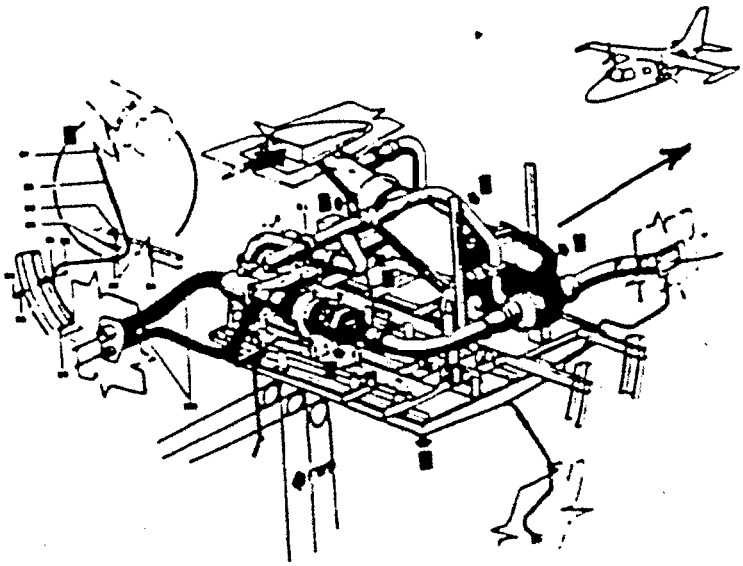
Direction of Failures

The AiResearch cooling turbine is installed on 21.29 airplanes, Serial Number 4 through 263 for the short body airplanes and Serial Number 501 through 570 for the long body airplanes.

Three of the four failures resulted in pieces of the turbine damaging the aircraft skin, the fourth failure did no damage to the airplane. In all failures, damage to the airplane occurred quite some distance and in a direction opposite from components critical to safety of flight. Components critical to safety of flight are considered to be simultaneous failures of the elevator cable and elevator trim cable. Since the cables are well separated from each other and all previous failures have occurred in the direction opposite from the cables, there is little likelihood of a simultaneous failure due to uncontained rotor failure.
