SEATTLE-TACOMA INTL AIRPORT

ALERT NOTICE

ATTENTION ALL AIRCRAFT LANDING TO THE SOUTH:

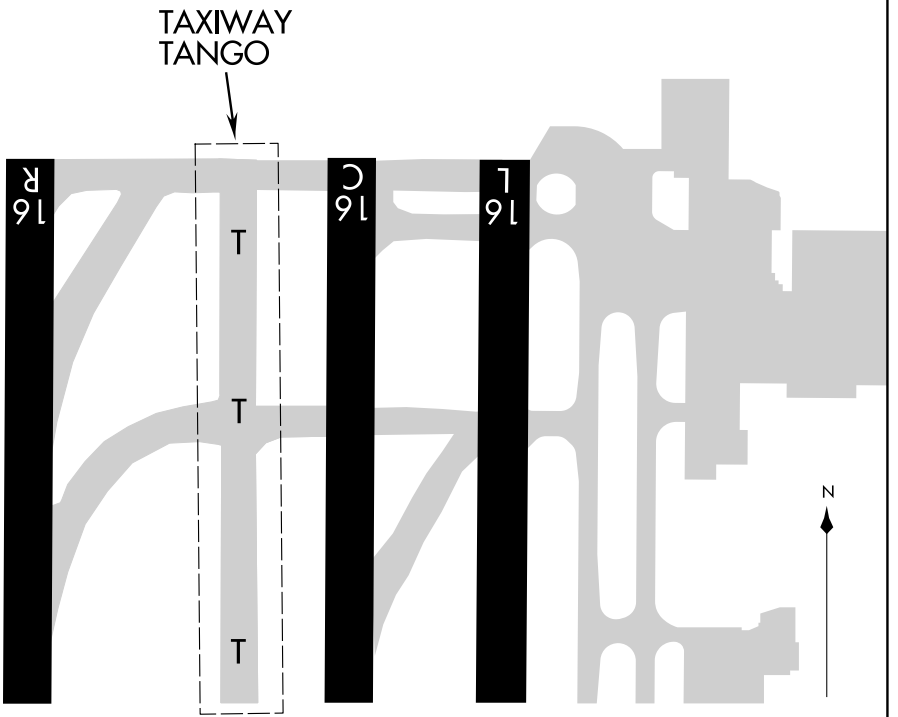
When transitioning from an instrument procedure to a visual approach to Runway 16C, verify you are aligned for the intended landing Runway, not Taxiway Tango. Taxiway Tango is west and parallel to Runway 16C.

Taxiway Tango has been mistaken for Runway 16C from the air during certain visibility conditions, i.e., wet runway, low sun angle reflections. Aircrews are advised to be aware of the proximity of the taxiway to Runway 16C and its runway-like appearance while on approach.

Aircrews should use visual cues, e.g., approach lighting systems, REILs, when available, to confirm alignment with Runway 16C not Taxiway Tango. Additionally, it is recommended when executing a segment of the ILS approach for a visual transition, track the localizer until the runway environment is visually verified.
