SEATTLE-TACOMA INTL AIRPORT

ALERT NOTICE

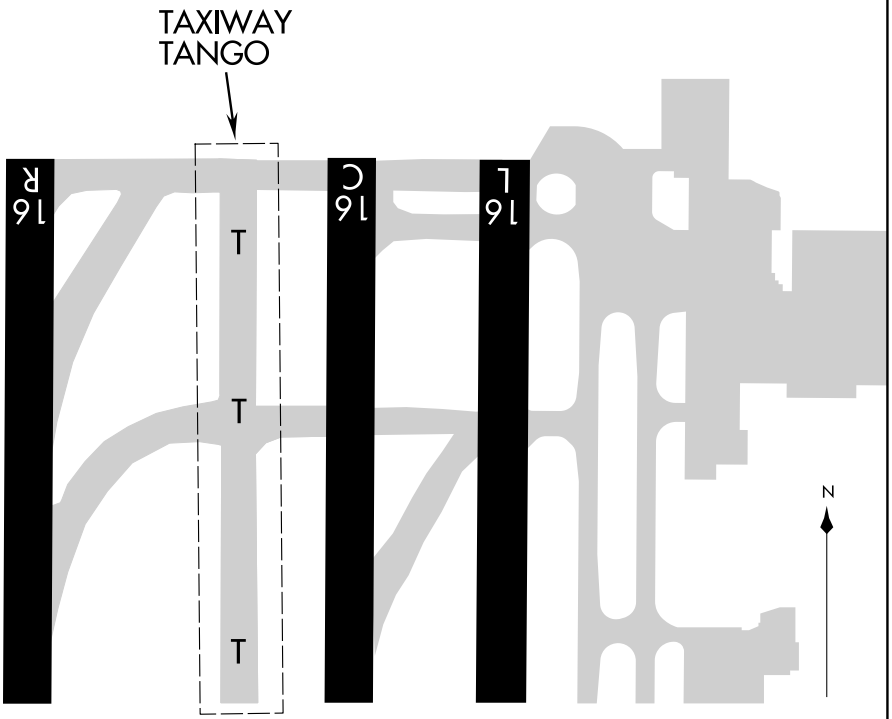
When transitioning from an instrument procedure to a visual approach to Runway 16C, verify you are aligned for the intended landing Runway, not Taxiway Tango. Taxiway Tango is west and parallel to Runway 16C.

Taxiway Tango has been mistaken for Runway 16C from the air during certain visibility conditions, i.e., wet runway, low sun angle reflections. Aircrews are advised to be aware of the proximity of the taxiway to Runway 16C and its runway-like appearance while on approach.

Aircrews should use visual cues, e.g., approach lighting systems, REILs, when available, to confirm alignment with Runway 16C not Taxiway Tango. Additionally, it is recommended when executing a segment of the ILS approach for a visual transition, track the localizer until the runway environment is visually verified.
