U.S. Department of Transportation
Federal Aviation Administration

ADVISORY CIRCULAR

43-16A

AVIATION MAINTENANCE ALERTS

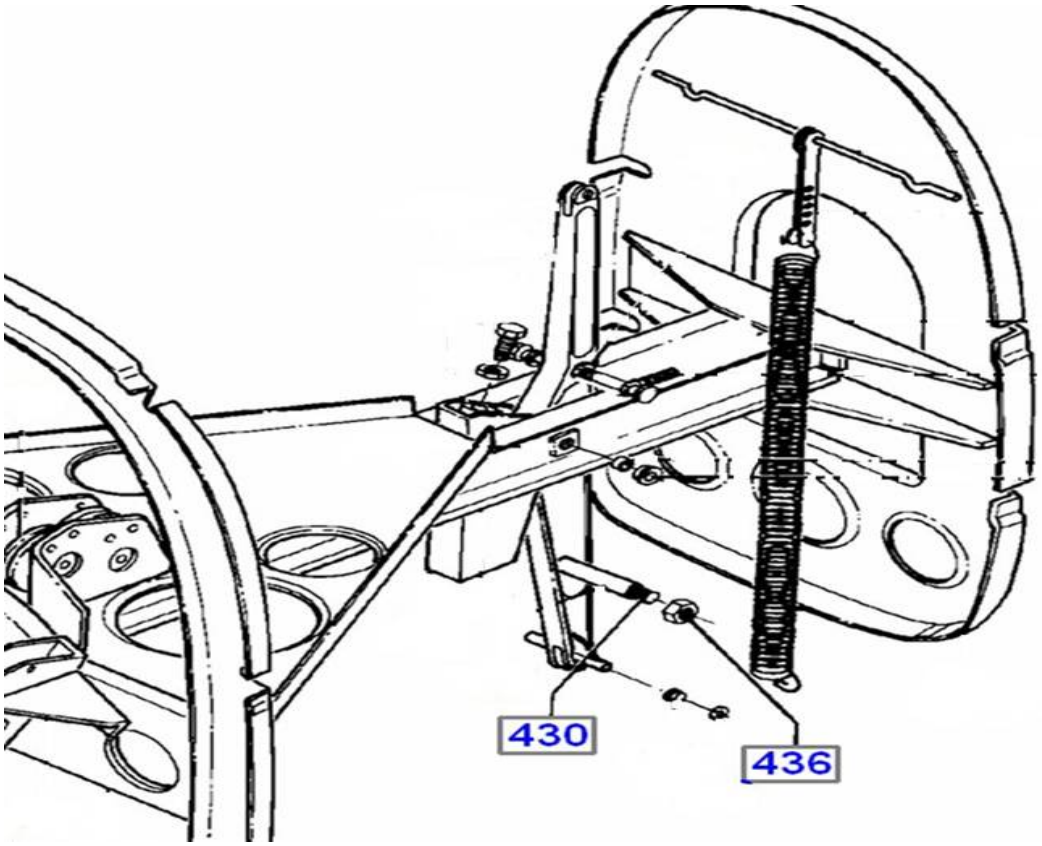
"The rod (elevator downspring limit bolt) identified in Alert number 345 was mistakenly identified by the submitter as part of the autopilot system. The limit bolt is an integral component of the downspring system and is required equipment on all model 36 and most model 33 Bonanza airplanes for static longitudinal stability. The limit bolt is a necessary part of the elevator control system and must be properly installed to meet airworthiness requirements.

"When inspecting for proper limit bolt installation in the 002-524024-51 elevator bell crank assembly, there must be at least two threads extending through the self locking nuts at each end. It is permissible to tighten the nuts to a maximum torque of 70 inch pounds.

"The limit bolt is not rigidly fixed to the bell crank (slip fit) and some axial and radial movement of the limit bolt is a normal part of the elevator bell crank assembly design.

"Item 430 in the following illustration is the elevator downspring limit bolt (as shown in the G36 illustrated parts catalog). Item 436 in the following illustration is the self-locking nut (two required). The washers are not shown, but are installed under each nut."

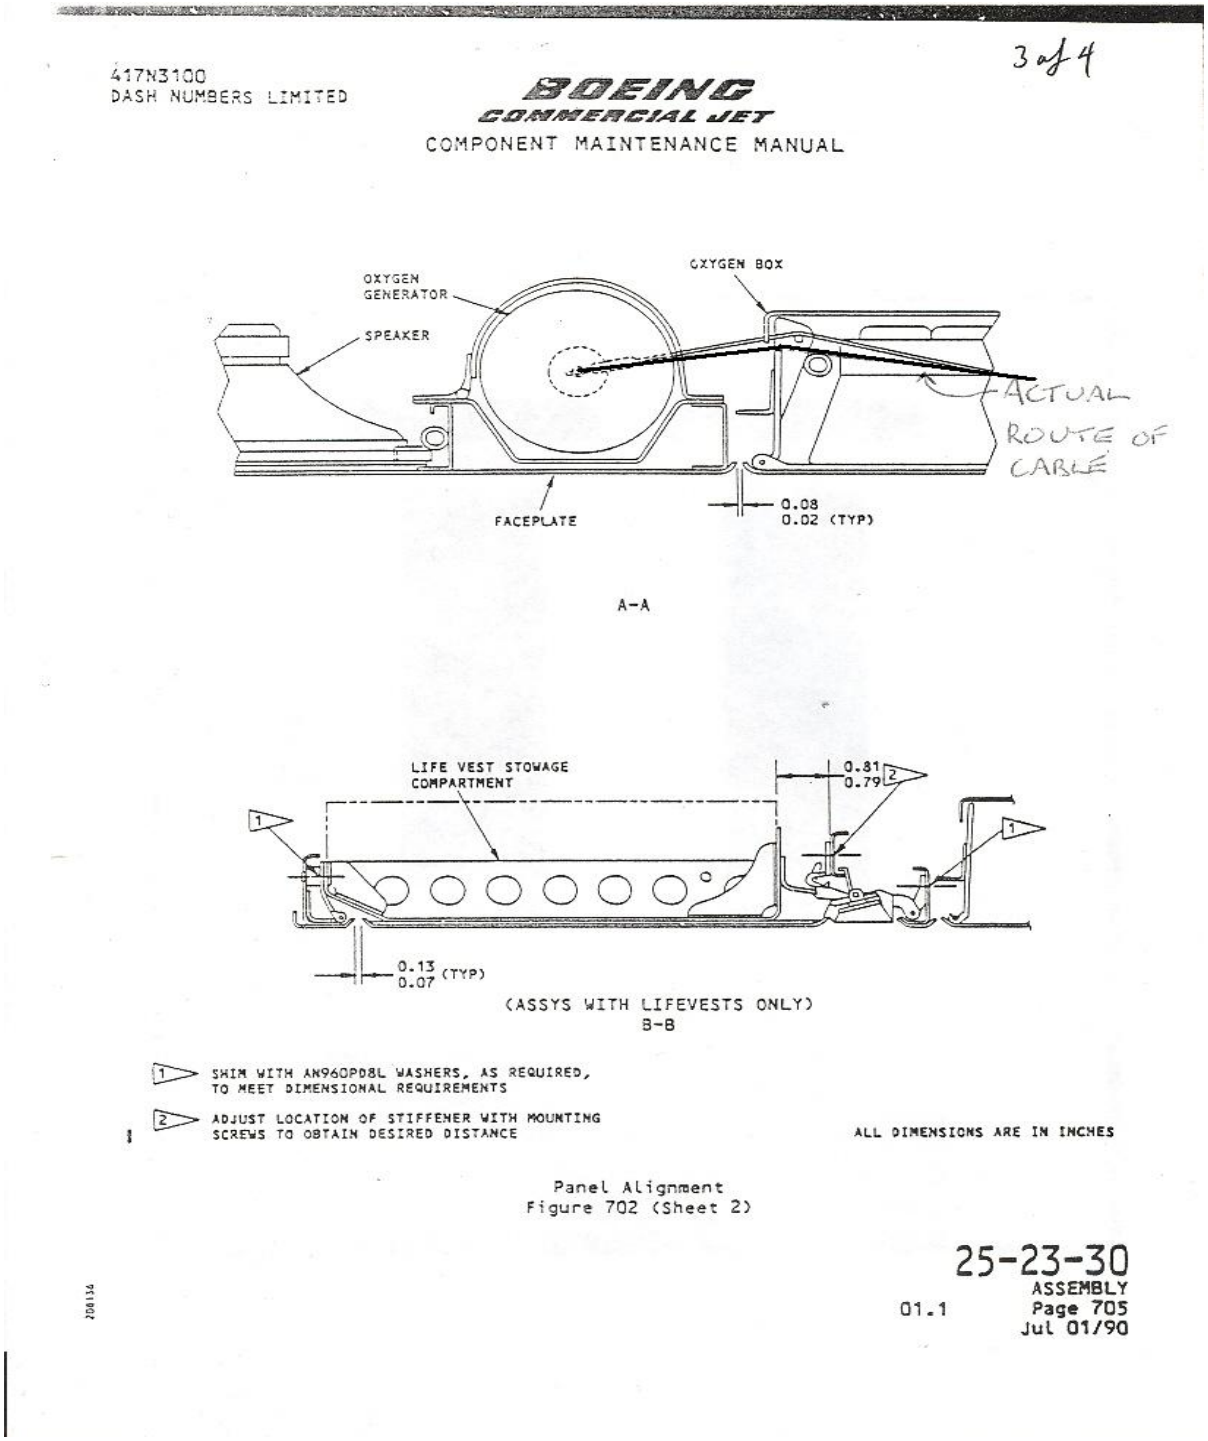
A submission from an English repair station describes an oxygen activation defect. "The actuating cables to the chemical oxygen generators on passenger service units were found to be incorrectly routed—under the support pin and resting on the plastic molding." *(See the following diagram.)*

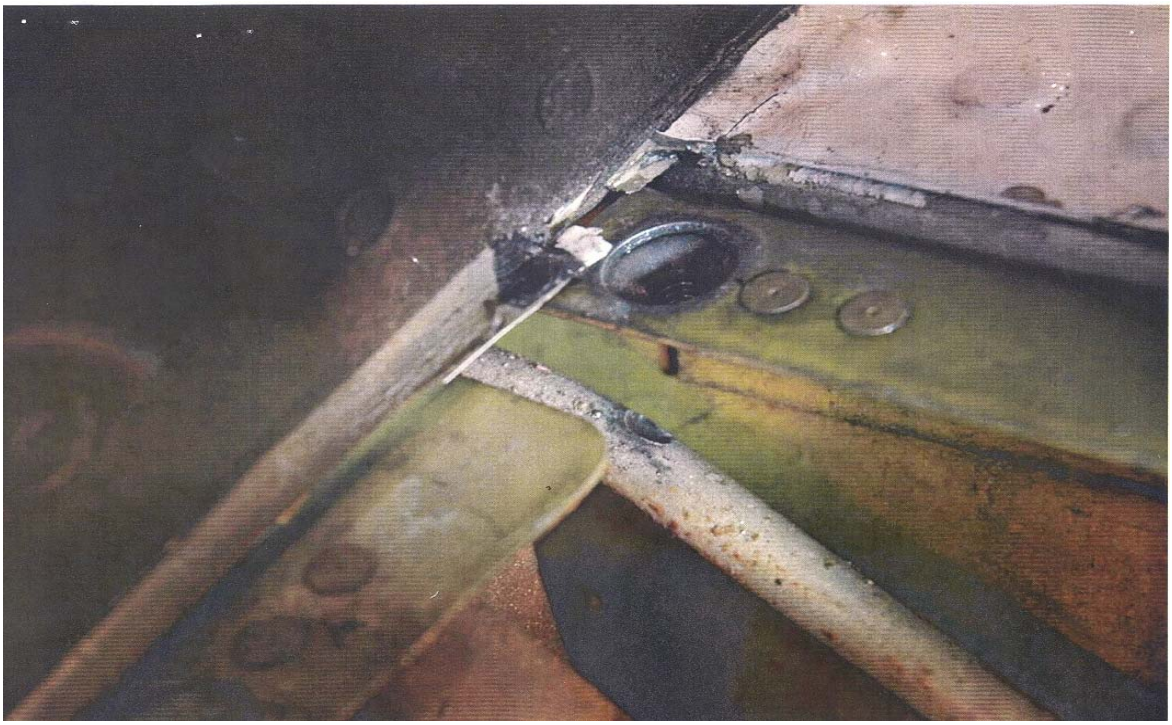
"The customer reported red fluid seep at the top, inboard *(area)* of the right wing," states the submitter. "The *(wing's)* inboard leading edges were removed. It was determined a leading edge retaining screw had chaffed the right hydraulic pressure line *(P/N 50157-001)*, causing a hydraulic leak. The line was replaced and the aircraft was returned to service. This area is not normally accessed during periodic inspections. It is suggested this area be inspected at 800 hour intervals."

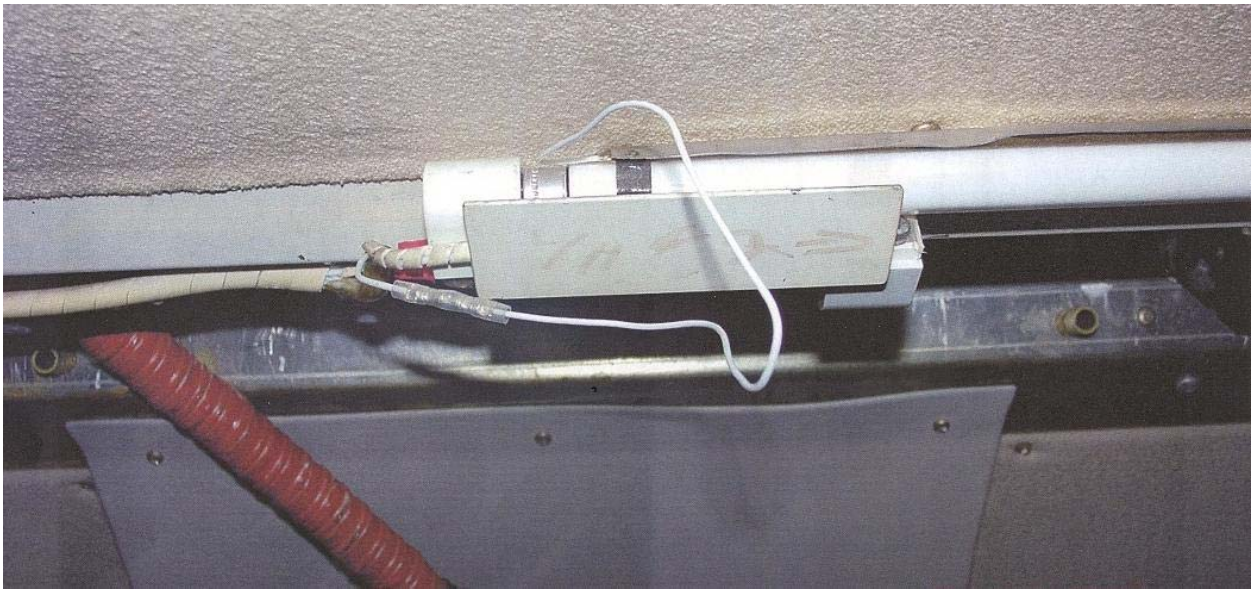
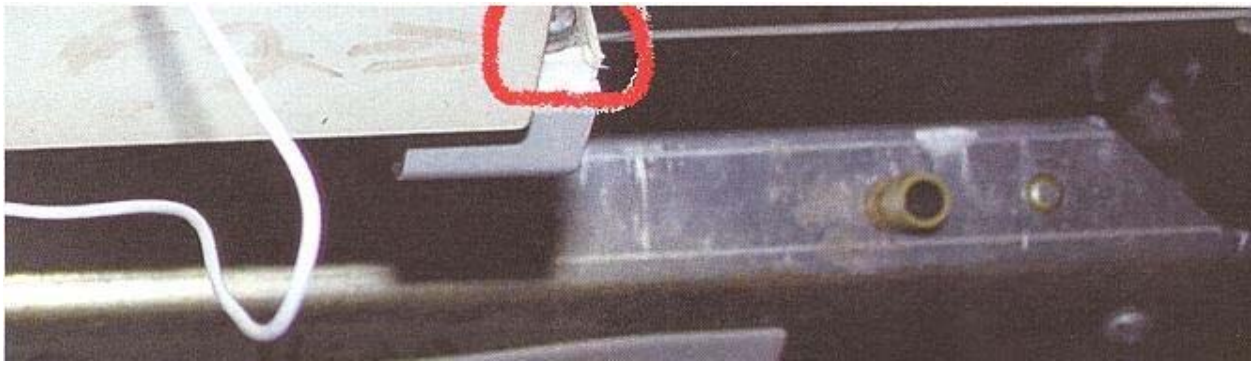
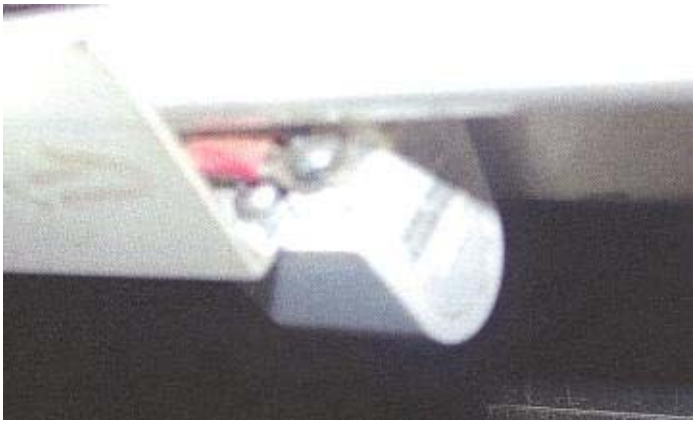
An unidentified submitter from a repair station writes, "The aircraft was disassembled for inspection. During re-assembly, we noted the grounding straps on the cabin valence lights were broken. The grounding straps were repaired, the aircraft re-assembled, and *(electrical)* power applied *(to the systems for operational checks.)* Power was on the aircraft for many hours.

"During turnover to second shift we noticed a spark in the overhead lighting. *(When)* we dropped the valence to investigate, the power supply blew up *(Day-Ray Products; P/N 61-21-3)*. Upon further investigation we noticed silicone sealant was used to keep the grounding straps from rubbing on the lamp holders. This particular lamp holder's *(sealant)* was worn down and the grounding strap was *(shorting to the electrically hot, lamp holder)*. This caused the power supply to overheat and blow up. We readjusted the grounding straps to keep them away from the lamp holders. The power supply was suppose to shut the lights off in the event of a short, but this one did not. *(A search of the FAA Service Difficulty Reporting System data base revealed two additional entries having trouble with this power supply.)*
