U.S. Department of Transportation
Federal Aviation Administration

ADVISORY CIRCULAR

AVIATION MAINTENANCE ALERTS

ALERT NUMBER 358

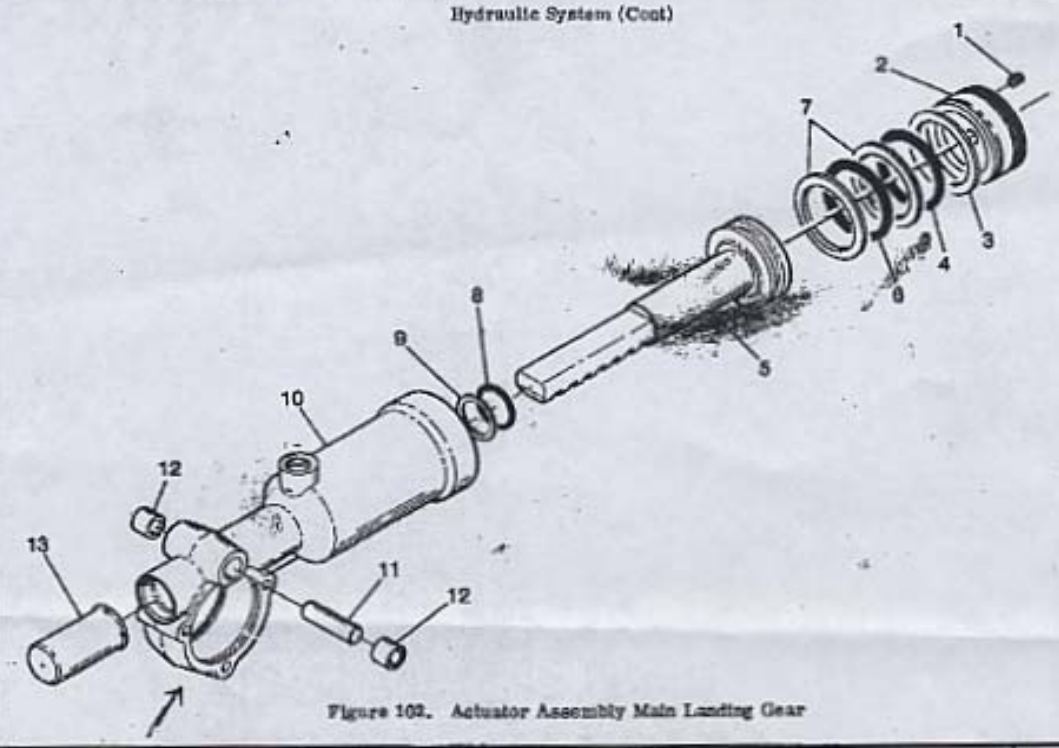
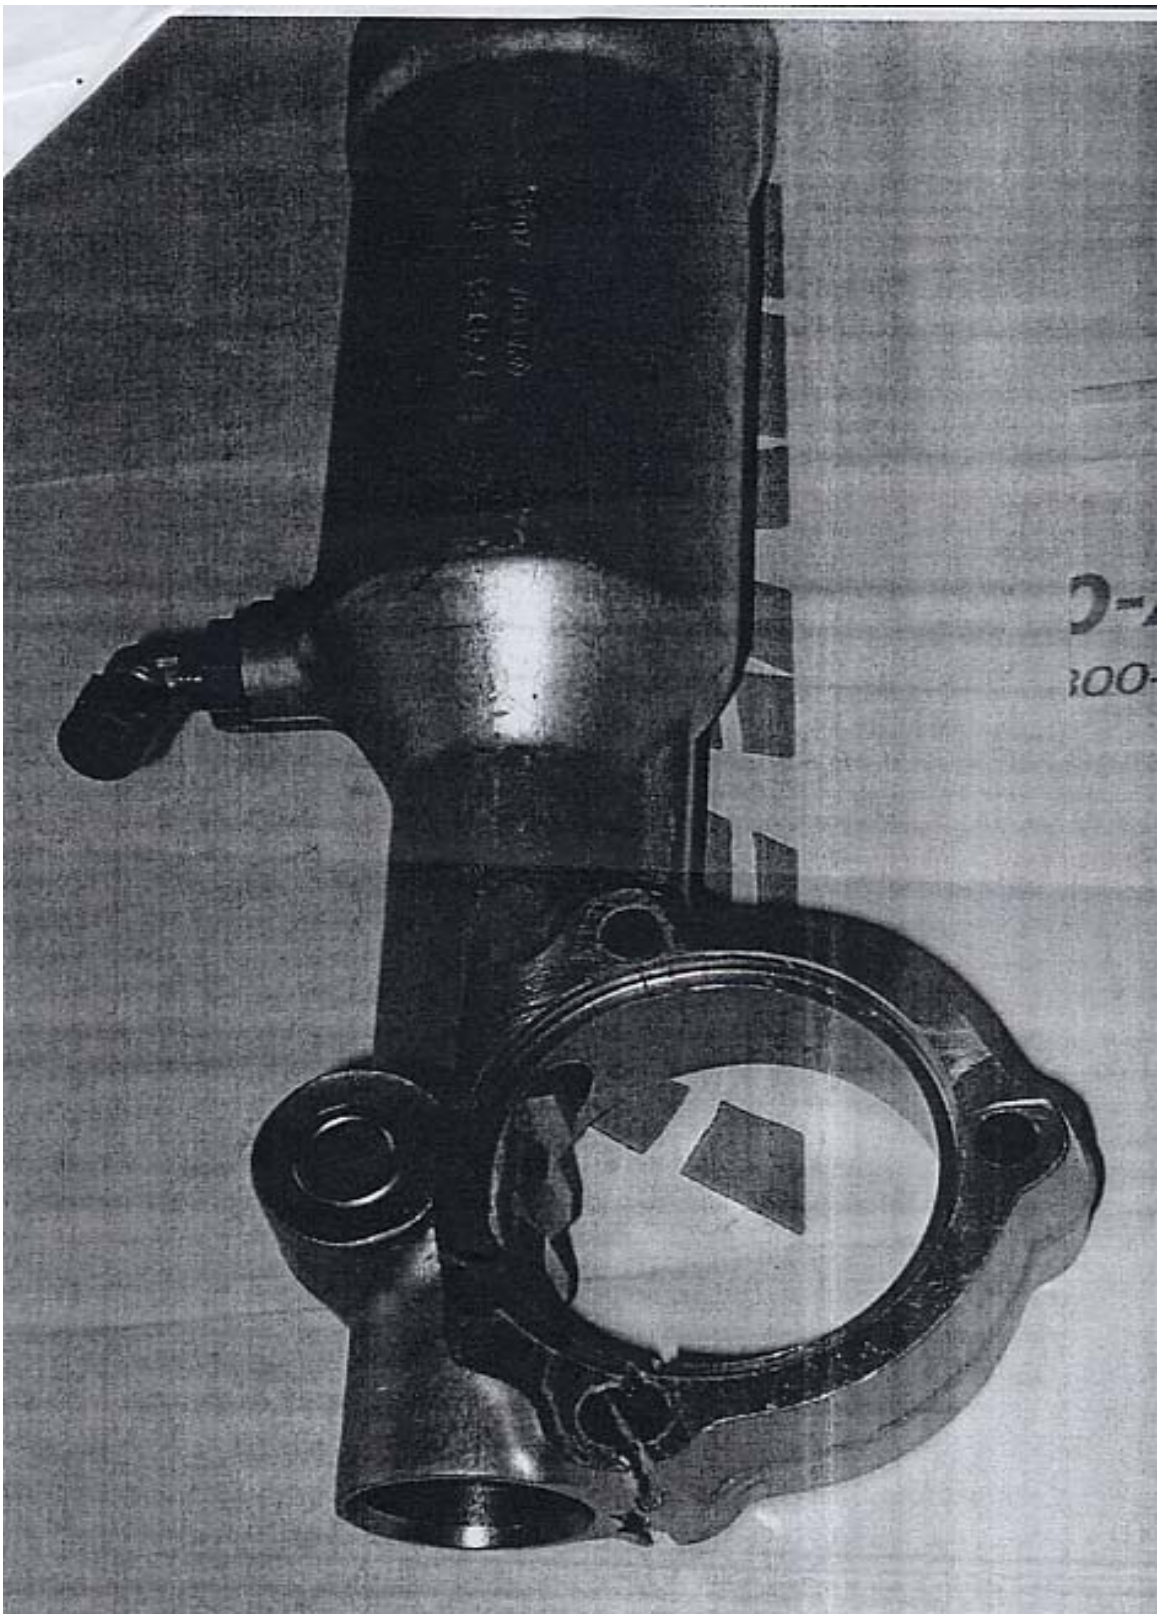
Figure 102. Actuator Assembly Main Landing Gear

Cessna: 172RG; Cracked Main Gear Actuator; ATA 3233

A licensed aircraft mechanic states, "On a dual training flight a student and instructor heard a noise when the *(aircraft's)* landing gear was retracted. The left landing gear remained in a partially retracted position, unable to actuate up or down. A successful gear up landing was made.

"The L/H landing gear actuator body *(P/N 128101-3)* had failed (cracked) at the forward mounting bolt hole, allowing the actuator bore to open—enough that the piston would not engage the pivot sector gear sufficiently to move the landing gear."

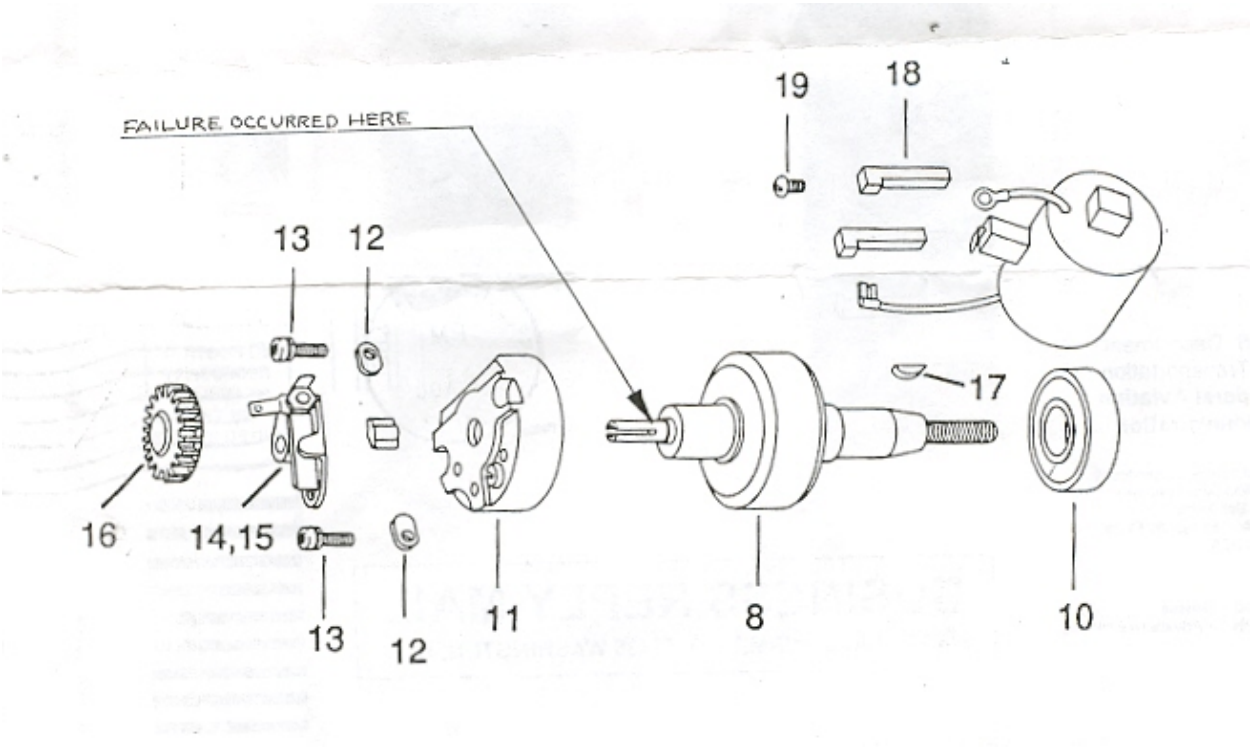
Unison Magneto: 4370; Broken Rotor Shaft; ATA 7414

"Upon opening the magneto, the rotor gear (P/N M3827) and a portion of the rotor shaft were found laying inside the magneto housing. The rotor gear was pressed on the shaft as per manufacturer's drawing—*(this part)* and the gear in the distributor block assembly (P/N K3822) were not damaged and were free of obstructions. They moved without binding. The shaft broke just below the slot in the shaft that holds the cam which, *(in turn)* opens the contacts. There did not appear to be any other mechanical defect with the magneto."

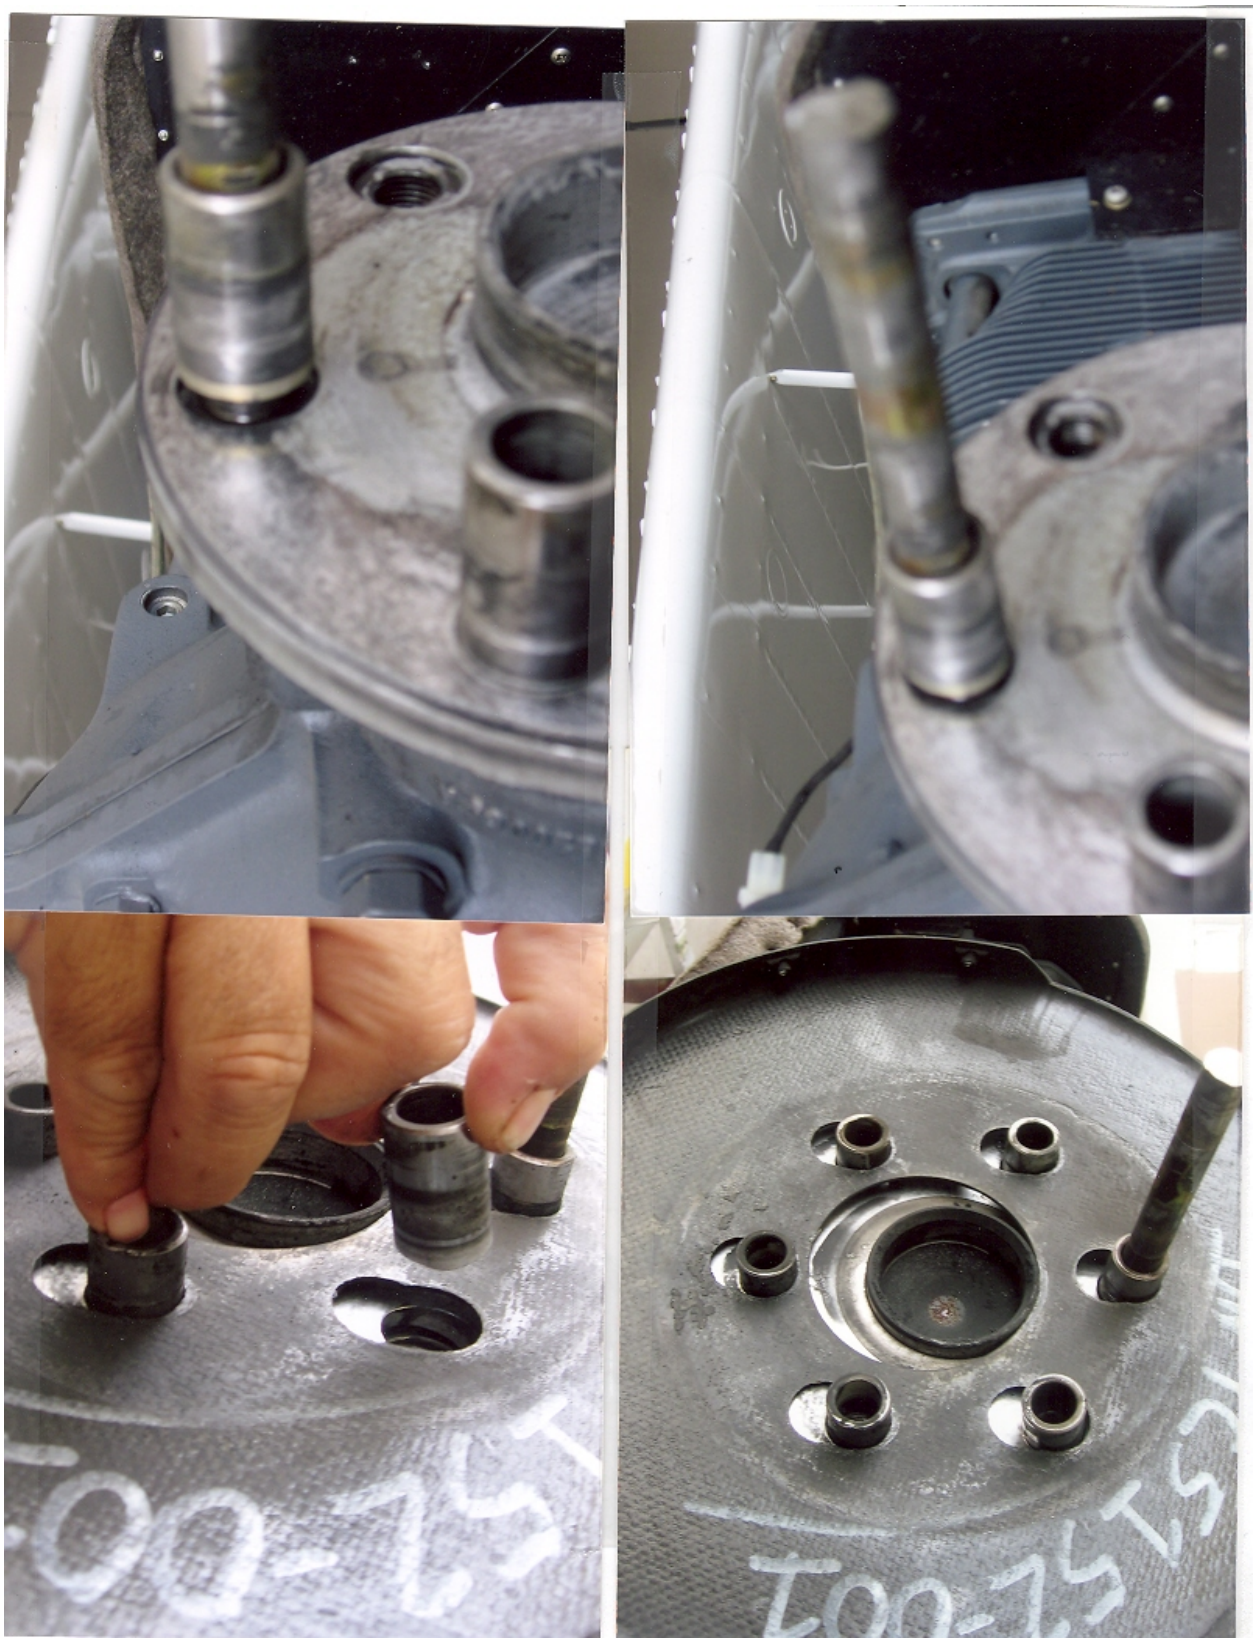
Sensenich: W80CM845; Loose Propeller; ATA 6110

"The pilot reported slight vibration during a flight of approximately one hour. When power was reduced for landing the vibration became more evident. Our initial inspection found one prop bolt *(missing; bolt #1)* had come out forward and through the spinner, and the propeller *(itself)* was loose. After removal of the spinner we found *(...bolt 2 had also backed out about approximately 1/8 inch)*. Bolts *(3 and 4)* remained safety-wired but not tight. On the remaining pair of bolts *(5 and 6)* the safety wire was broken...and these bolts were backed out approximately one inch. Complete removal of the prop required cutting the head off one bolt. *(Its)* attachment bushing *(was found)* broken off flush with the crankshaft flange. A second attachment bushing was also found broken off...."

(This submission provided no speculation as to cause. To summarize the log entries: the wood prop was installed and run for 1 hour, then the bolts re-torqued. Six months and 15 flight hours pass and apparently all is well. The aircraft receives an annual inspection—with prop torque. Another 6 months pass with another 15 hours flight time, but now the bolts are falling out—and there is no mention of thread failure in this report. An obvious question: what would this same equipment look like if the bolts had been run down to the flange in preparation for a final but forgotten torque, then saftied and flown for 15 hours? One would have to look hard at the last inspection. "Thank-you" to the submitter for the scary photographs—Ed.)
