U.S. Department of Transportation
Federal Aviation Administration

ADVISORY CIRCULAR

43-16A

AVIATION MAINTENANCE ALERTS

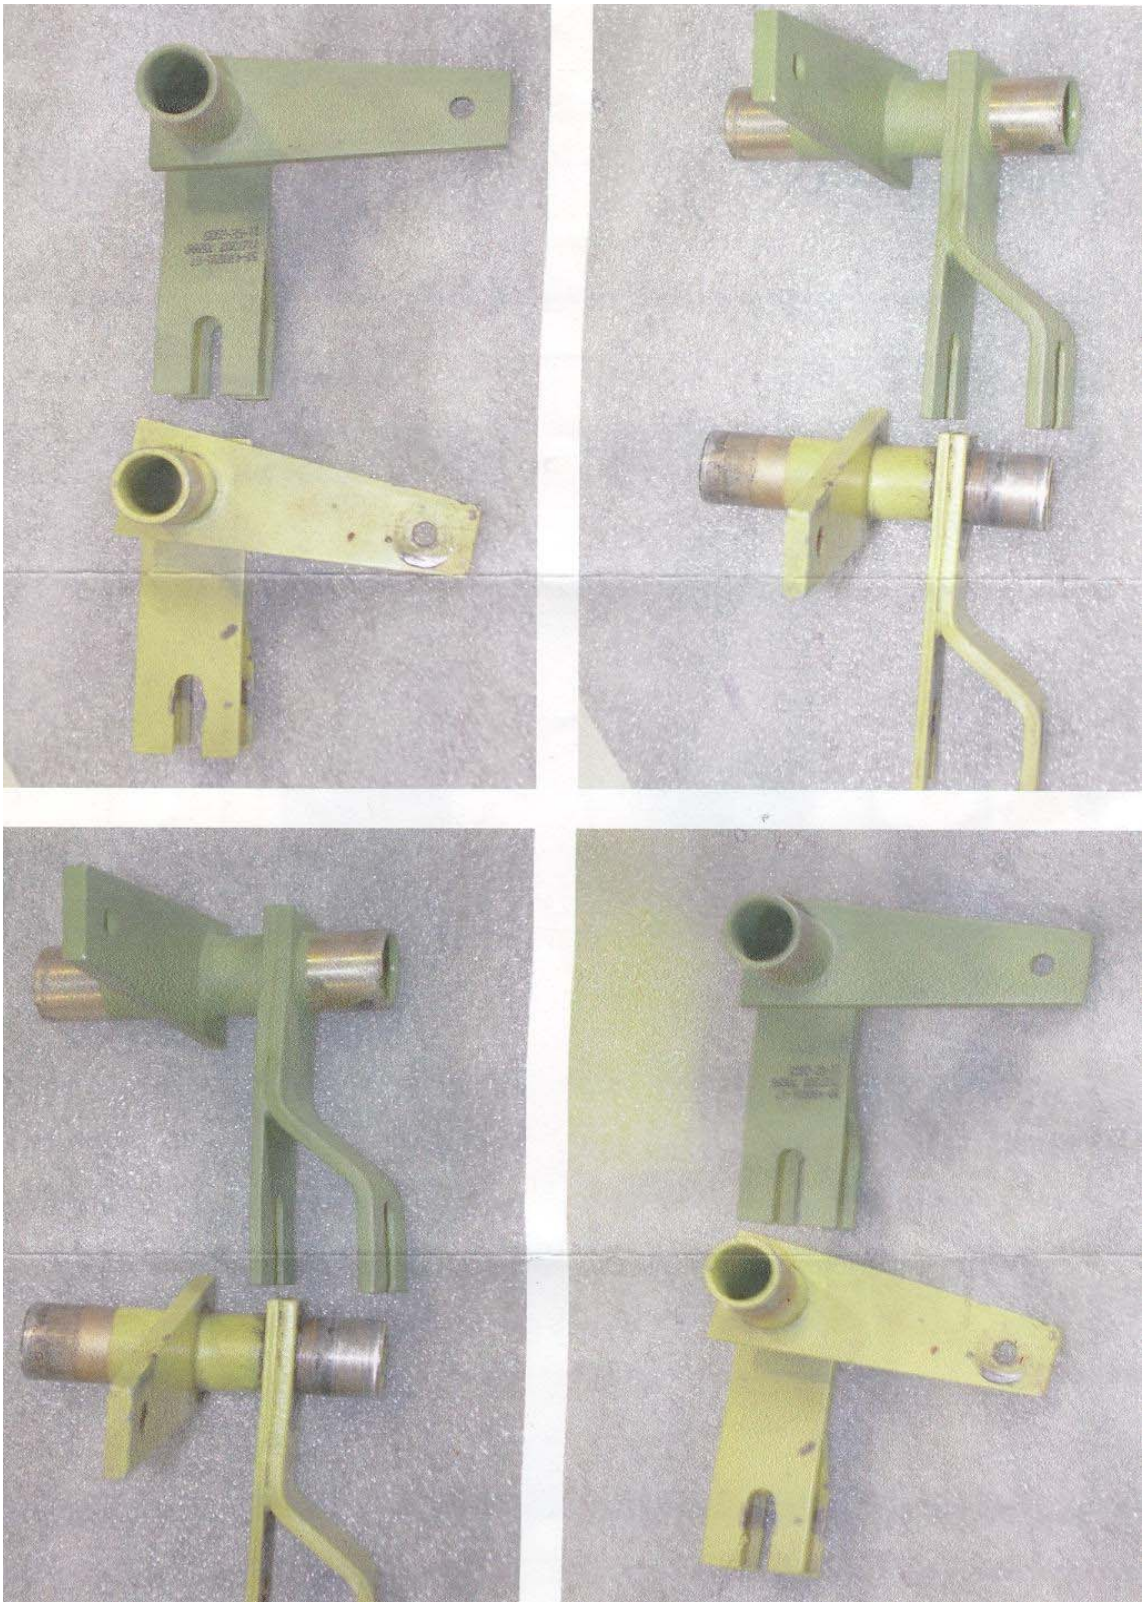
A technician for an air taxi operation states, "During a routine, Phase 3 inspection the main cabin door aft up-lock bell crank was found twisted about 10 degrees from *(that)* of a new bell crank *(P/N 50-430031-17)*. The up-lock bracket pivot bolt (P/N NAS1103-21D) was also noted to be slightly deformed. This *(condition)* was probably caused by the up-lock hook being *(improperly)* rigged. All effected parts were replaced and the up-lock hooks were *(then)* able to be rigged properly."

(Slightly deformed? Nice comparison photos.)

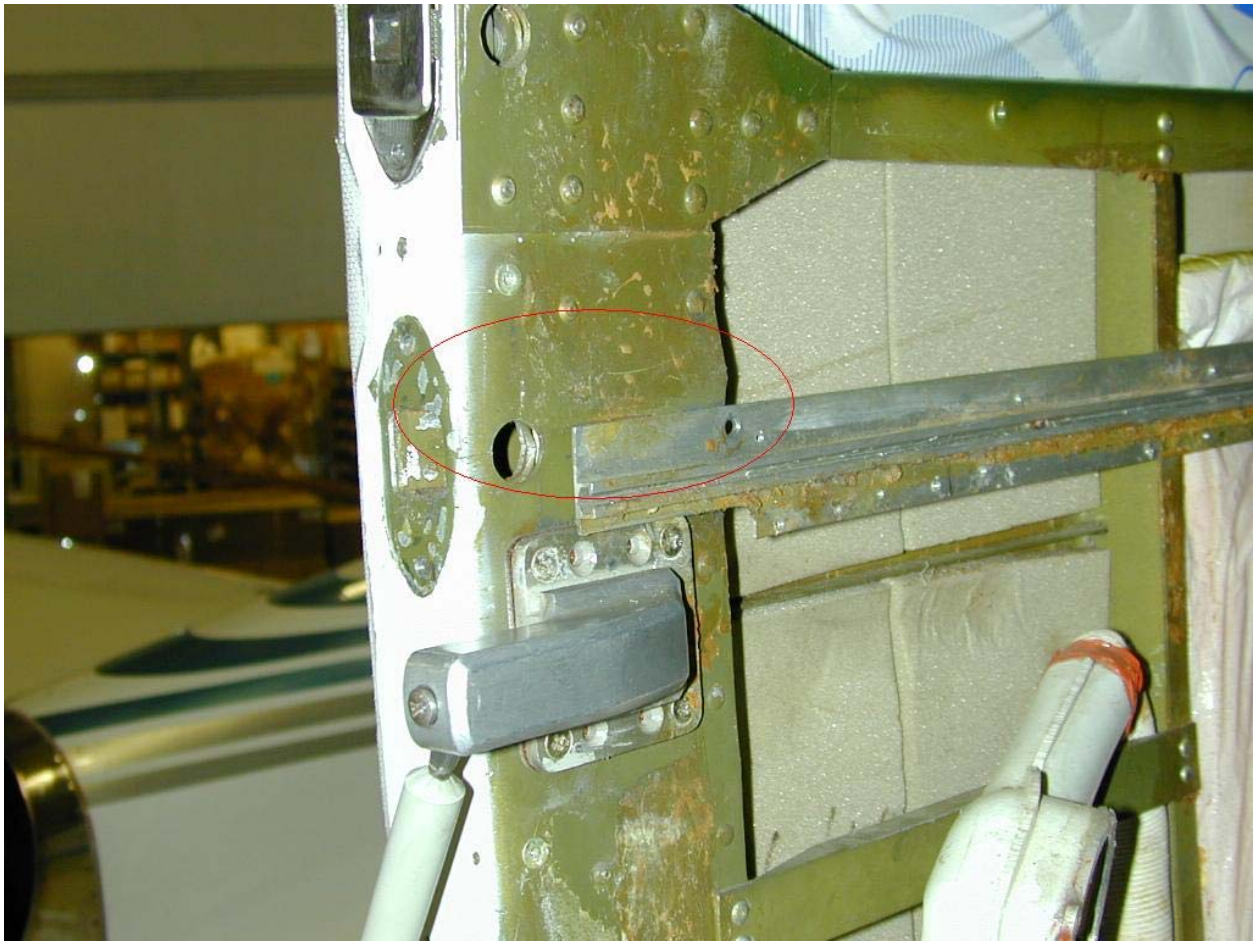
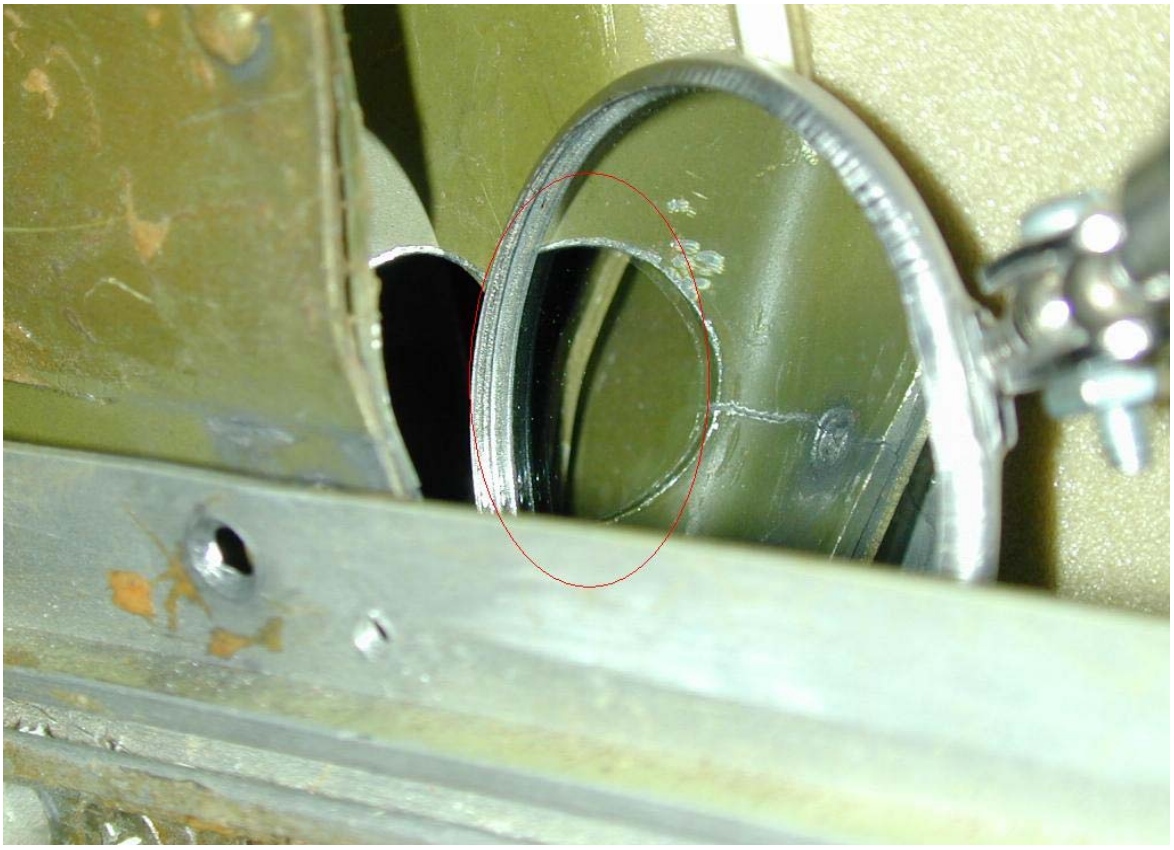
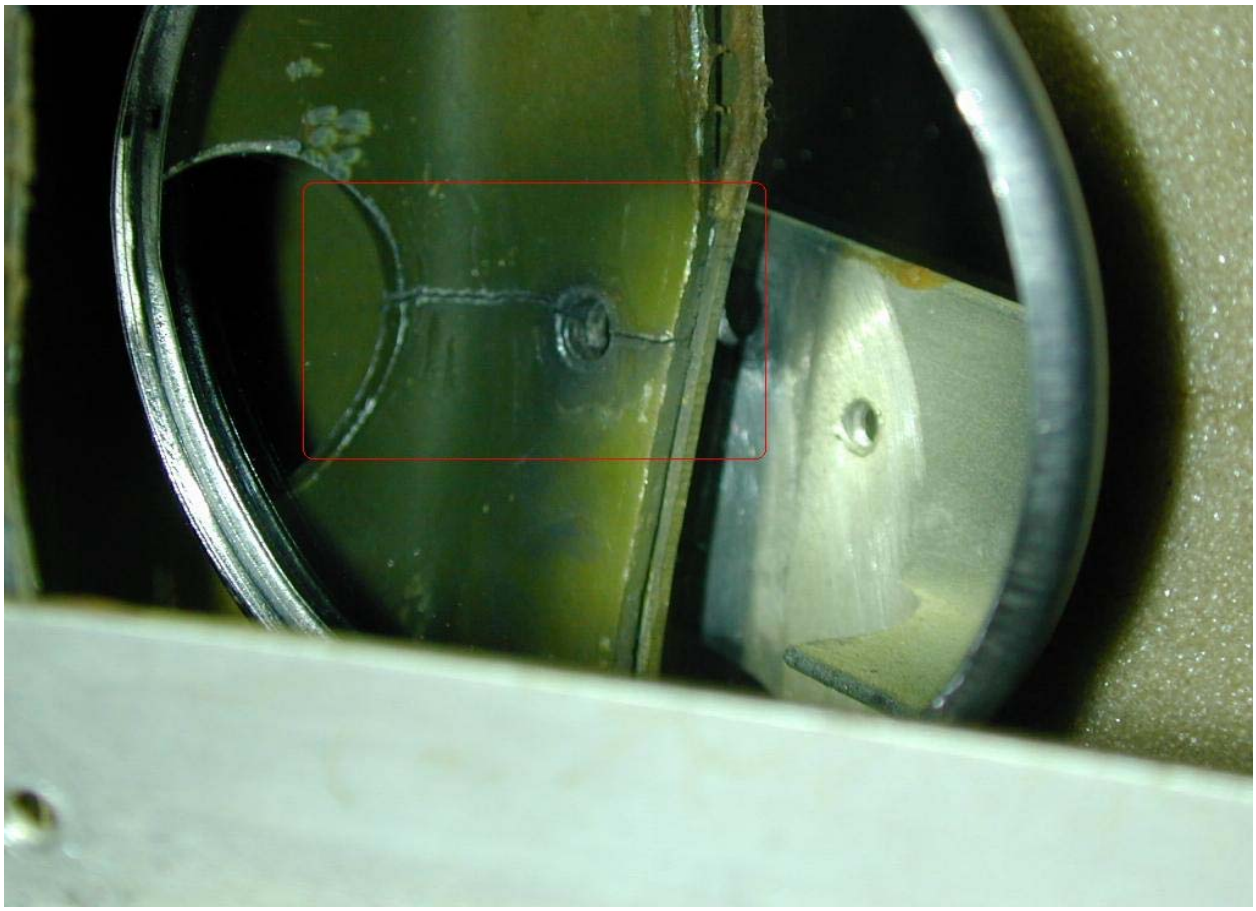
"During the SID *(shaft inspection device)* inspection," says an unknown submitter, "the fuselage bulkhead at the forward opening of the cabin door and secondary bulkhead were found cracked, buckled, and distorted. *(The only reason...)* this was found was the SID inspection requires removal of the door bayonet receptacles for inspection, and *(also)* the removal of the interior sidewall upholstery."

(Bulkhead P/N 57111434345. Nice camera/mirror work—Ed.)
