Final Report

On the accident on **1st June 2009**
to the **Airbus A330-203**
registered **F-GZCP**
operated by **Air France**
flight AF 447 Rio de Janeiro - Paris

BEA

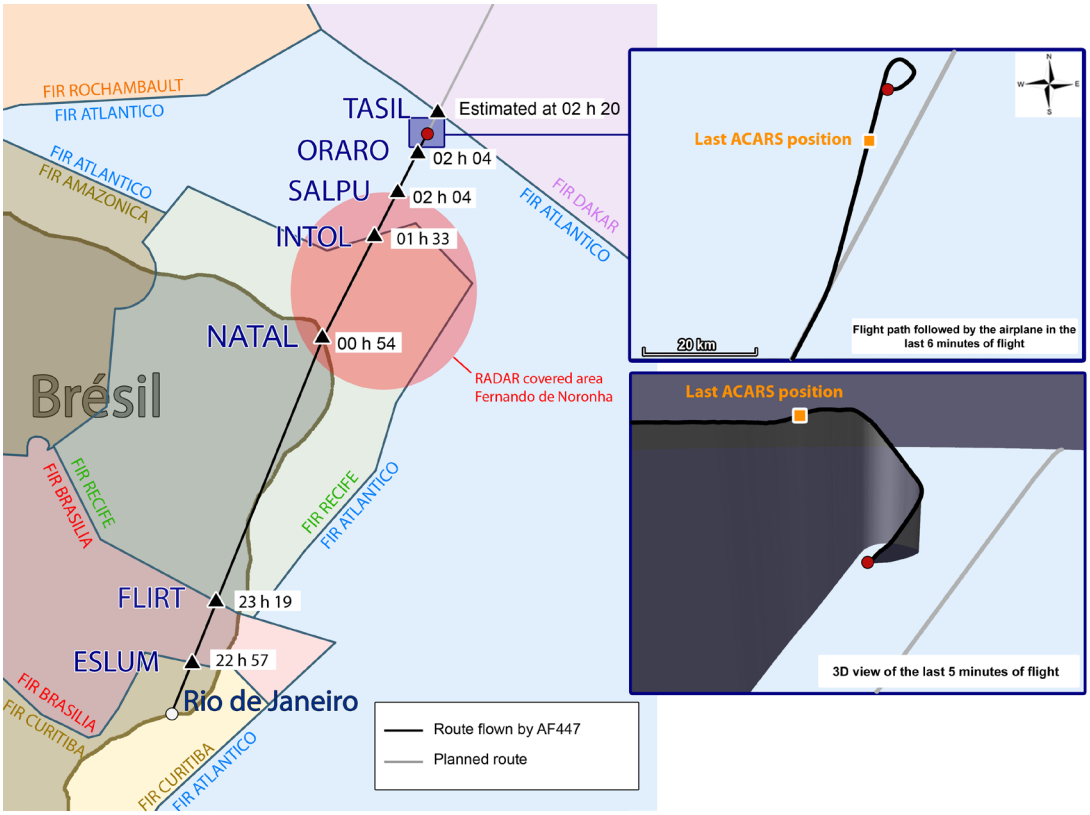
Figure 1: History of Flight

At 2 h 12 min 02, the PF said, *"I have no more displays"*, and the PNF *"we have no valid indications"*. At that moment, the thrust levers were in the IDLE detent and the engines' N1's were at 55%. Around fifteen seconds later, the PF made pitch-down inputs. In the following moments, the angle of attack decreased, the speeds became valid again and the stall warning triggered again.

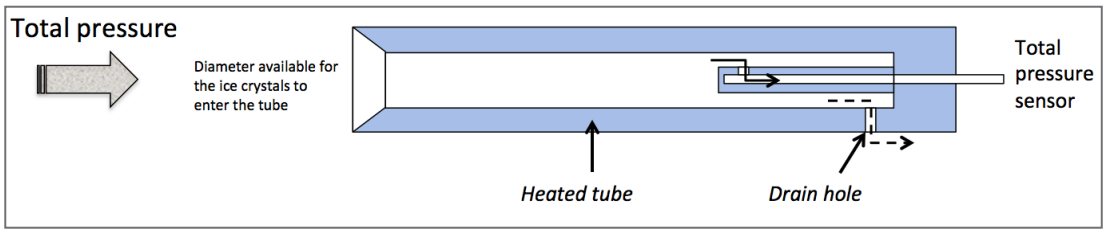
Figure 8: Pitot probe diagram

In the presence of ice crystals, there is no visible accretion of ice or frost on the outside, nor on the nose of the probe, since the crystals bounce off of these surfaces. However, the ice crystals can be ingested by the probe air intake. According to the flight conditions (altitude, temperature, Mach) if the concentration of crystals is greater than the capacity for de-icing of the heating element and evacuation by the purge holes, the crystals accumulate in large numbers in the probe tube.

As soon as the concentration of ice crystals is lower than the de-icing capacity of the probe, the physical barrier created by the accumulation of crystals disappears and measurement of the total pressure becomes correct again.

Experience and follow-up of these phenomena in very severe conditions show that this loss of function is of limited duration, in general around 1 or 2 minutes.

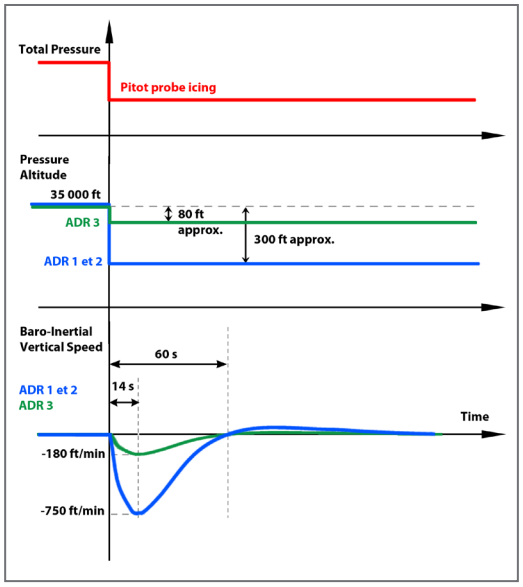
Figure 10: Effect of a drop in total measured pressure on standard altitude and vertical speed

The first consequence of a drop in measured total pressure is a drop in the Mach and the CAS. The drop in Mach leads to a drop in standard altitude due to the correction of the measured static pressure. This drop is different according to the ADR under consideration: in the flight conditions of the event, it is of the order of 300 to 350 ft for the ADR 1 and 2 and of 80 ft for ADR 3.

The drop in indicated standard altitude also causes a transient variation in Vzbi. Just as the drop in standard altitude is lower for ADR 3 than for ADR 1 and 2, the variation in Vzbi is lower for ADR 3 than for the two others, as illustrated by the graph below:

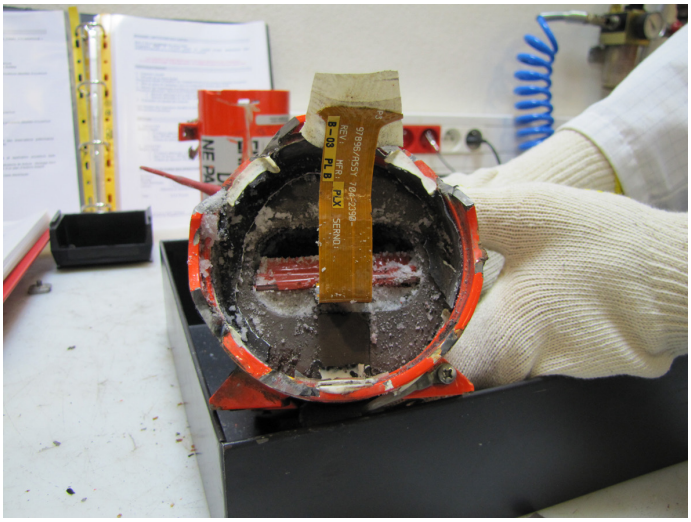
Figure 18: FDR CSMU after removal of cover

The memory board was cleaned. Visual inspection did not reveal any damage to the board. The board was placed in an oven for 36 hours in order to remove the moisture in the components and the printed circuit board. The impedance measurements that were then made on the input connector were in accordance with the measurements made on reference units.

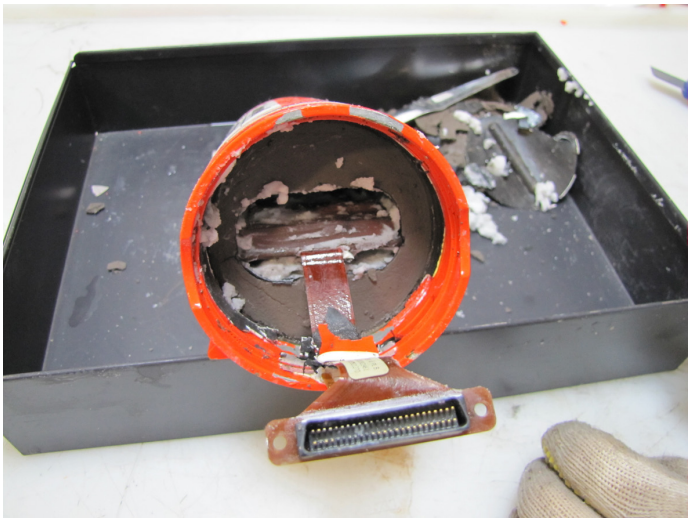
Figure 22: CVR memory board after removal of thermal protections

Figure 23: CVR memory boards before cleaning

Visual inspection of the boards revealed damage: a capacitor and a resistor were cracked on one of the boards; two decoder-type components were damaged on the other board.

The boards were placed in an oven for 42 hours. The damaged components were unsoldered and replaced. The impedance value measured at the input connector complied with the measurements made on reference boards. The memory boards were then connected separately to the BEA's memory reader. A few memory components selected previously were addressed and read entirely. The consistency of the binary contents of each memory could then be checked using the manufacturer's hardware and software. The boards were then connected to the BEA's chassis and the data was extracted and decompressed using the manufacturer's official hardware.

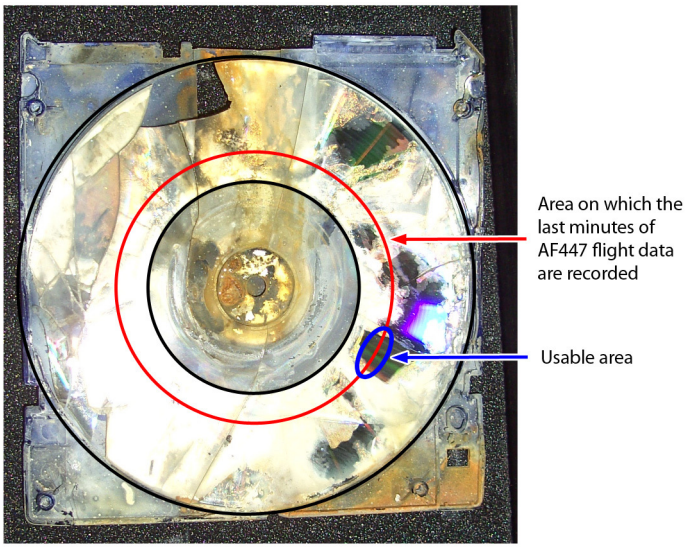
Figure 29: Optical disk showing the location of the readable zones

This computer is an unprotected parameter recorder used for flight analysis purposes by the operator. The data was recorded on a magneto-optical disk which was removed from the computer. The disk was so badly damaged that it was impossible to use traditional reading methods. It was therefore examined in collaboration with the solid-state physics laboratory at Paris-Sud University, and in conjunction with the manufacturer, Thales.

Readable zones were identified. The only zone likely to contain flight data was analysed. It relates to one second of information recorded every 100 seconds. Very little information could thus be recovered, and this data did not supplement the elements recovered by other means. The examination was therefore terminated after this feasibility study.

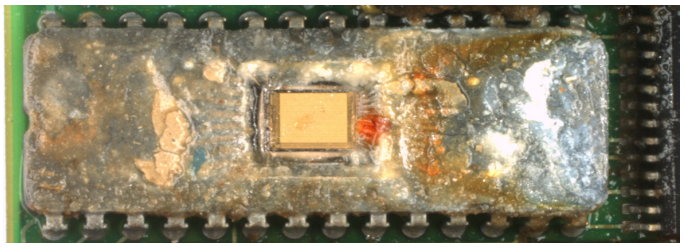
The two computers were examined. The memory components containing the data were damaged. One of the components had been torn out and the other suffered from internal short-circuits. The work was brought to a conclusion.

Figure 30: Memory component from one of the FCDC

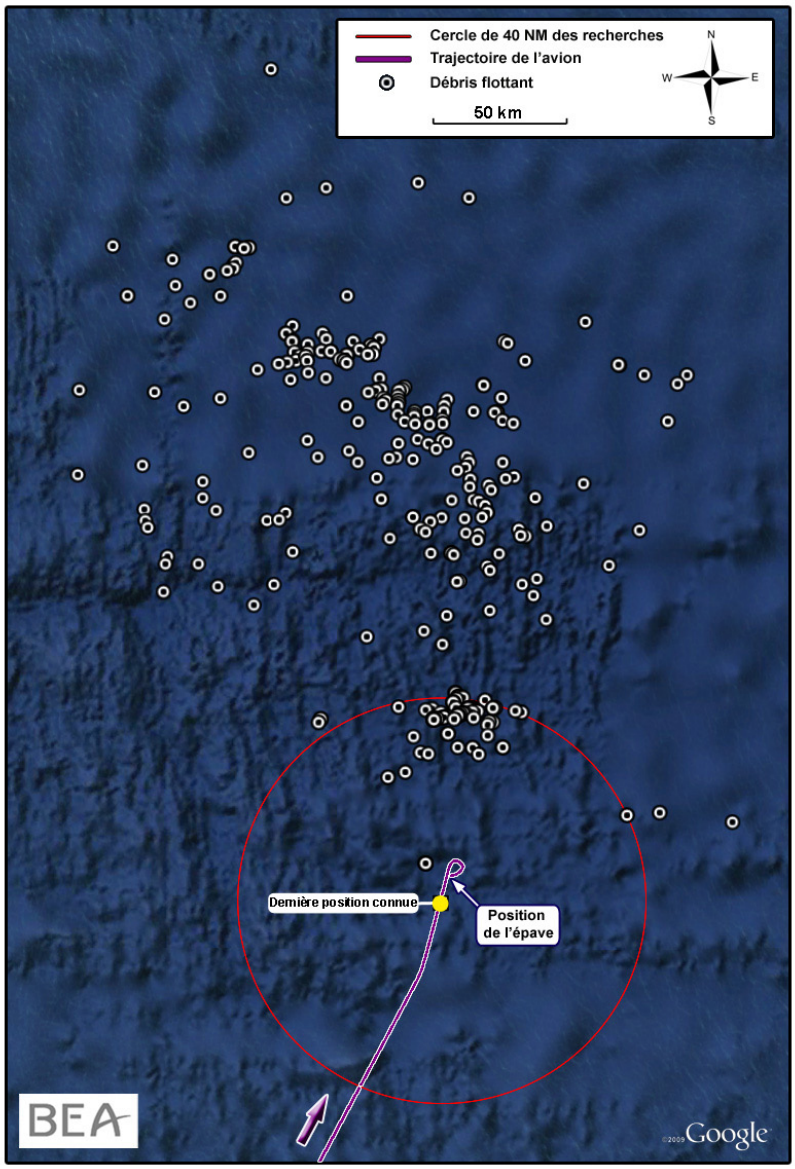
Figure 31: All of floating debris (found between 6 and 26 June), last known position and wreckage site

Most of the parts found were low-density honeycomb or composite material parts.

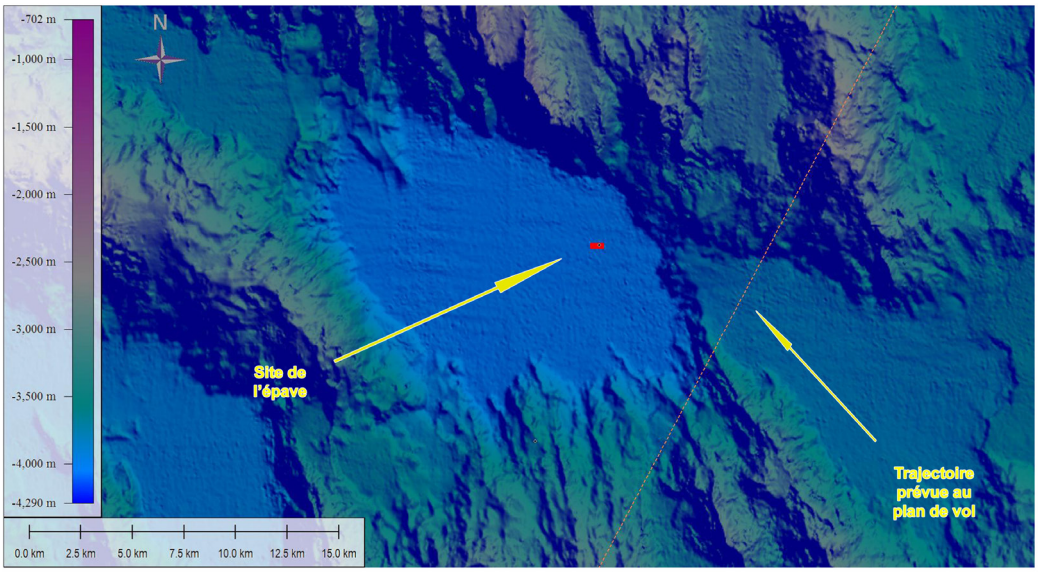
Figure 32: Wreckage localisation

The aeroplane wreckage was found about 6.5 NM on the radial 019 from the last known position, slightly to the left of the planned route. The wreckage rested on an abyssal plain at a depth of 3,900 metres. This plain, surrounded by terrain, made of clay type sediment, was around 15 km wide and was located west of the scheduled aeroplane flight path.

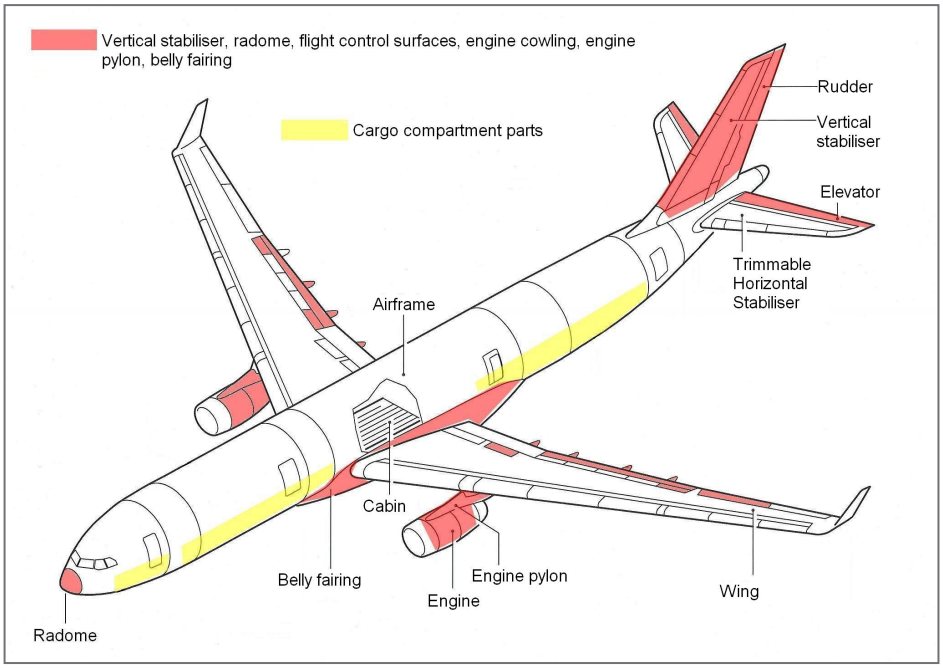
Figure 33: Position of the recovered parts (exterior and cargo)

This repositioning provides a distribution of the debris:

- From the forward (radome) to the aft end (vertical stabiliser) of the aircraft;
- From the left- to the right-hand side of the aircraft for the cabin or wing parts.

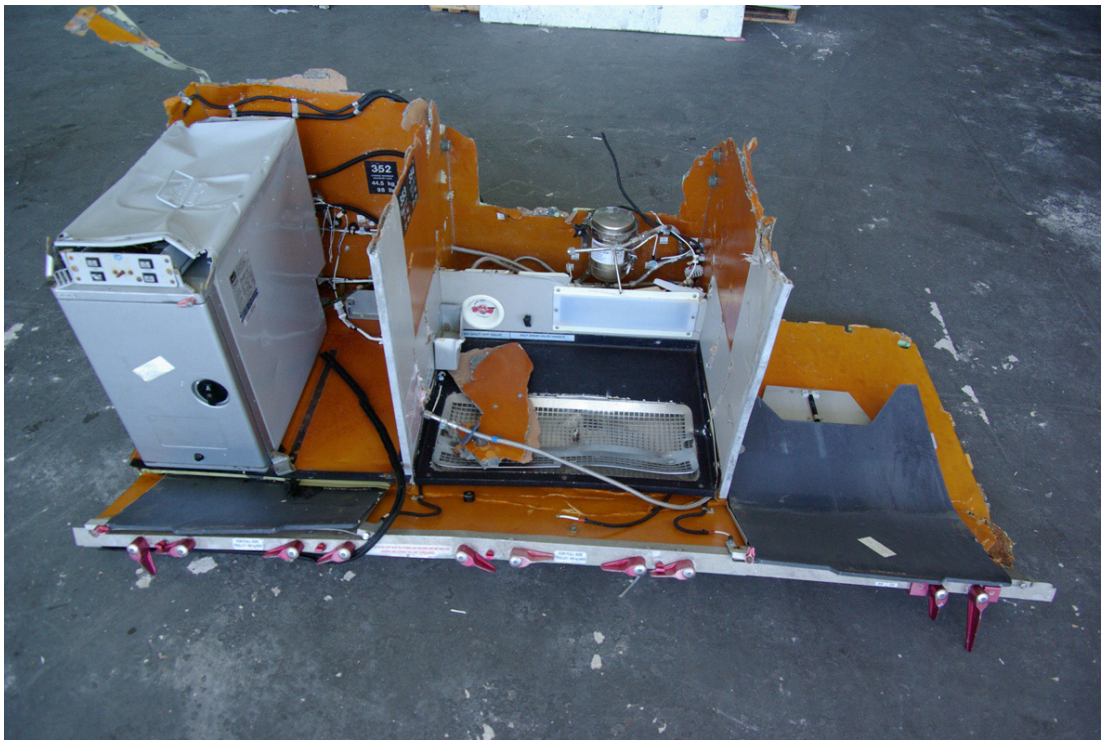
The overhead luggage rack attachment fittings had deformations that are due to vertical compression and to a forward movement of the luggage racks.

Figure 35: Part of Galley G3: downwards deformation at the level of the galley's heavy parts

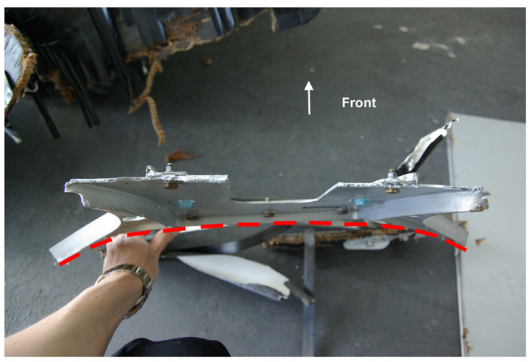
Figure 36: Luggage rack fitting deformed towards the front Toilet door (L54)

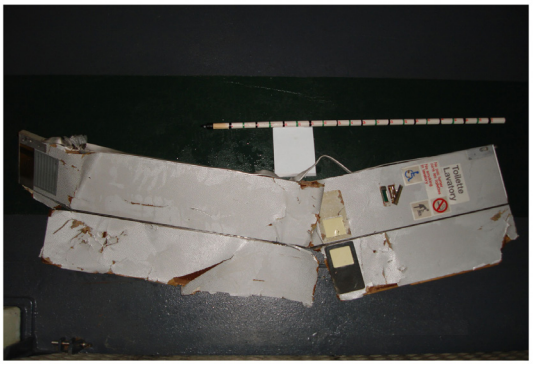
Figure 37: Metallic stiffeners deformed by buckling

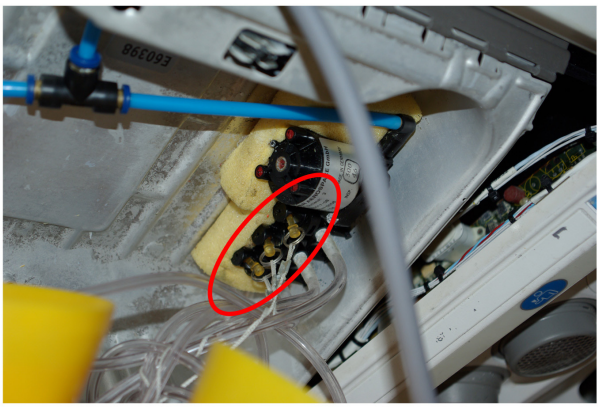
In normal operation, the oxygen is sent to the mask when the passenger releases the system's lock-pin by pulling on the mask. Several pins were found in place, closing the oxygen circuit.

Figure 41: Passenger oxygen container recovered open: the three pins are in place

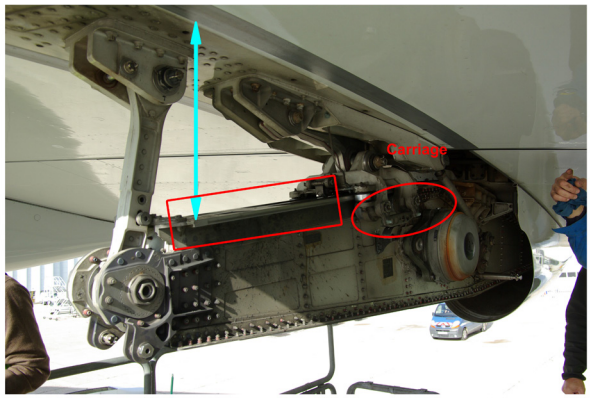
Several parts of the flap extension mechanism fairing were found. There were marks on two of them (positioned at the level of flap track N°3), made by the flap extension track on impact. Analysis of these marks (morphological and dimensional examinations) and comparison with an identical aeroplane made it possible to determine that the flaps were in the "retracted" position (see photo below) at the time of impact with the water (measurement of the distance between the track and the lower surface of the flap, position of the carriage on the track).

Figure 42: Flap extension mechanism (or flap track) No. 3 in retracted position

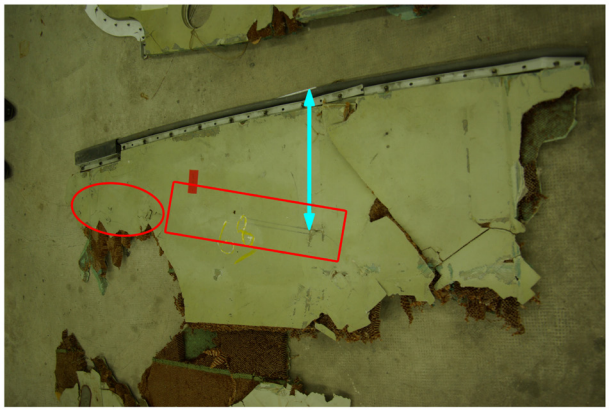
Figure 43: Part of the No. 3 flap track fairing on the left wing

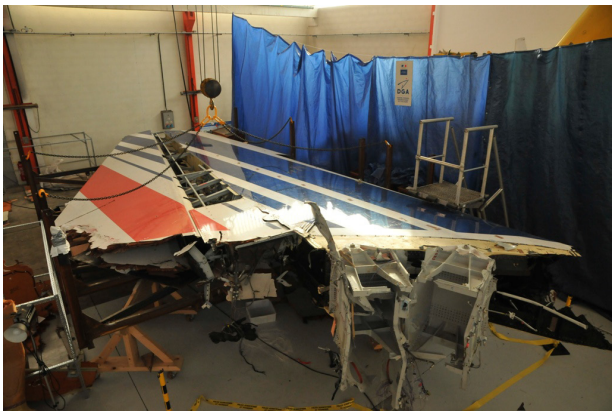
- The forward attachment (male and female lugs) and the lower part of the side panels (lug reinforcements) were missing;
- The centre and aft attachments were present: male and female lugs and parts of the fuselage frames.

Figure 44: Fin – In the foreground the base of the fin with the central and forward attachment lugs

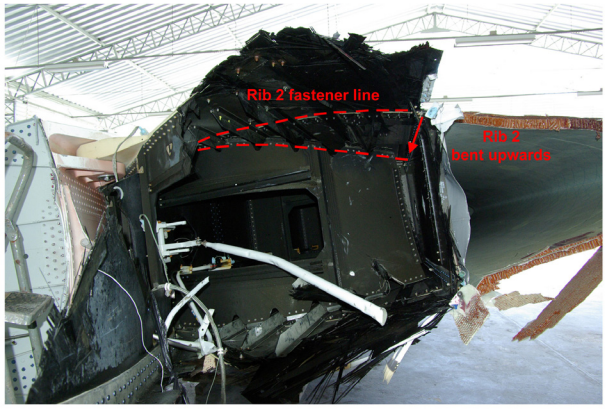
- Failure of the leading edge right- and left-hand panels
- Longitudinal cracking of the leading edge stiffener
- HF antenna support (attached to the forward spar): failure of the lower part, crumpling indicating bottom-upwards compression loads.

Figure 45: Rib 2 bent upwards as a result of bottom-upwards compression loads

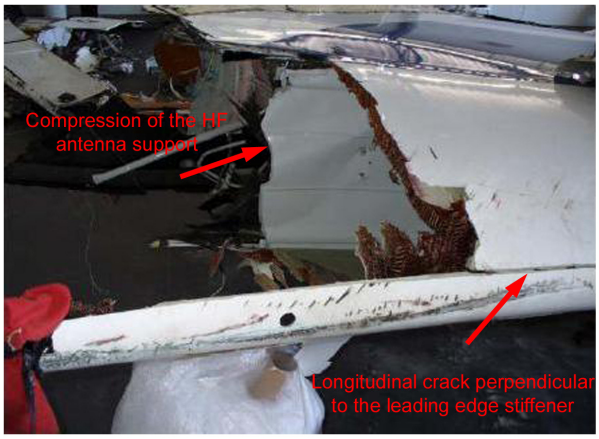
Figure 46: HF antenna support

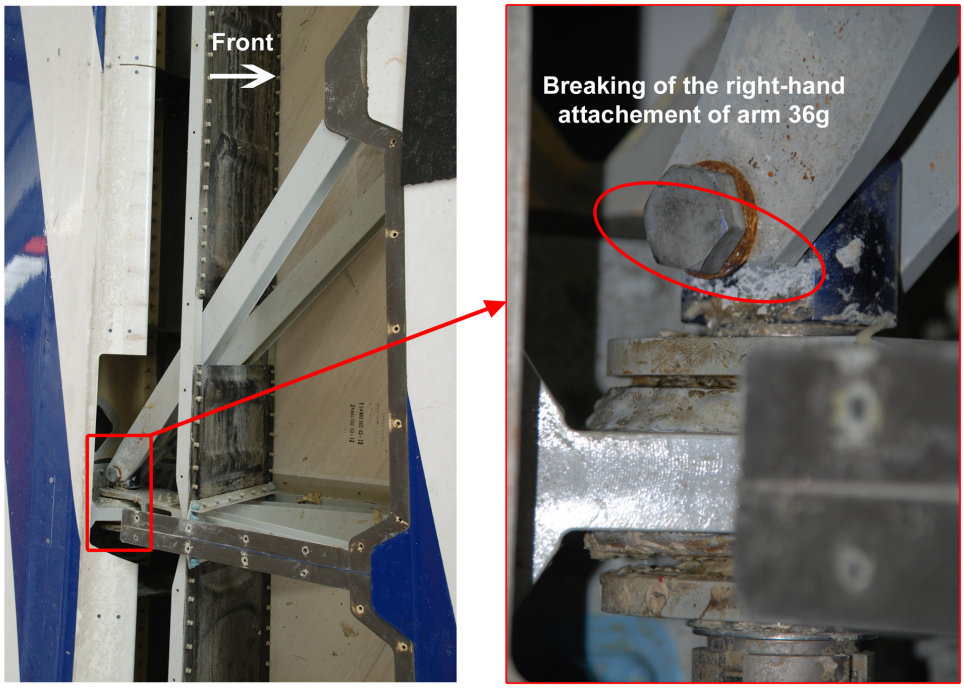
The size of this arm is calculated to withstand a maximum load of 120,000 N, corresponding to a relative acceleration of 36G of the rudder in relation to the vertical stabilizer.

Figure 47: Arm 36G, right view: failure of the rudder attachments

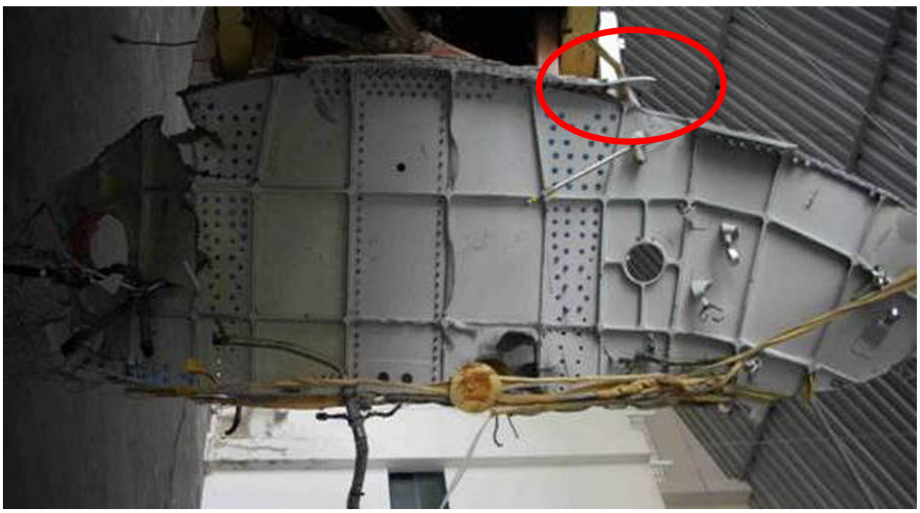
The fuselage was sheared along the frames and centre and aft attachment lugs by loads applied bottom-upwards.

Figure 48: Frame 87: shearing of the frame and fuselage skin along the frame

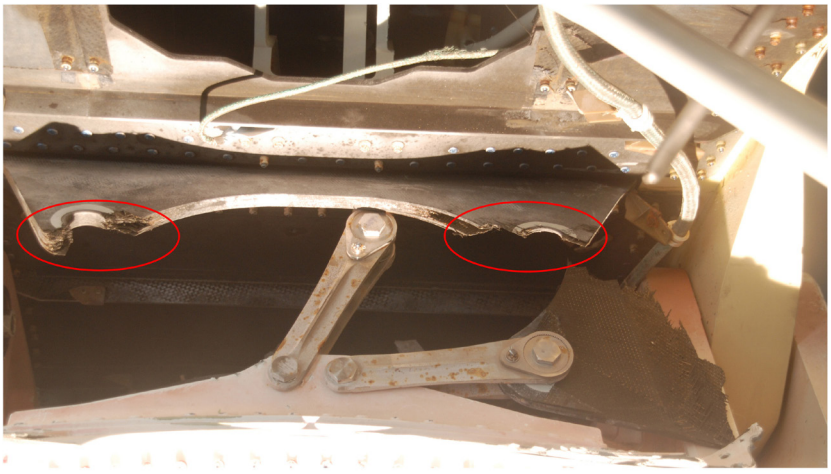
- Tensile failure of the centre spar at the level of the centre rod attachments;
- Compression failure of the aft spar at the level of the aft rod attachments and failure of the left-hand rod by buckling.

Figure 53: Tensile failure of the centre spar at the level of the attachment of the lateral load pick-up rods

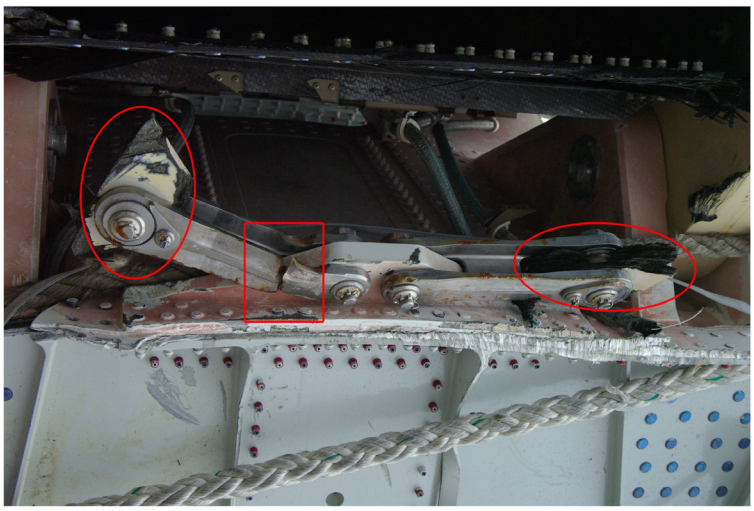
Figure 54: Compression failure of the aft spar at the level of the attachments of the lateral load pick-up rods and failure of the left-hand rod by buckling

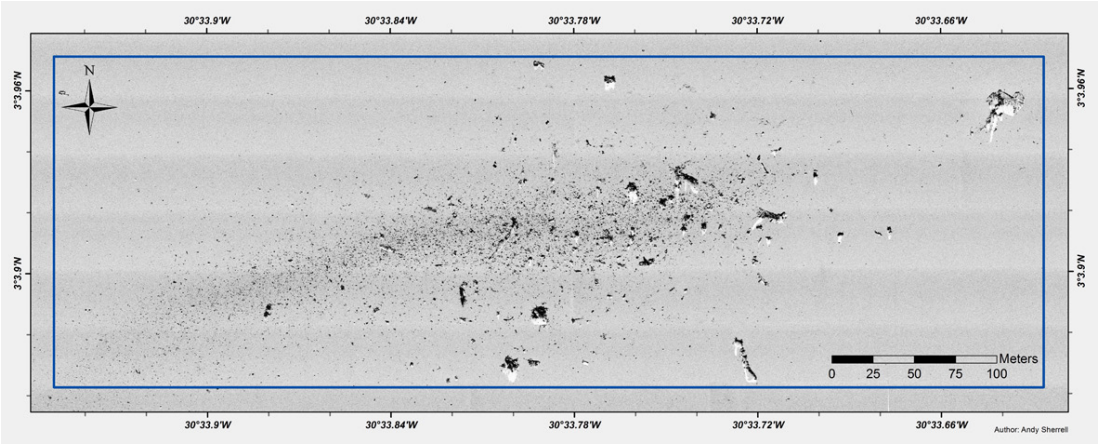
Figure 55: Sonar Images of the debris field

The densest debris (central section, engines, APU, landing gear) was found to the east of the site and the lighter debris to the west.

Outside the main area of 600 metres by 200 metres, a rear left fuselage panel containing eleven windows and around seven metres long was found approximately two kilometres south-west of the area. Part of the lower surface of the trimmable horizontal stabiliser was also found slightly to the south-west of this area.

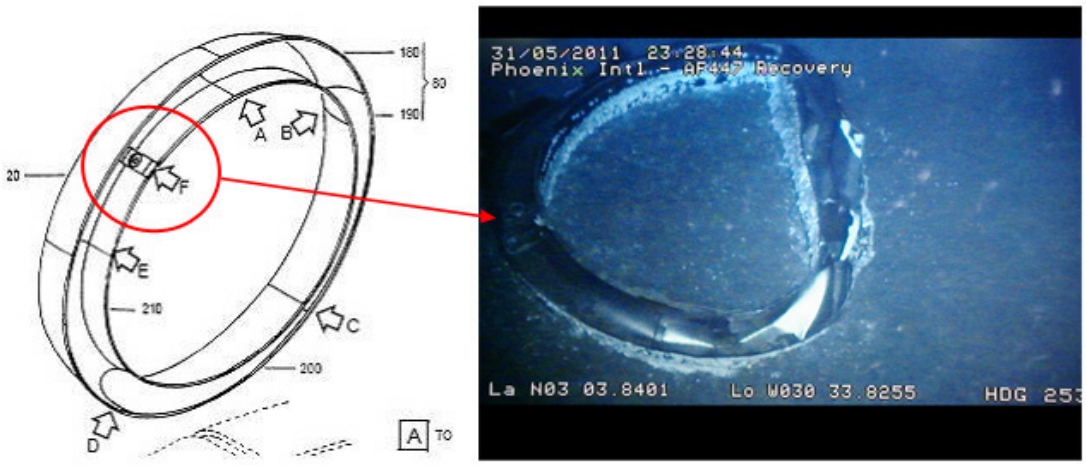
The left engine air entry leading edge had significant deformation on its lower part.

Figure 57: Left engine air intake

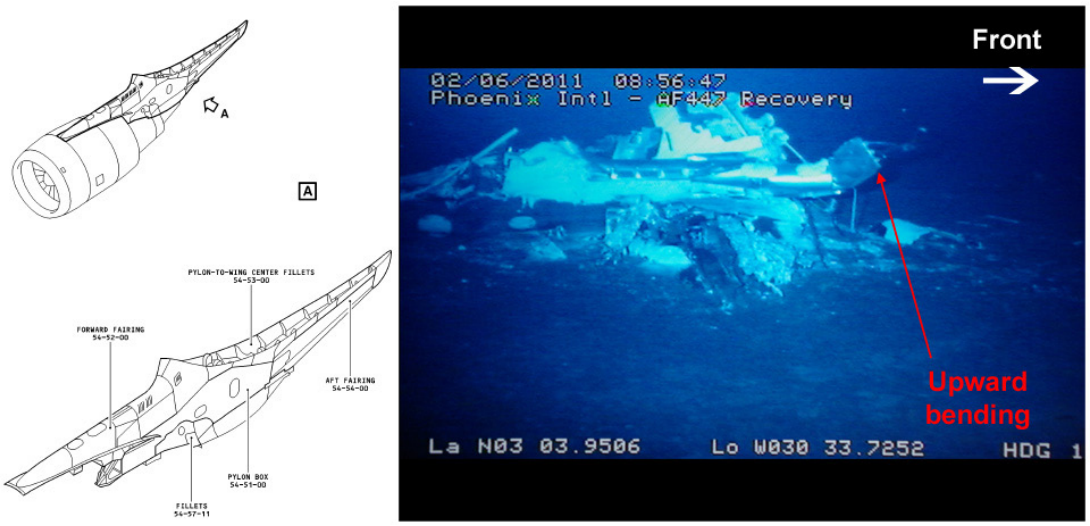
The engine pylons were found separated from the wings. They had deformations compatible with loads on the engines from below to above.

Figure 58: Engine pylon

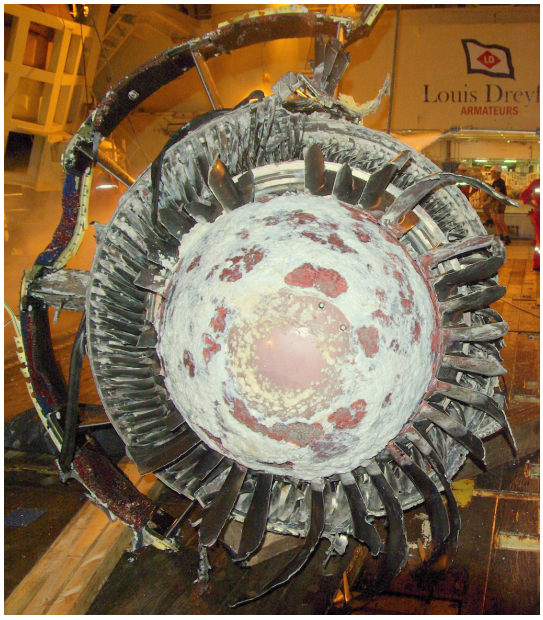
Figure 60: Front view of engine

The visual examination of the two engines showed that they were at high RPM at the moment of impact with the sea.

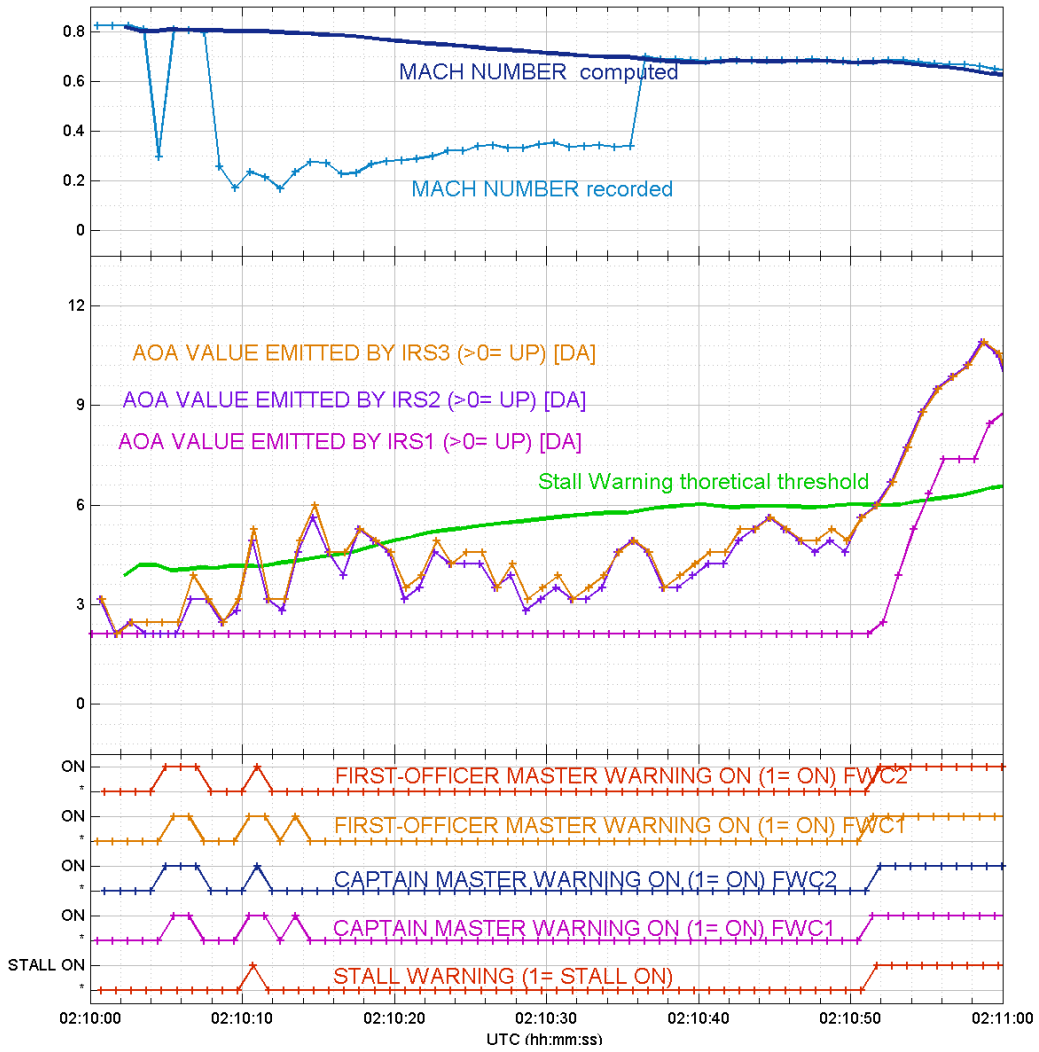
Figure 62: Evolutions of recorded angles of attack and of the stall warning trigger threshold

The graph below shows the change in the three recorded angles of attack as a function of time, in addition to the theoretical threshold at which the stall warning was triggered. This threshold was determined from a Mach value that was itself calculated from ground speed, wind and static temperature parameters. Comparison of this calculated Mach with the recorded Mach shows a good correlation.

The activations of the warning picked up by the CVR were identified as occurring at between 2 h 10 min 10.4 and 11.3 and between 2 h 10 min 13 and 13.4. The short duration of activation did not make it possible to detect it from the "Stall warning" parameter, but the FWC 1's "Master warning" parameters were triggered on one point at this time. However, this warning should have continued until about 2 h 10 min 15.5, and then have been triggered again between 2 h 10 min 17 and 19. The disabling of this warning was probably due to the fact that, between 13.4 and 15.5 and then between 17 and 19, and possibly at other times, the three Mach values were abnormally low (three Pitot probes iced up). The warning triggering threshold then suddenly increased to values of about 10°, much greater than the recorded angles of attack, which led to the warning stopping.

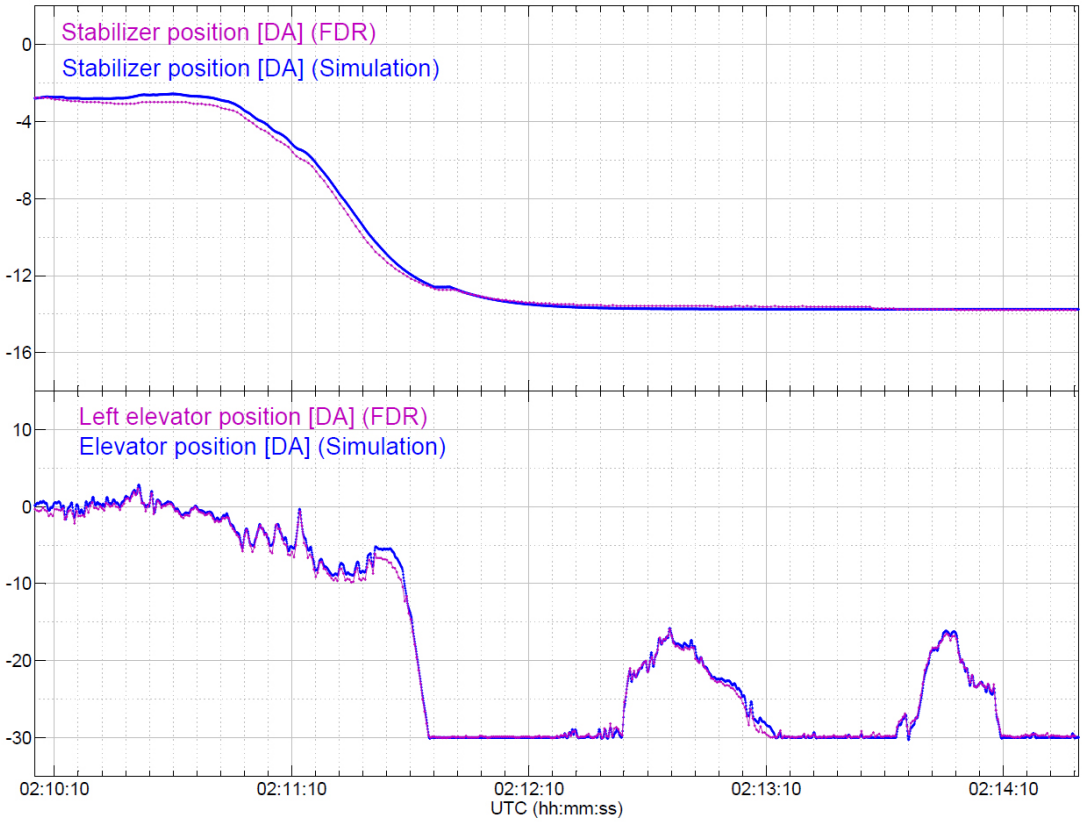
Figure 63: Comparison between the recorded positions of the elevator and THS and the simulation

A simulation of the operation of the flight control computers was undertaken, which involved recalculating the movements of the elevators and of the trimmable horizontal stabiliser (THS) based on pilots' inputs and compared the results against FDR parameters. This simulation was continued up until the end of the flight. The recalculated deflection angles for the elevators and the PHR are consistent with the parameters recorded.

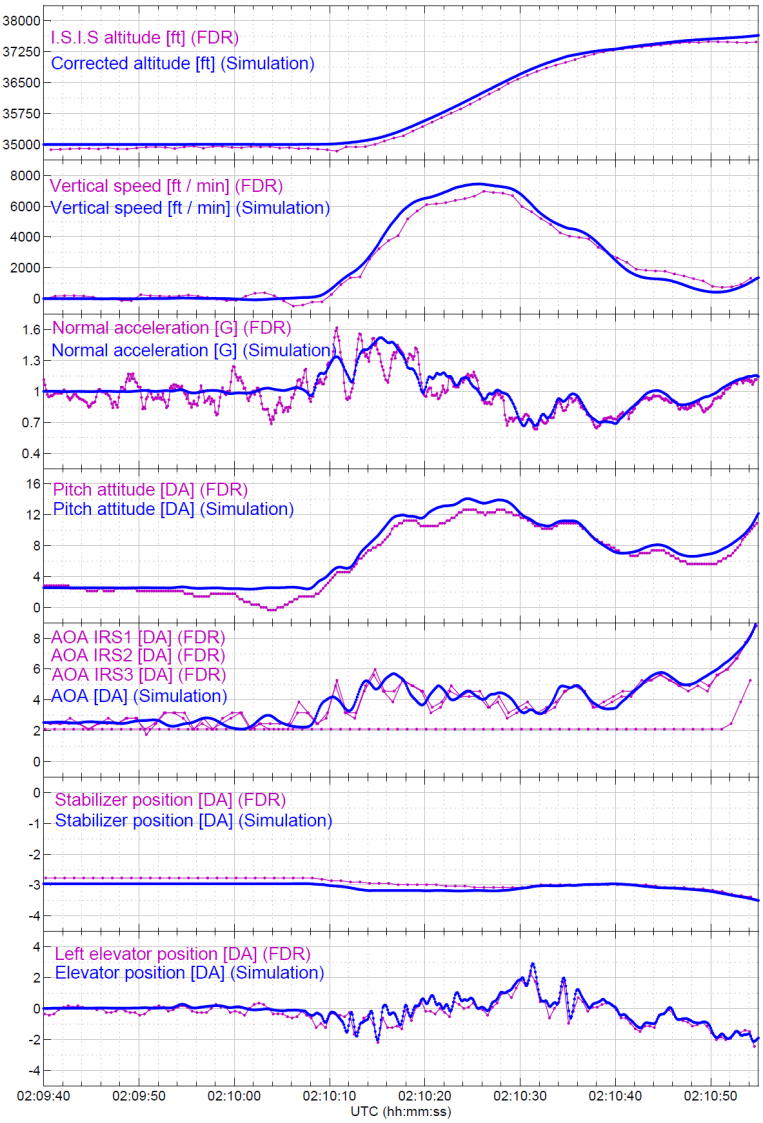
Figure 64: Comparison between altitudes of the aeroplane and the simulation (longitudinal axis)

- From about 15 seconds before disconnection, the autopilot countered aerological disturbances whose intensity would be defined as "light" on the ICAO scale (variations in vertical acceleration of less than 0.5 g);
- When the autopilot disengaged, a concomitant lateral gust caused the aircraft to depart from its flight path with a roll to the right;
- The subsequent roll movements resulted from the inputs by the PF;
- The aircraft's movements in the longitudinal axis were primarily due to the inputs by the PF, with the exception of small variations due to the aerology (variations in normal acceleration of about 0.2 g);
- The turbulence eased as from about 2 h 10 min 30 s;
- With no PF inputs, the aircraft would have gradually rolled further to the left but the variations in pitch attitude and altitude would have been small.

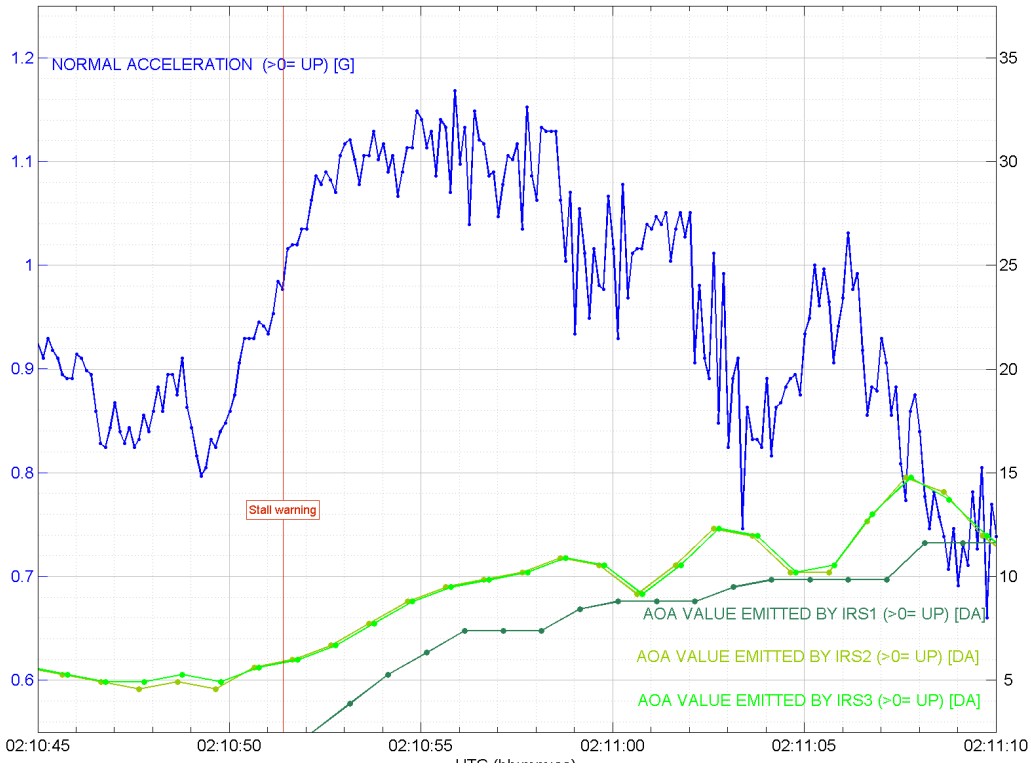
Figure 66: Evolution of normal acceleration recorded at the time of activation of the stall warning

At 2 h 10 min 51, when the aircraft was at about 37,500 ft and still climbing, the stall warning was triggered (see 1.16.3.2). A change in the recorded normal acceleration behaviour was demonstrated from 2 h 10 min 53, at an angle of attack about 1 to 2 degrees greater than the warning activation threshold.

This modification of the behaviour resulted in the appearance of a high frequency component of an amplitude increasing to up to about 0.1 g peak-to-peak, and with a signature that is very different from a turbulence signature of aerological origin. Furthermore, there is a noise on track 1 of the CVR, at about 2 h 10 min 55, which may be the impact of the microphone striking a panel, heard at a stable frequency.

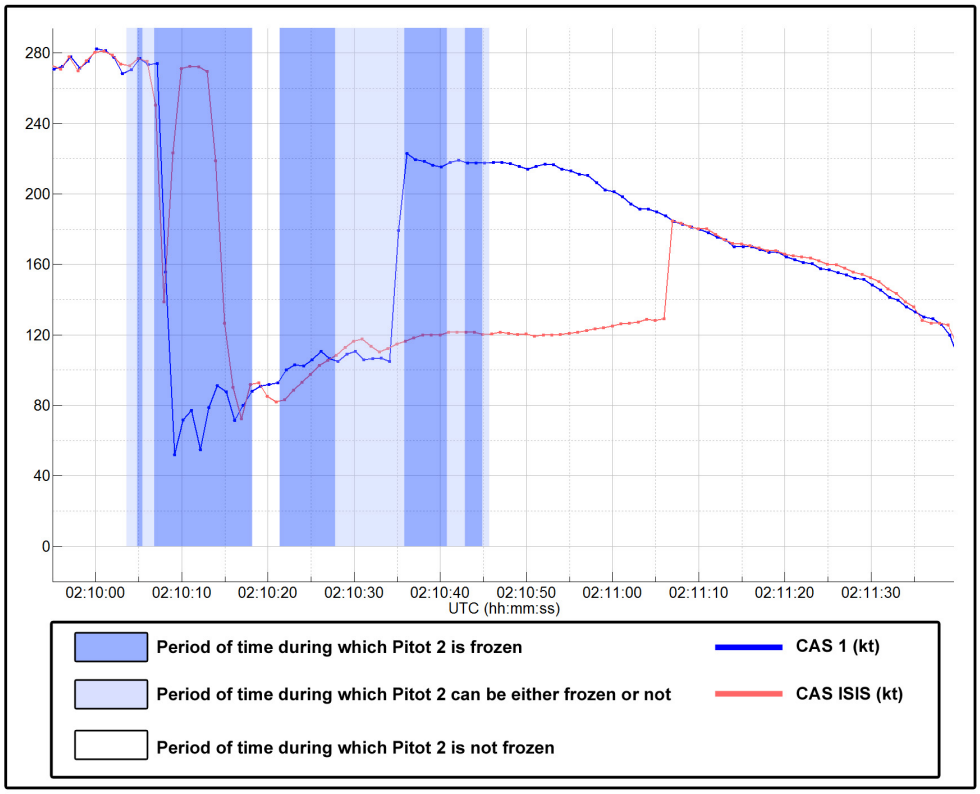
Figure 68: Evolution of the 3 CAS

Between these two moments, the Pitot probe on the copilot's side certainly unfroze, at least temporarily.

Two icing profiles were established, one in which the Pitot probe remained frozen for the longest period of time and the other for the shortest period of time. It was not possible to determine which of the two profiles was more likely. Consequently, the evolution of the CAS displayed on the right PFD is partially known for the period from 2 h 10 min 3.5 to 2 h 10 min 46, as the following graph illustrates.

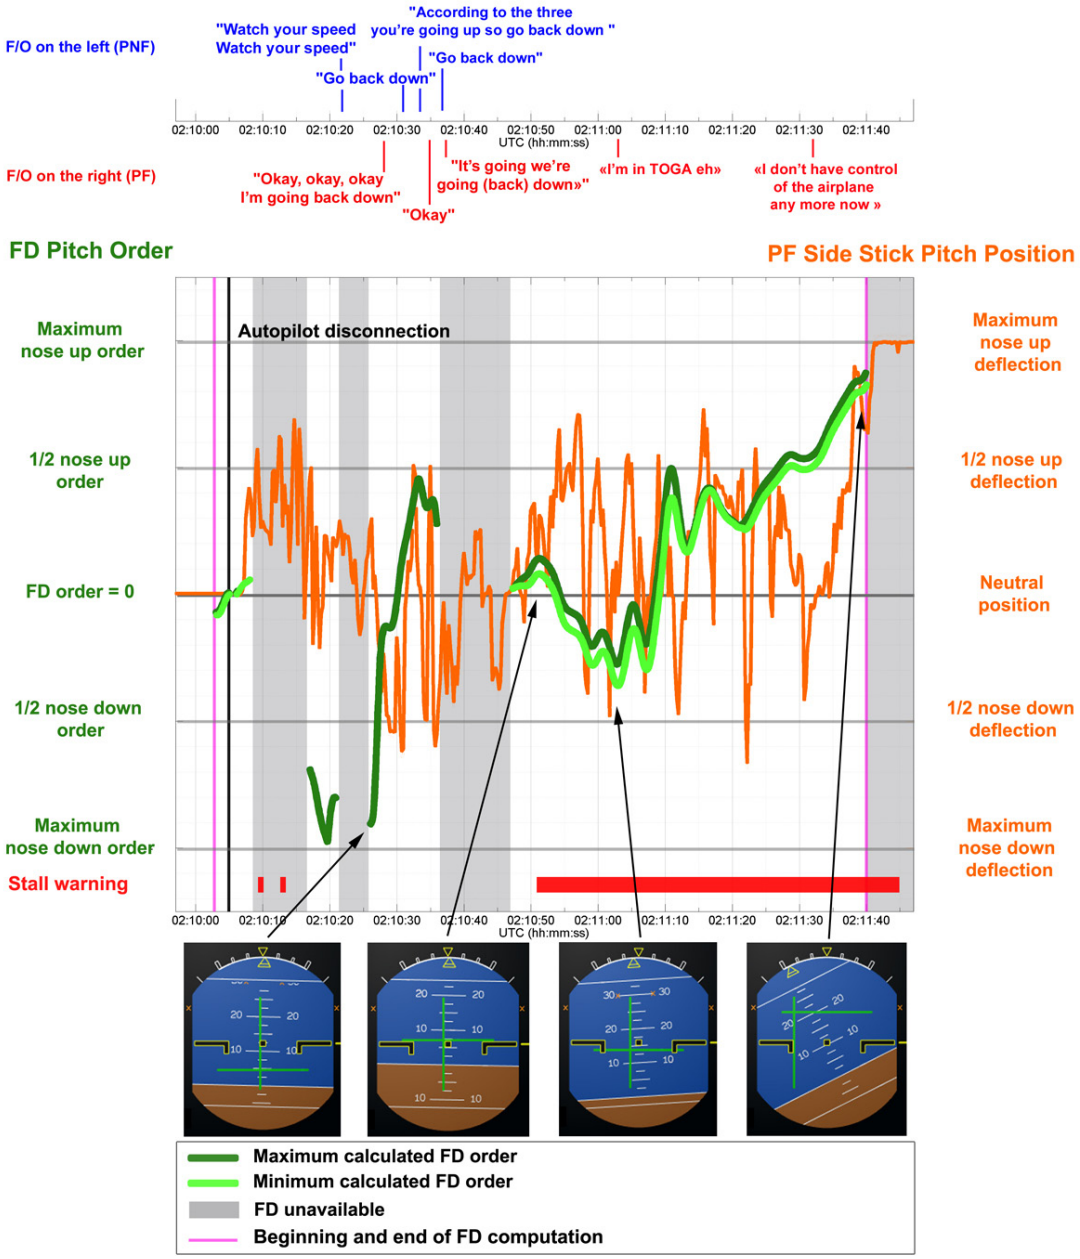
Figure 69: Evolution of FD crossbars

The following graph represents the maximum and minimum positions of the FD crossbars displayed between the disconnection of the autopilot and 2 h 11 min 40, as well as the longitudinal inputs made by the copilot on his sidestick:

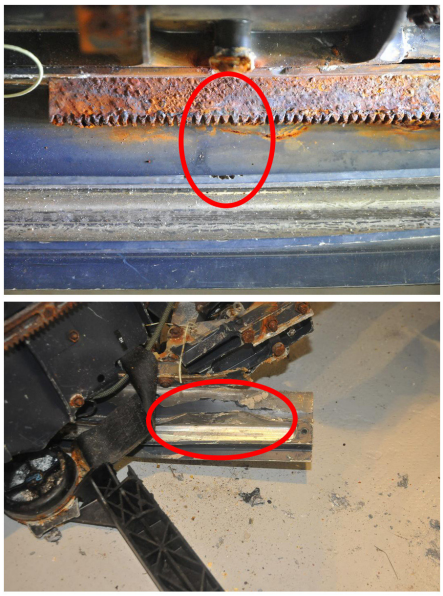
Figure 82: Marks on the adjustment mechanism

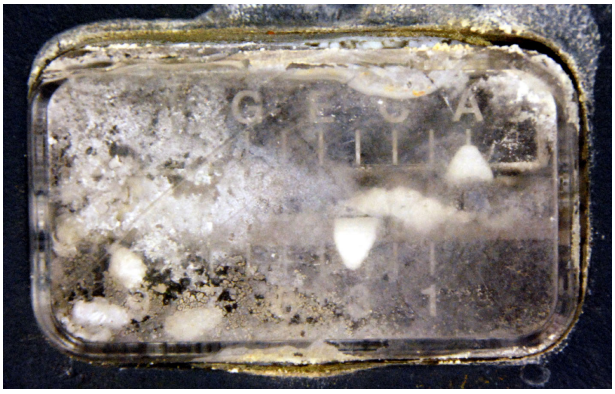
Figure 83: Dial indicating armrest position

The armrest was recovered in the up position, a probable consequence of the impact. The armrest position was indicated on the dial dedicated to this function. The needles were positioned on A values (adjustment from A to K for height) and 3 (adjustment from 1 to 9 for tilt angle). The armrest cladding was dismantled in order to check mechanism integrity and validate the needle positions. The mechanisms were demonstrated to be irreversible during certification tests, that is to say that leaning on the armrest did not modify the adjustments made with the knobs.

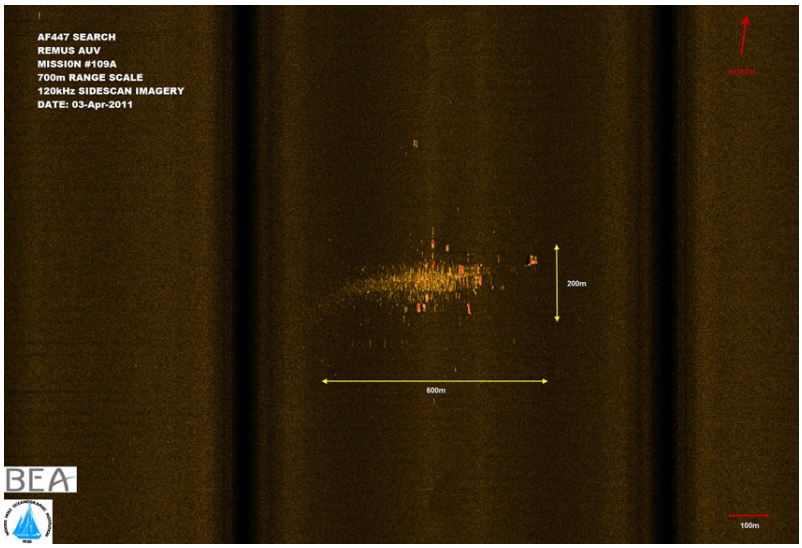
Figure 92: General view using sonar imaging: 120 kHz, range of 700 m

The first passage brought to light a concentration of backscattered data over an area of around 600 metres by 200 metres.

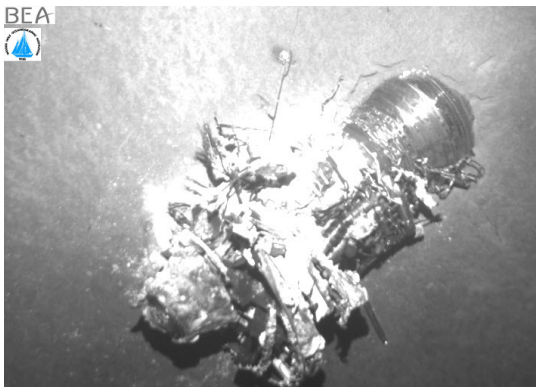
Figure 93: Engine

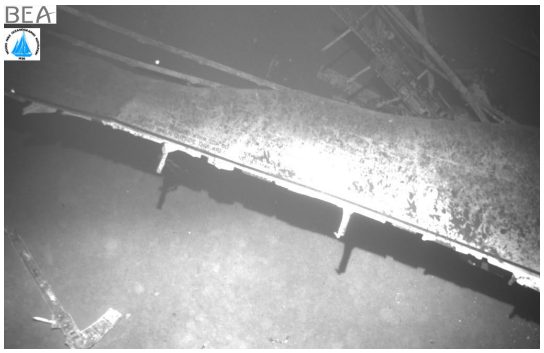
Figure 94: Wing

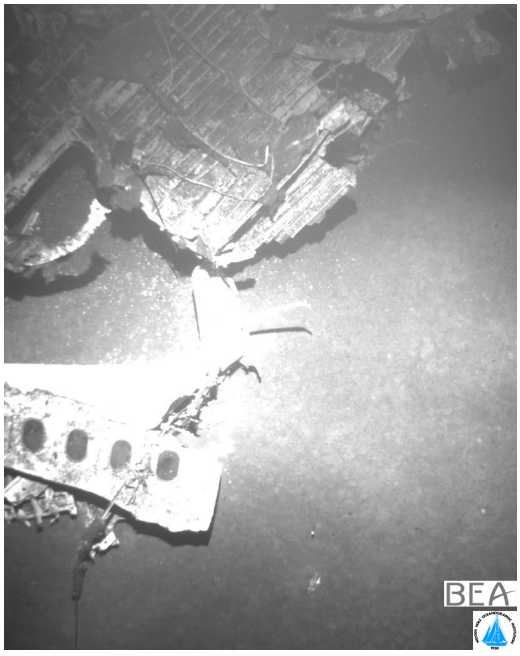
Figure 95: Section of fuselage
