Final Report

On the accident on **1st June 2009**
to the **Airbus A330-203**
registered **F-GZCP**
operated by **Air France**
flight AF 447 Rio de Janeiro - Paris

BEA

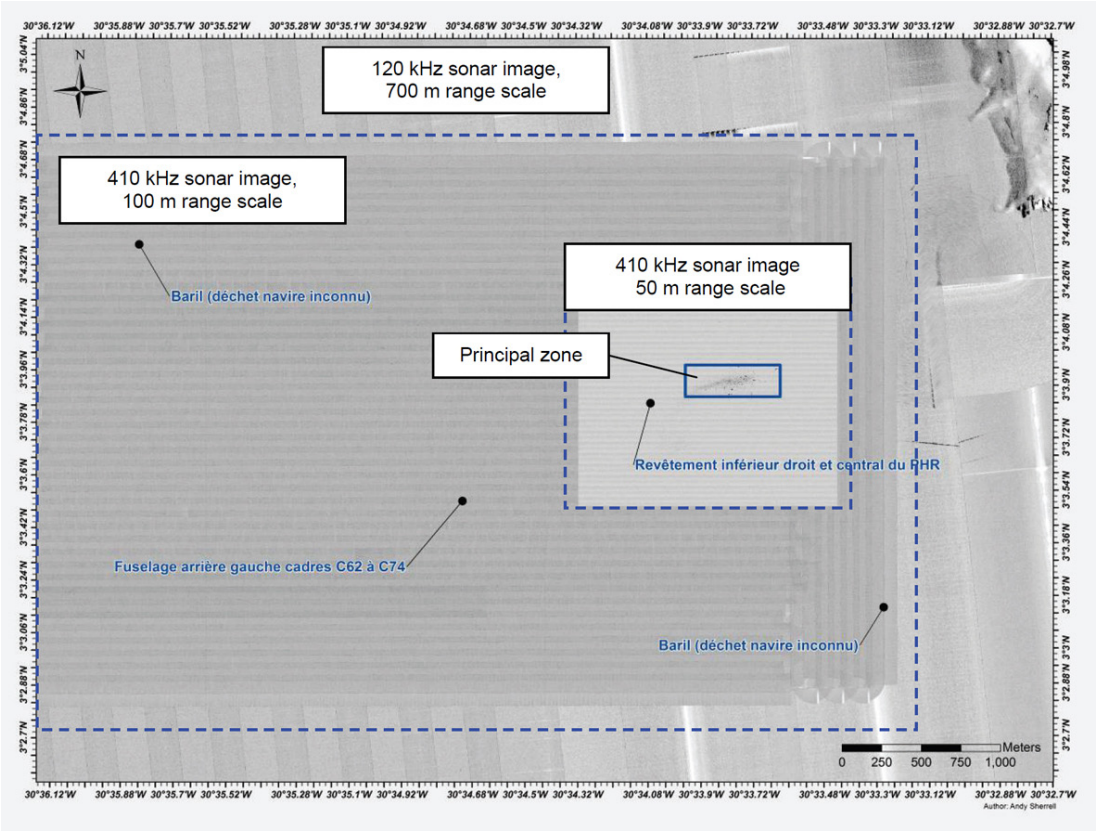
Figure 97: Overlay of sonar images taken with various settings:
120 kHz, 700 m range scale - 410 kHz, 100 m range scale - 410 kHz, 50 m range scale

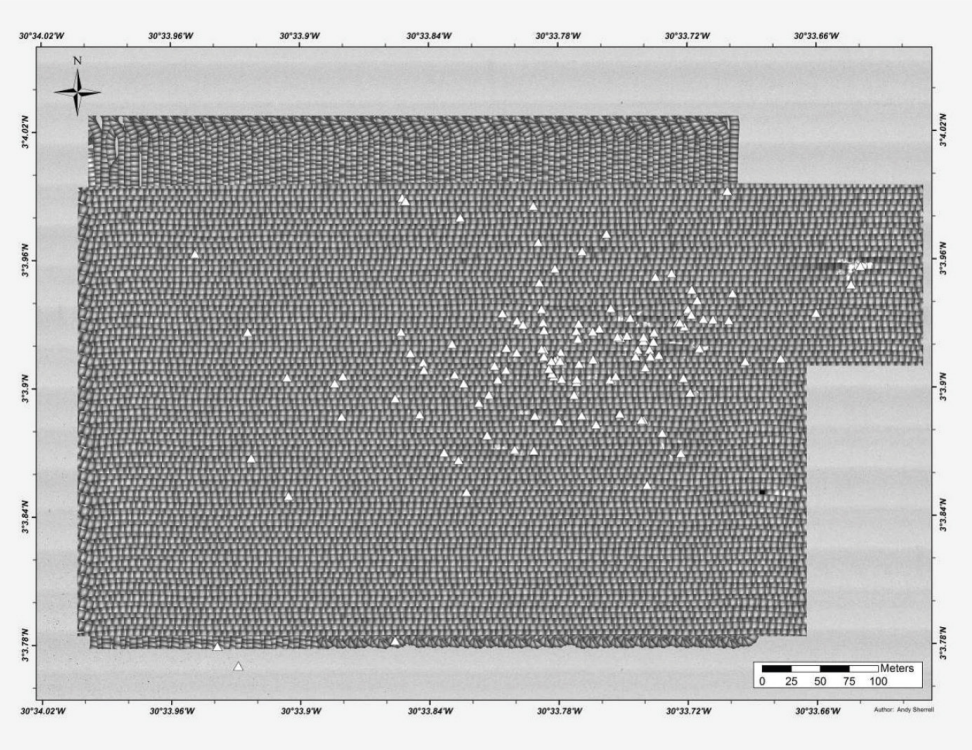
Figure 98: Visualisation of the photo mosaic obtained with REMUS AUV images and the aeroplane debris identified by using the REMORA ROV
