Aviation Occurrence Report Volume II

ASC-AOR-05-02-001

IN-FLIGHT BREAKUP OVER THE TAIWAN STRAIT

CHINA AIRLINES FLIGHT CI611

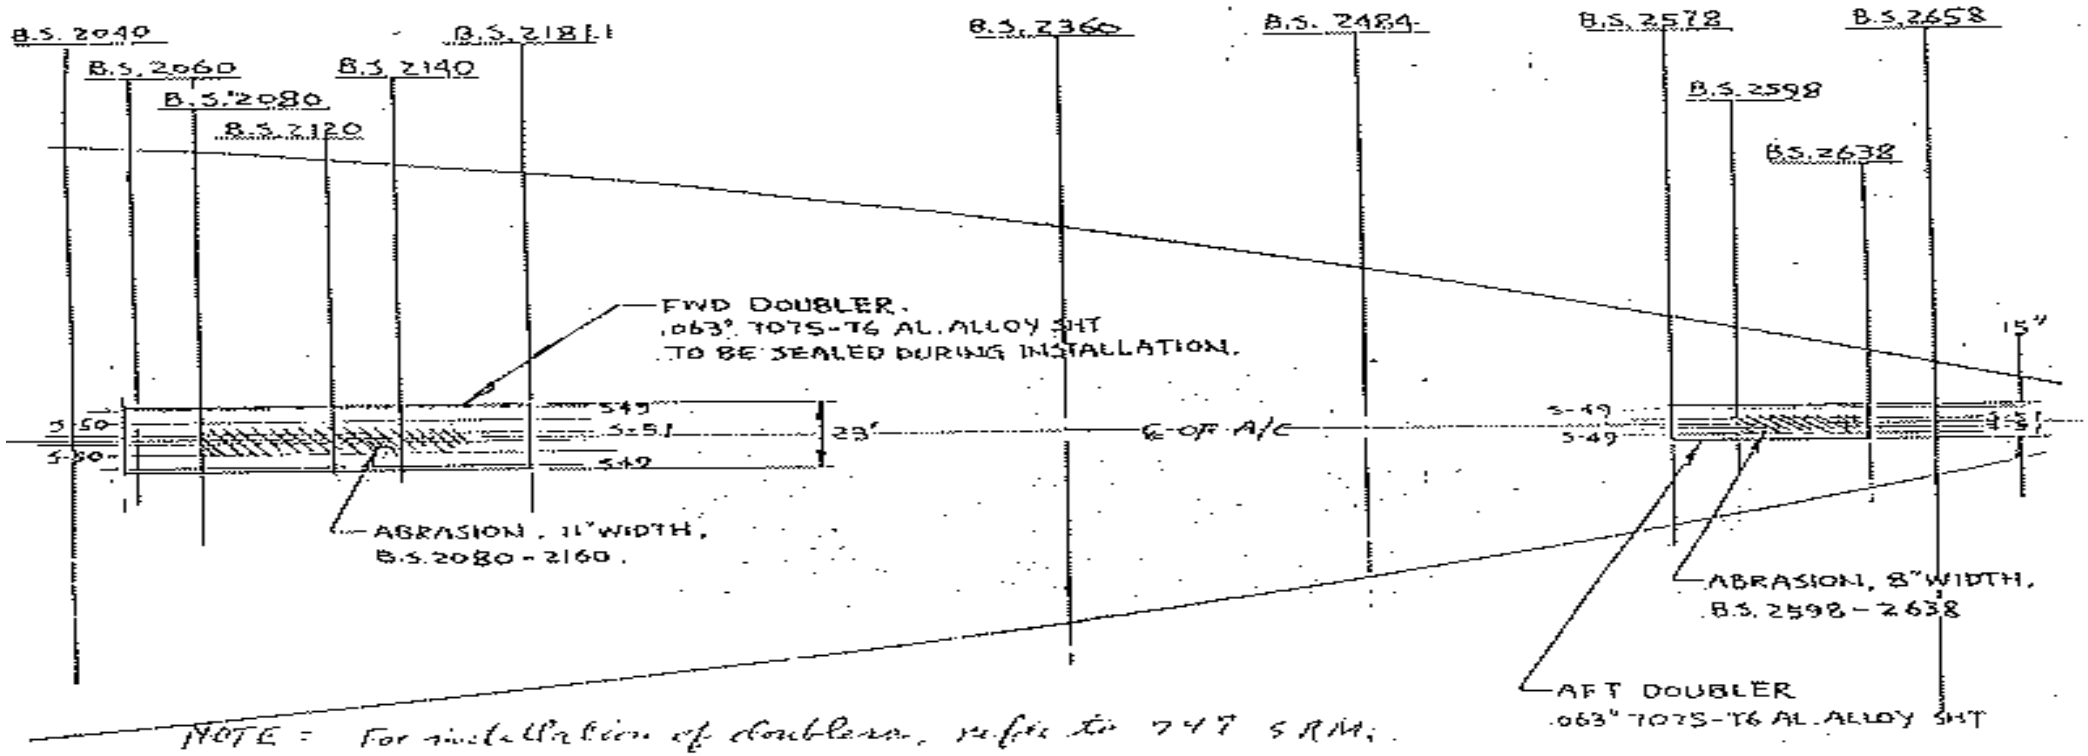
BOTTOM VIEW — FUSELAGE TAIL SECTION, 747 B-1866 A/C.

B-1866 low fuselage aft section damage occurred during landing with dragged tail on runway in HKG.

Preliminary inspection found the serious abrasion damages on fuselage tail portion bottom skin between F.S. 2080 and 2160 and between F.S. 2578 and 2638. The aft drain mast was missing. LH outflow valve door inb'd corner partially cut.

1. Close visual inspect internal structure for any defects inside the abraded skin.

4. LH outflow valve door cut area temporarilly repaired with 6061-T6 Alum. Alloy and functional test.

5. Conduct permanent repair IAW 747 SRM within four months.

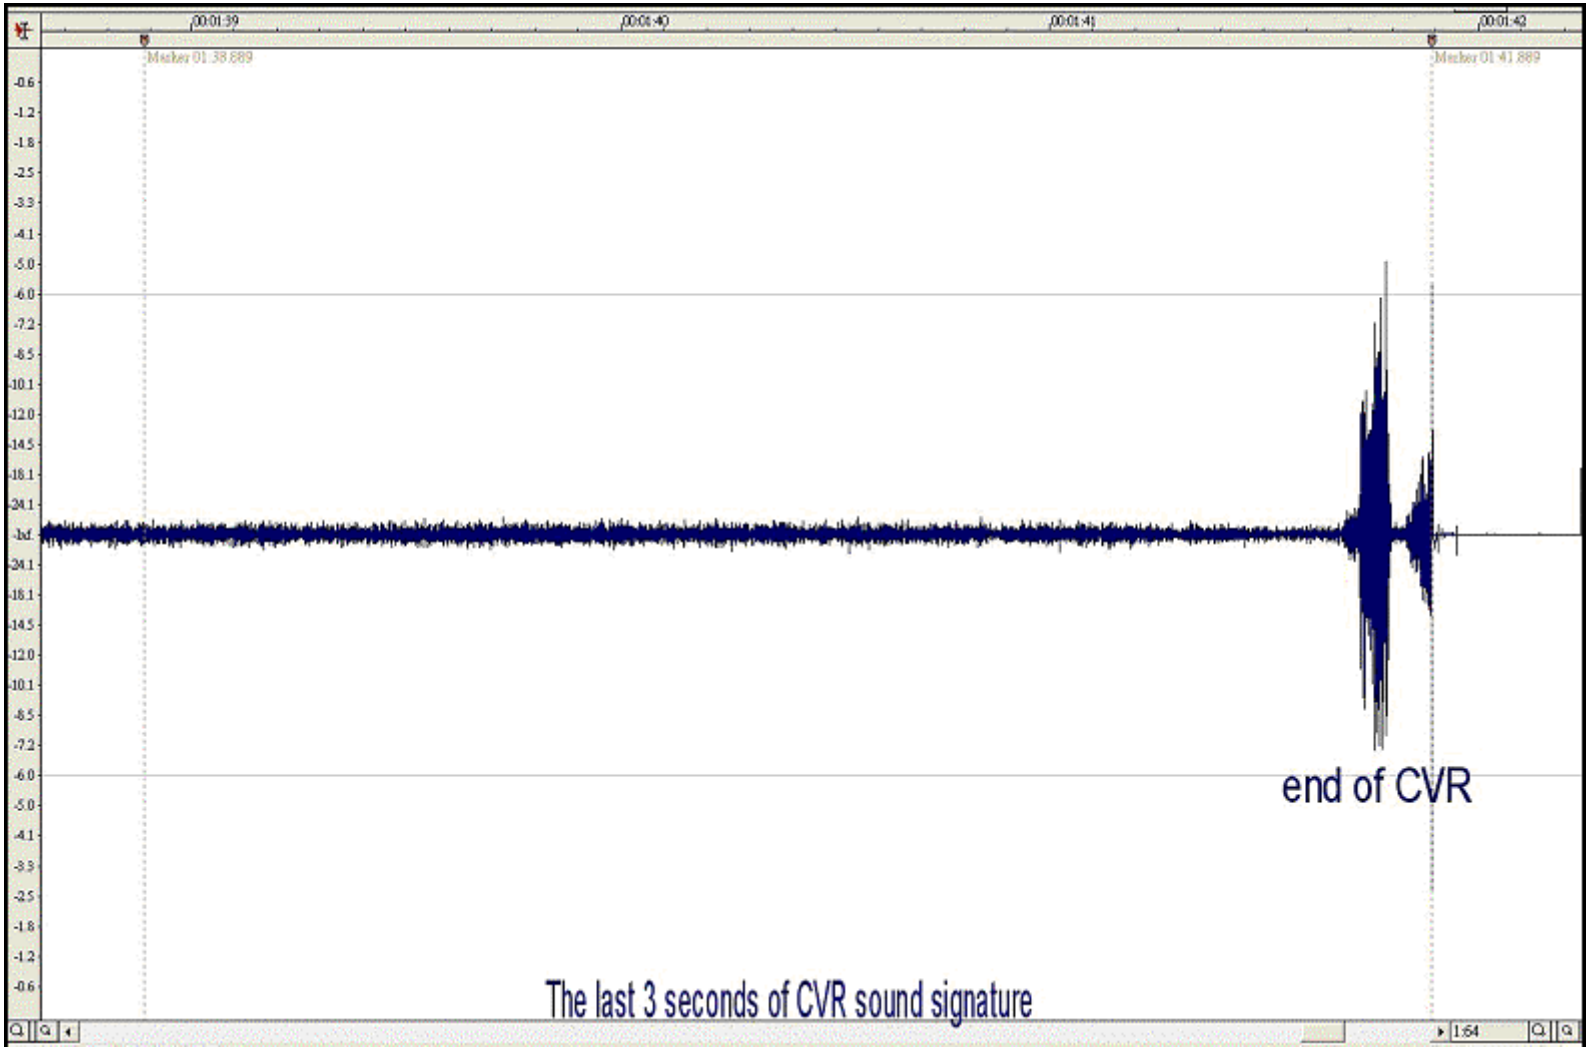
end of CVR
The last 3 seconds of CVR sound signature

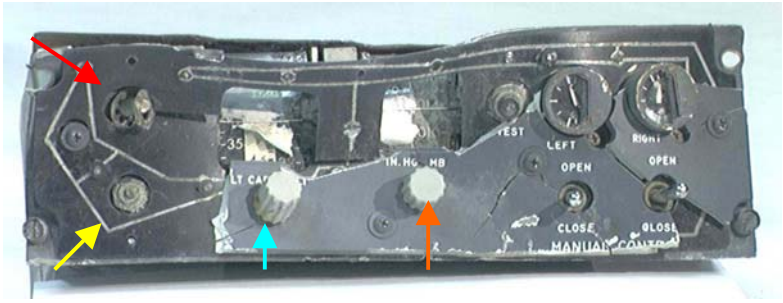
Figure 7: Flight Engineer's Cabin Pressure Control Selector Panel - (front view)

- **OUTFLOW VALVES** position indicators are both showing needle positions slightly below 9 O'clock (upon initial observations prior to taking photograph, fig. # 7).

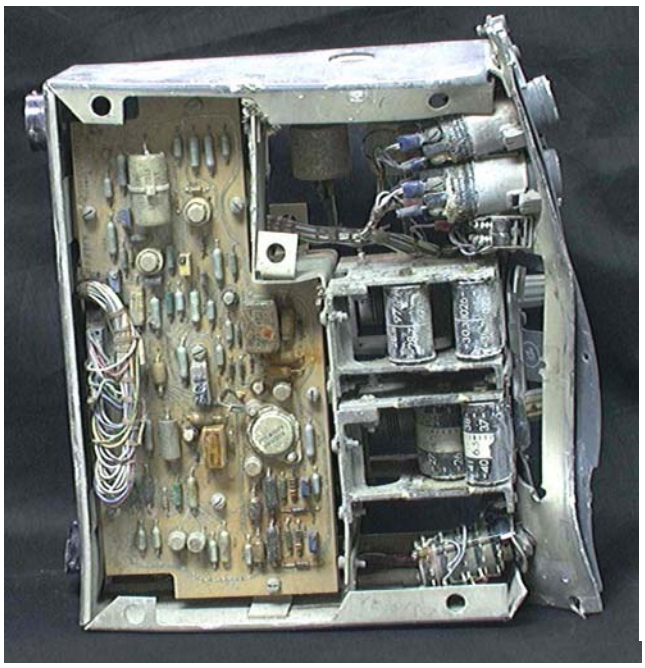
Figure 9: Flight Engineer's Cabin Pressure Control Selector Panel - (top view)

- Deformation of the face of the chassis.
- Broken spot welds and separation of face of chassis (lower right).
- Sedimentary deposits deposited throughout unit.
- Corrosion noted in multiple locations on multiple components.
- Slight deformation of rear chassis panel at the J3 plug (lower left).
- Flight **ALTITUDE** selection tape delaminated and partly missing.

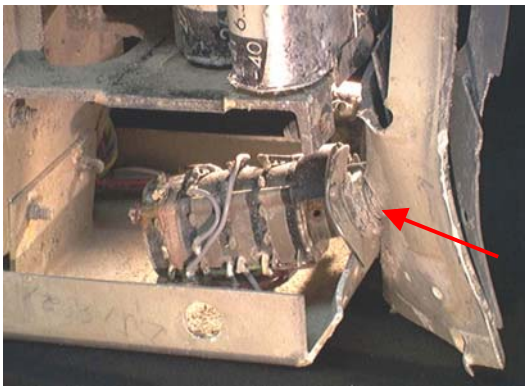
Figure 10: **MODE SELECT** Rotary Switch

- Rotary switch shaft slightly separated from front of chassis.

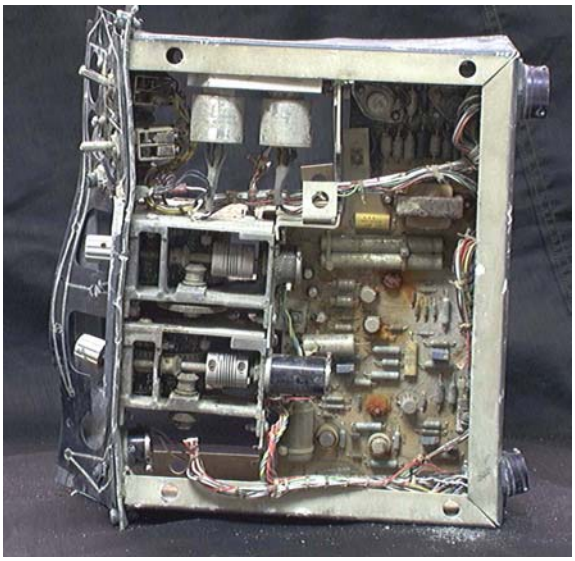
Figure 11: Flight Engineer's Cabin Pressure Control Selector Panel – (bottom view)

- Deformation of the face of the chassis.
- Sedimentary deposits deposited throughout unit.
- Corrosion noted in multiple locations on multiple components.

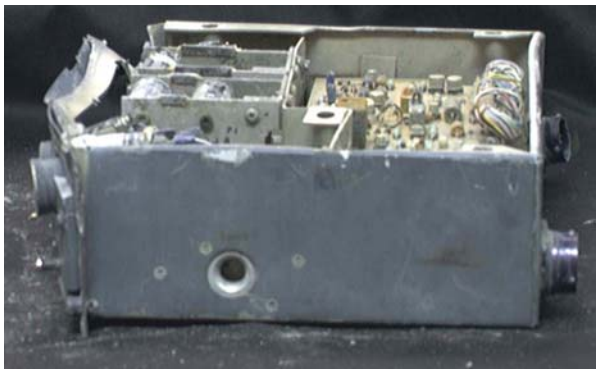
Figure 12: Flight Engineer's Cabin Pressure Control Selector Panel – (side view - cabin pressure port side).

- Deposits noted inside the sensor port.

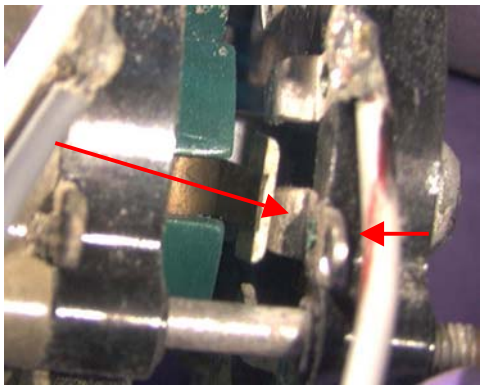
Figure 14: Panel, **MODE SELECT** Rotary Switch

- Continuity tests suggest setting was in manual (**MAN**) select mode, not **AUTO**.
- Confirmed wire continuity from J3 connector to rotary switch (S1)
- Initial visual inspection of the (S1) rotary **MODE SELECT** switch (reference, Figure 7) could not confirm switch setting because the shaft was bent (therefore inconclusive).
- X-ray of rotary switch (S1) could not verify **MODE SELECT** switch setting due to indistinguishable internal details.
- Disassembly of **MODE SELECT** rotary switch confirmed switch was set in manual (**MAN**) setting (Figure 14).

- Internal contact position verification (manual).

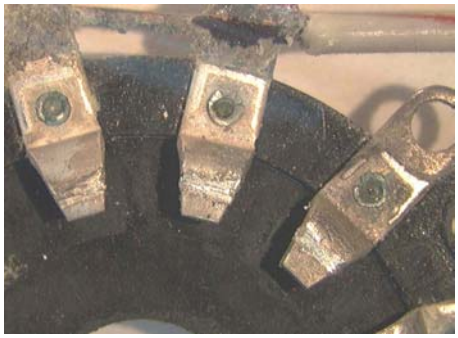
Figure 15: **MODE SELECT** Rotary Switch, Stationary contacts, deck 3, #1-2-3 (left to right).

- Contacts of rotary switch (S1), deck 3, #1-2-3, Wear marks on contacts appear to be normal.

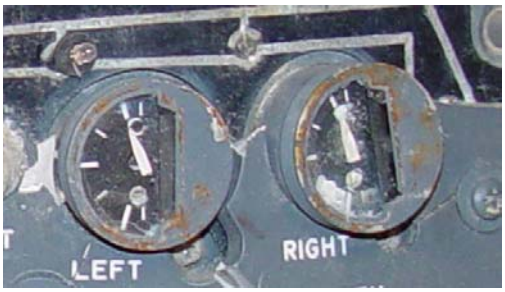
Figure 16: Panel, **OUTFLOW VALVES** Indicators.

- Internal surface of glass face: small surface anomaly observed as viewed from exterior.
- Case removed to inspect glass from inside. What appeared to be an anomaly on the inner side of glass was actually a debris deposit.
- No impact indications from needle impact were noted.

- Both **LEFT** and **RIGHT**, **OUTFLOW VALVES** Indicators' needles were detached from armature/needle mounting tabs and loose within the housings.

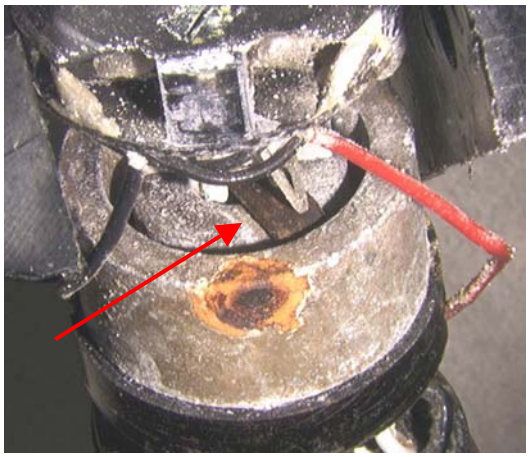
Figure 17: **LEFT**, **OUTFLOW VALVES** Position Indicator witness mark

- Moving armature/needle, mounting tab corresponds to a witness mark on underlying base. This position corresponds to needle positioned at approximately 25% open. The armature was moved from its location in Figure 17 to display the "witness" pattern underneath the movable armature, shown in Figure 18.

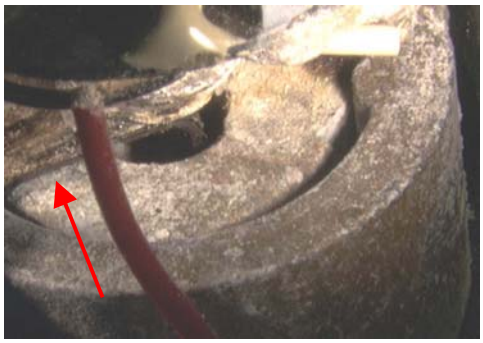
Figure 19: **RIGHT**, **OUTFLOW VALVES** Indicator; armature is over witness mark.

- Armature/wiper member corresponds to witness marks on base at two places (at both extreme ends of possible needle movement). It was inconclusive as to the exact corresponding location of needle position.

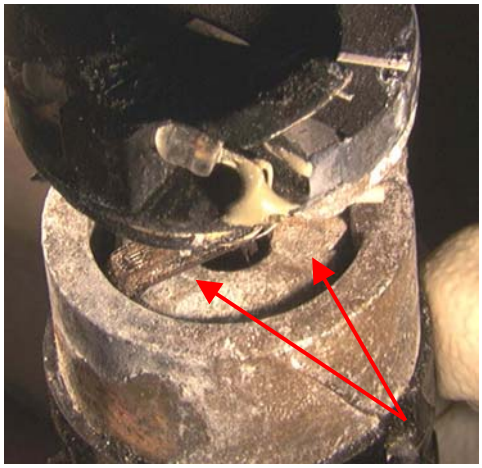
Figure 21: **RIGHT**, **OUTFLOW VALVES** Position Indicator witness mark (right).

- There appeared to be two “witness” marks on the underlying base of this indicator. The one on the left appeared to be more distinct than the one on the right.

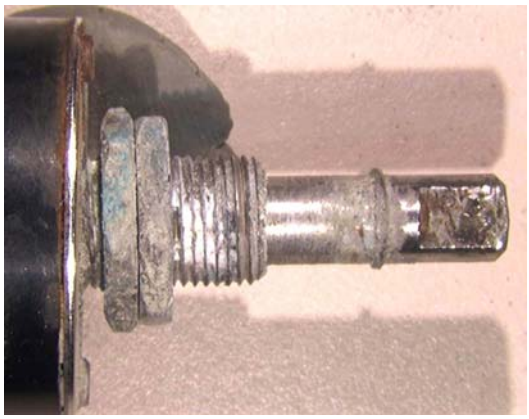
Figure 26: Detail of switch #1 shaft.

- Corrosion on all metallic parts
- Shaft can be pulled easily from switch body.
- Shaft is slightly bent relative to body.
- All wiring is intact, but no continuity.
- Terminals are significantly corroded.
- No cracking is apparent in the switch body.
- X-ray confirms that the valve-closed electrical contacts are aligned with each other.
- After removal of the switch, it was noted that the indexing ring tab to shaft was sheared or corroded away.

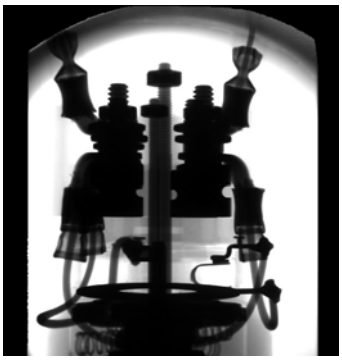
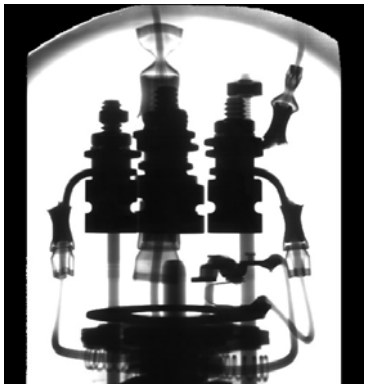
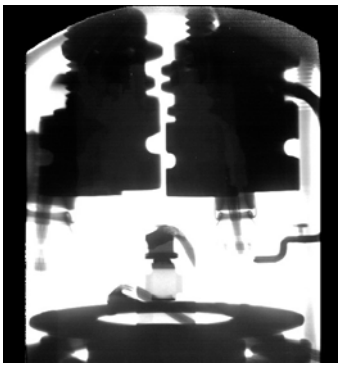
Figures 27a, 27b, 27c: X-rays of Pack Valve Switch #2

- Corrosion on all metallic parts
- Minor cracking of the switch body.
- No continuity could be attained.
- All external wiring appears intact.
- X-ray confirms that the valve-closed electrical contacts are aligned with each other.

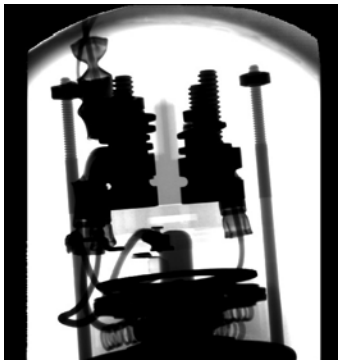
Figures 29A, 29B, 29C: X-rays of Pack Valve Switch #3

- Corrosion on all metallic parts
- Severe cracking of the switch body.
- No continuity could be attained.
- All external wiring appears intact.
- X-ray shows that the valve-closed electrical contacts are not aligned with each other. Misalignment approximately 10 degrees. The switch knob was not in the full closed position.

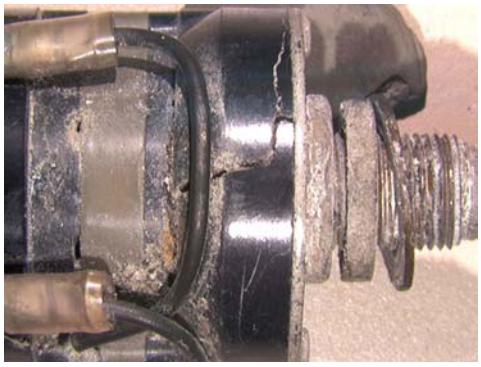
Figure 30: Switch #3 body crack detail

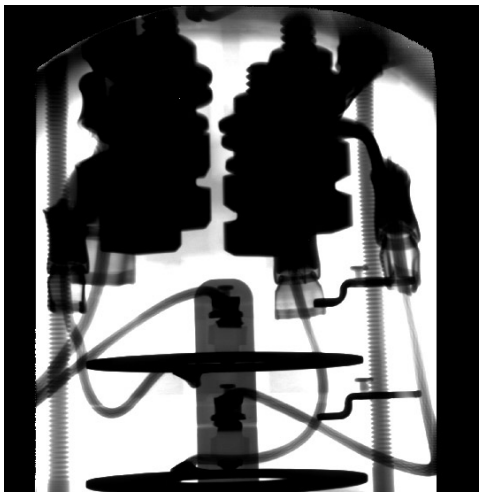
Figure 32: X-ray of Bleed Air Valve Switch #1.

- X-ray confirms that both sets of active electrical contacts are aligned with each other.

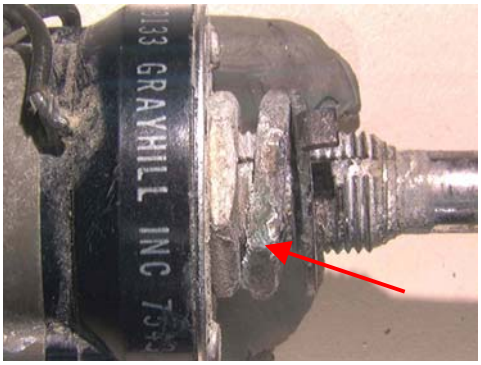
Figure 33: Bleed Air Switch #1
- Displaced nut
- Knob in OFF position
- Rear mounting nut has been displaced.
- Corrosion on all metallic parts

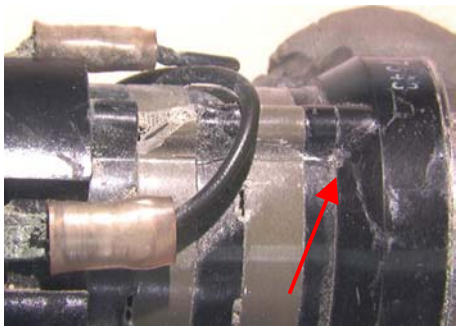
Figure 34: Bleed Air Switch #1.
- Minor cracking of housing is apparent.
- Crack detail.
- No continuity could be attained.
- All external wiring appears intact.

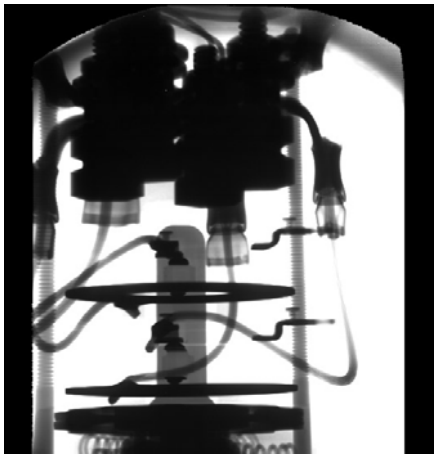
Figure 35: X-ray of Bleed Air Valve Switch #2.
- X-ray confirms that both sets of active electrical contacts are aligned with each other.

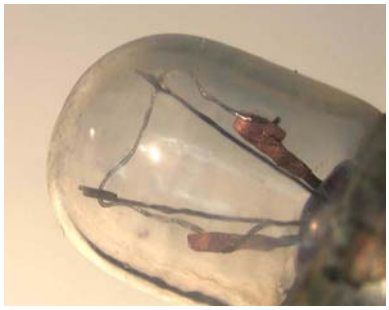
Figure 38: **PRESS RELIEF** light, upper, left lamp, (filament intact) - (Ref. Figure 37, yellow arrow for lamp location).

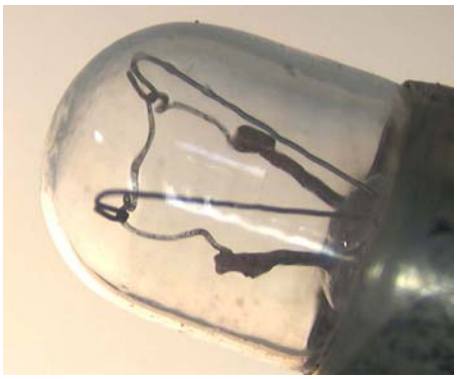
Figure 39: **PRESS RELIEF** light, upper right lamp, (filament intact). - (Ref. Figure 37, yellow arrow for lamp location).

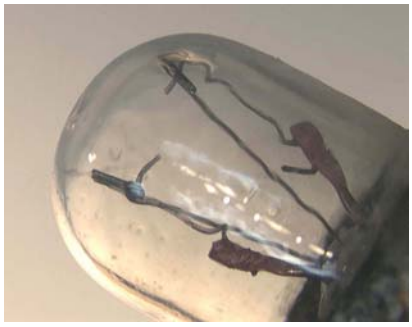
Figure 40: **PRESS RELIEF** light, lower left lamp.
- Filament is broken - (Ref. Figure 37, red arrow for lamp location).

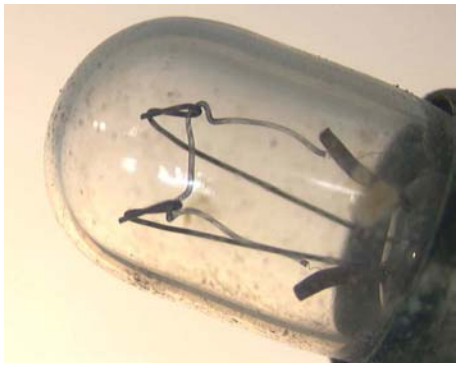
Figure 41: **PRESS RELIEF** light, lower right lamp.
- Filament appears to be intact.
- Legend plate missing, (Ref. Figure 37, red arrow for lamp location).

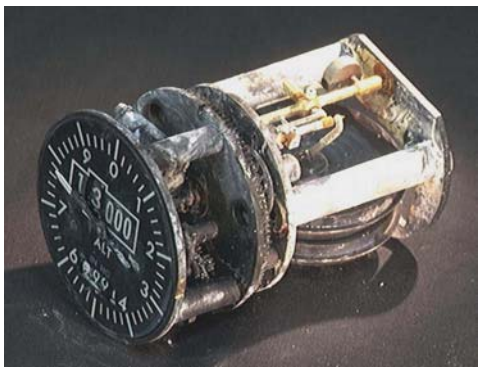
Figure 44: Cabin Altitude Indicator, housing removed.

- Removed back of Altimeter housing to observe internal mechanism. Large amount of sedimentary type debris noted internally.
- No observable damage to internal mechanical parts. It did not appear that the physical damage to the outer case caused the case to come into contact with inner components.
- Significant amount of sedimentary type debris noted on internal parts.

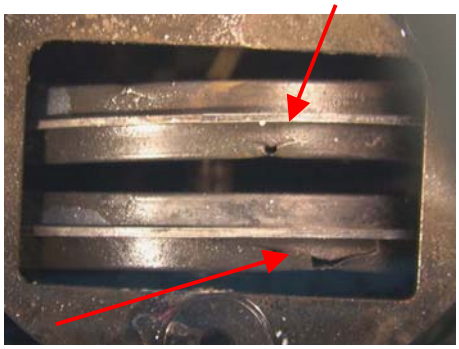
Figure 46: Cabin Altimeter Indicator, bellows, visible damage

- Both bellows have fractures along the outer circumference of the bellows. Those fractures appear on a portion of the bellows at the back of the instrument. The fractures are on the lower half of each of the bellows. The edge features, at the fractures, are oriented outward from the inside of the bellows.

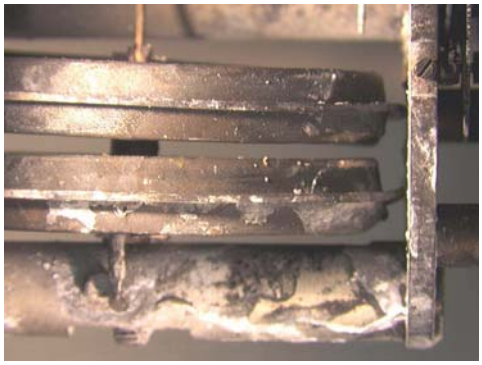
Figure 47: Cabin Altimeter Indicator, bellows displacement

- The upper bellows is tilted with respect to its axis. The lower bellows is also tilted, but to a lesser degree.
- The upper bellows is in contact with the gear mounting plate. The lower bellows flange is deformed at the point nearest the gear mounting plate, but doesn't contact the plate.

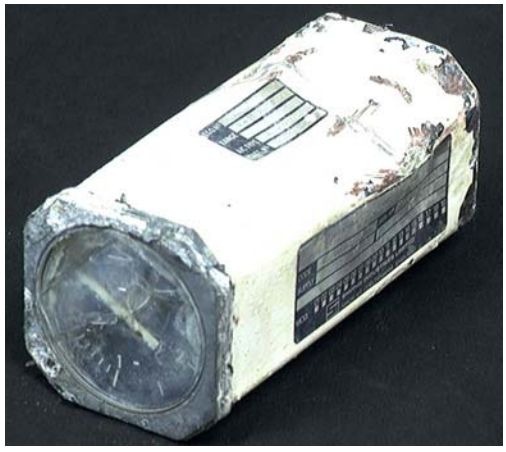
Figure 50: Cabin **DIFF PRESS** Indicator
- Water stains inside glass face.
- Needle is indicating below zero.

Detailed observations:
- Removal of the bezel did not reveal any abnormal markings on inside of glass.
- Dial indicated less than zero (at approximately 0.6 - 0.8 psi).
- Casing was removed. Cabin pressure line was cut to remove indicator from case. When pressure line was cut, the indicator dial returned to zero.
- No apparent damage was visible to internal parts.
- Minimal corrosion was present on internal surfaces.
- Red scale mark on face at approximately 9.25 – 9.3 (mechanism is physically limited at that point).

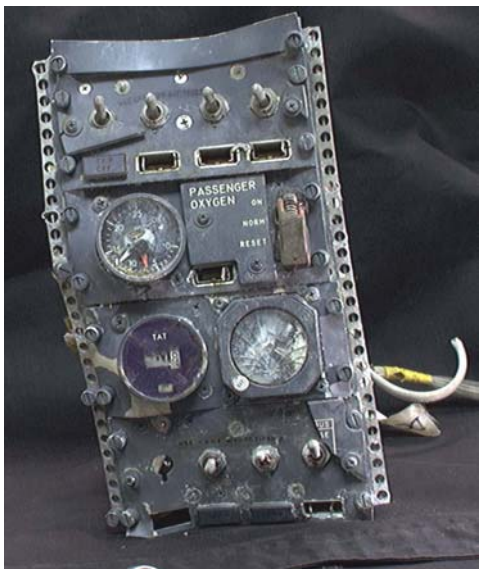
Figure 51: Flight Engineers Panel, overview. Includes modules M179, M183, M184 & M557.

- Light plate is missing.
- All switch toggles are in up position.
- **TRIP OFF** indicator lights, numbers 2, 3 & 4 legend plates, bulbs and retaining assemblies are missing.

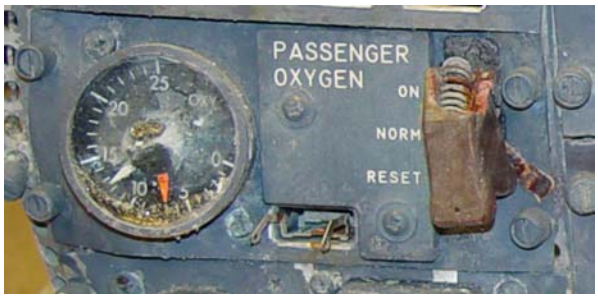
Figure 53: Passenger Oxygen Panel, module M183.

- Case removed indicator- found heavy corrosion and sedimentary deposits present internally.
- **PASSENGER OXYGEN** needle was disconnected from its driving rod, either on disassembly or prior to disassembly.
- No indication of needle strike on indicator face.
- Dial indicator needles at 700 PSI for passenger and 1250 PSI for crew.
- Residue visible through glass face of indicator.
- Power **ON** indicator legend plate, bulbs and retaining assembly are missing.
- Switch guard safety wire is broken.
- Switch guard broken and partially missing.
- Light plate is intact.

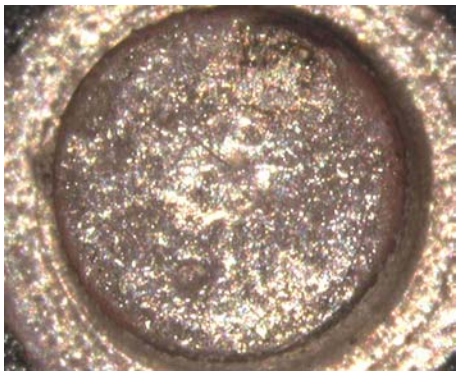
PASSENGER OXYGEN control switch of Module M183 was found to be in the **NORM** position as received. Continuity tests indicated that the switch functioned properly in the **ON**, **NORM** and **RESET** positions. See Figures 54 through 58.

Figure 55: Stationary contact of oxygen control switch "**ON**" position.

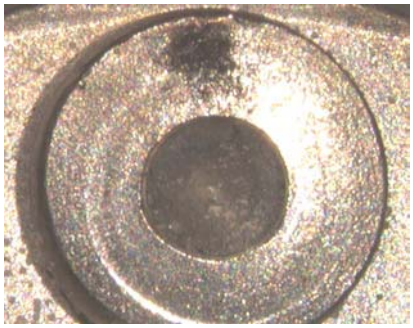
Figure 56: Movable contact of oxygen control switch "**ON**" position.

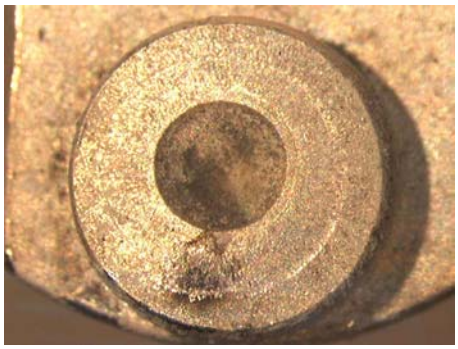
Figure 57: Movable contact of the oxygen control switch "**RESET**" position.

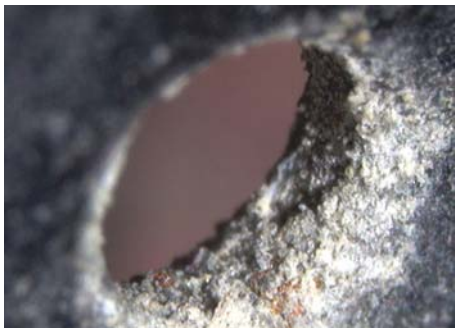
Figure 64: Switch safety wire (breakaway wire) tab hole.

- Observed sediment contamination on inside diameter of hole, recess.

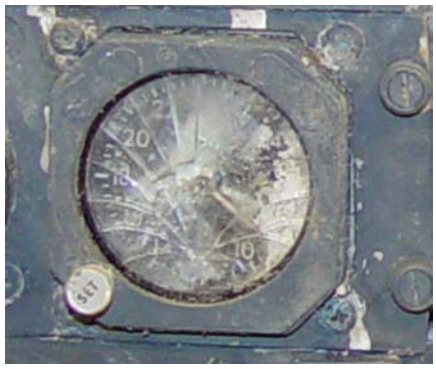
- Clock glass is fractured.
- Hands set at approximately 0825, partially obscured by broken glass.
- **TAT** partially obscured by discoloration.
  - Reads 1.8 deg. C and **OFF**
- After removal from Flight Engineer's Panel, slight impact damage to top rear of case was noted.

Figure 66: M184 Clock, face glass fractured heavily.

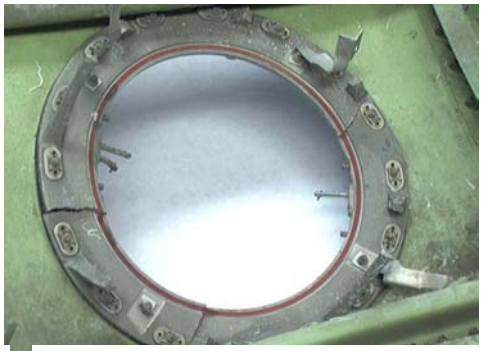
Figure 91: Interior view of opening with valve removed (looking inside to outside).

- Forward/lower hinge pin missing.

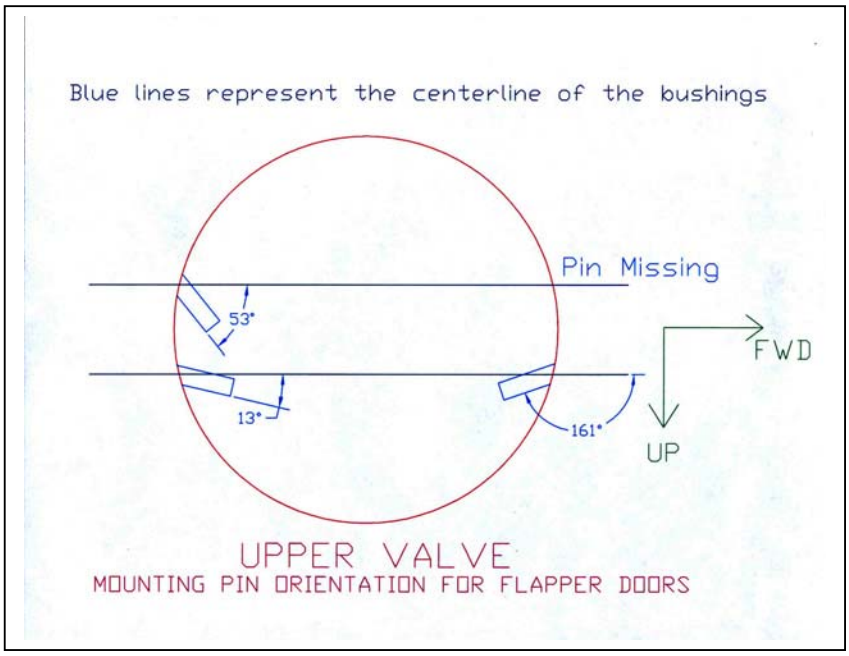
- Performed **measurement** of pin angles using a flat reference plane (outer skin of aircraft); using two imaginary reference lines running between the centerlines of the pin mounting holes (upper fwd to upper aft) & (lower fwd to lower aft). All angular measurements were based from these two imaginary lines. (See: diagram. Upper Valve, flapper doors' pins, orientation, Figure 96).

- Results of measurements (approximation):
  Upper aft pin = 13º; Upper fwd pin = 161º; Lower aft pin = 53º

Figure 96: Upper Pressure Relief Valve, flapper valve doors, pin orientation.

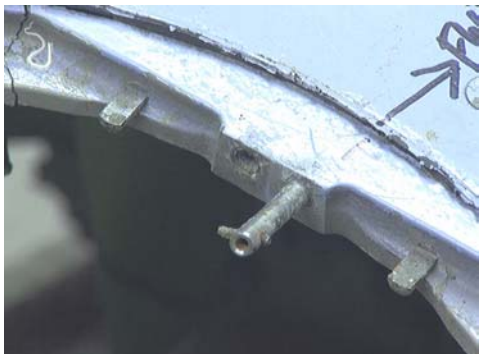
Figure 102: Forward stops and hinge pins, (looking from outside to inside).
- Forward/upper hinge pin can rotate freely.
- Stop pins look normal and unbent.

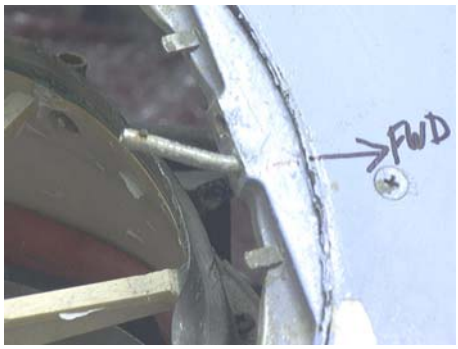
Figure 113: Forward/upper hinge pin, upper door (forward/ lower hinge pin is missing).

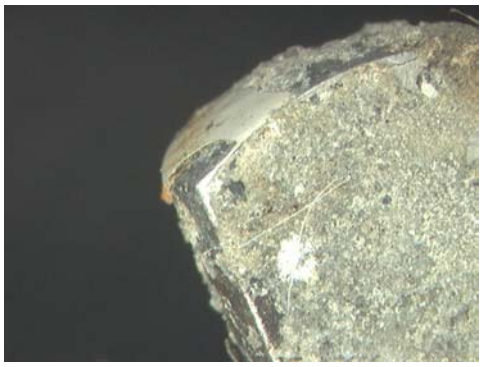
- Pin is relatively straight, paint missing.

Figure 121: Forward/upper stop pin, close-up of figures #119 & #120.

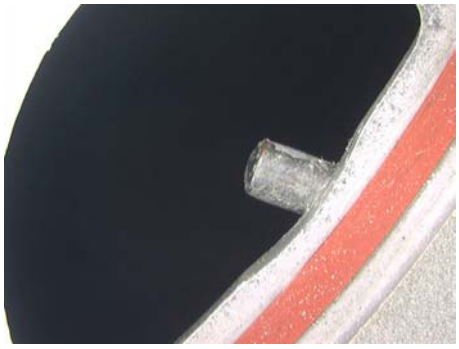
Figure 129: Overview of forward/lower stop pin, as viewed from inside.

- Pin is relatively straight.

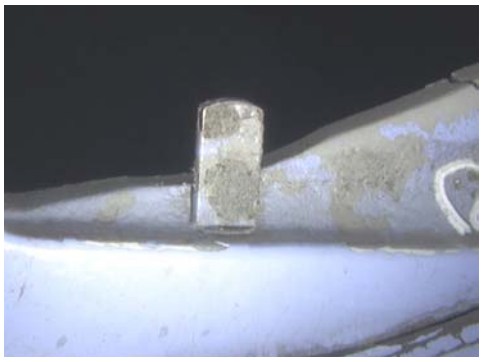
Figure 131: Overview of forward/lower stop pin, as viewed from outside.

- Pin is relatively straight.

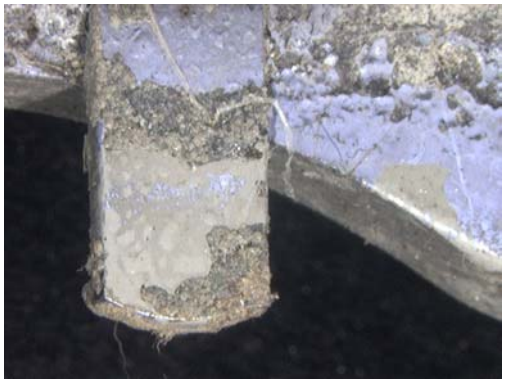
Figure 137: Aft/lower stop pin, close-up of figure #136.

- Paint is chipped.

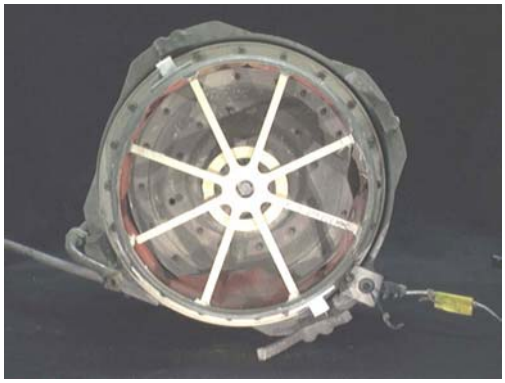
Figure 138: Overview of valve face.

- Knife-edge has some rolled over areas and some bent edges.
- In general, reasonably round.
- 2 gate spacers, HS P/N 727407-30 are missing, remaining 2 spacers on top and bottom as shown.

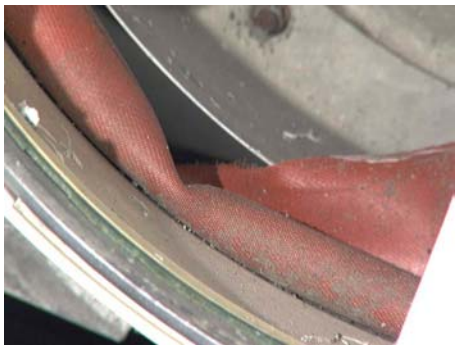
Figure 146: Diaphragm, showing typical tear.

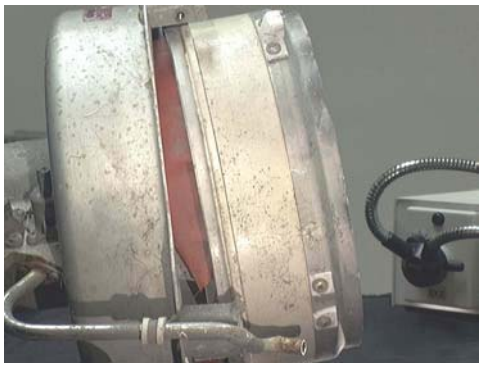
Figure 149: Offset angle between valve housing and gate.

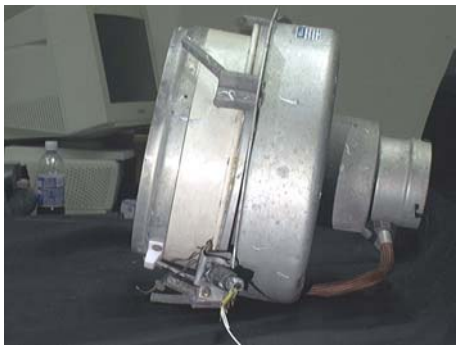
Figure 150: Offset angle (same as in figure #149) from the opposite side.

Figure 151: Switch mounting bracket, gate is against bracket.

- The switch actuator is intact but the basic switch is missing.
- The (electrical connector and plug) mating is intact.

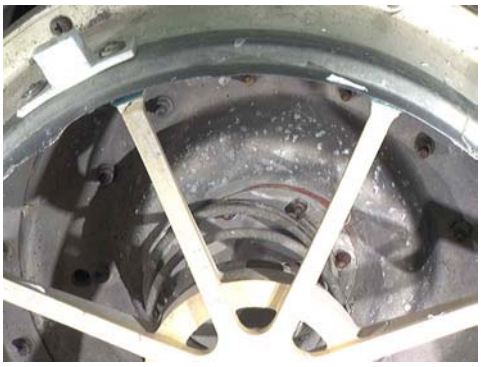
Figure 155: Gate return spring, showing unseated spring.

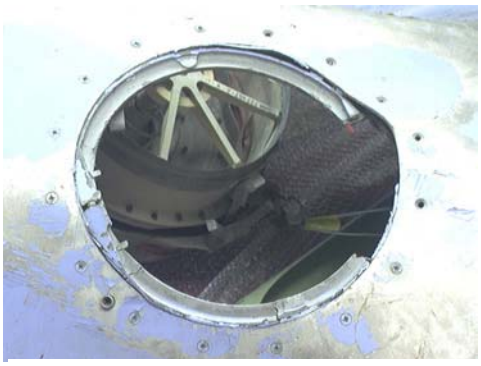
Figure 179: Exterior opening for Lower Pressure Relief Valve (valve still inside).

- External view shows the heads of 5 attachments screws to the skin, are missing and about 25% of mounting flange is missing.

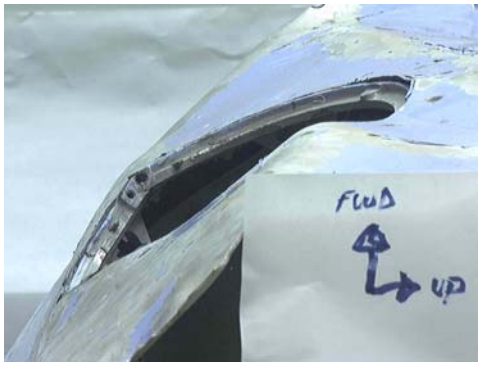
Figure 183: Skin distortion at valve mounting location.

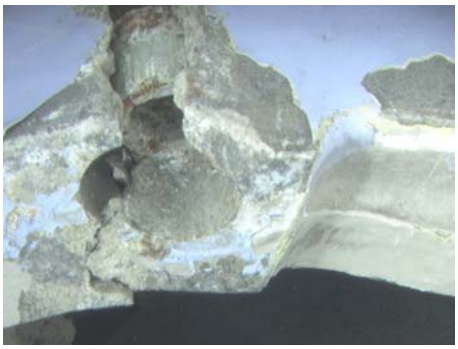
Figure 186: Forward/upper hinge pin bushing hole.

- Housing is cracked and contains partial bushing.

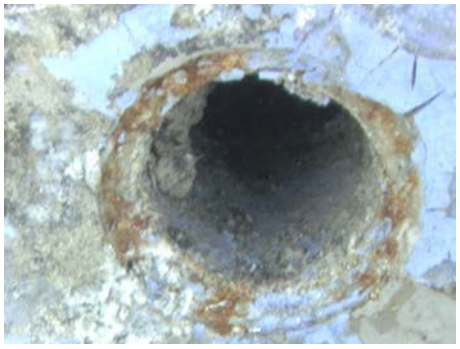
Figure 188: Forward/upper hinge pin, close-up view of partial bushing in hole.

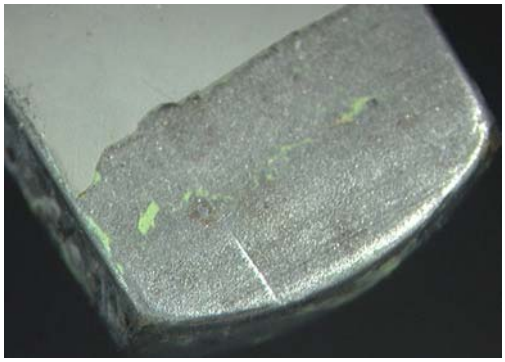
Figure 199: Forward/upper stop pin, close-up of figure #198.

- Paint is chipped.

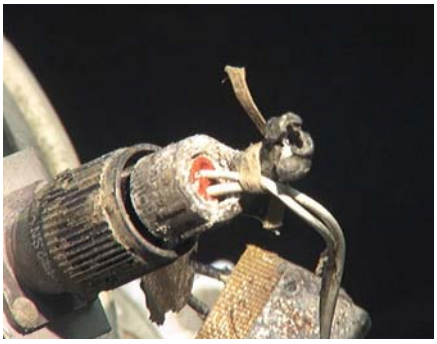
Figure 210: Electrical switch connector interface appears to be intact.

- Wires are intact exiting plug.
- Strain relief on backshell is broken.

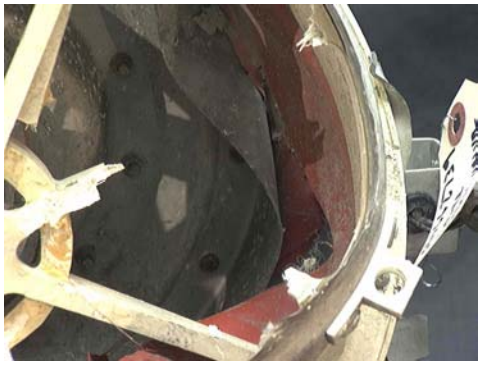
Figure 218: Web damage.

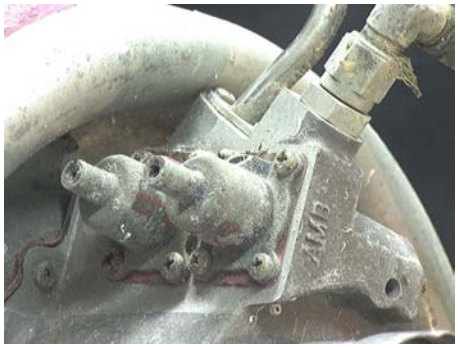
Figure 240: Control assembly area (sense housing area), overview.

- Intact, some surface accumulation.
- Nothing looks out of place.
- Integral ambient sensing tube attachment looks normal.
- Remote tube attachment looks normal.

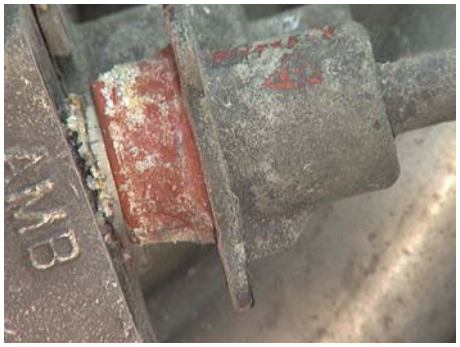
Figure 249: Remote ambient sensor, cover and diaphragm partially removed.
- Heavy salt deposits on spring, piston and diaphragm.

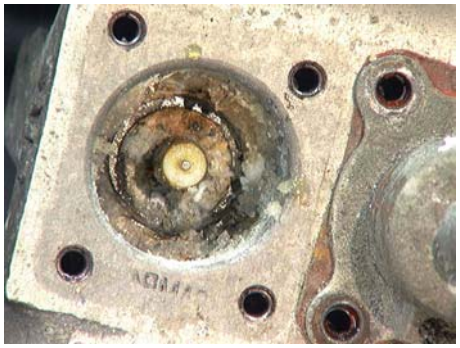
Figure 251: Close-up of salt deposits inside housing bore.

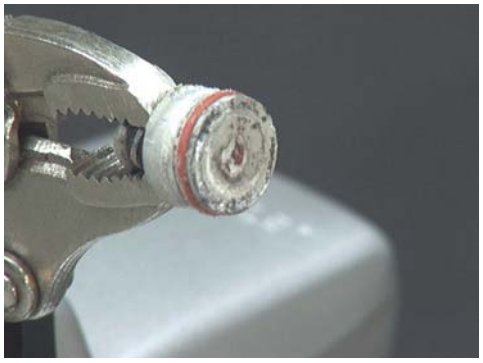
Figure 253: Plug HS P/N 719280-1 and seal, seal looks normal and uncut.

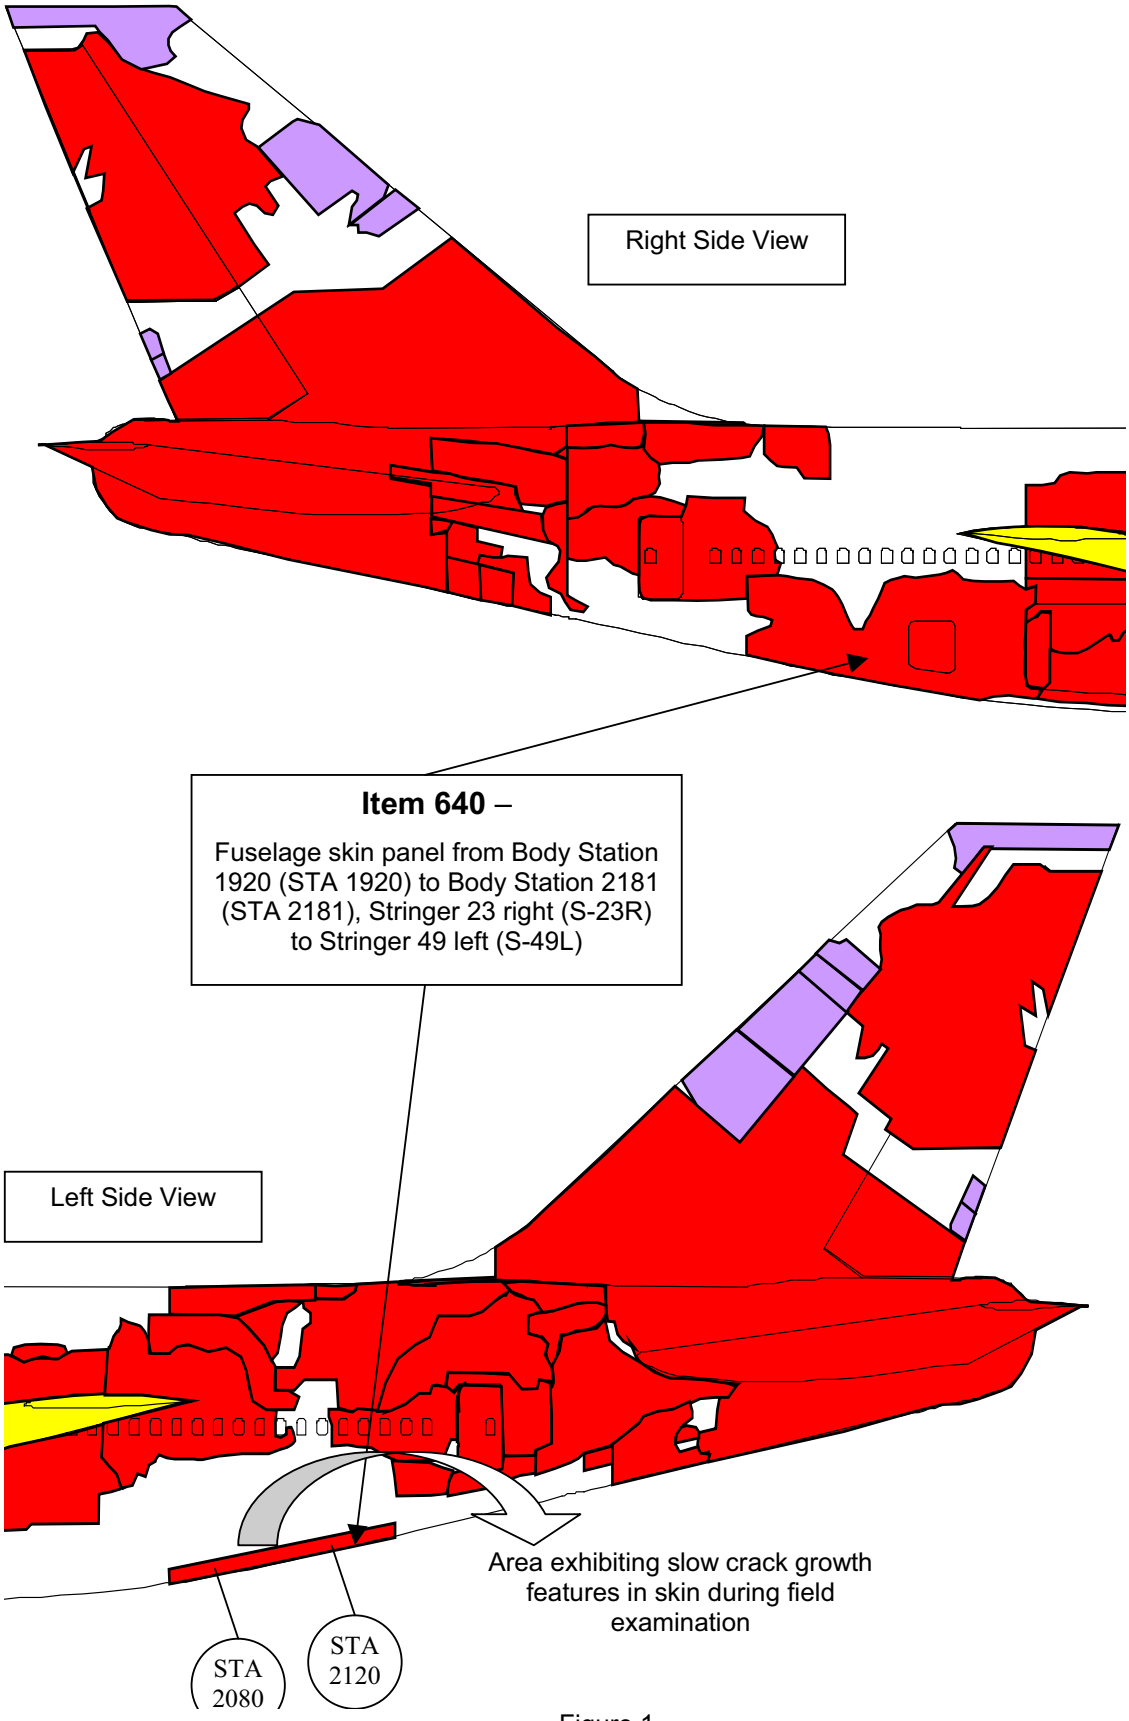
Figure 1.
Partial wreckage recovery map for CI611 showing the location of the item 640 skin panel and the area where slow crack growth features were found in the skin along S-49L during field examination.

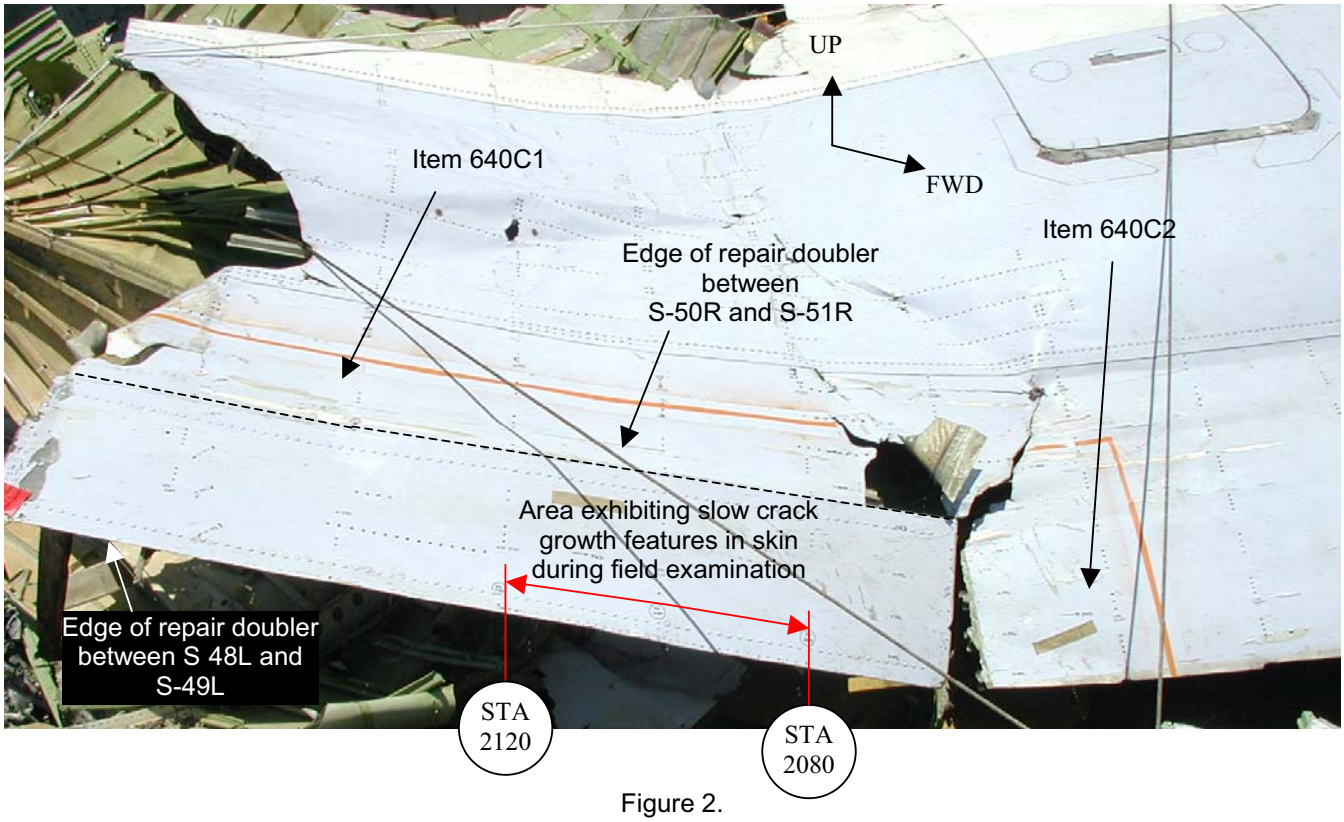
Figure 2.
Item 640C1 and C2 Skin panel segments prior to removal from the parent item 640 wreckage in Makung, Taiwan.

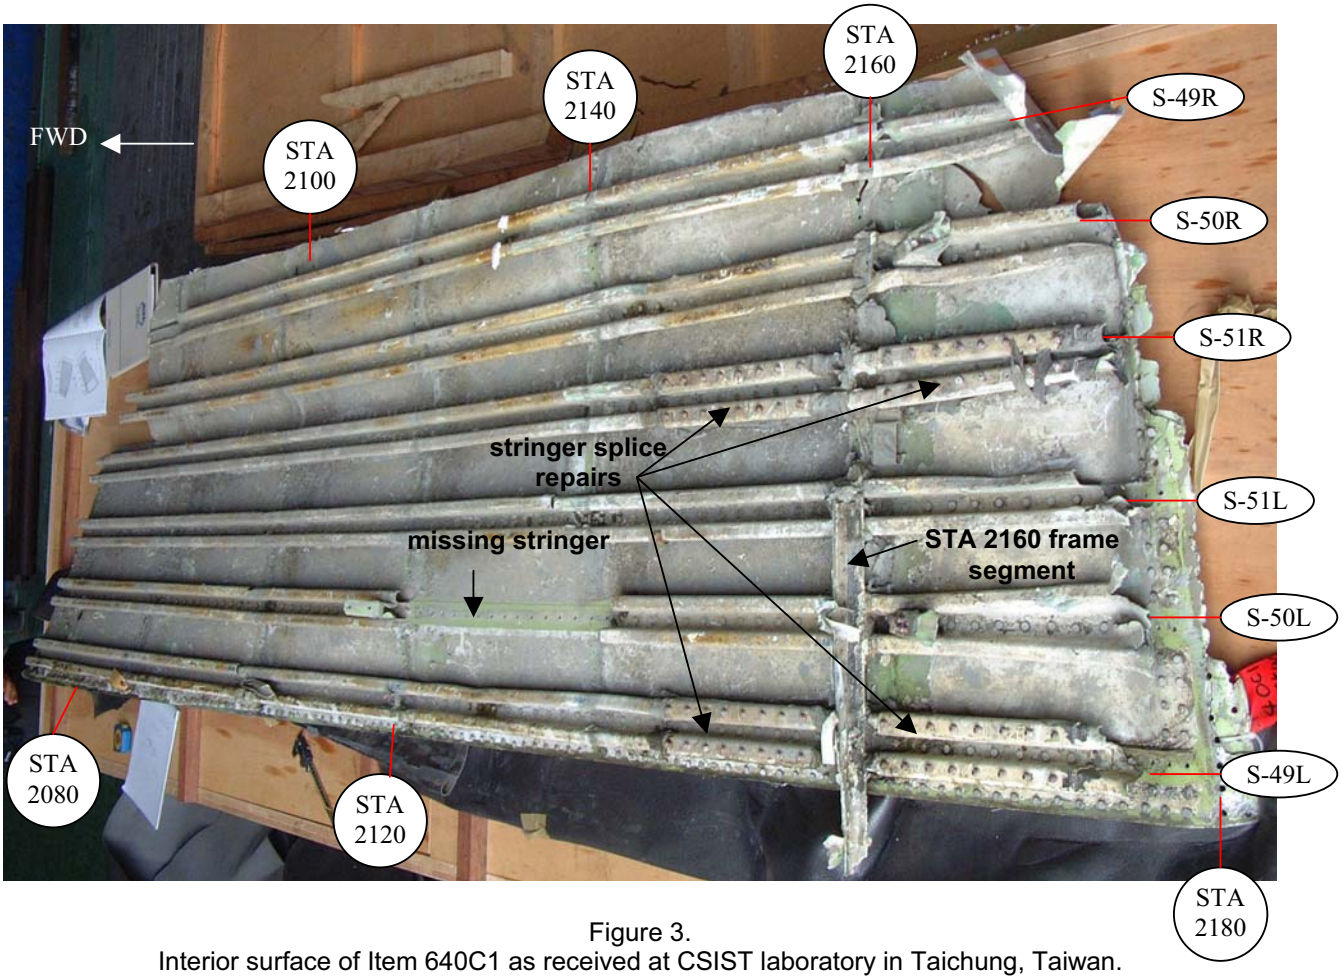
Figure 3.
Interior surface of Item 640C1 as received at CSIST laboratory in Taichung, Taiwan.
