Aviation Occurrence Report Volume II

ASC-AOR-05-02-001

IN-FLIGHT BREAKUP OVER THE TAIWAN STRAIT

CHINA AIRLINES FLIGHT CI611

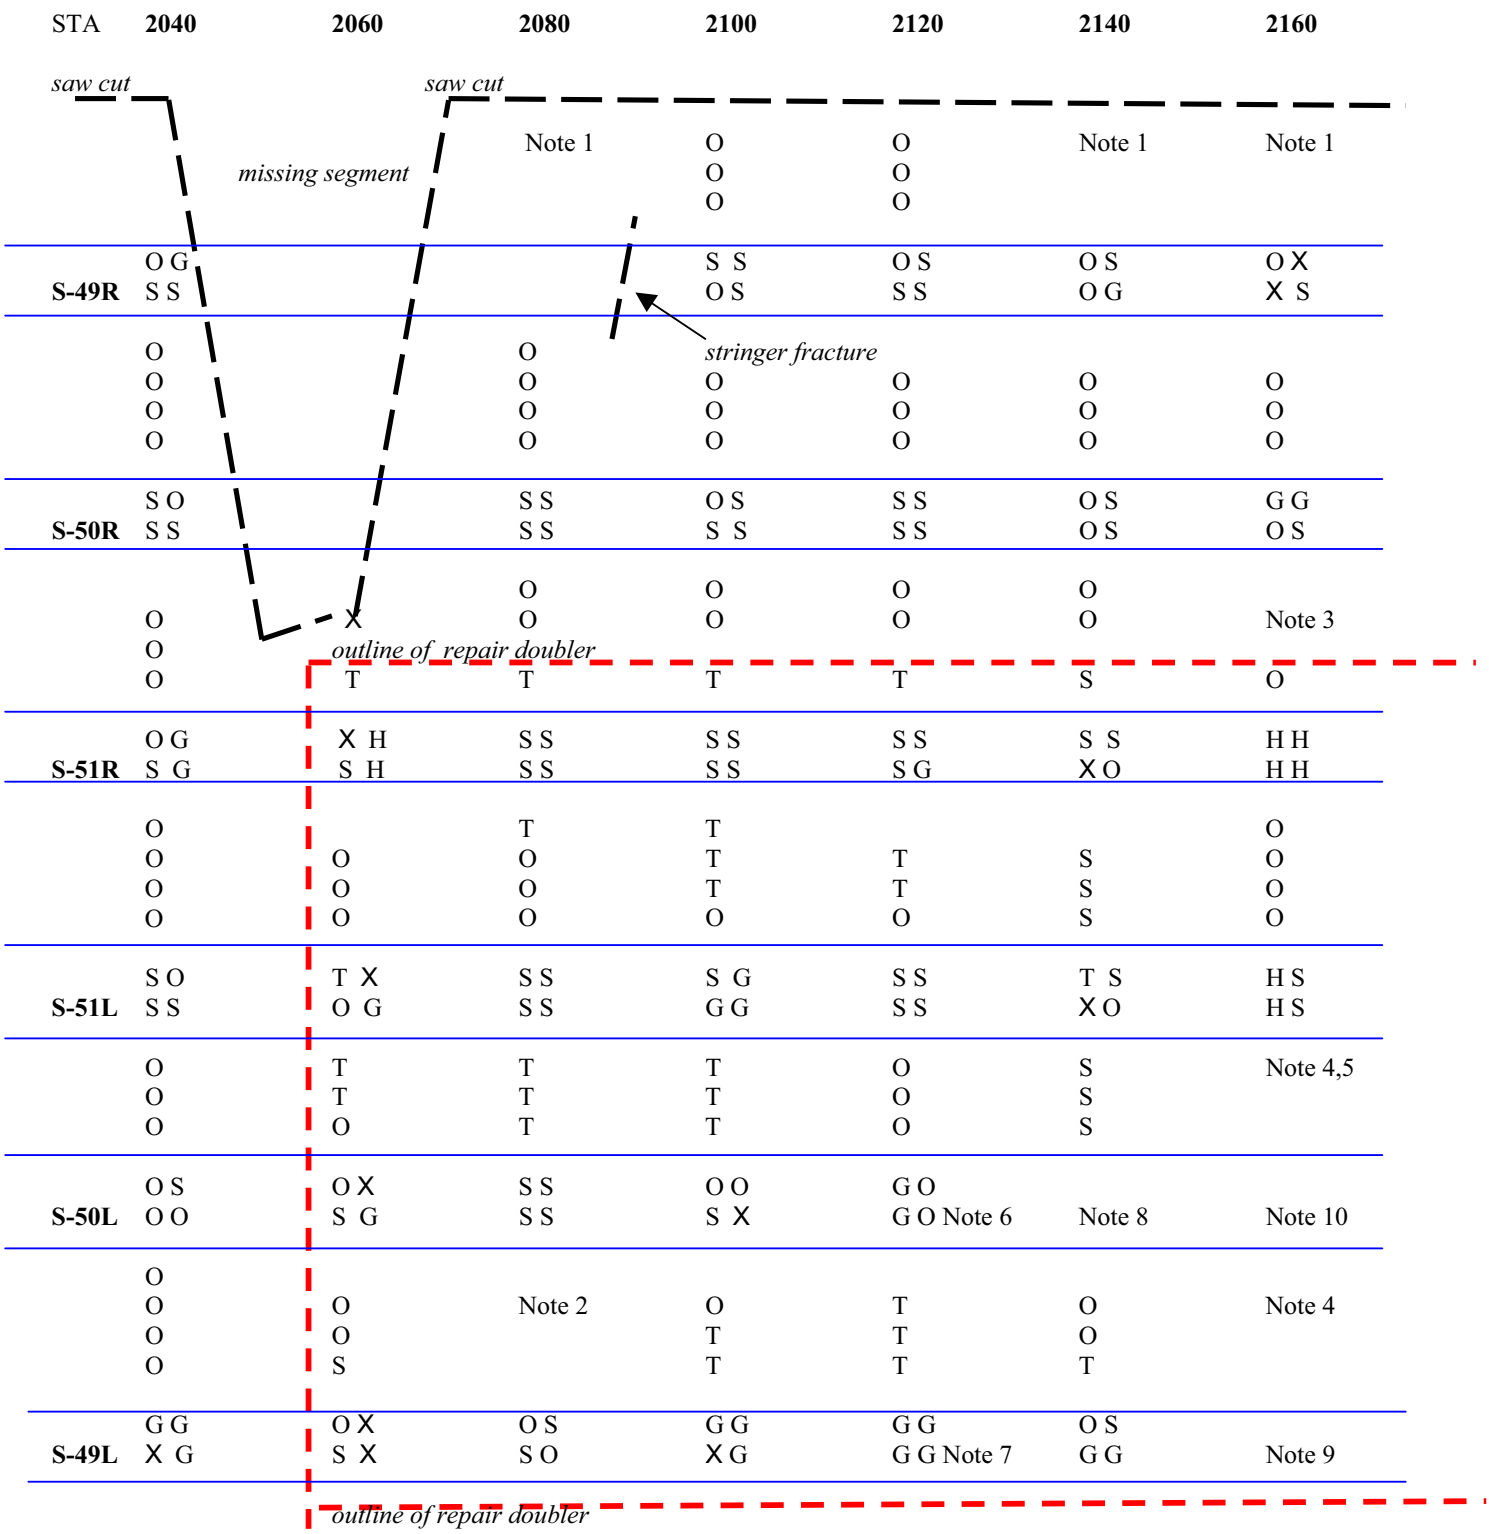
Table II.

Schematic representation of shear tie and stringer clip attachment to item 640C1 and C2 skin sections.

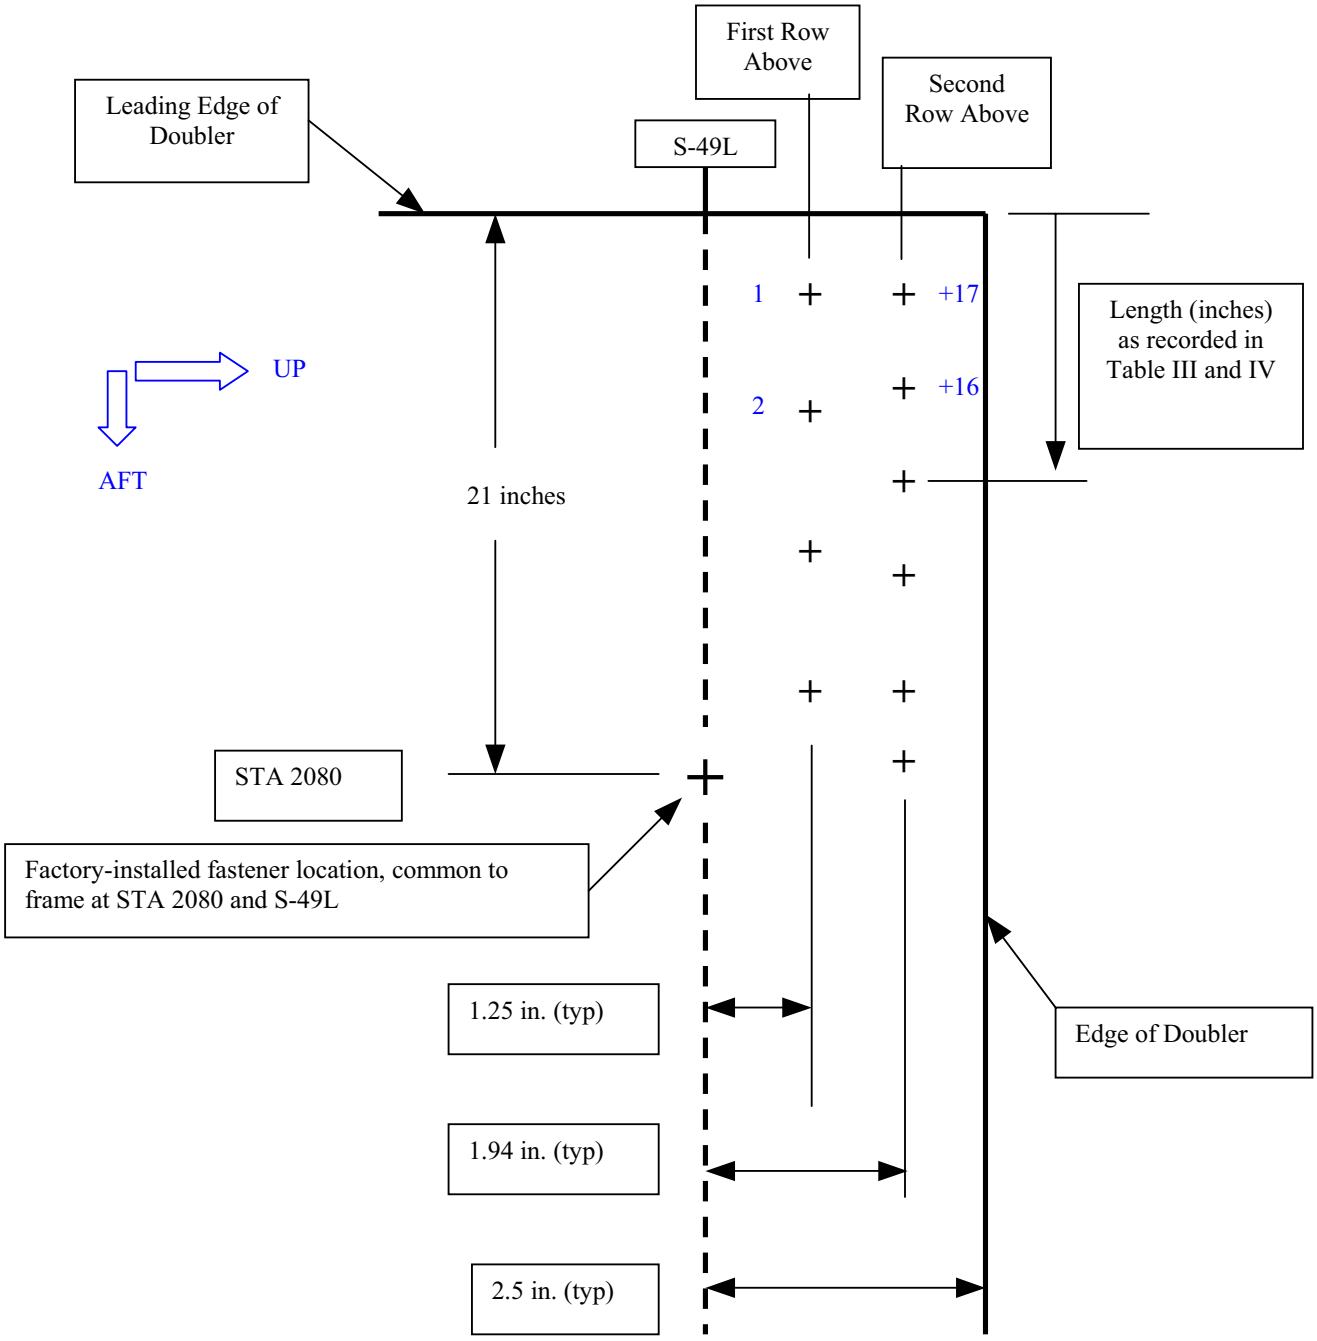
Figure 4.

The spacing of the rivets for the two rows used to attach the doubler to the skin above S-49L was measured from the forward edge of the doubler. Figure 4 provides general information on the spacing of these rows in relationship to S-49L and the edge of the doubler. The driven rivet button diameter and thickness of the two rows of rivets used to attach the doubler above S-49L and S-51R were collected as well. Table III and IV contain the rivet spacing, driven rivet button diameter, and driven rivet button thickness data for the two rows above S-49L. Table V contains the driven rivet button diameter and thickness data for the two rows above S-51R. The numbering convention assigned to the rivets was established to provide a correlation to the field notes on this item. Reference to the body station location at particular rivet locations is provided for easier identification. All rivets installed in the two rows above S-49L and S-51R were ¼ inch diameter with the exception of a few blind rivets and smaller diameter solid rivets at certain shear tie locations (see Tables III, IV, and V for details). Figure 3 of SRM 51-30-02 (ref. 3), “Dimensions for Driving Non-Fluid-Tight Solid Shank Rivet” provides requirements for the minimum driven rivet button diameter and minimum driven rivet button thickness for installed rivets. For ¼ inch diameter rivets, the limits are 0.325 inch and 0.100 inch, respectively. The majority of rivets in the two rows above S-49L and S-51R did not satisfy these SRM requirements (see Tables III, IV, and V for details).

Schematic showing the spacing of the two rows of rivets in relationship to S-49L and the edge of the doubler.

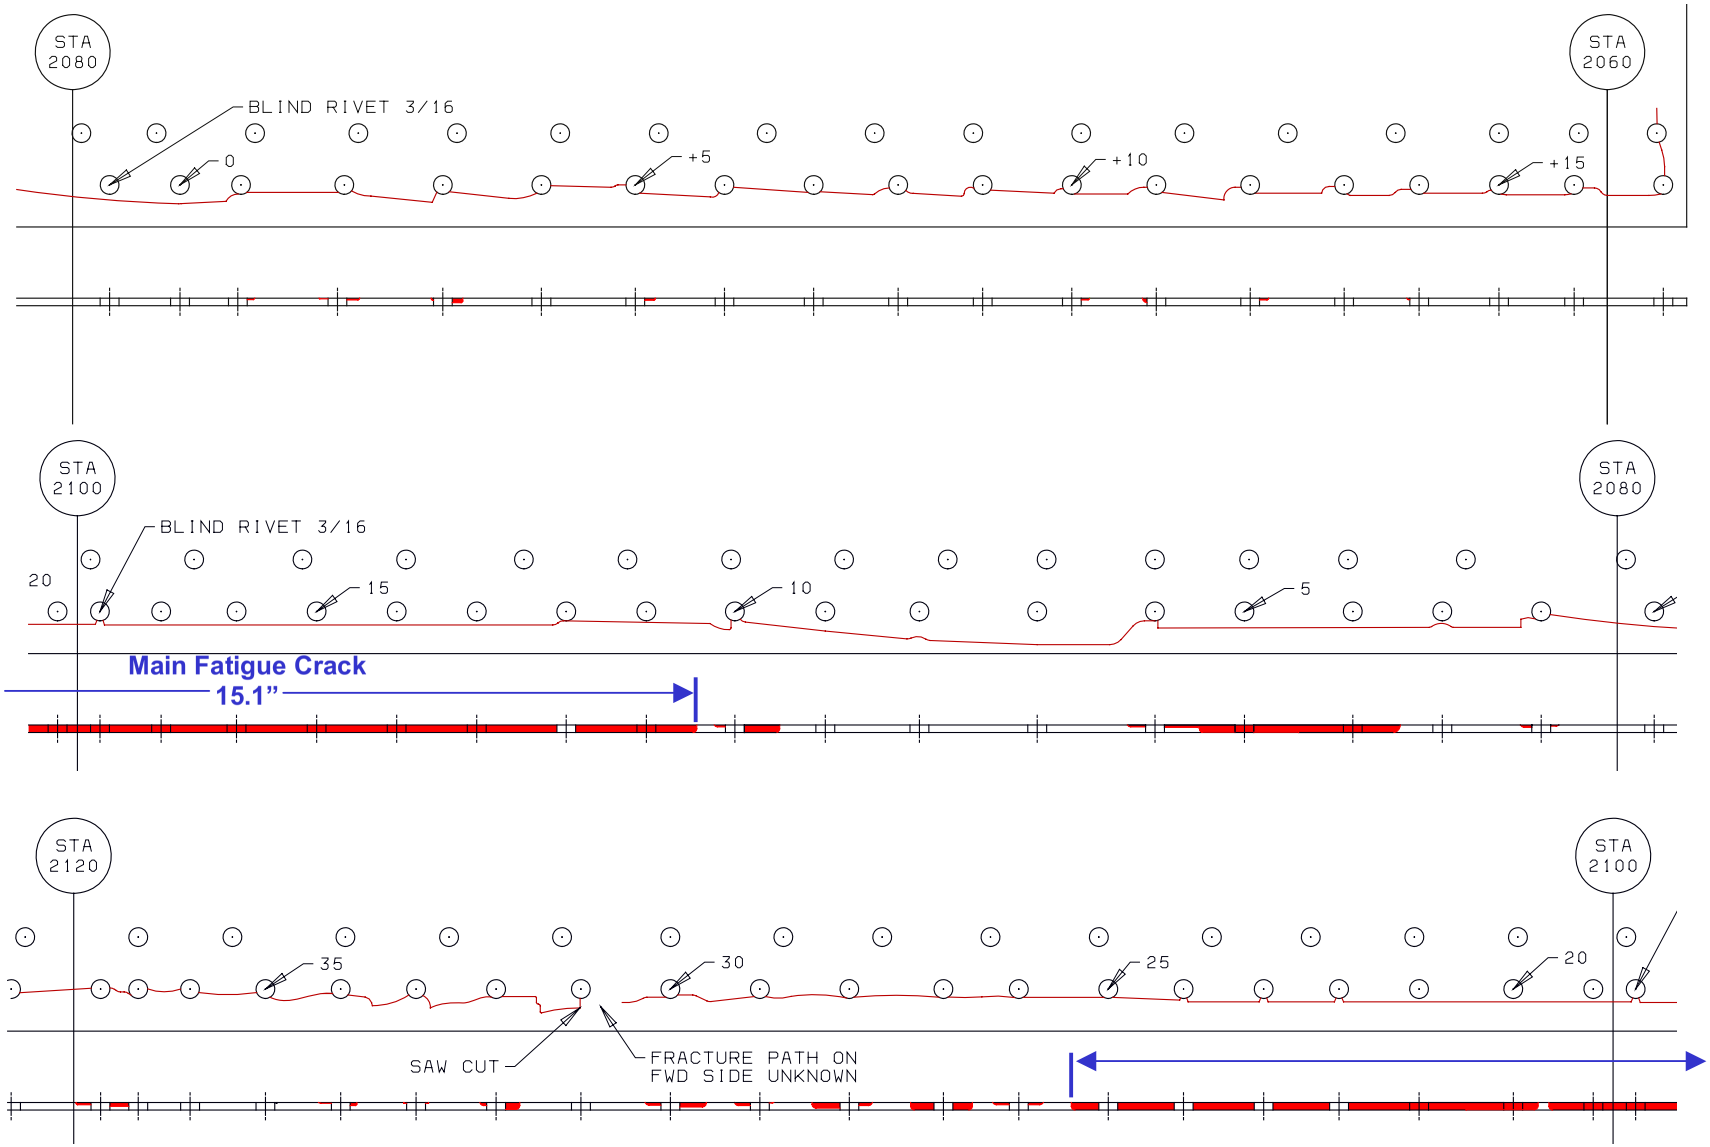
Figure 5.
Map of fatigue cracking (red areas) observed on fracture above S-49L from STA 2060 to STA 2120. The length of the main fatigue crack centered about STA 2100 is shown. Refer to Table JVI for a complete list of fatigue crack lengths and depths.

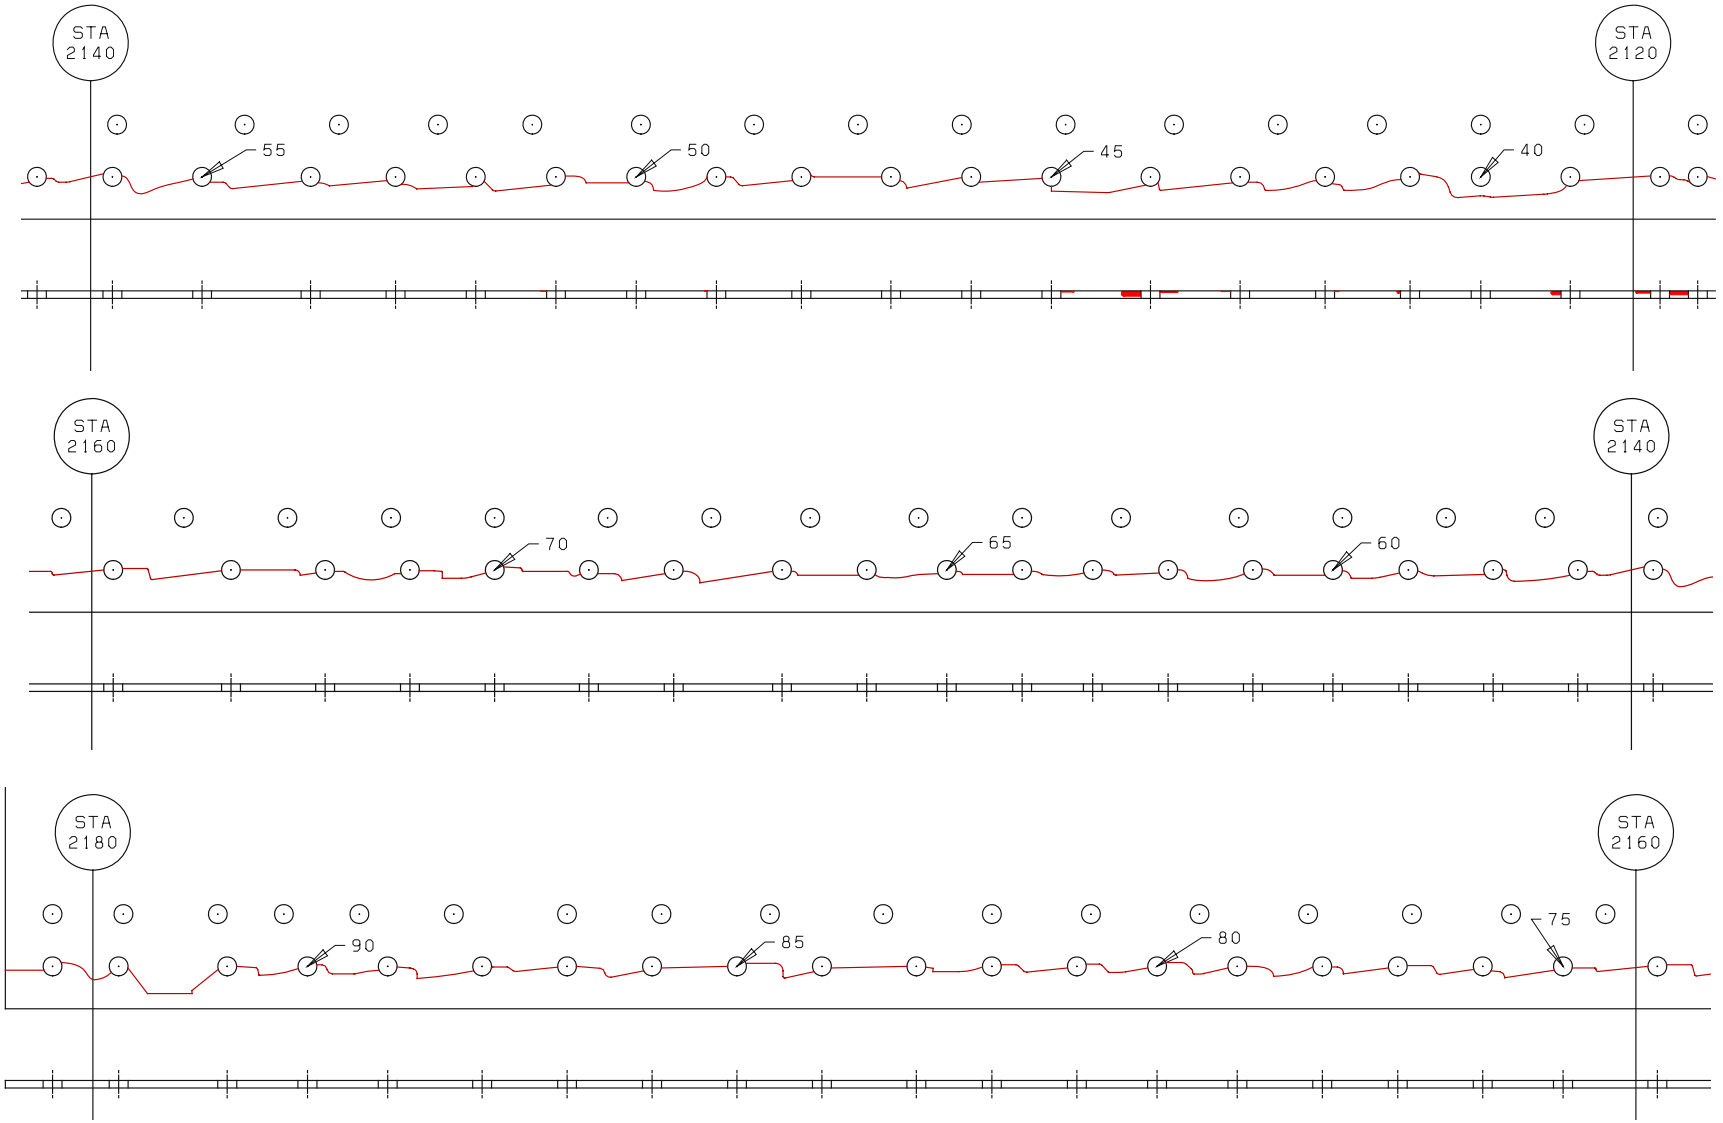
Figure 6.
Map of fatigue cracking (red areas) observed on fracture above S-49L from STA 2120 to STA 2180. Refer to Table JVI for lengths and depths of the fatigue cracks provided in this figure.

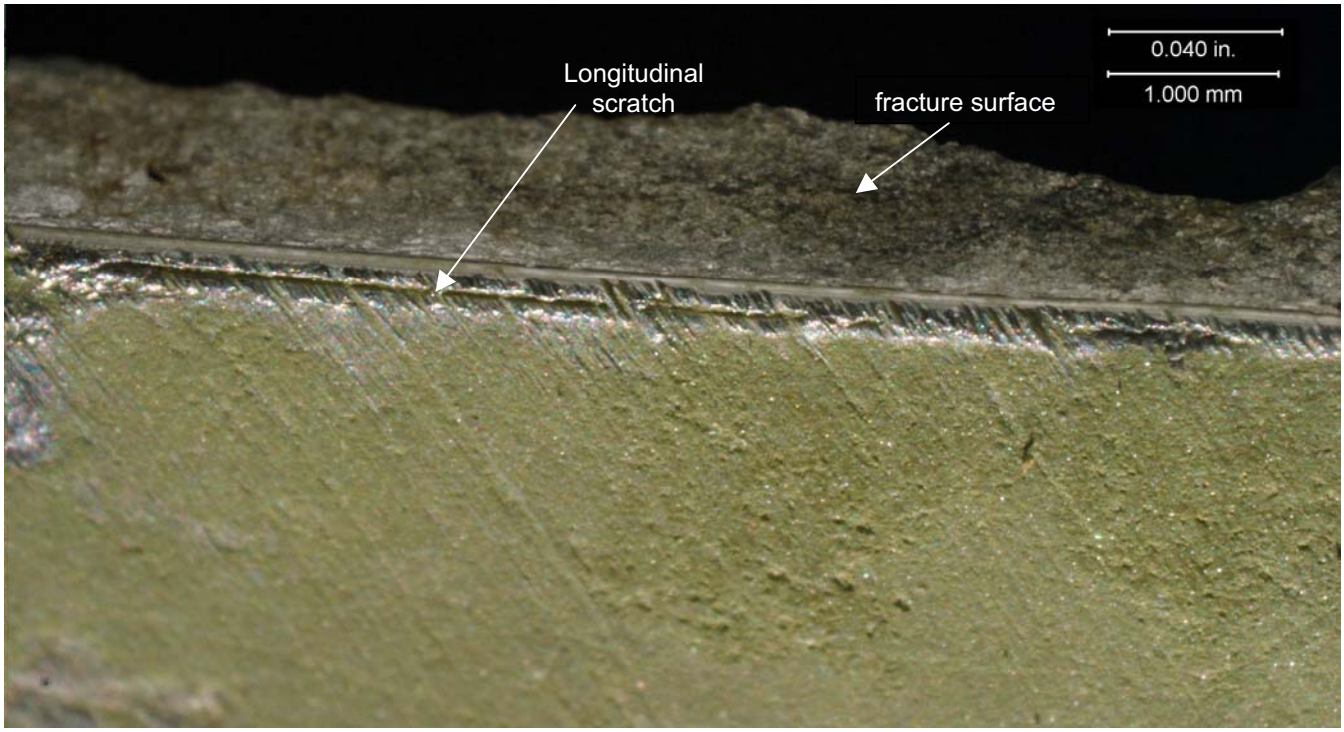
Figure 7.
Surface of skin faying with repair doubler near hole 20 showing the longitudinal scratch where fatigue crack initiation occurred from multiple origins. Also note the sanding marks induced during rework of the skin.

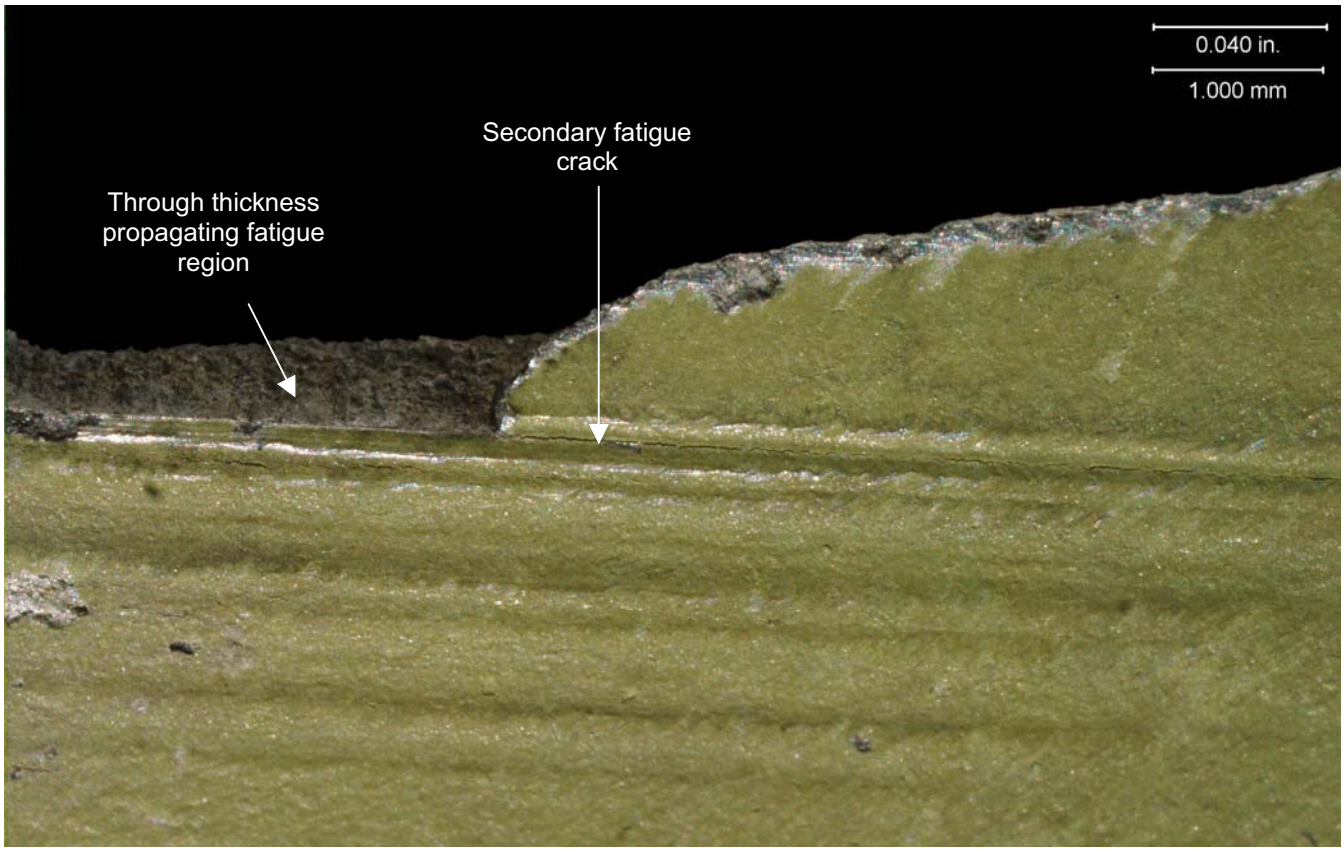
Figure 8.
Surface of skin faying with repair doubler between hole 29 and hole 30 showing the longitudinal scratches in relationship to this fatigue crack. Note the secondary crack extending out of this common scratch.

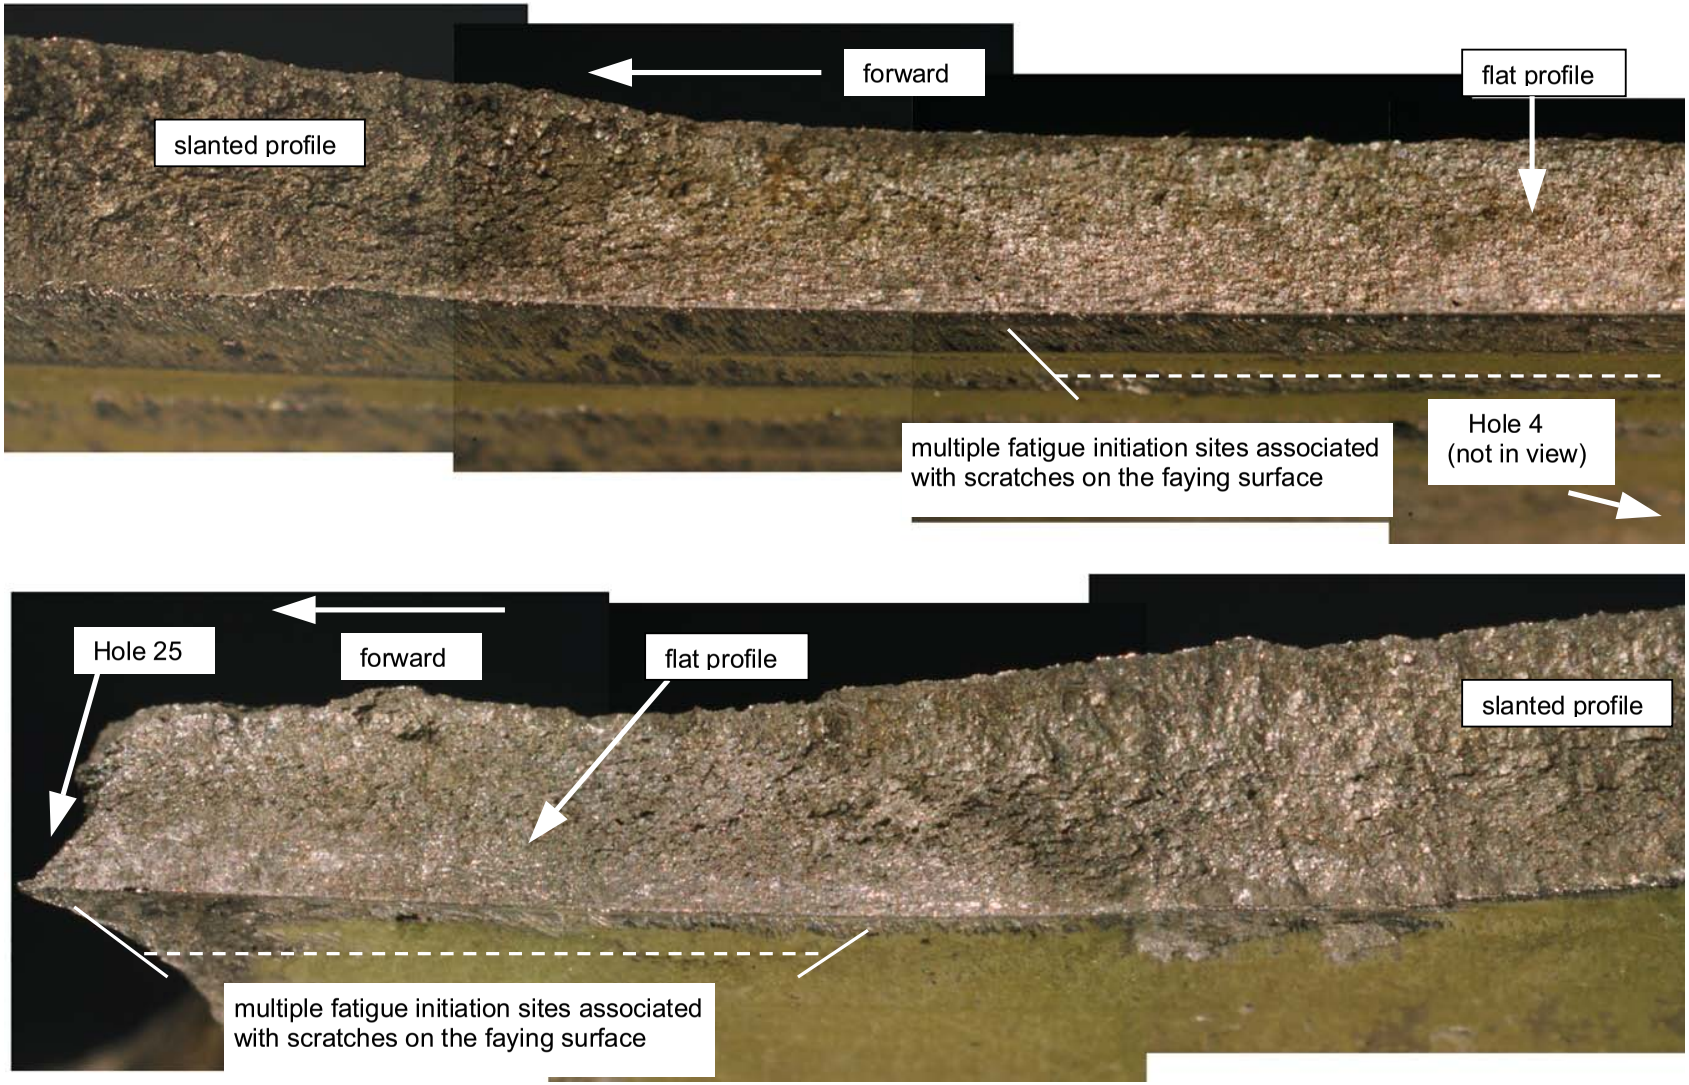
Figure 9, Photographs showing the transition regions from flat fracture profiles to slanted profiles just forward of fastener Hole 4 (top) and Hole 25 (bottom).

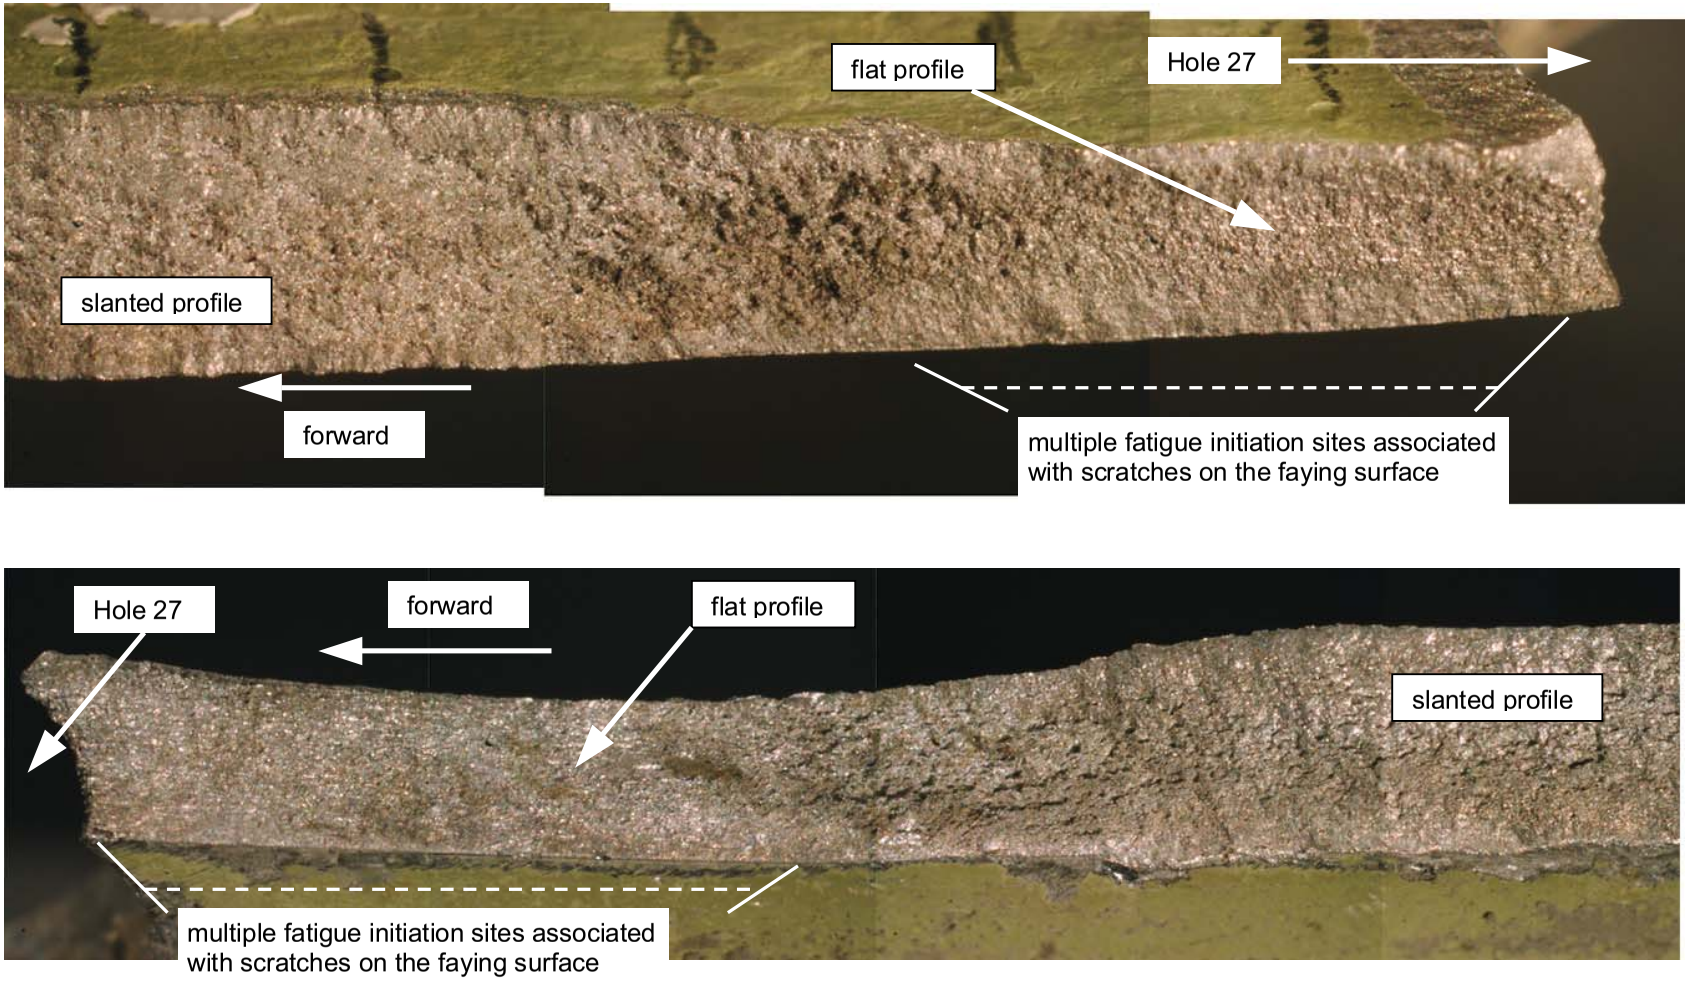
Figure 10, Photographs showing the transition regions from flat fracture profiles to slanted profiles at fastener Hole 27 in the forward direction (top) and the aft direction (bottom).

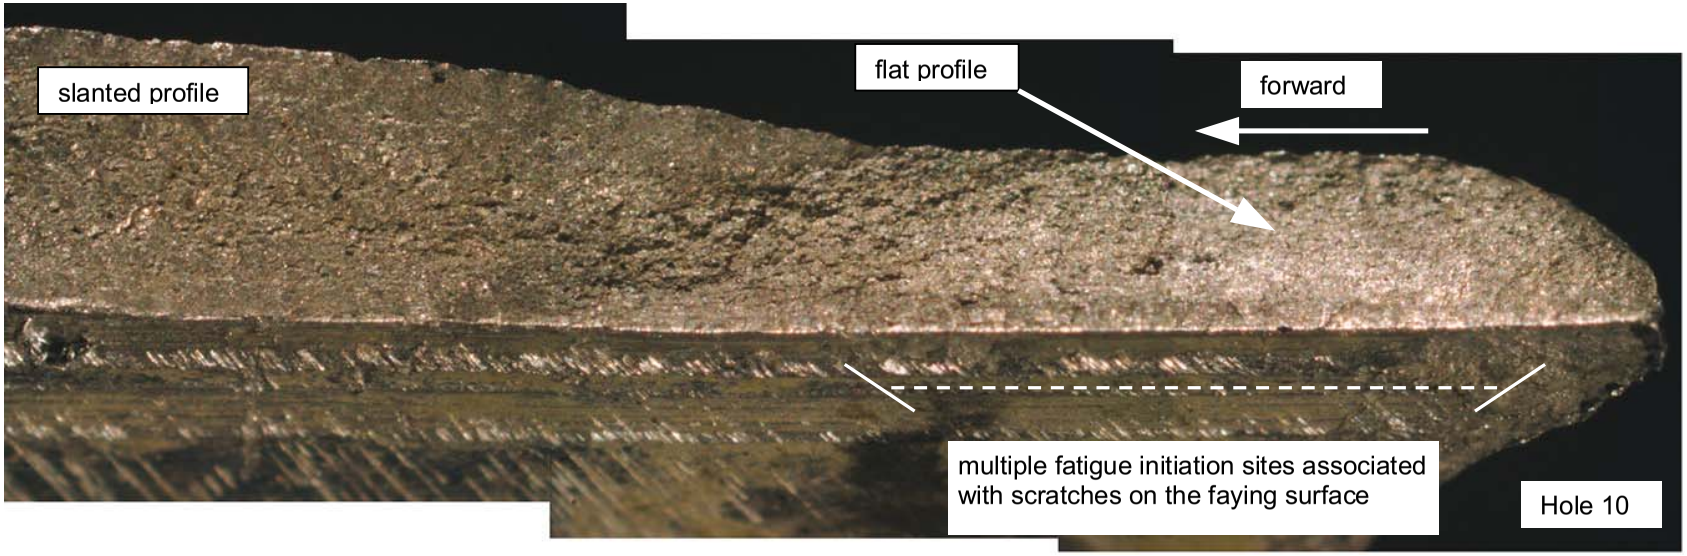
Figure 11, Photograph showing the transition region from a flat fracture profile to a slanted profile at fastener Hole 10 in the forward direction.

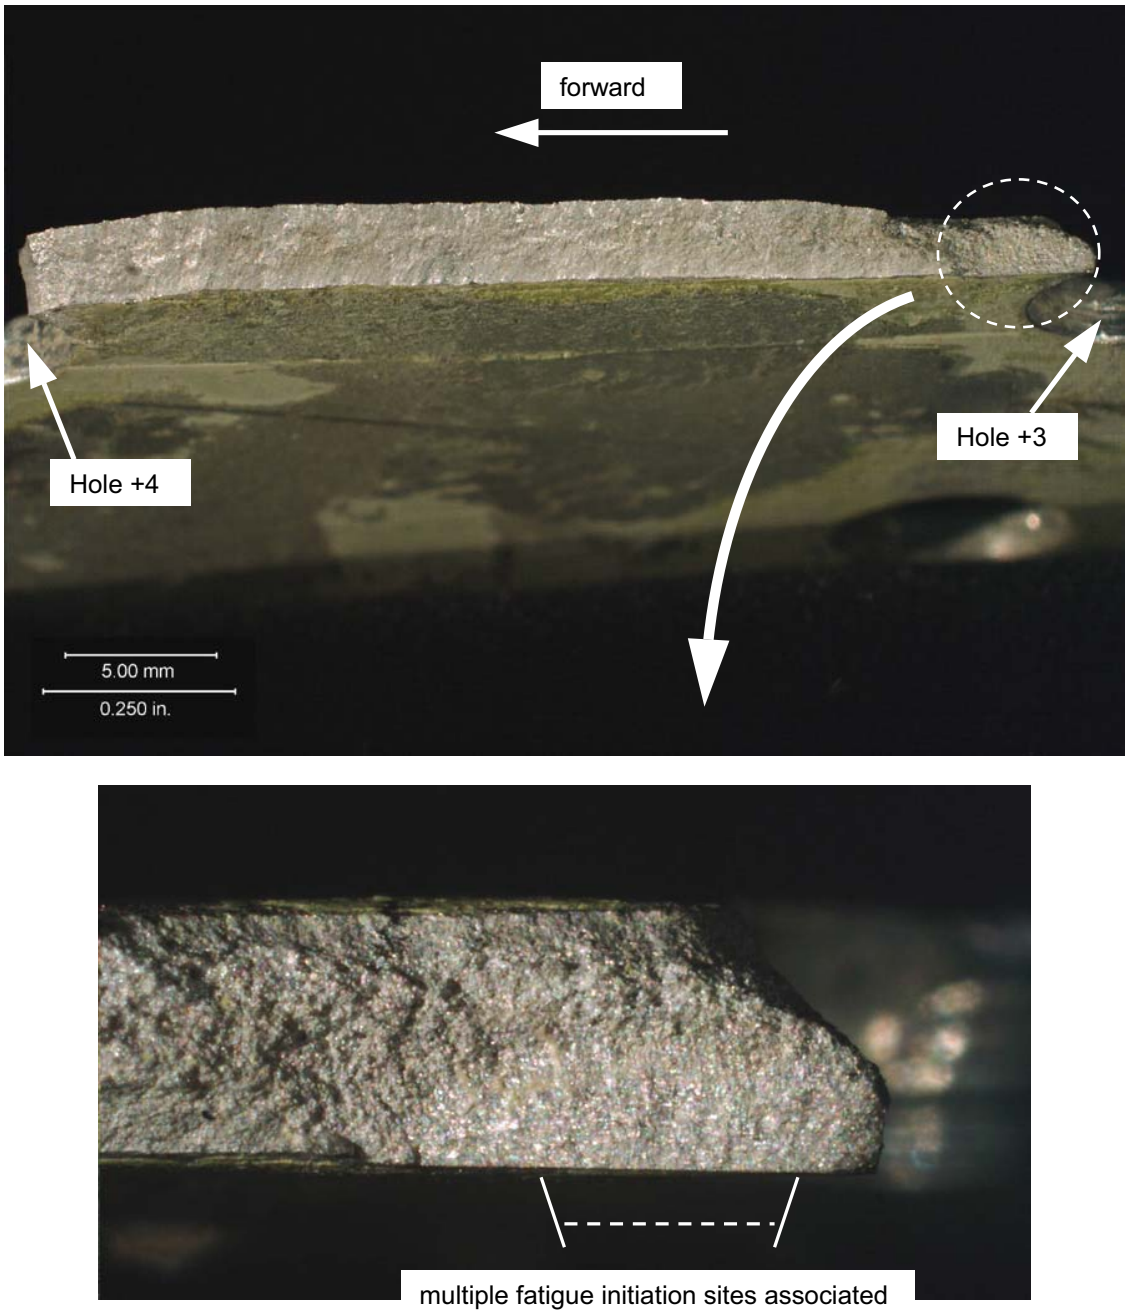
Figure 12, Photographs of the fracture segment extending from Hole +3 to +4 (top), and closer view of the flat profile fatigue region on the forward side of Hole +3 (bottom).

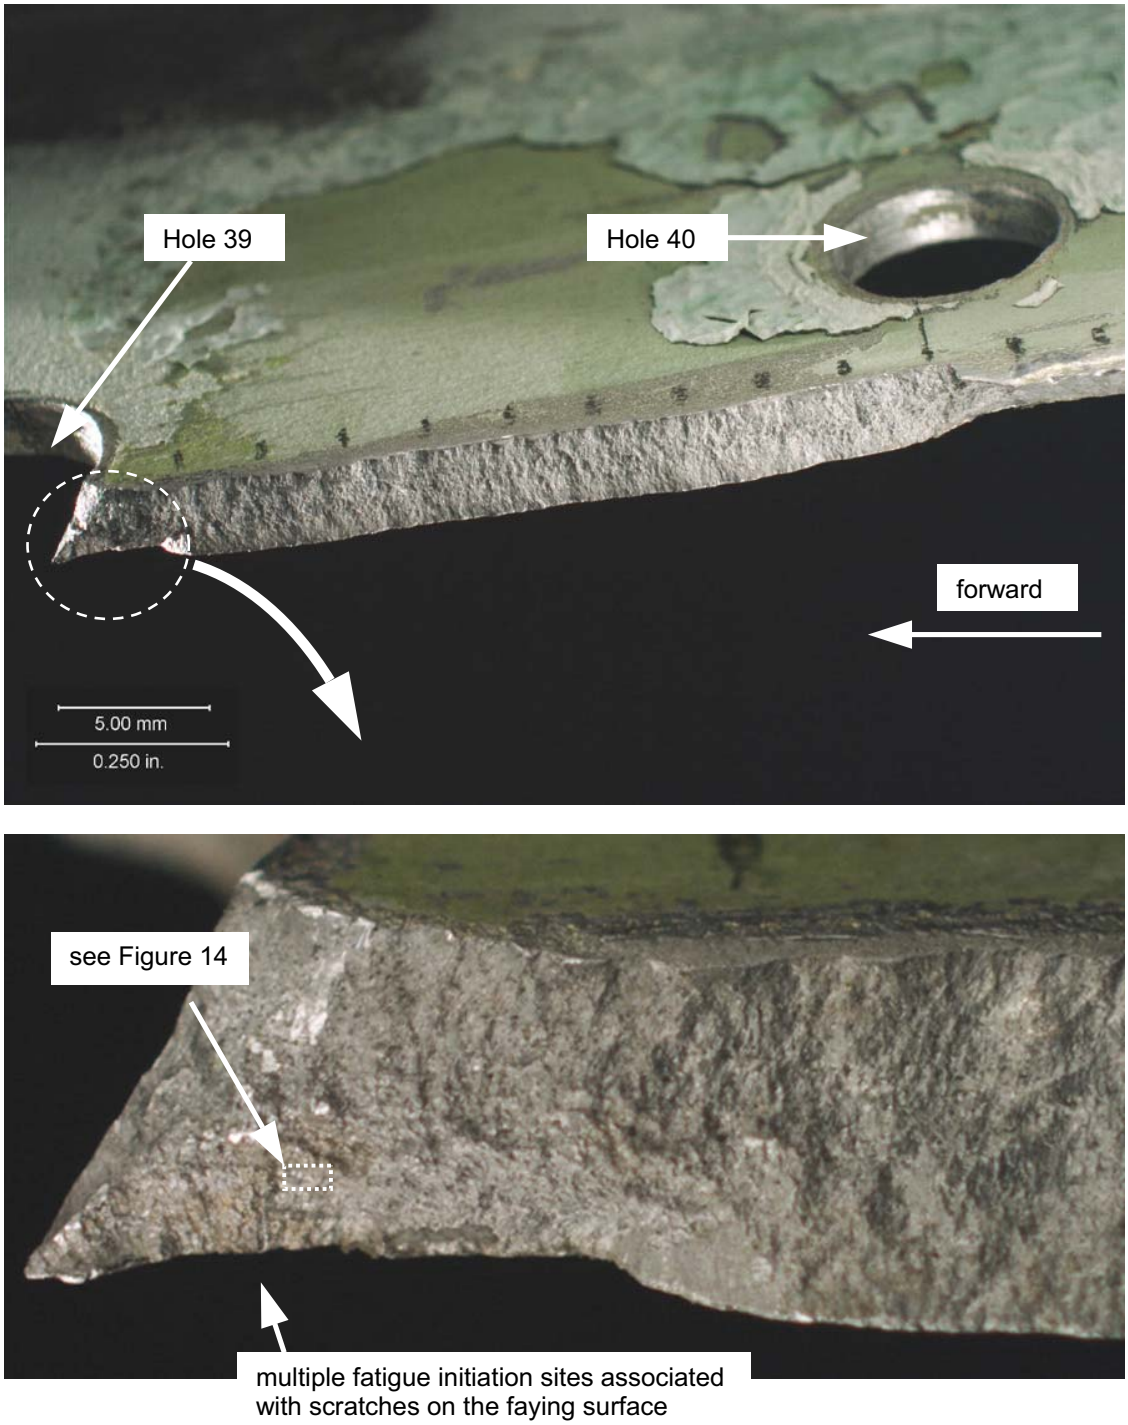
Figure 13, Photographs of the fracture segment extending from Hole 39 to 40 (top), and closer view of the flat profile fatigue region and short transition zone on the aft side of Hole 39 (bottom). SEM photographs showing a dramatic increase in striation spacing near the extent of the flat fracture thumbnail (indicated area) are shown below in Figure 14.

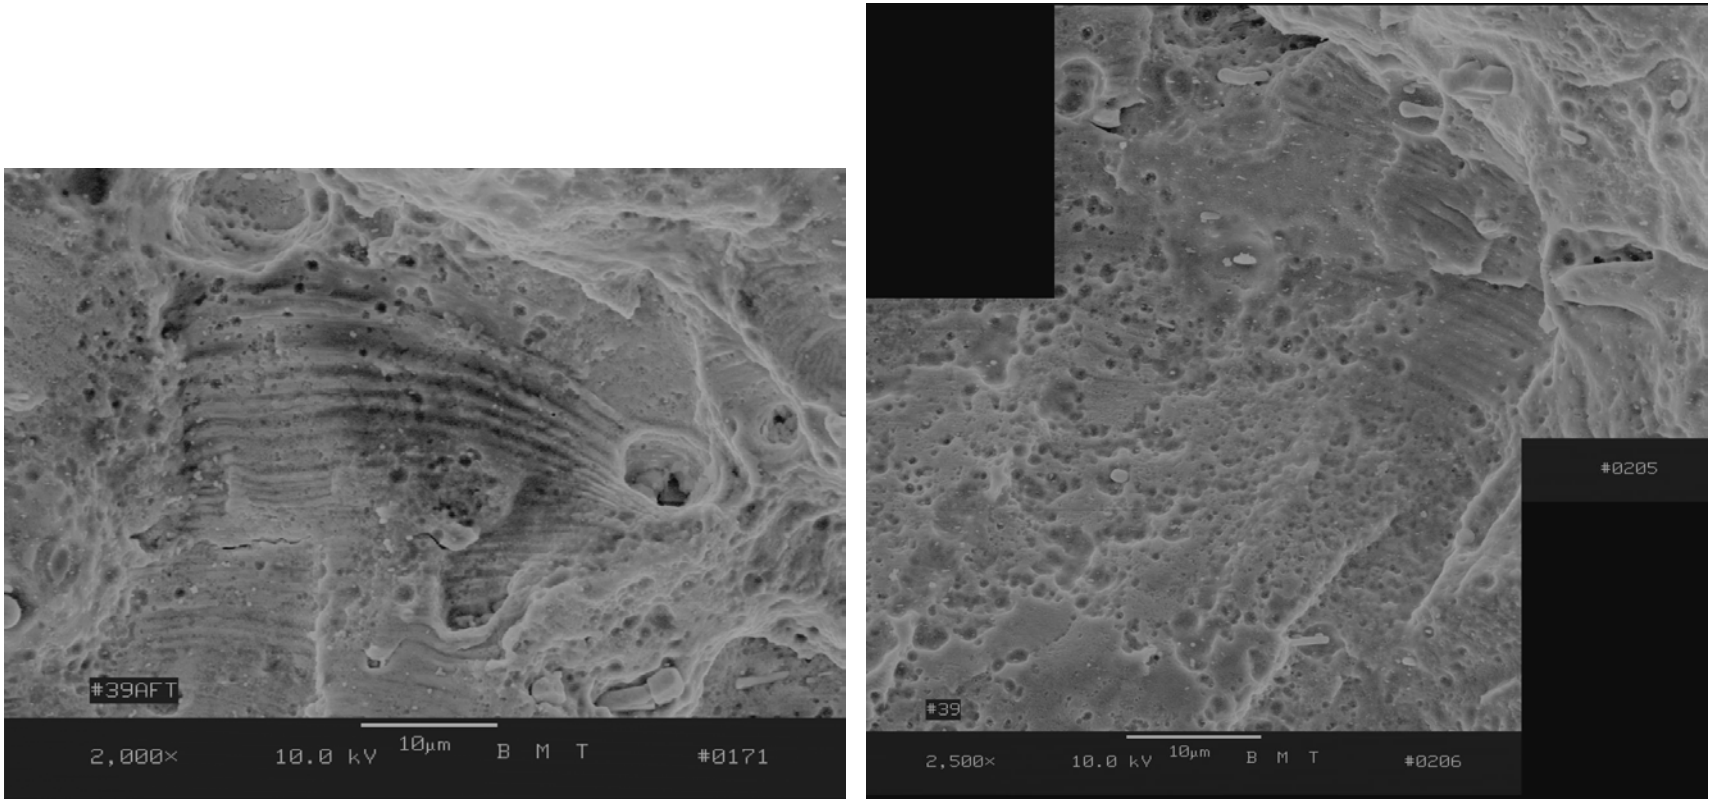
Figure 14, scanning electron microscope photographs showing fatigue striations near the end of the flat profile fracture surface aft of Hole 39. Just beyond these regions, the fracture surface was dominated by a dimpled morphology, indicative of the fracture mechanism of micro-void coalescence, or ductile separation. Severe pitting due to corrosion can also be seen.

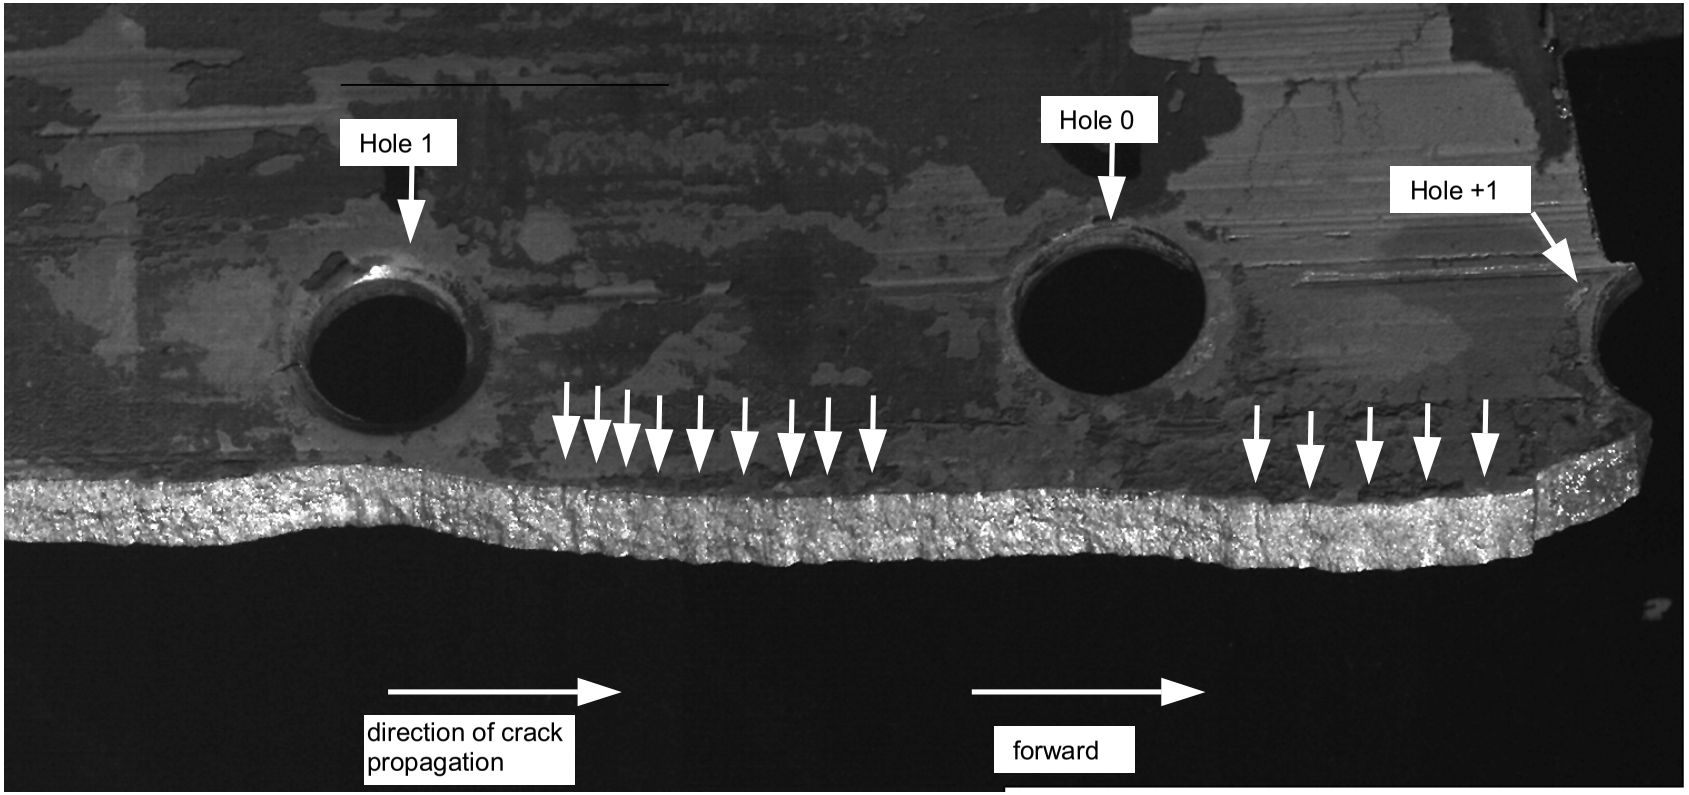
Figure 15, Photograph showing the incremental crack growth indications on the fracture segment from Hole 1 to Hole +1 with two groups of them identified with arrows. This area is just a few inches forward of the flat profile fatigue and transition areas of Hole 4 shown in Figure 9. Note that the regular spacing generally increases as the distance increases from the main cracking system at Holes 4 through 26. These features indicate that the dominant crack was growing at macroscopic rates in a forward direction here when these features were formed, rather than in a through-thickness direction as was the earlier fatigue initiation and propagation mechanism. This point is further exemplified in the following Figure 16.

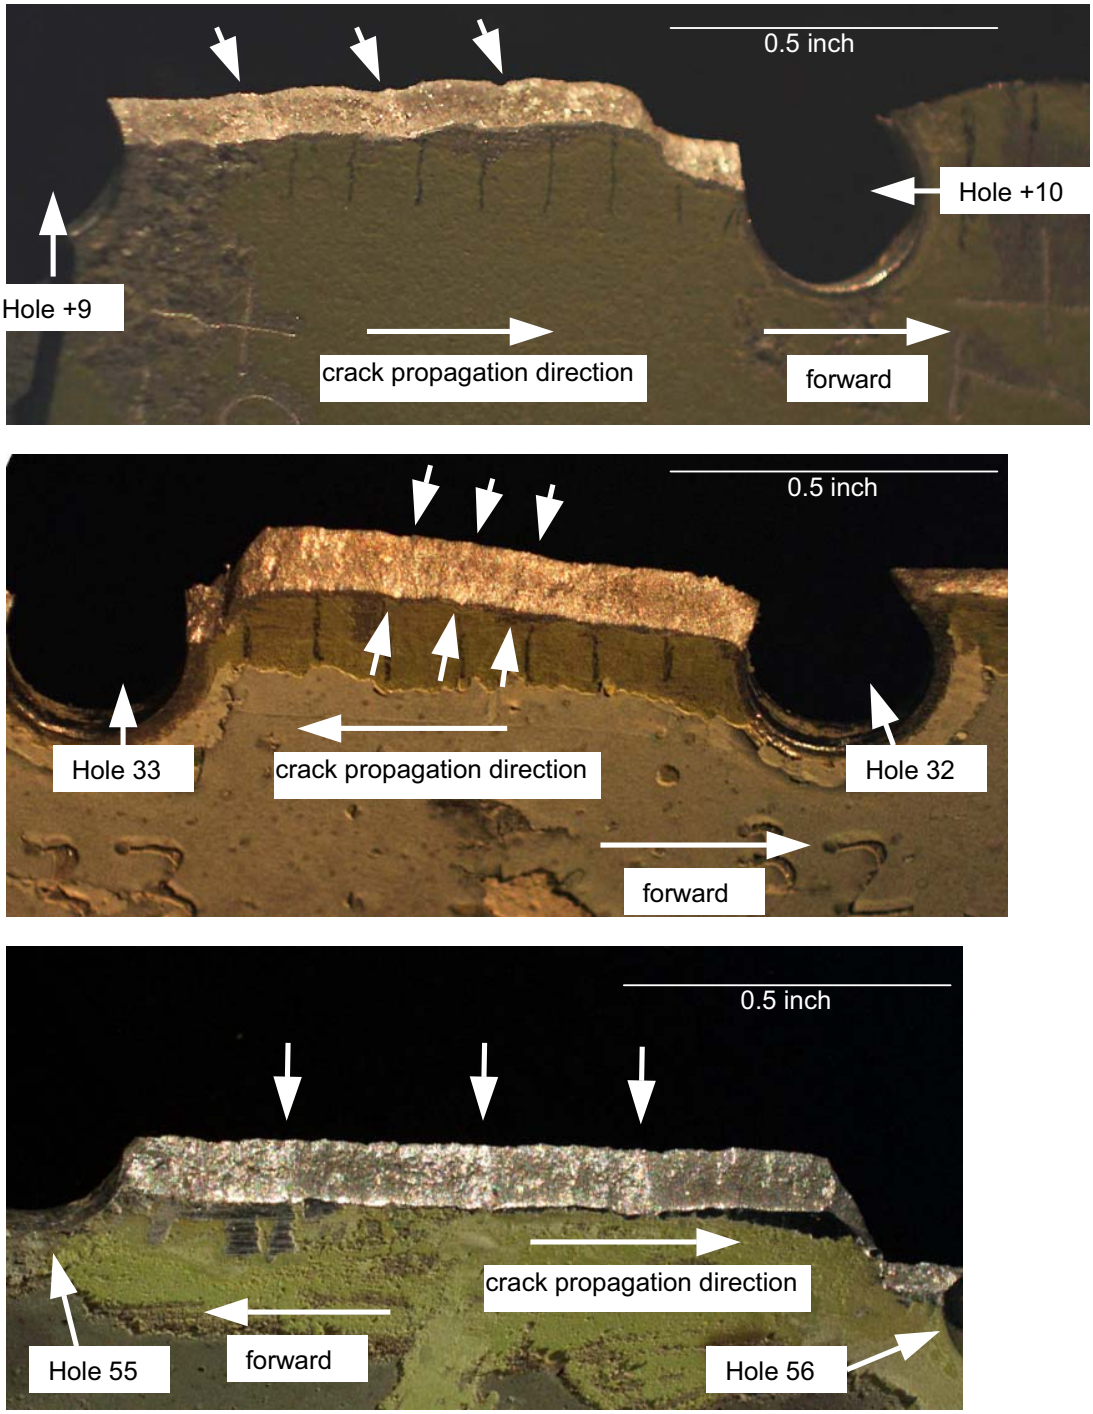
Figure 16, Photographs showing the incremental crack growth indications on the fracture segments between Holes +9 and +10 (top), Holes 32 and 33 (center), and Holes 55 and 56 (bottom).
