Aviation Occurrence Report Volume II

ASC-AOR-05-02-001

IN-FLIGHT BREAKUP OVER THE TAIWAN STRAIT

CHINA AIRLINES FLIGHT CI611

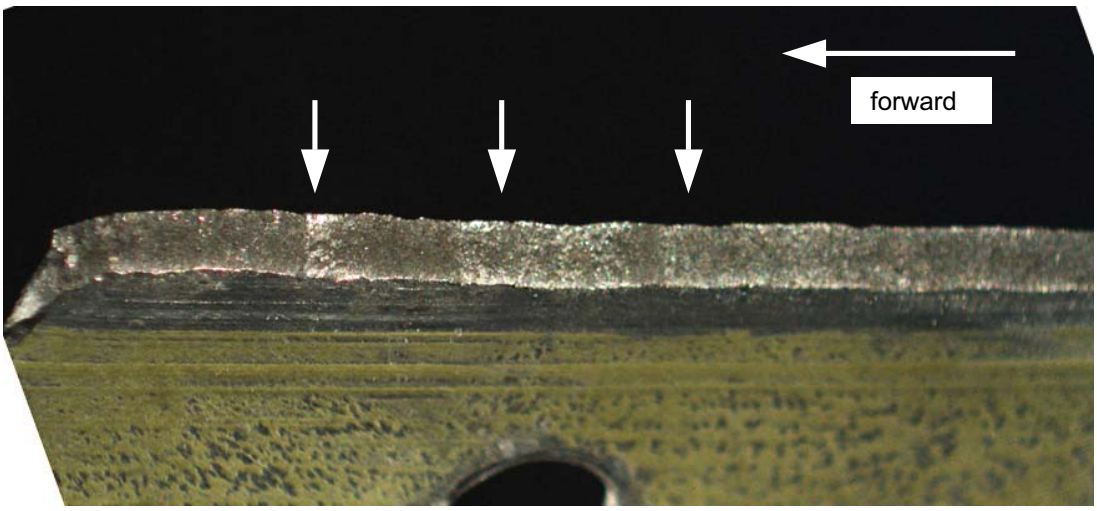
Beyond the flat profile and transition zones of the main fatigue areas, the fracture surface contained numerous segments that displayed indications of incremental crack growth (referred to as quasi-stable crack growth in this report) that could be observed visually or with the aid of low power optical instrumentation (Figures 15 and 16). In general, these indications were observed to increase in spacing as the distance from the flat profile fatigue regions increased in both the forward and aft directions. Such features were also observed on the fracture face between holes 6 and 10 with increasing spacing in the forward direction (Figure 17). Incremental crack growth indications were observed as far forward as approximately STA 2055 and as far aft as hole 56 (STA 2140).

Figure 17, Photograph showing the incremental crack growth indications (arrows) on the fracture segment near Hole 7, which is between the two main fatigue cracking systems at Holes 4 and 5 and Holes 10 through 25.

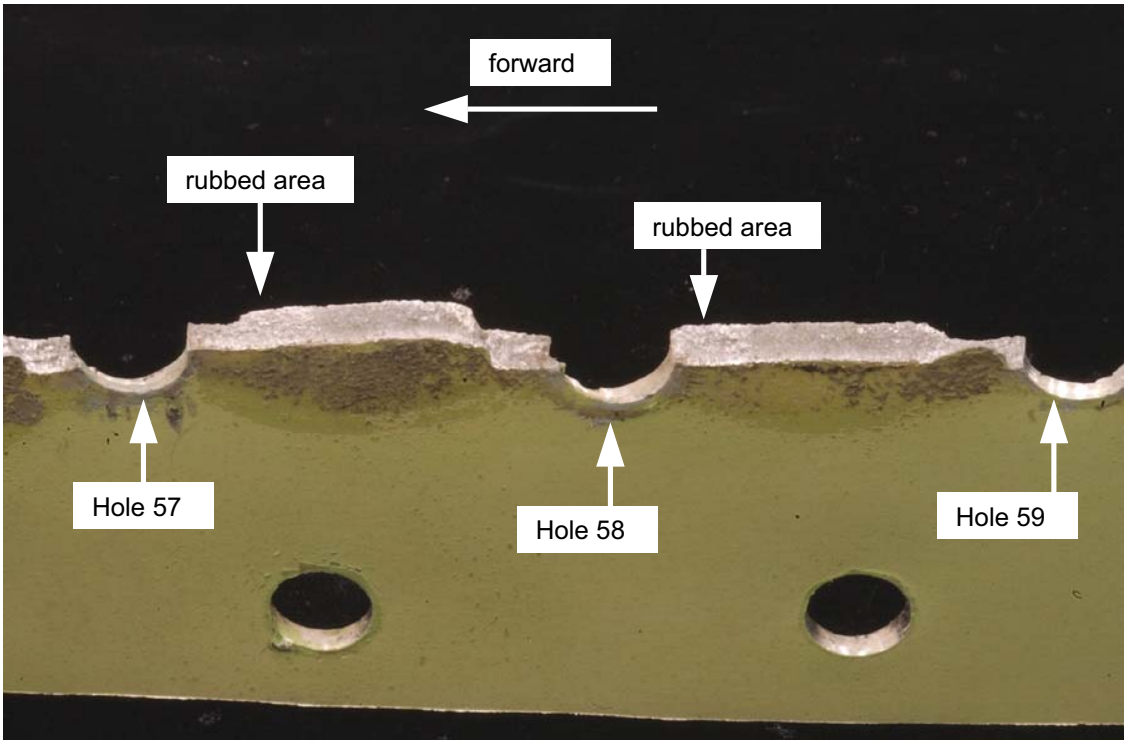
Figure 18, Photograph of the fracture surface at Holes 57, 58, and 59. The shiny areas are indicative of rubbing with the mating fracture surface and appeared consistently forward of this area, but were not present aftward beyond Hole 62.

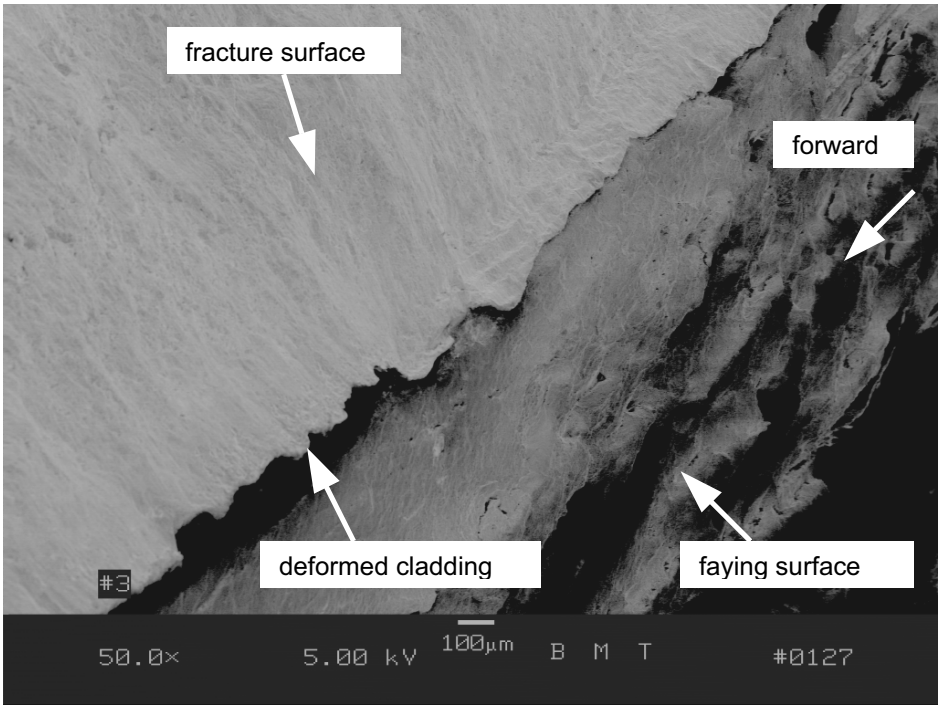
Figure 19, Scanning electron microscope photograph along the edge of the fracture common to the faying surface where the aluminum cladding remained near Hole 3. The fracture surface profile was slanted here. Another example further forward of this area is shown in Figure 20 below. Quasi-stable crack growth beyond these regions allowed cyclic crack closure, causing surface rubbing and compressive deformation of the cladding.

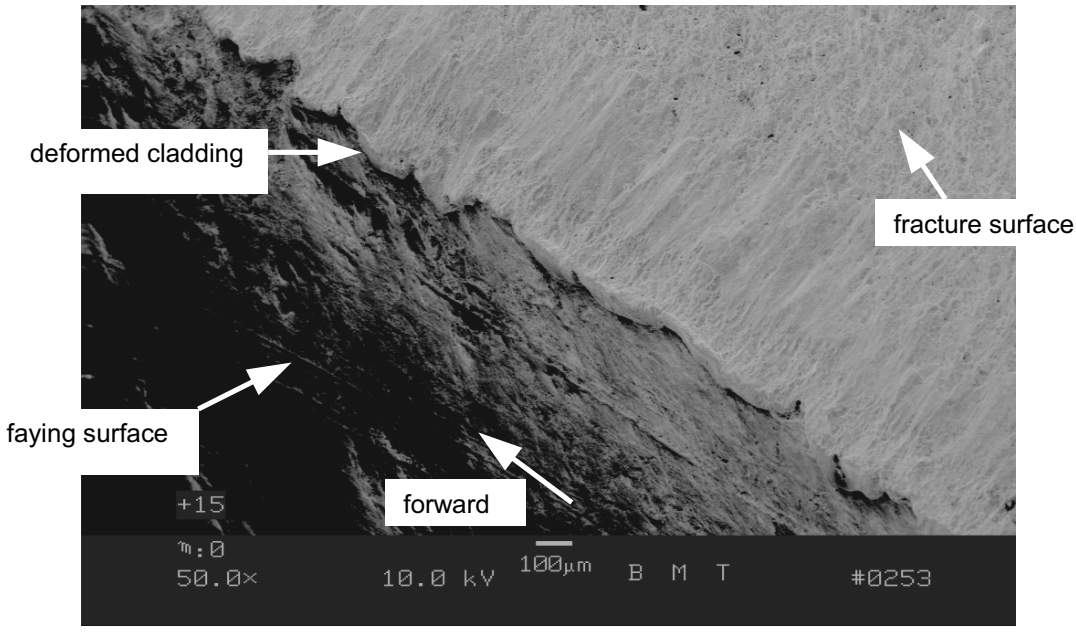
Cyclic rubbing of the fracture surface and associated compression deformation of the cladding was observed along the faying surface providing additional evidence of cracking that occurred prior to the accident flight. Figure 18 shows the visible appearance of the fracture surface near holes 57, 58, and 59. The damage that produced the scratches on the faying surface removed significant amounts of cladding. However, all areas where cladding remained forward and aft of the main fatigue cracking displayed compressive deformation due to crack closure as far forward as hole +17 and as far aft as hole 62. Figures 19 through 21 are SEM photographs showing the appearance of such aluminum cladding deformation. The remaining fracture aft of hole 62 displayed “necking”, which is typical of continuous tensile loading to ultimate tensile separation (Figure 22). These observations suggest that cracking in the skin was continuous from approximately STA 2055 to 2146, or approximately 93 inches prior to the accident flight.

Figure 20, SEM photograph showing the compressive deformation of the cladding just forward of Hole +15.

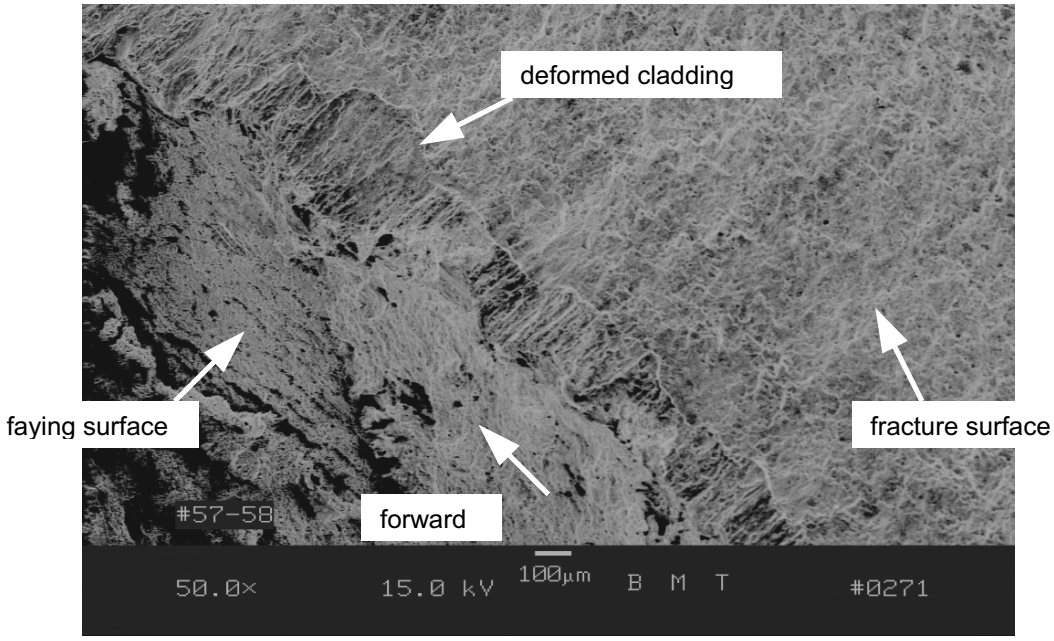
Figure 21, SEM photograph showing the compressive deformation of the cladding between Holes 57 and 58. Note that the degree of compressive damage is less severe than that observed closer to the main cracking system, Figure 19 for example. Fracture surfaces near the extreme extent of pre-existing cracking would have experienced few repetitive crack closures.

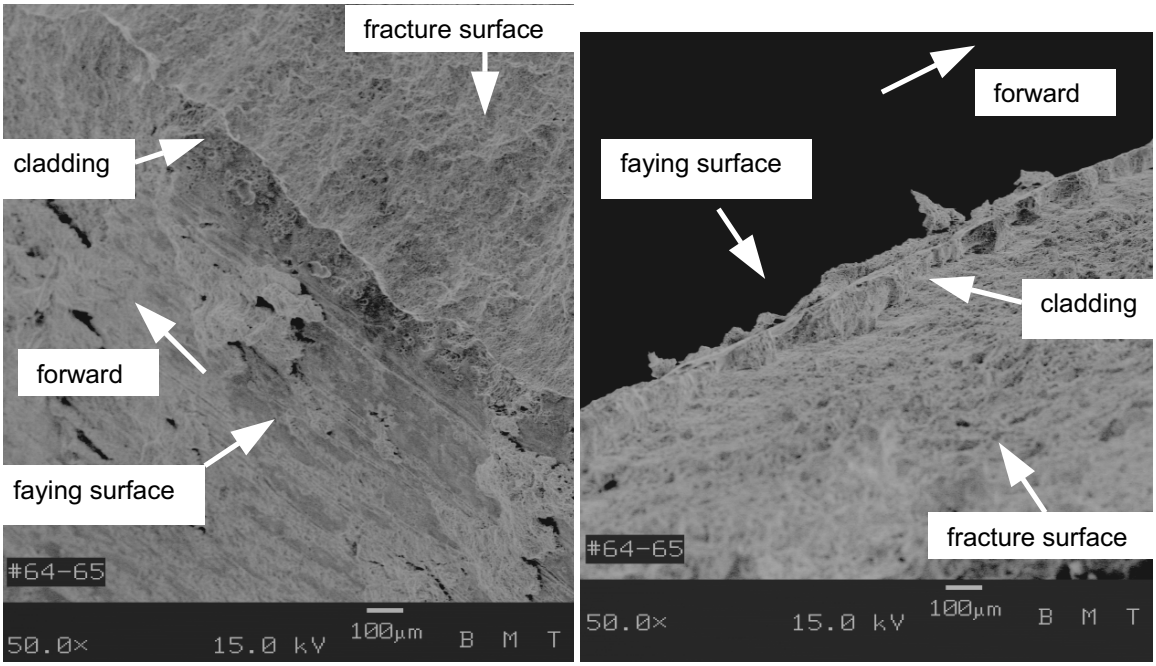
Figure 22, opposing angle SEM photographs of the fracture segment between Holes 64 and 65 showing the cladding on the faying surface retaining its upward profile from the necking process during ultimate tensile separation without subsequent crack closure.

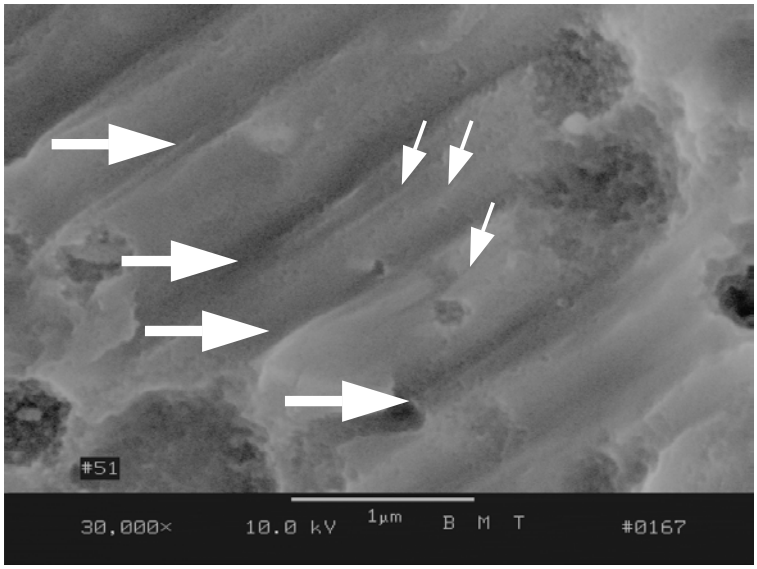
Although much of the fracture suffered from heavy corrosion, fatigue striations were resolved by SEM in many local areas of the fatigue cracking regions as described in Figures 5 and 6. Striation counting was performed at a number of locations along the flat profile fatigue regions of the fracture. Since the fracture surface was not continuous from a single fatigue initiation origin to the ultimate extent of stage II (striation producing) cracking, it was not possible to estimate a time of initiation. Instead, the nature of cracking on this detail provided numerous initiation sites along scratches on the faying surface, with subsequent propagation in the through-thickness direction. Because cyclic cabin pressure is the prevailing driving force for cracking at this detail, each striation is considered to represent the microscopic crack advancement during one flight cycle of the airplane. Thus, striation counting was performed in order to obtain an estimate of the number of flight cycles that contributed to the fatigue crack propagation through the material thickness. Reference 1 reported the observation of “major” and “minor” striations. The occurrence of striation-like features appearing between actual striations is not uncommon for fatigue cracks in similar structural details propagating at mature growth rates. These minor striation-like features are shown in Figure 23 and were ignored for striation counting purposes.

Figure 23, SEM photograph showing minor striation-like features (indicated with smaller arrows), which were also observed during examination at the Chung Shan Institute of Science and Technology. Such features are not uncommon and were ignored for striation counting purposes. The striations corresponding to flight cycles, and used for estimating growth rates are indicated with the large arrows.

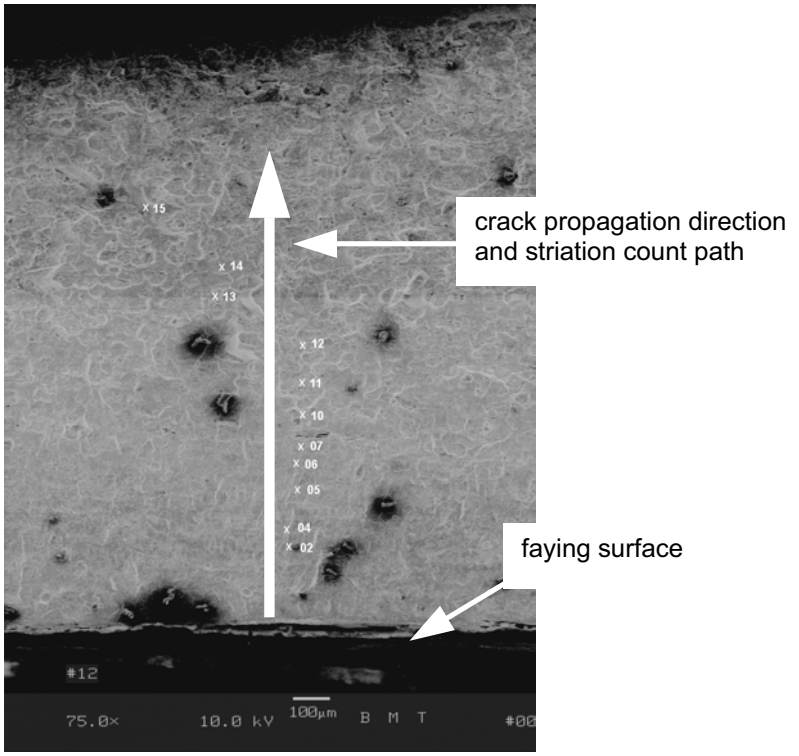
Fatigue cycle estimates were obtained at the locations on the fracture listed in Table VII along with the calculated results. For each location, a traverse across the fracture at several points between the skin surfaces was made by sampling striation spacing with SEM photographs (Figure 24). For determining the crack length at each sample point, x and y Cartesian coordinates generated by the SEM stage were recorded and compared with a reference slope using an analytical geometrical approach. Striation spacing was determined by direct measurement from a photograph at each sampling location. The data was reduced and calculated by employing a trapezoidal integration method, whereby the number of cycles between two successive data points is equal to the distance divided by the average striation spacing (half of the sum of the growth rates at the two points). Although this approach may not precisely represent actual cracking behavior, it removes some of the subjectivity of assigning best-fit curves to widely scattered data points and can provide useful information, given an understanding of its limitations.

Figure 24, SEM photograph showing the locations through the skin thickness that were sampled for crack growth rate at Hole 12. The approach was repeated for other through-thickness areas

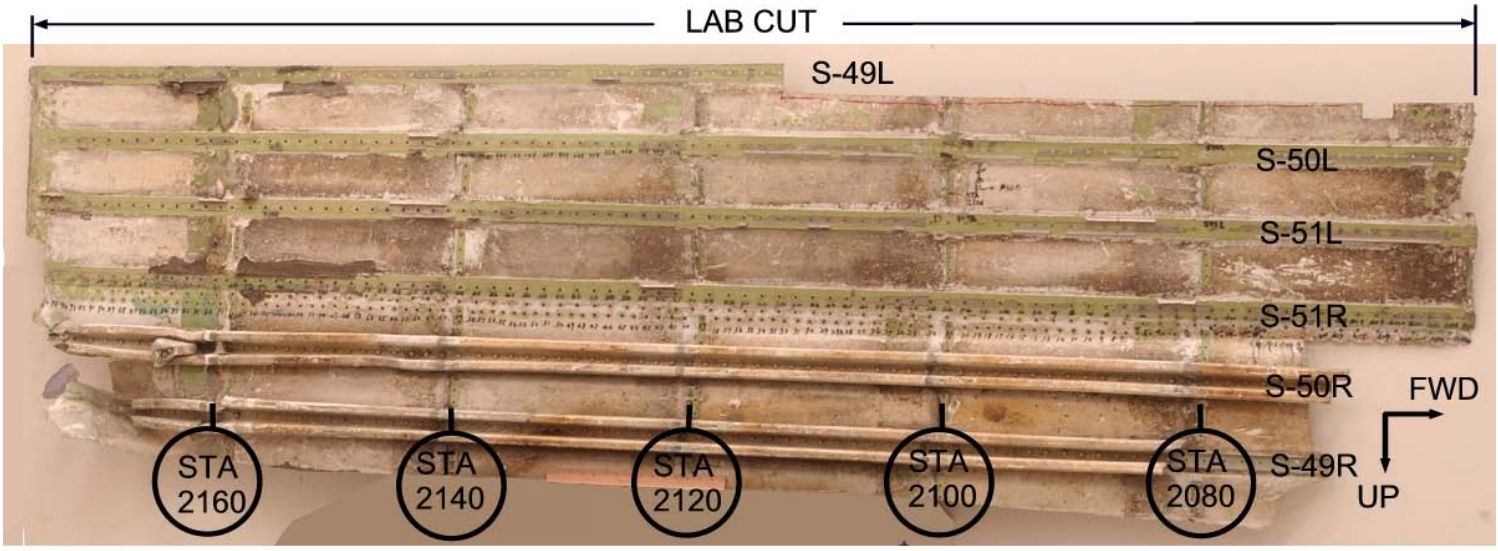
Photographs showing features of the as-received item 640 C1 skin inboard and outboard (repair faying surface) surfaces are shown in Figures 25 and 26 respectively. Protective finishes had previously been removed from much of the repair faying surface at the CSIST to enable examination of skin damage consistent with a tail strike event. Close-up photographs displaying the extent of damage consistent with a tail strike are shown in Figures 27 through 36. This damage consists primarily of fore to aft (longitudinal) scratching with the most severe scratching typically occurring at the location of skin stiffening members such as skin stringers and body frame shear ties. Figure 37 displays the location of the most severe skin damage. As noted in this photograph, the most severe damage consistent with a tail strike occurred on the left hand side of the airplane in the area covered by the repair doubler. Evidence of an attempt to blend out these skin scratches, in the form of rework sanding marks, was noted over much of the repair surface.

FIGURE 25. AS RECEIVED ITEM 640 CI SKIN INBOARD SURFACE- The S-49L fracture segment was removed at the CSIST during the initial examination.

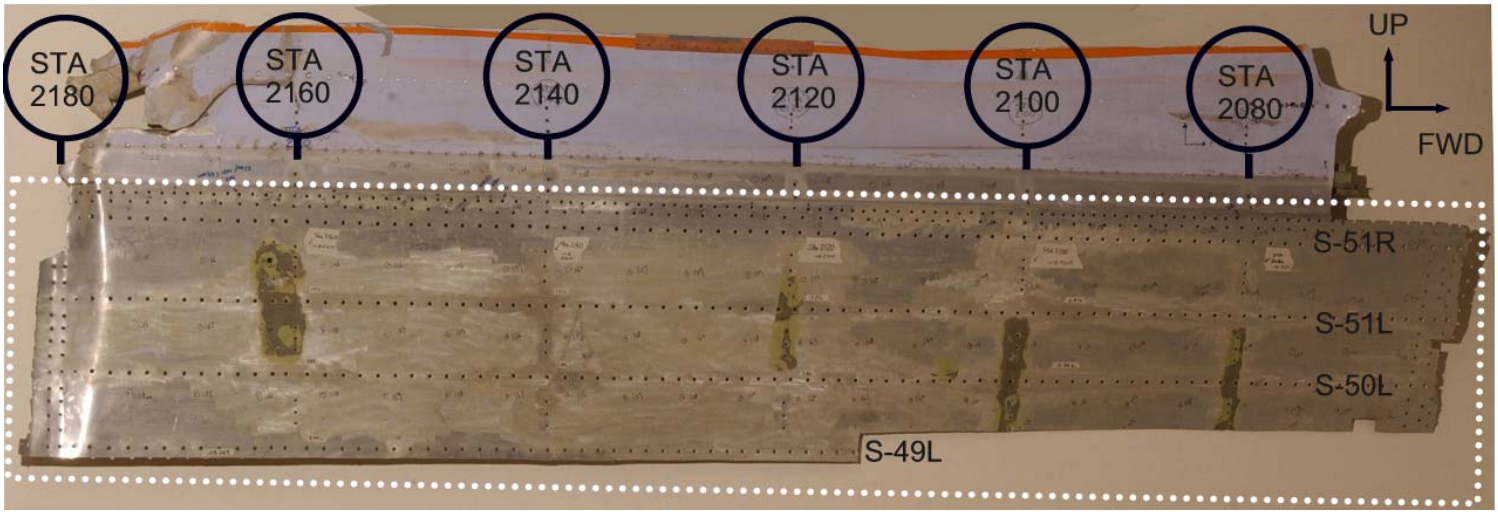
FIGURE 26. AS RECEIVED ITEM 640 C1 SKIN OUTBOARD SURFACE – The approximate location of the repair doubler is shown with dotted lines. Protective finishes were removed from the repair faying surface at the CSIST.

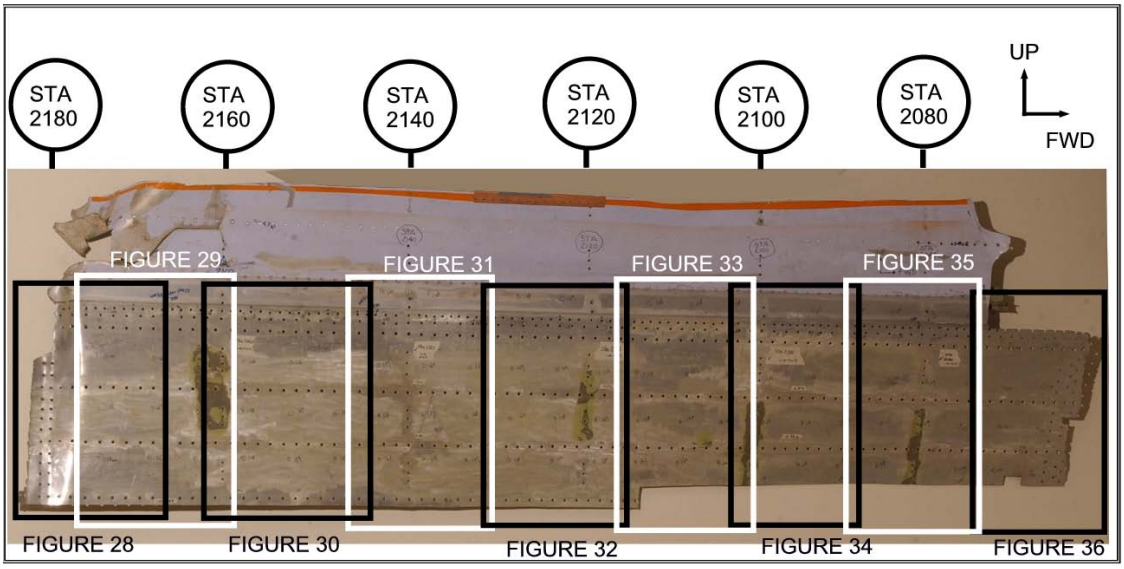
FIGURE 27. SCRATCH PHOTOGRAPH LEGEND – This illustration identifies the location of following photographs that document scratch features observed on the skin repair faying surface. Scratches are fore/aft in orientation and characteristic of a tail strike event.

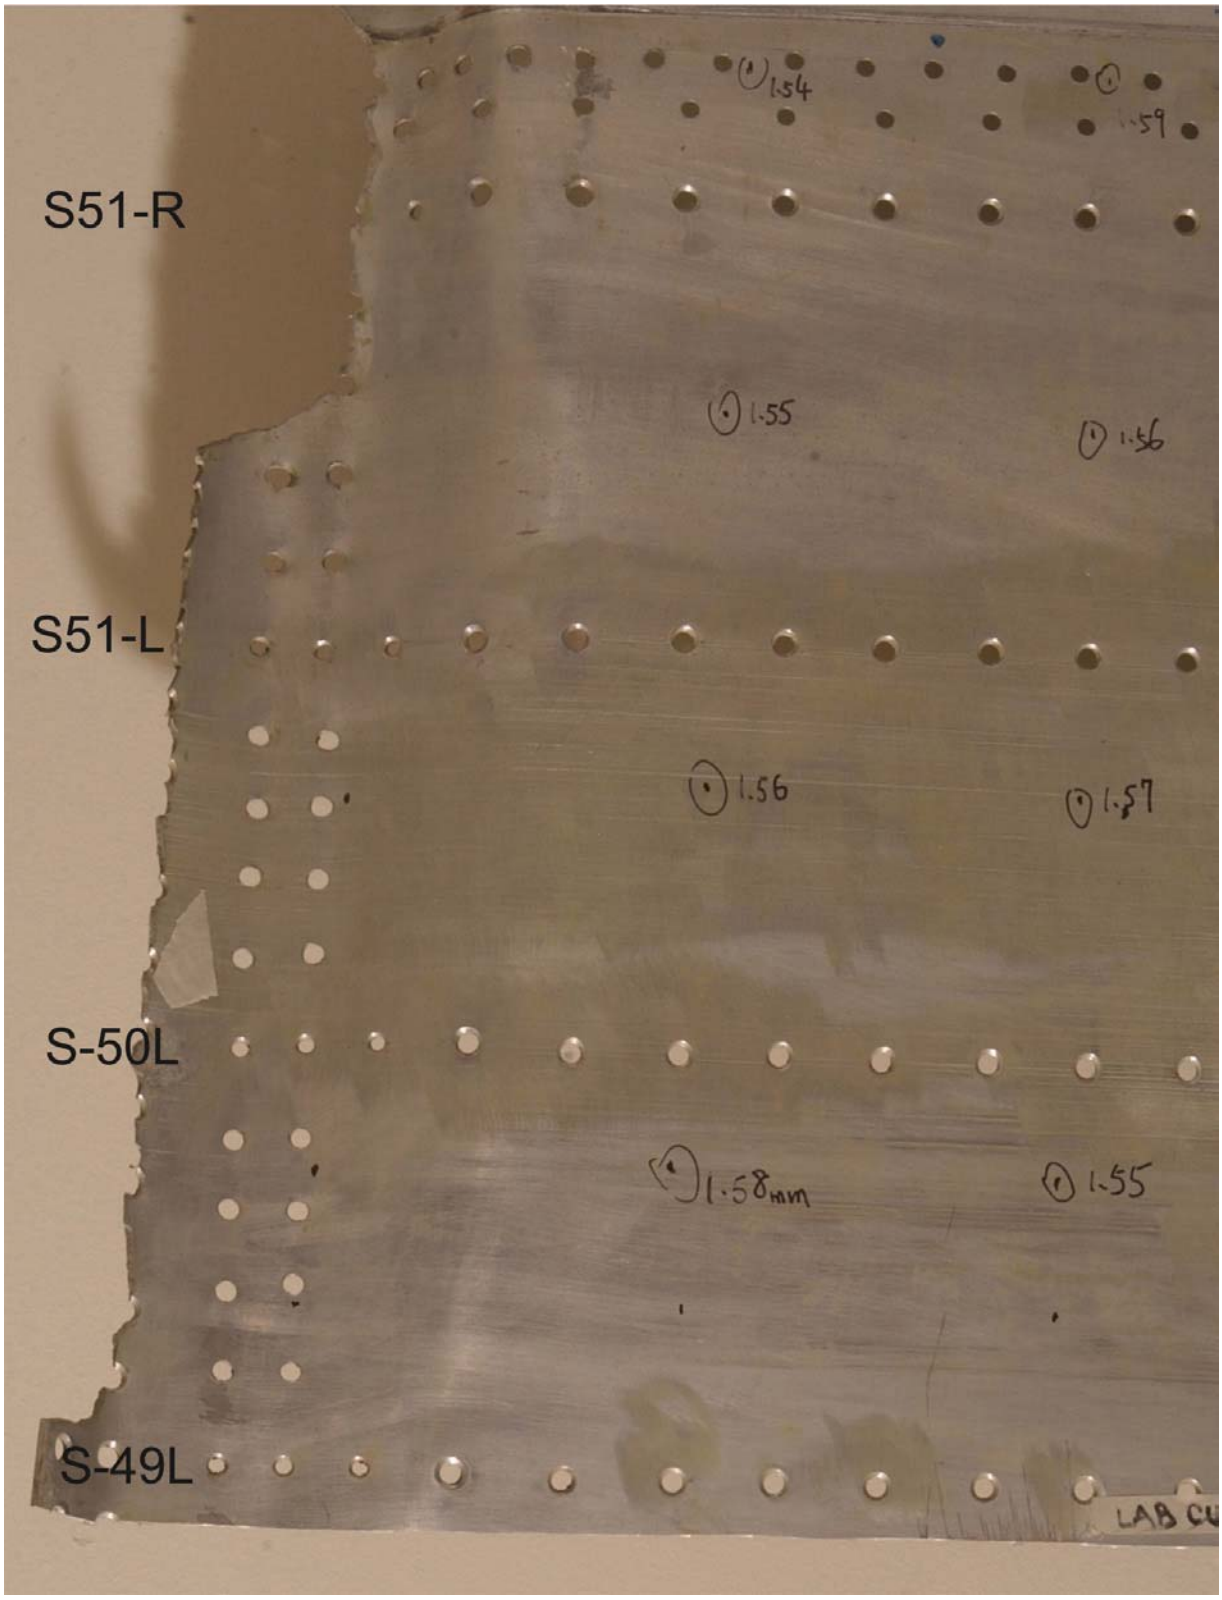
FIGURE 28 – EXTENT OF DAMAGE CONSISTENT WITH A TAIL STRIKE – Scratches may be noted at S-50L and S-51L. Numerical information on skin are results of thickness measurements at the CSIST. Scratch severity increases as you move forward on the panel as shown in the following photographs.

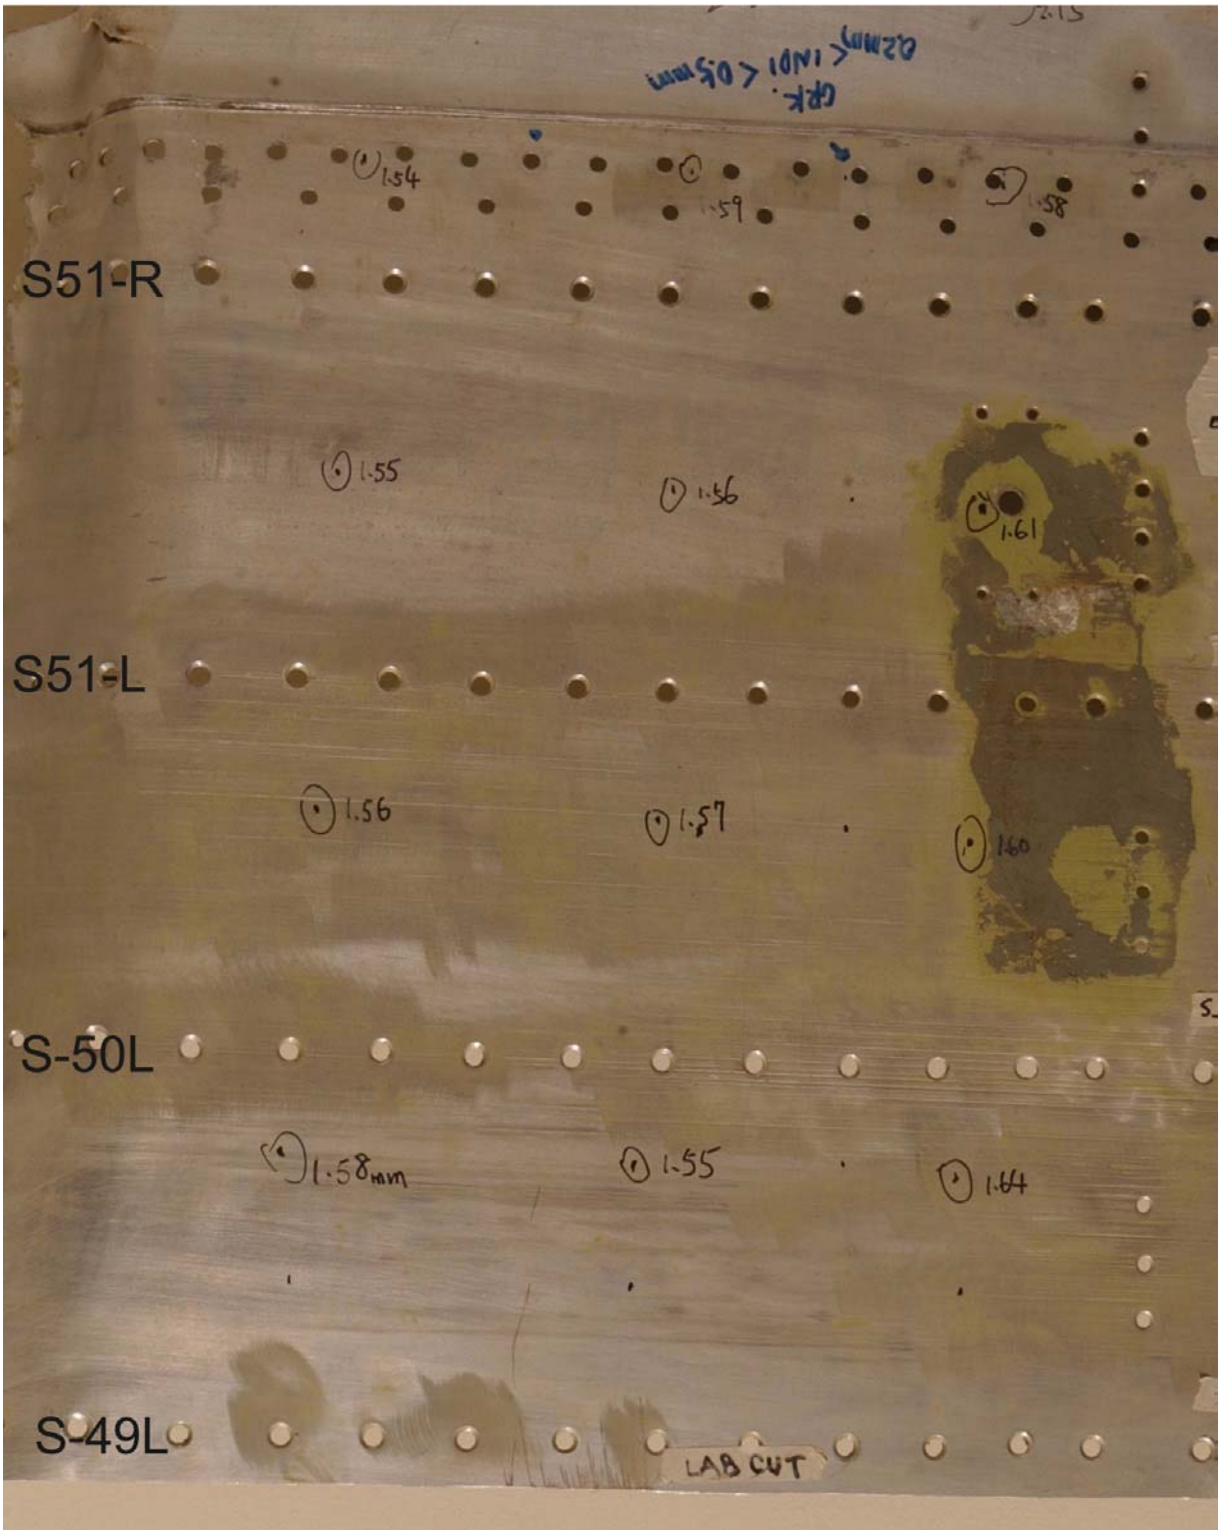
FIGURE 29. EXTENT OF DAMAGE CONSISTENT WITH A TAIL STRIKE – Scratches may be noted at S-50L and S-51L Scratches may also be noted at the shear tie between S-49L and S-50L.

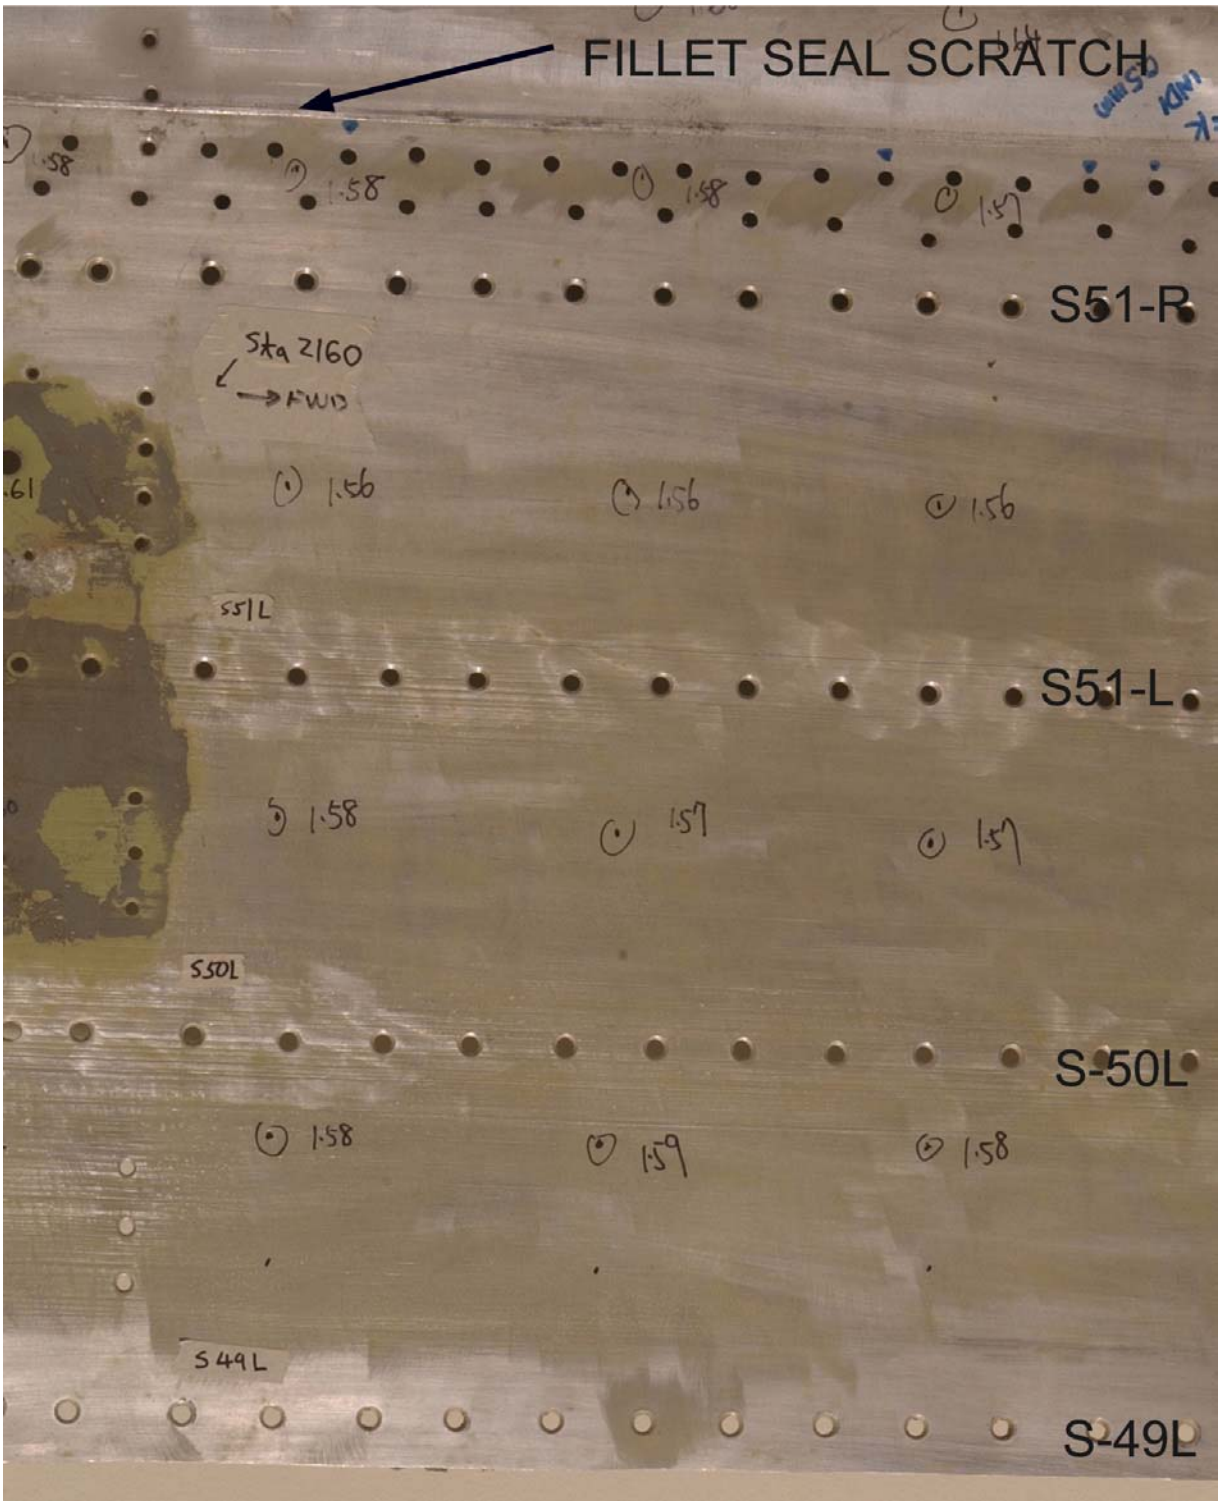
FIGURE 30. EXTENT OF DAMAGE CONSISTENT WITH A TAIL STRIKE - Note that minimal damage occurs on the right hand side of the repair area. Scratching in the doubler fillet seal area may also be seen in this photo.

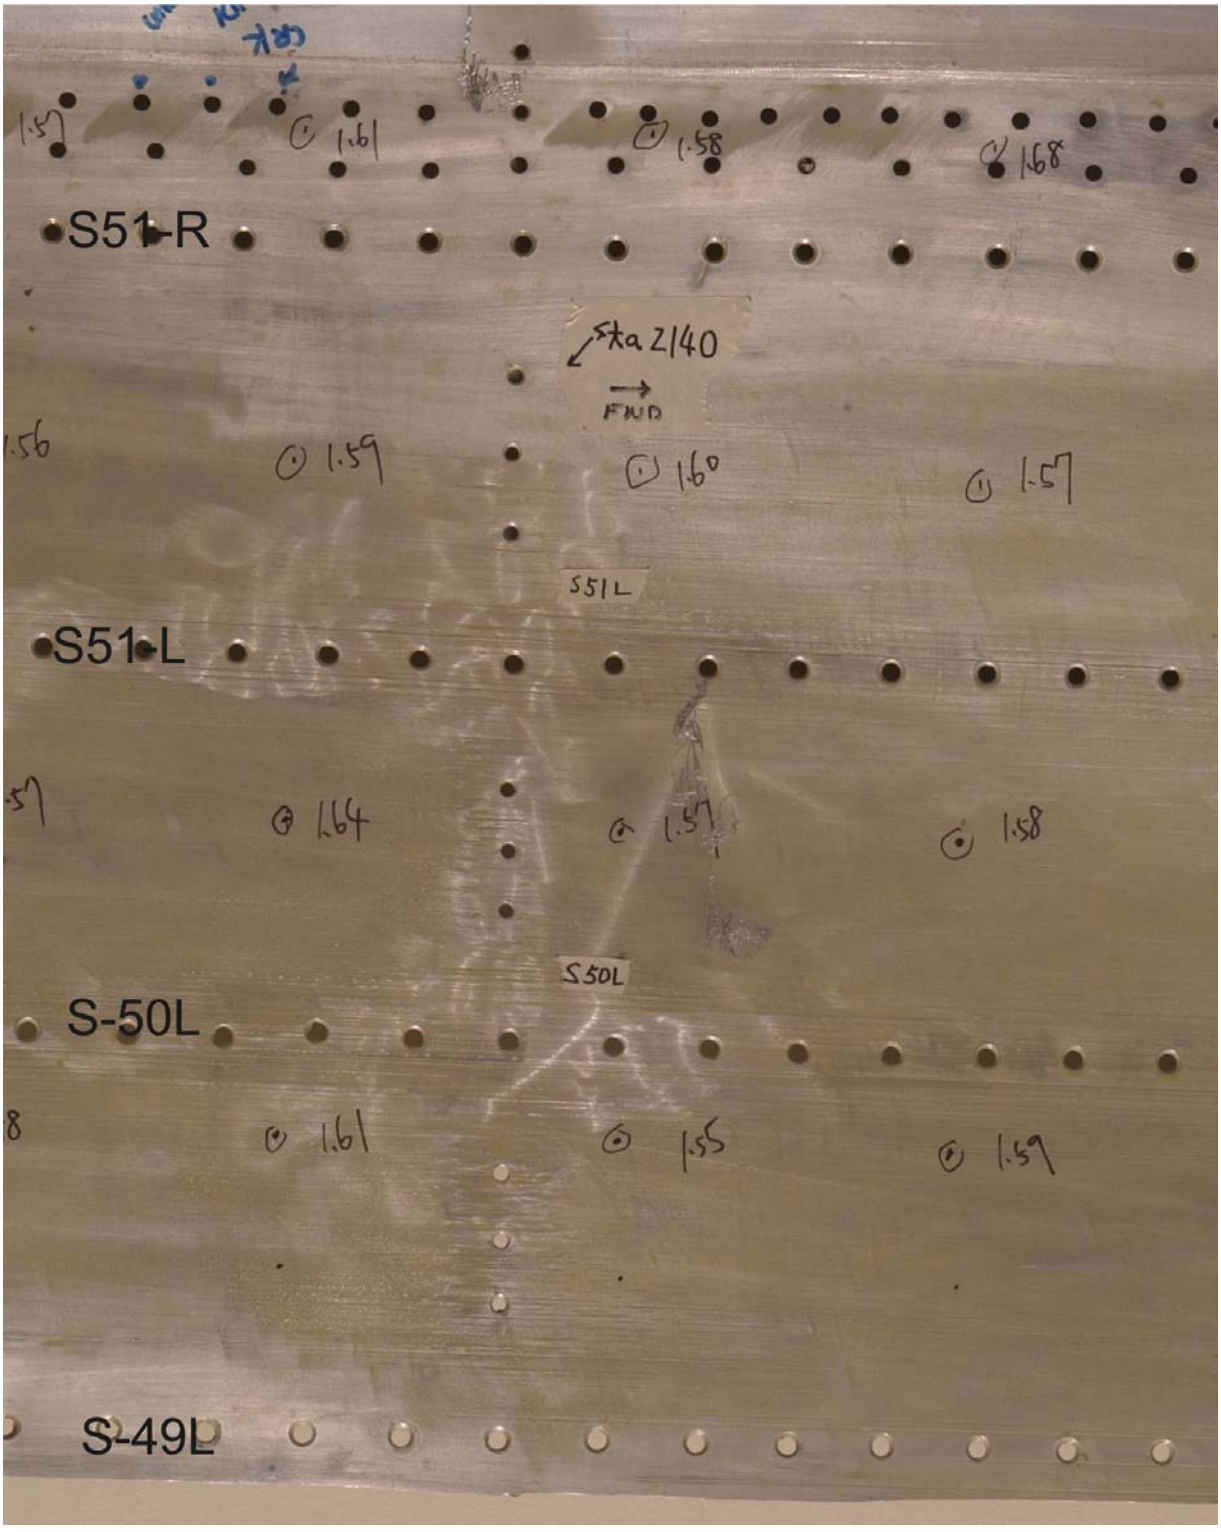
FIGURE 31. EXTENT OF DAMAGE CONSISTENT WITH A TAIL STRIKE

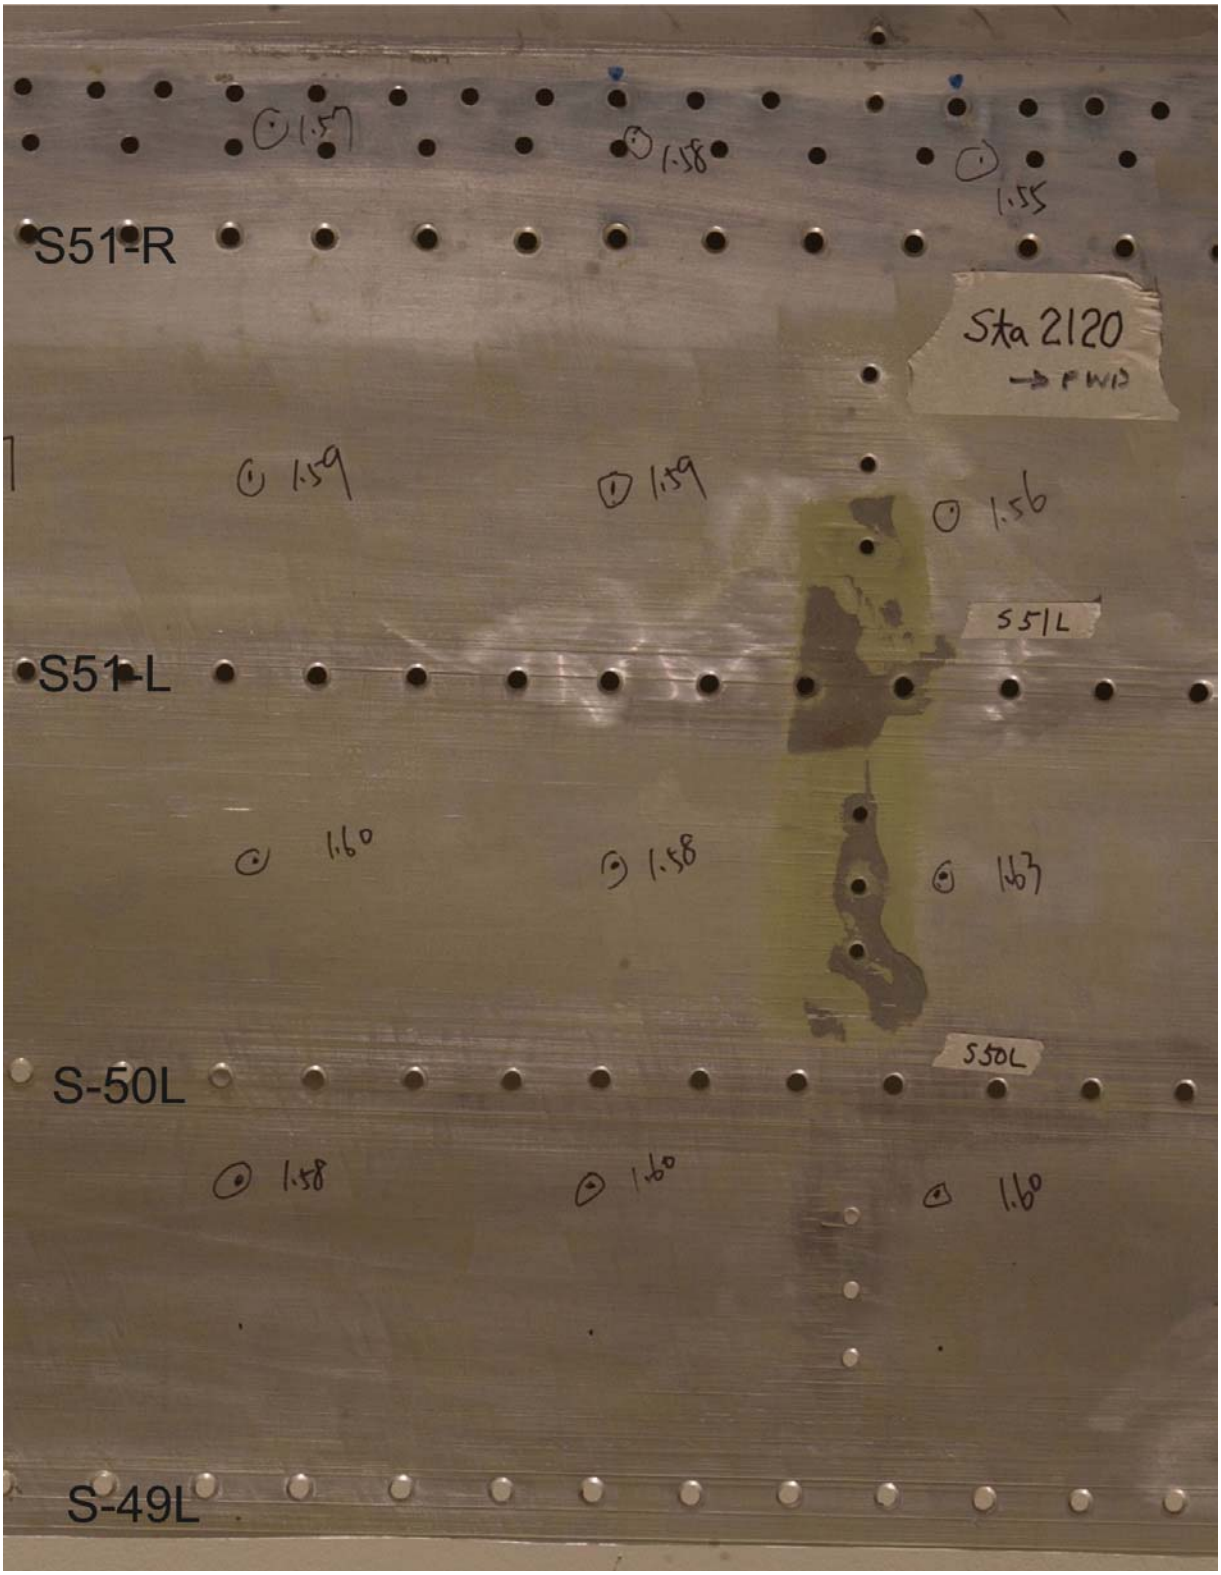
FIGURE 32. EXTENT OF DAMAGE CONSISTENT WITH A TAIL STRIKE – Deep scratches can be noted at S-49L, S-50L, AND S-51L.

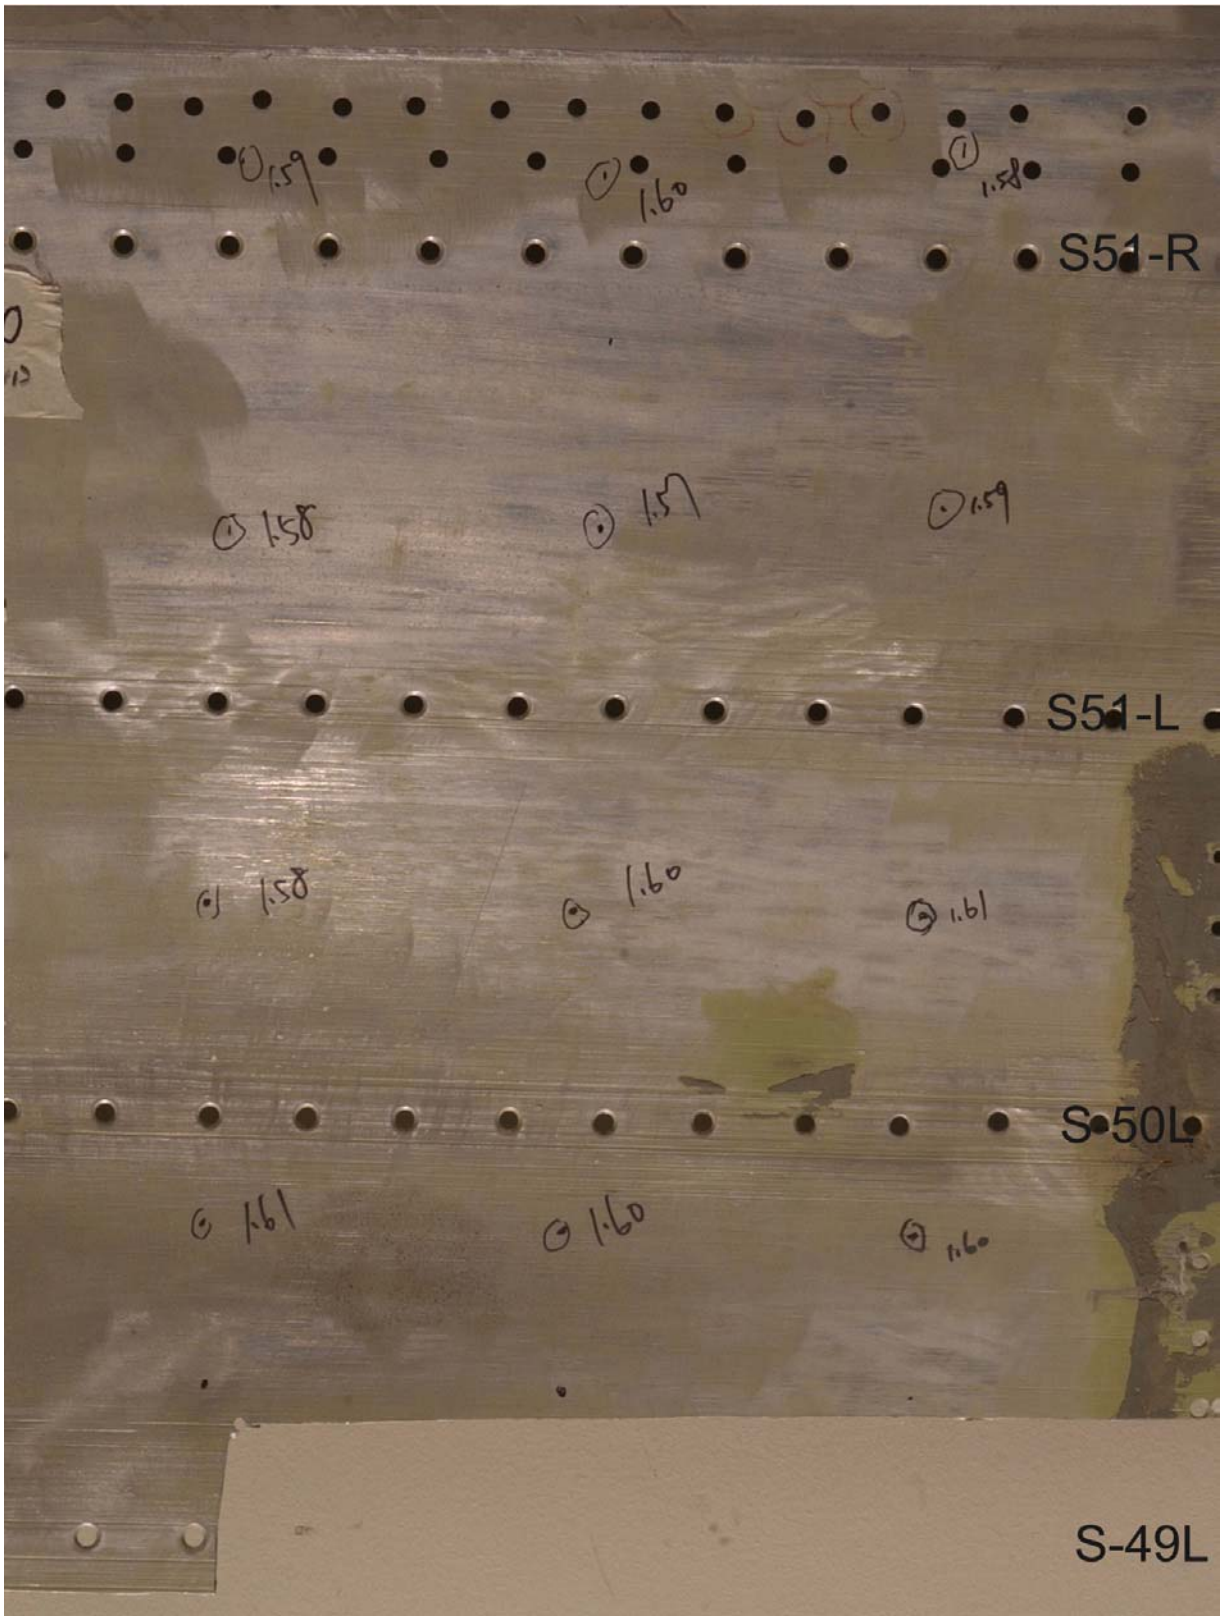
FIGURE 33. EXTENT OF DAMAGE CONSISTENT WITH A TAIL STRIKE
