Aviation Occurrence Report Volume II

ASC-AOR-05-02-001

IN-FLIGHT BREAKUP OVER THE TAIWAN STRAIT

CHINA AIRLINES FLIGHT CI611

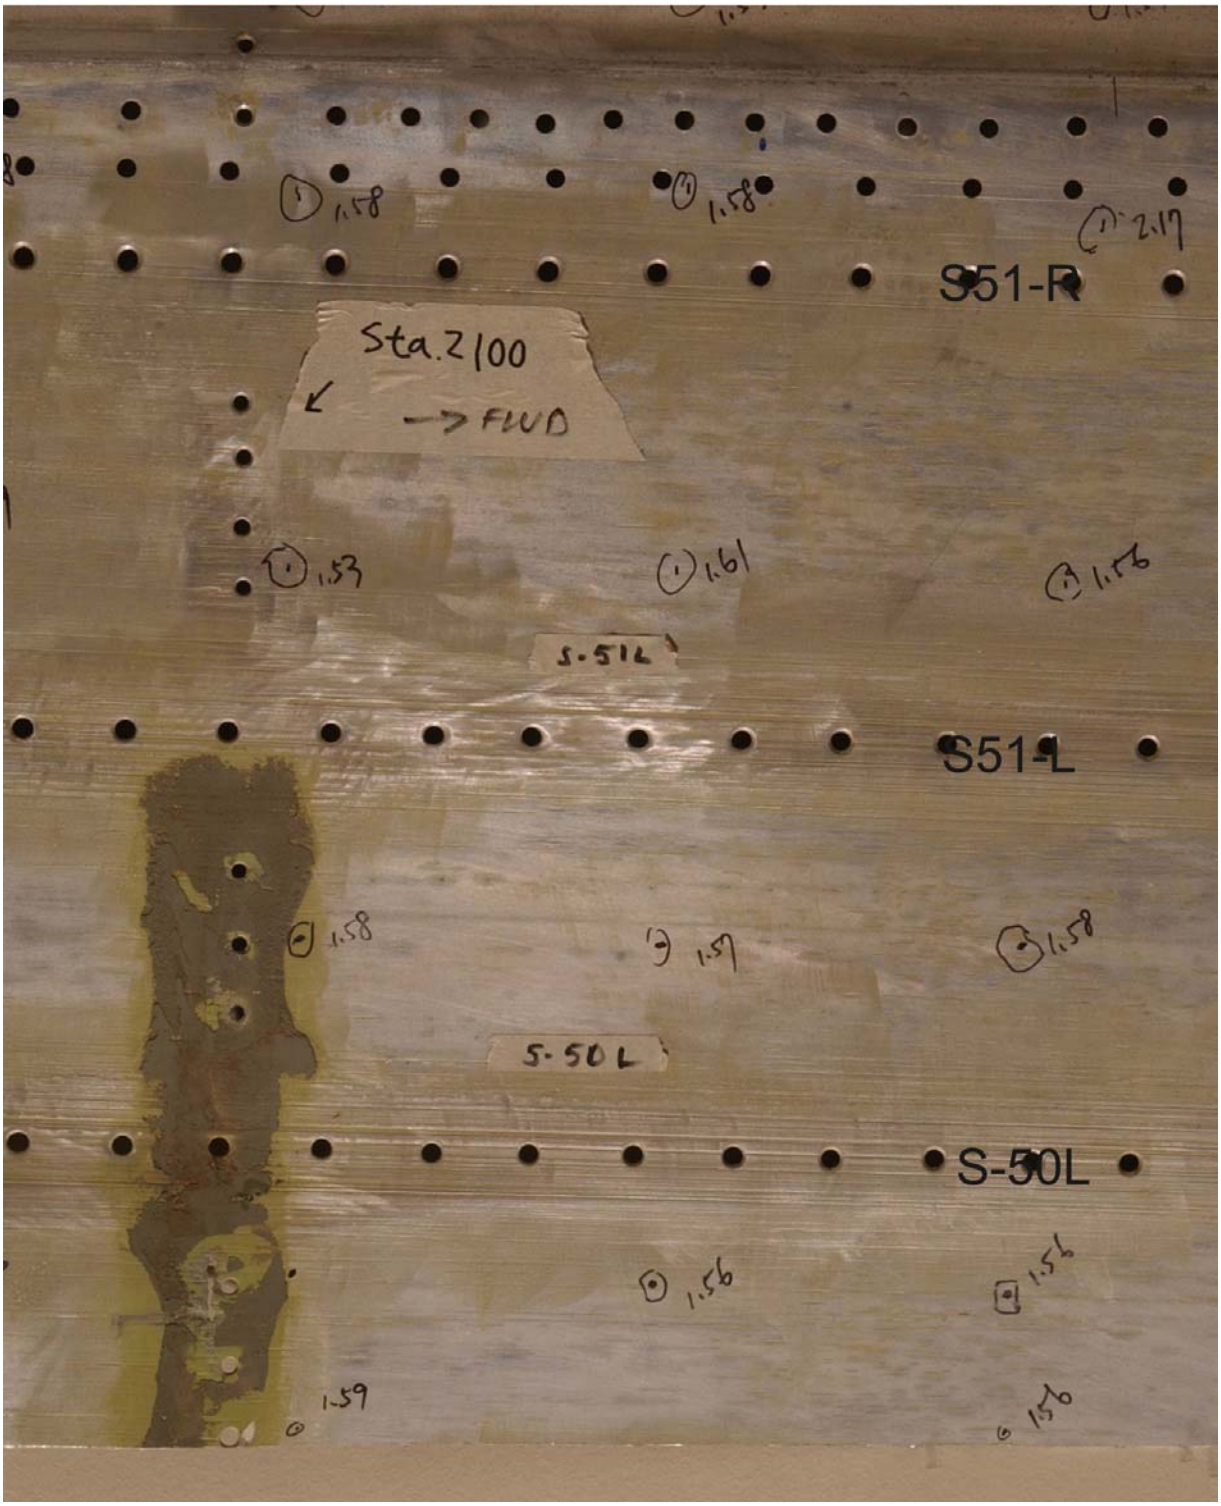
FIGURE 34. EXTENT OF DAMAGE CONSISTENT WITH A TAIL STRIKE

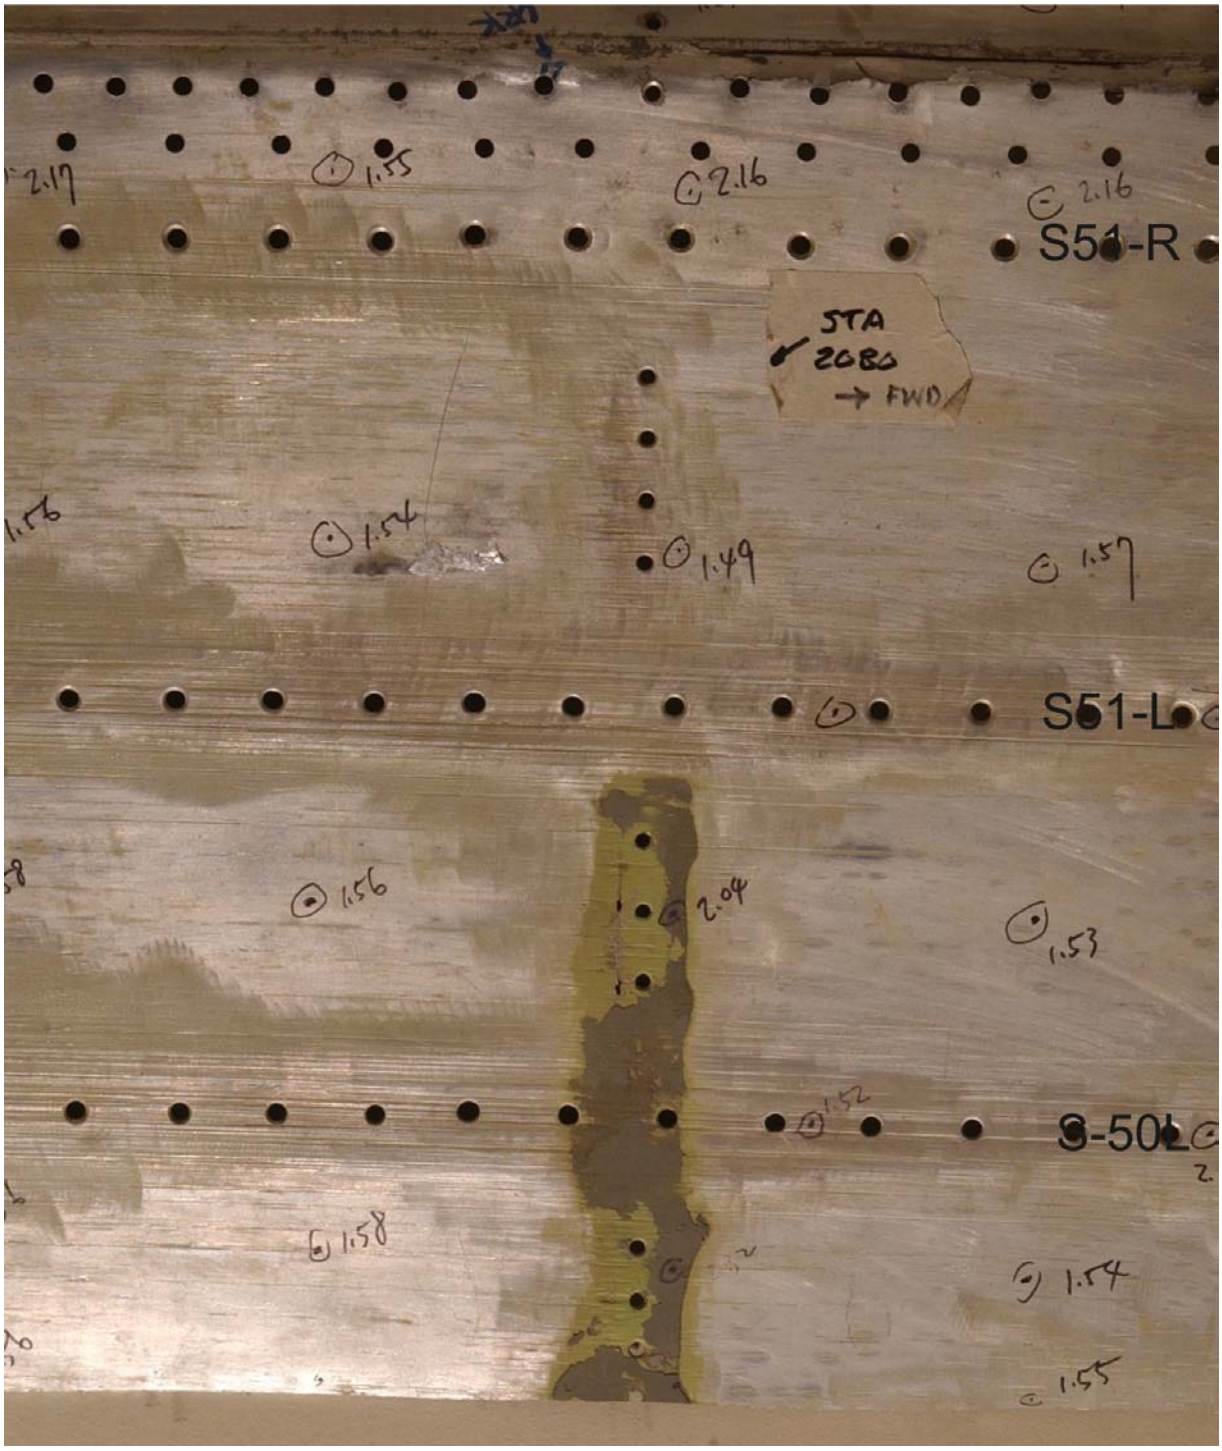
FIGURE 35. EXTENT OF DAMAGE CONSISTENT WITH A TAIL STRIKE – Note the severity of damage in this photo.

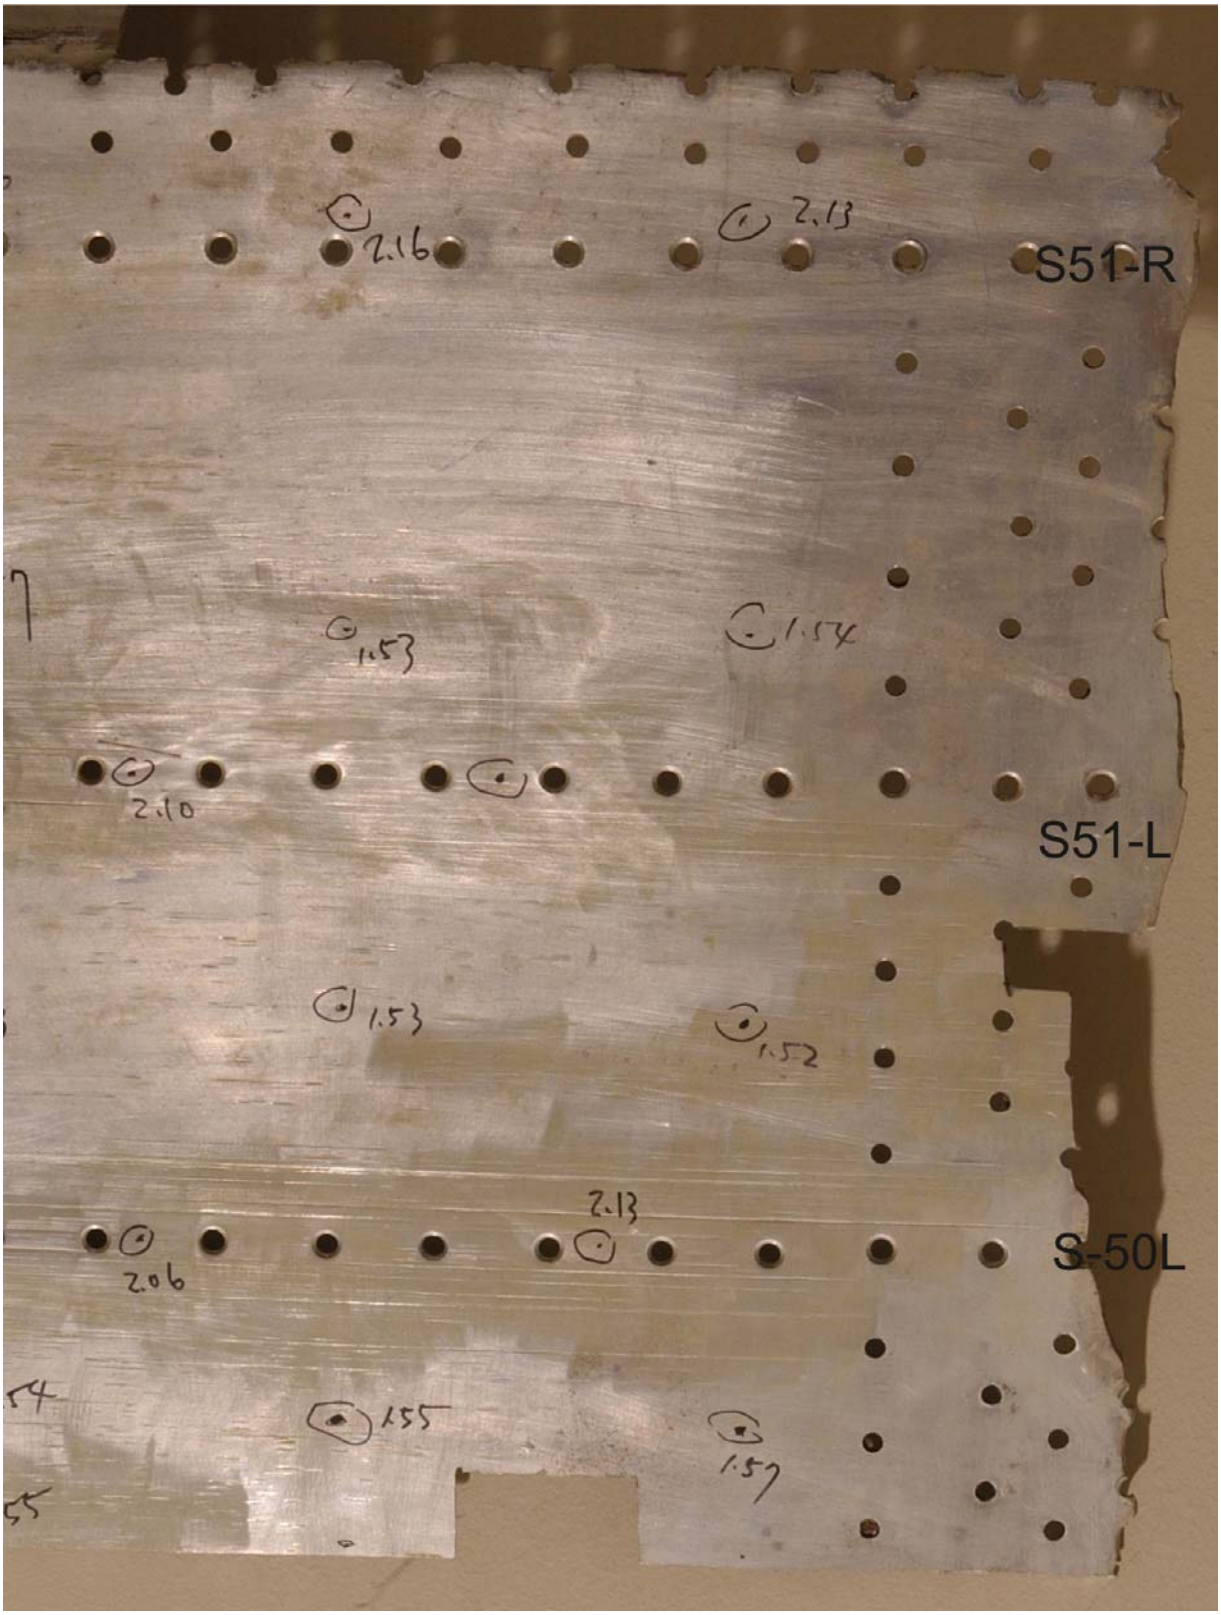
FIGURE 36. EXTENT OF DAMAGE CONSISTENT WITH A TAIL STRIKE

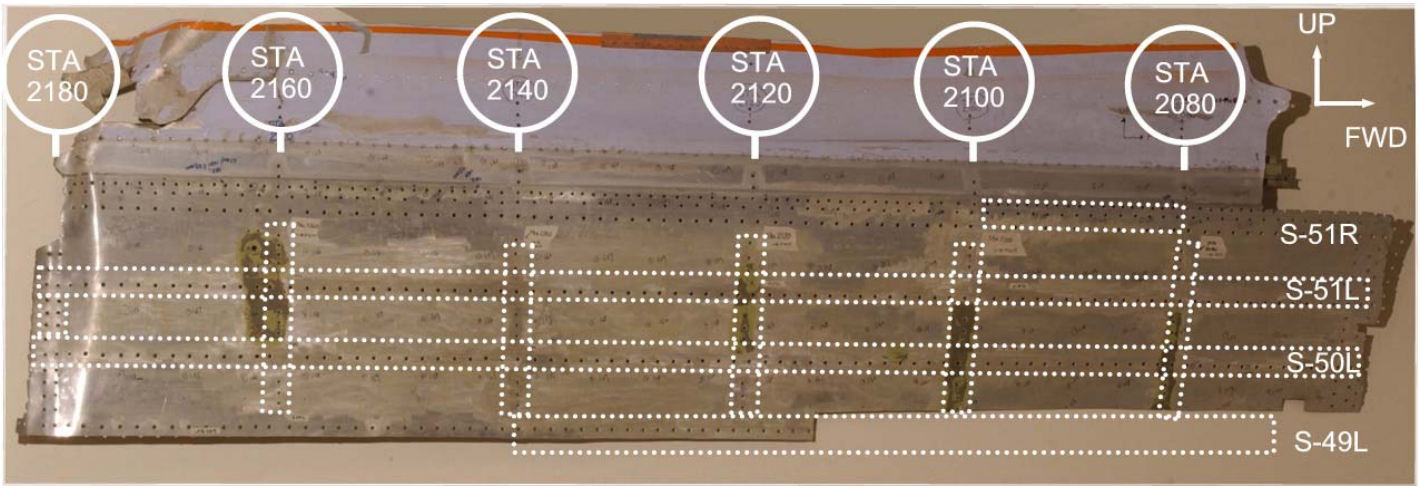
FIGURE 37. AREAS OF MOST SEVERE SKIN DAMAGE – Scratch severity was greatest in the left hand/forward area of the skin.

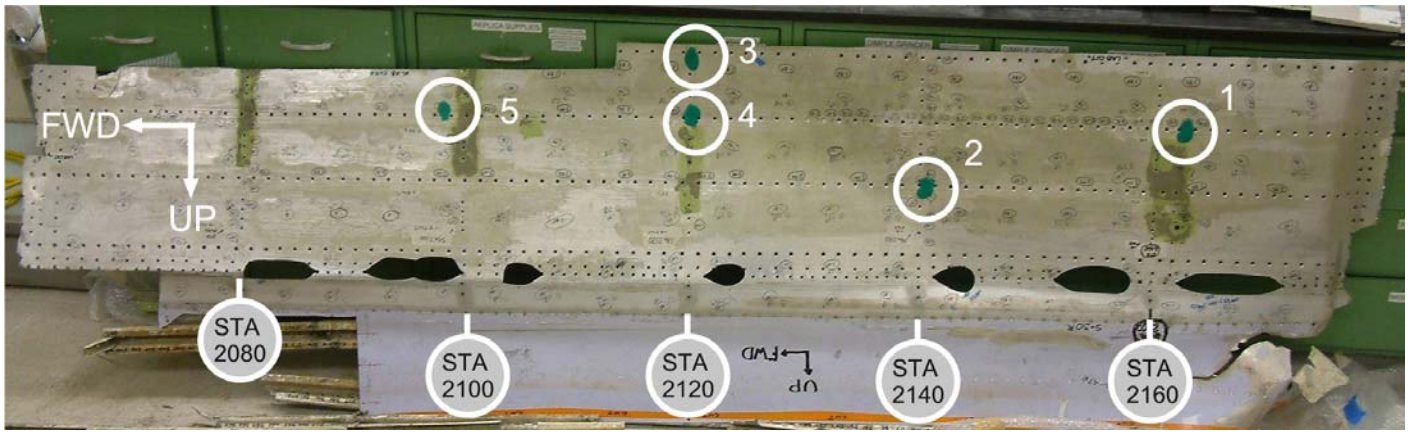
FIGURE 38. LOCATION OF SCRATCH REPLICATION AREAS

A surface replication medium was applied at five locations on the skin repair faying surface as shown in Figure 38 to examine scratch geometry and depth. The locations were chosen to display surface features typical to areas exhibiting major scratching. This medium creates a “positive” of the surface it is applied to, enabling direct feature measurement from the replica. The maximum scratch depth measured with this technique was 0.0096 inch. Composite photographs exhibiting scratch profiles at locations noted above are shown in Figures 39 and 40.

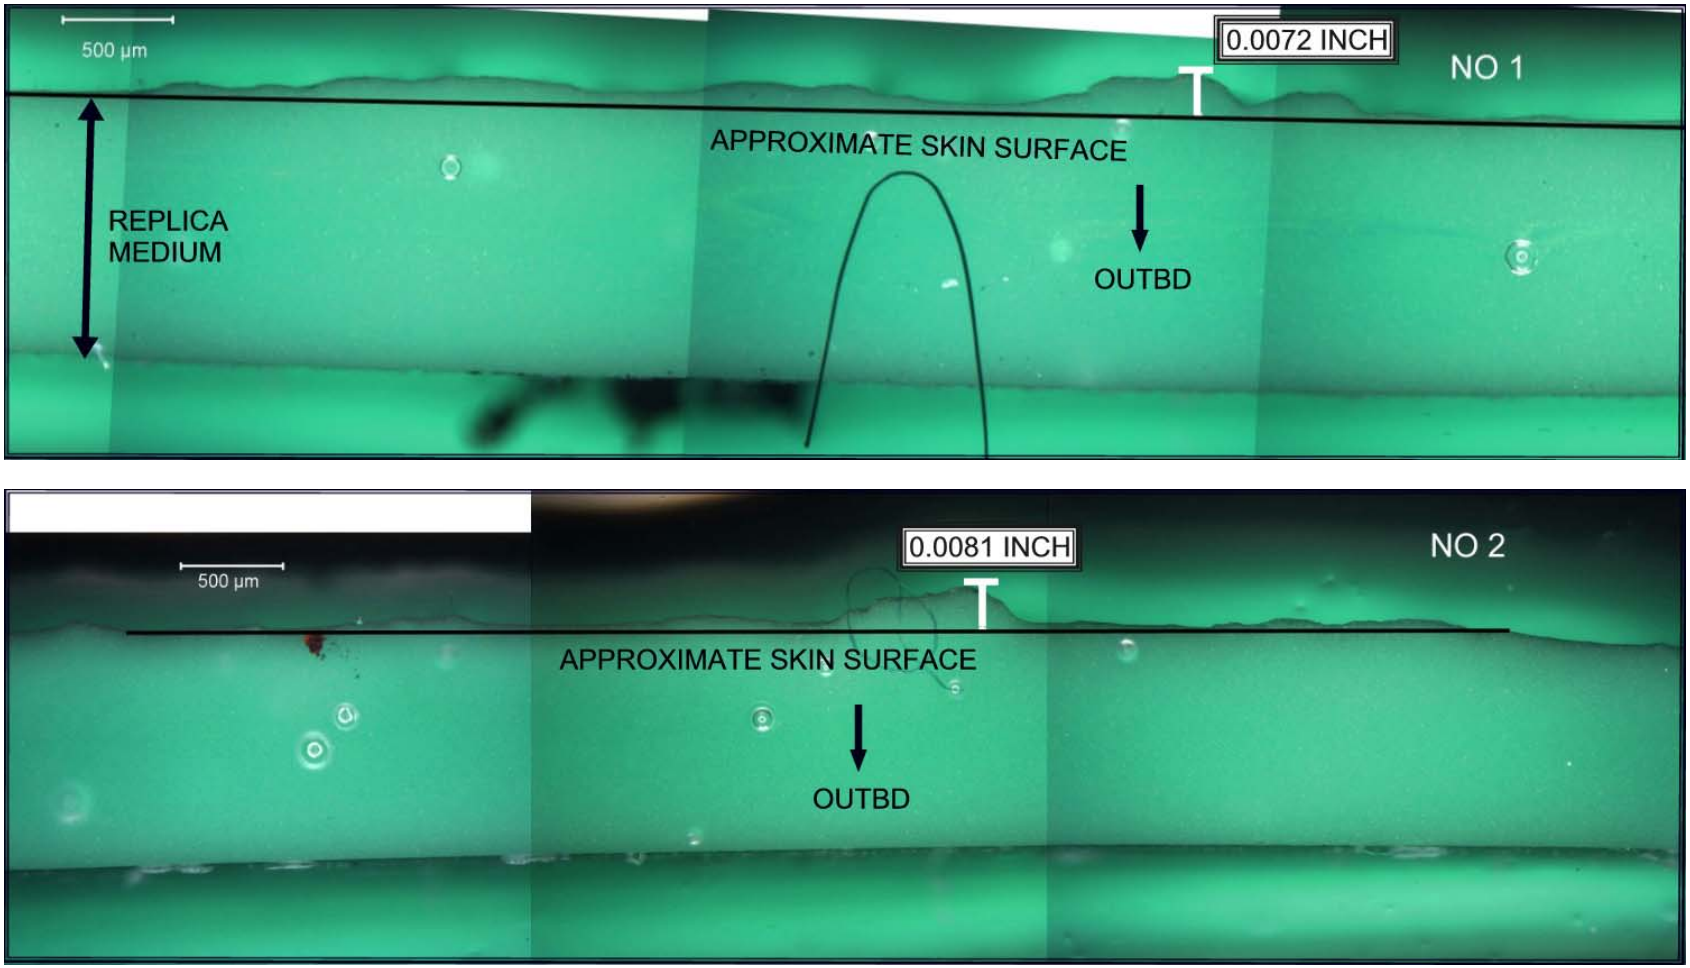
FIGURE 39. SCRATCH PROFILE COMPOSITE PHOTOGRAPHS – The replication medium creates a “positive” of the skin scratches. Scratch features of replica locations 1 and 2 are shown above.

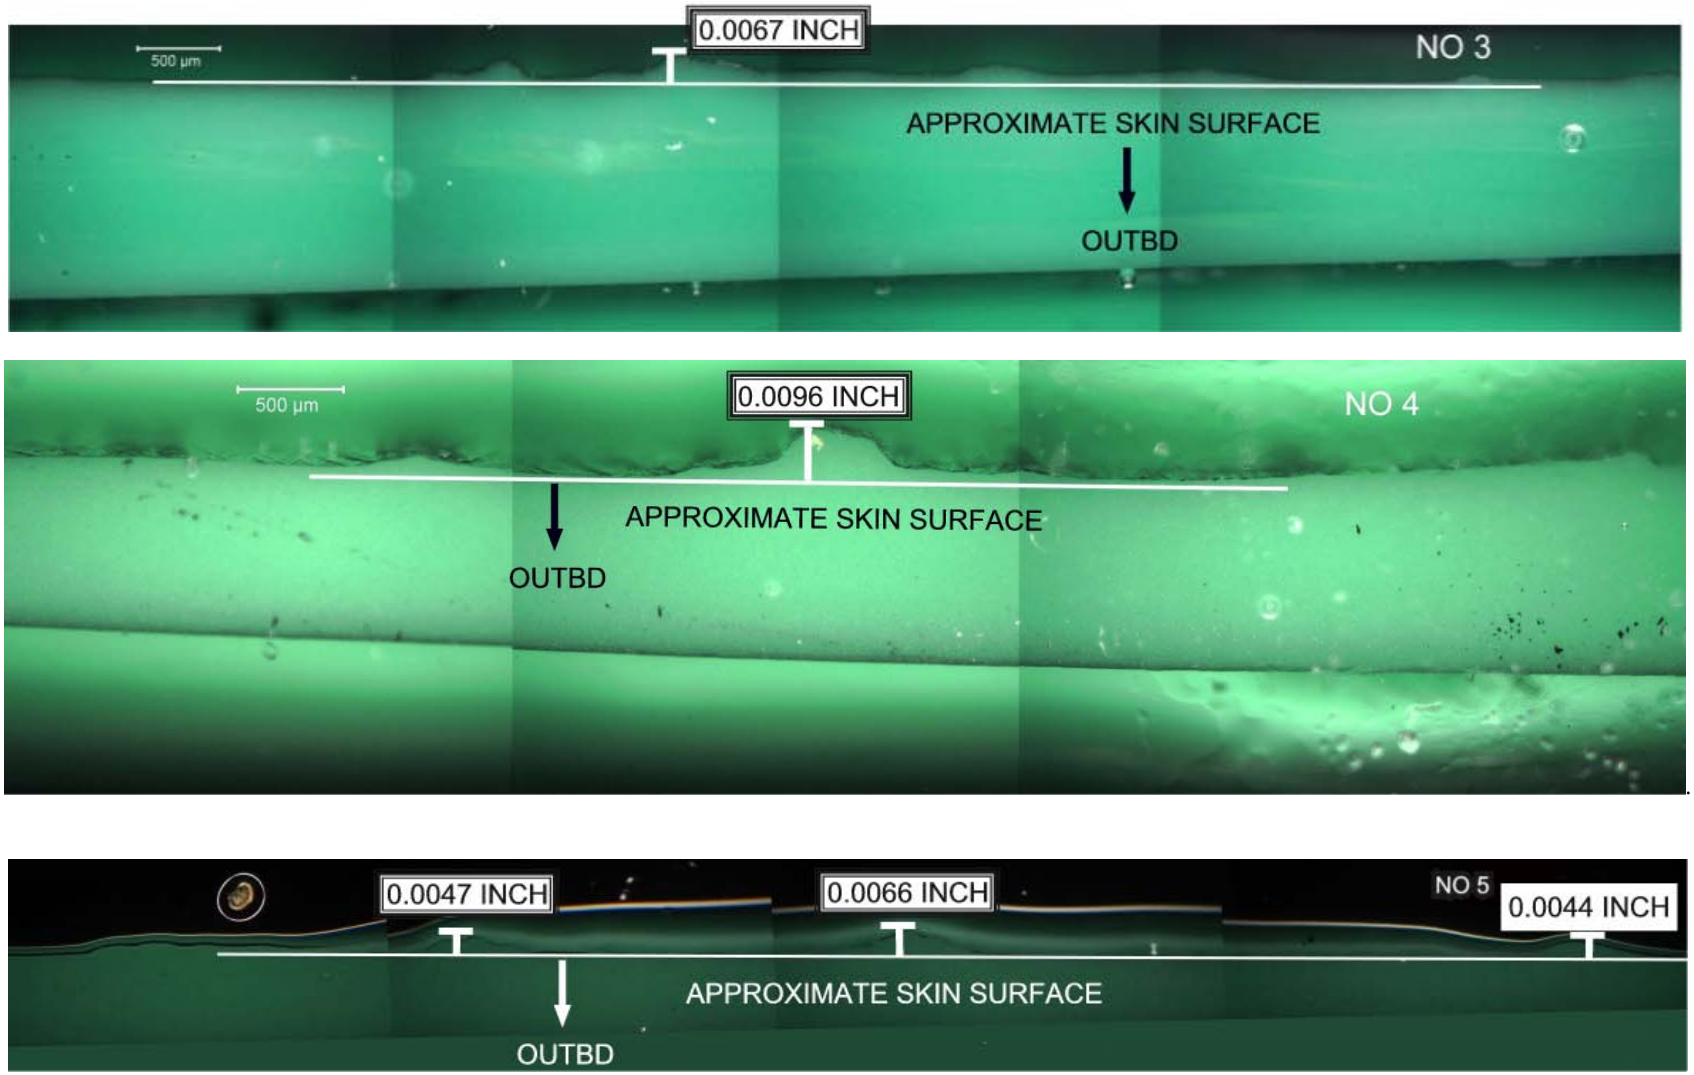
FIGURE 40. SCRATCH PROFILE COMPOSITE PHOTOGRAPHS – Shown above are replicas from locations 3,4, and 5. Location 4 presented the deepest scratch found using this technique.

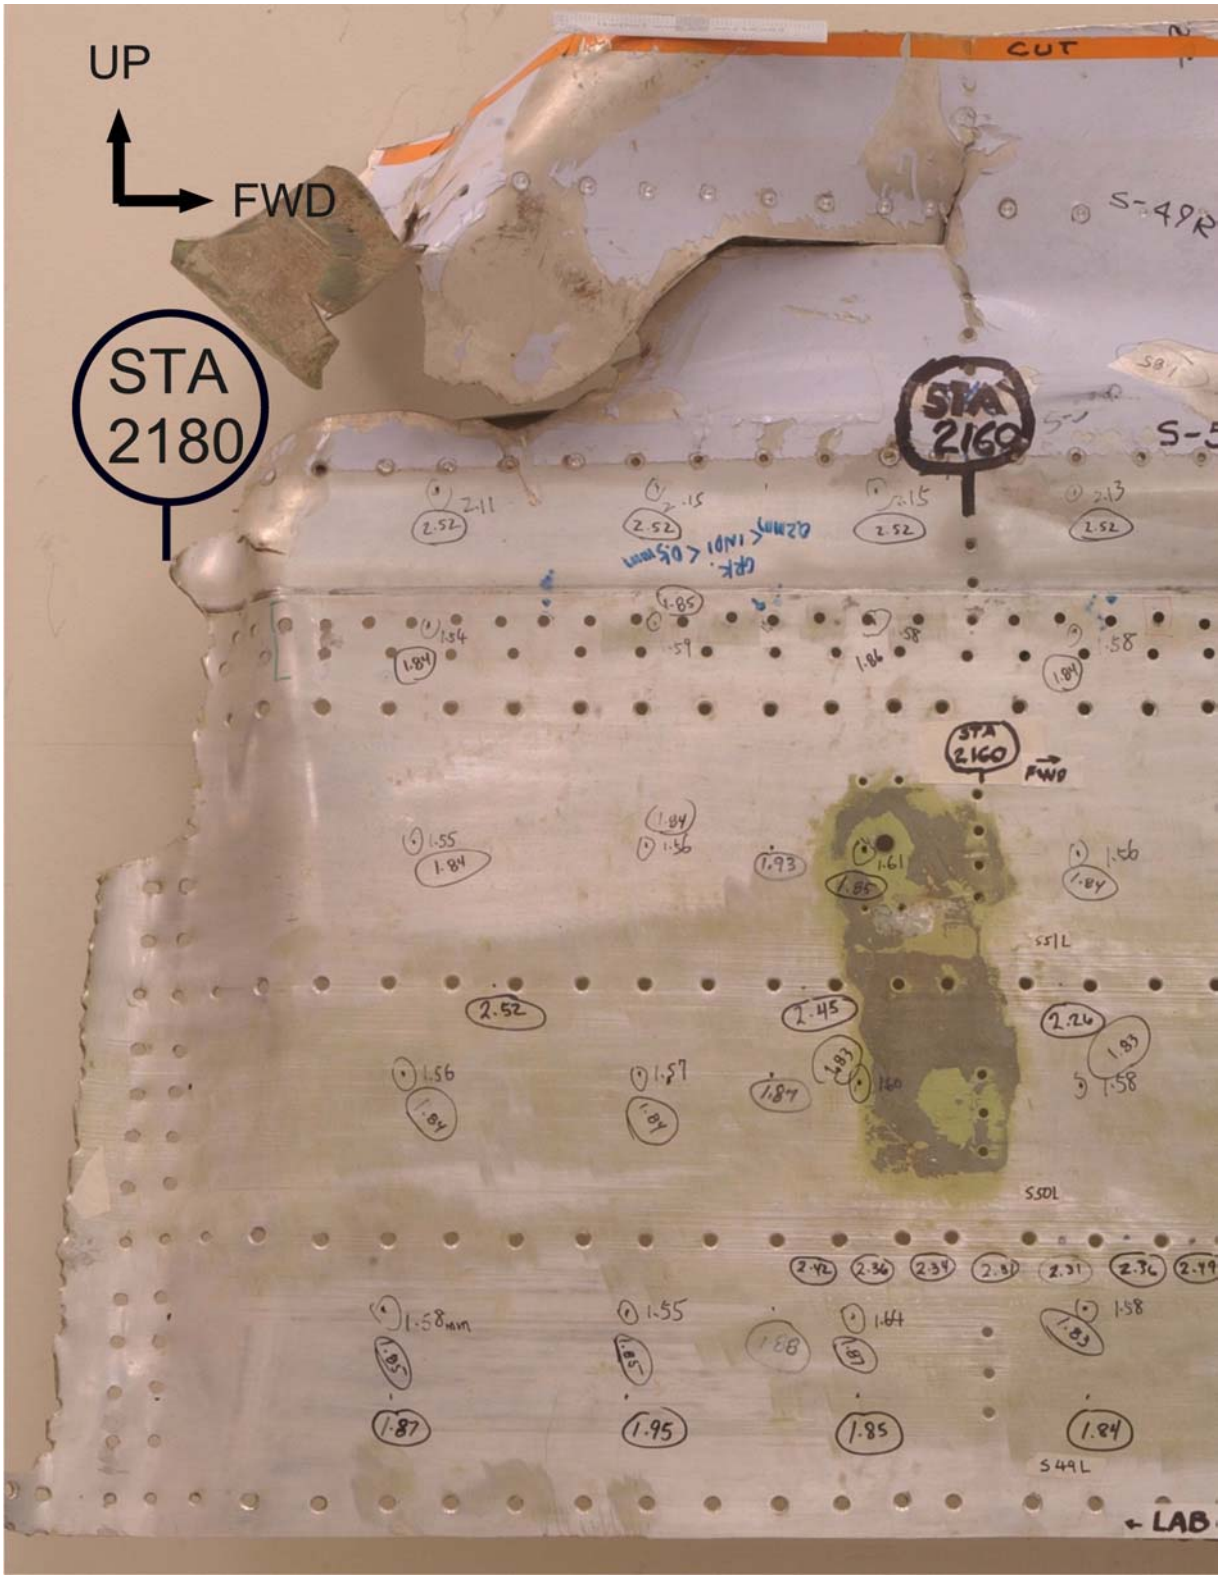
Figure 41. SKIN THICKNESS MEASUREMENTS - All measurements are in millimeters. Circled values were performed at Boeing.

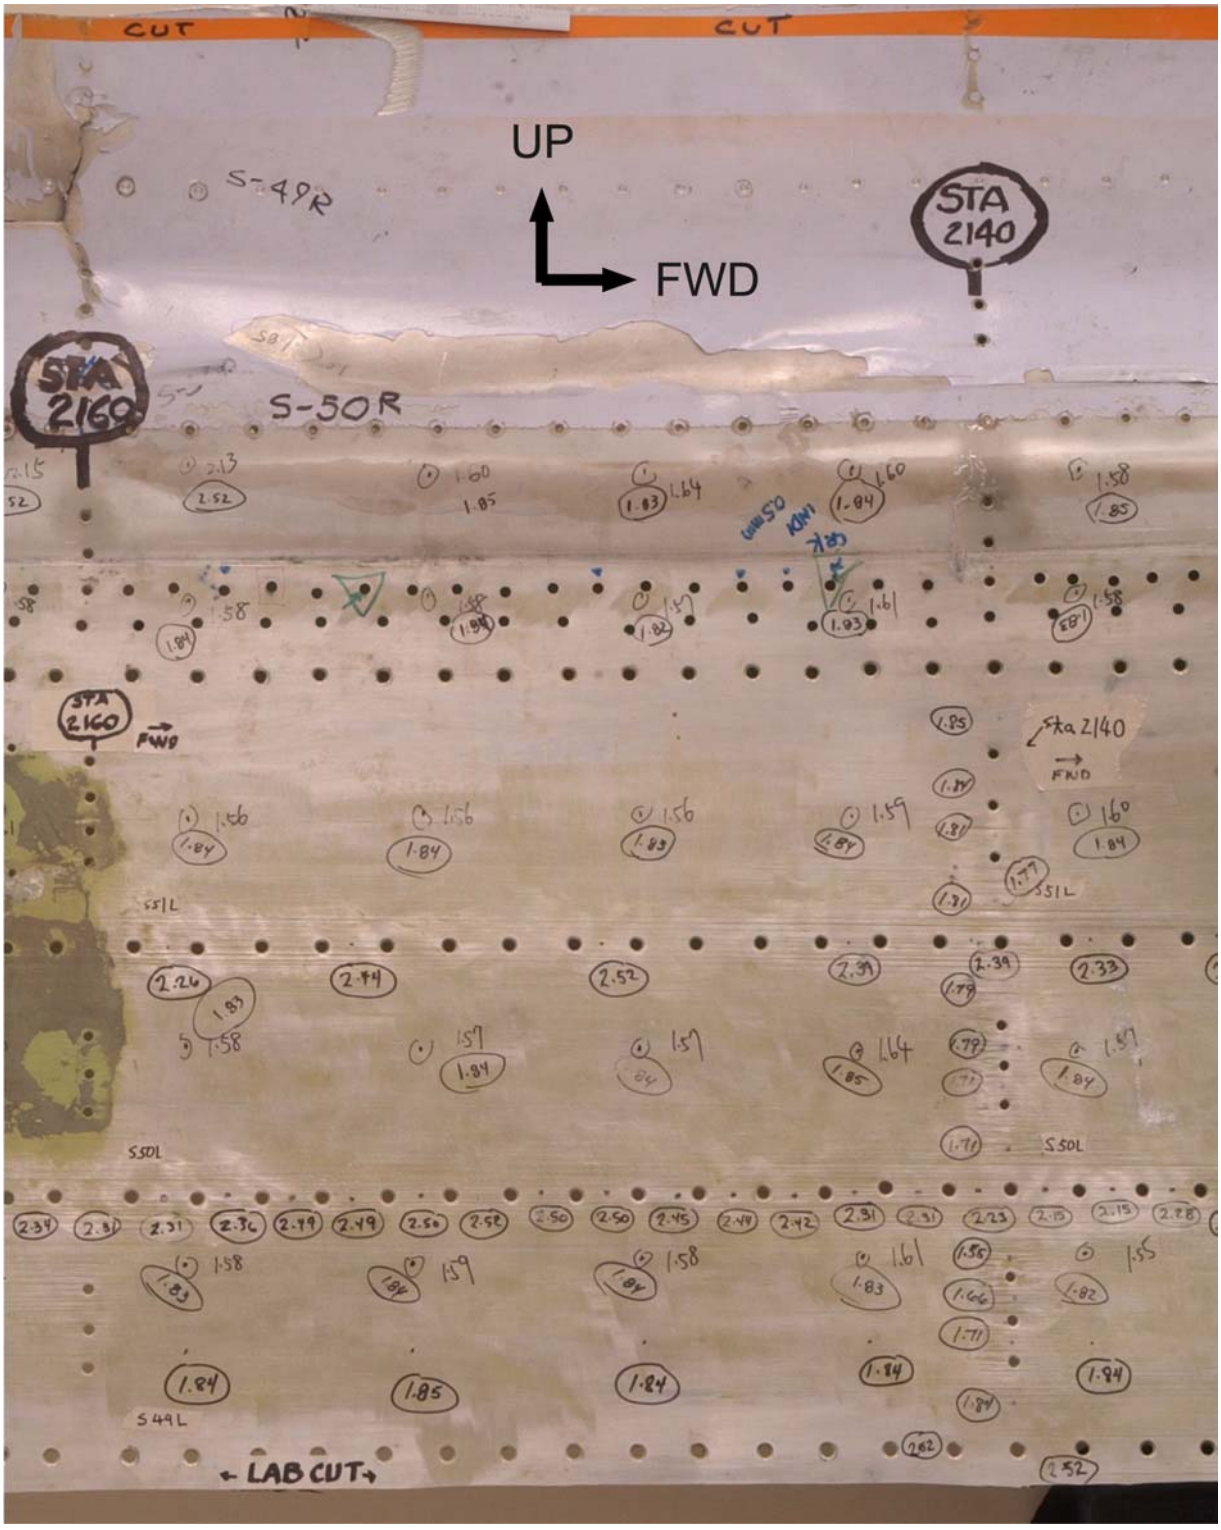
Figure 42. SKIN THICKNESS MEASUREMENTS - All measurements are in millimeters. Circled values were performed at Boeing.

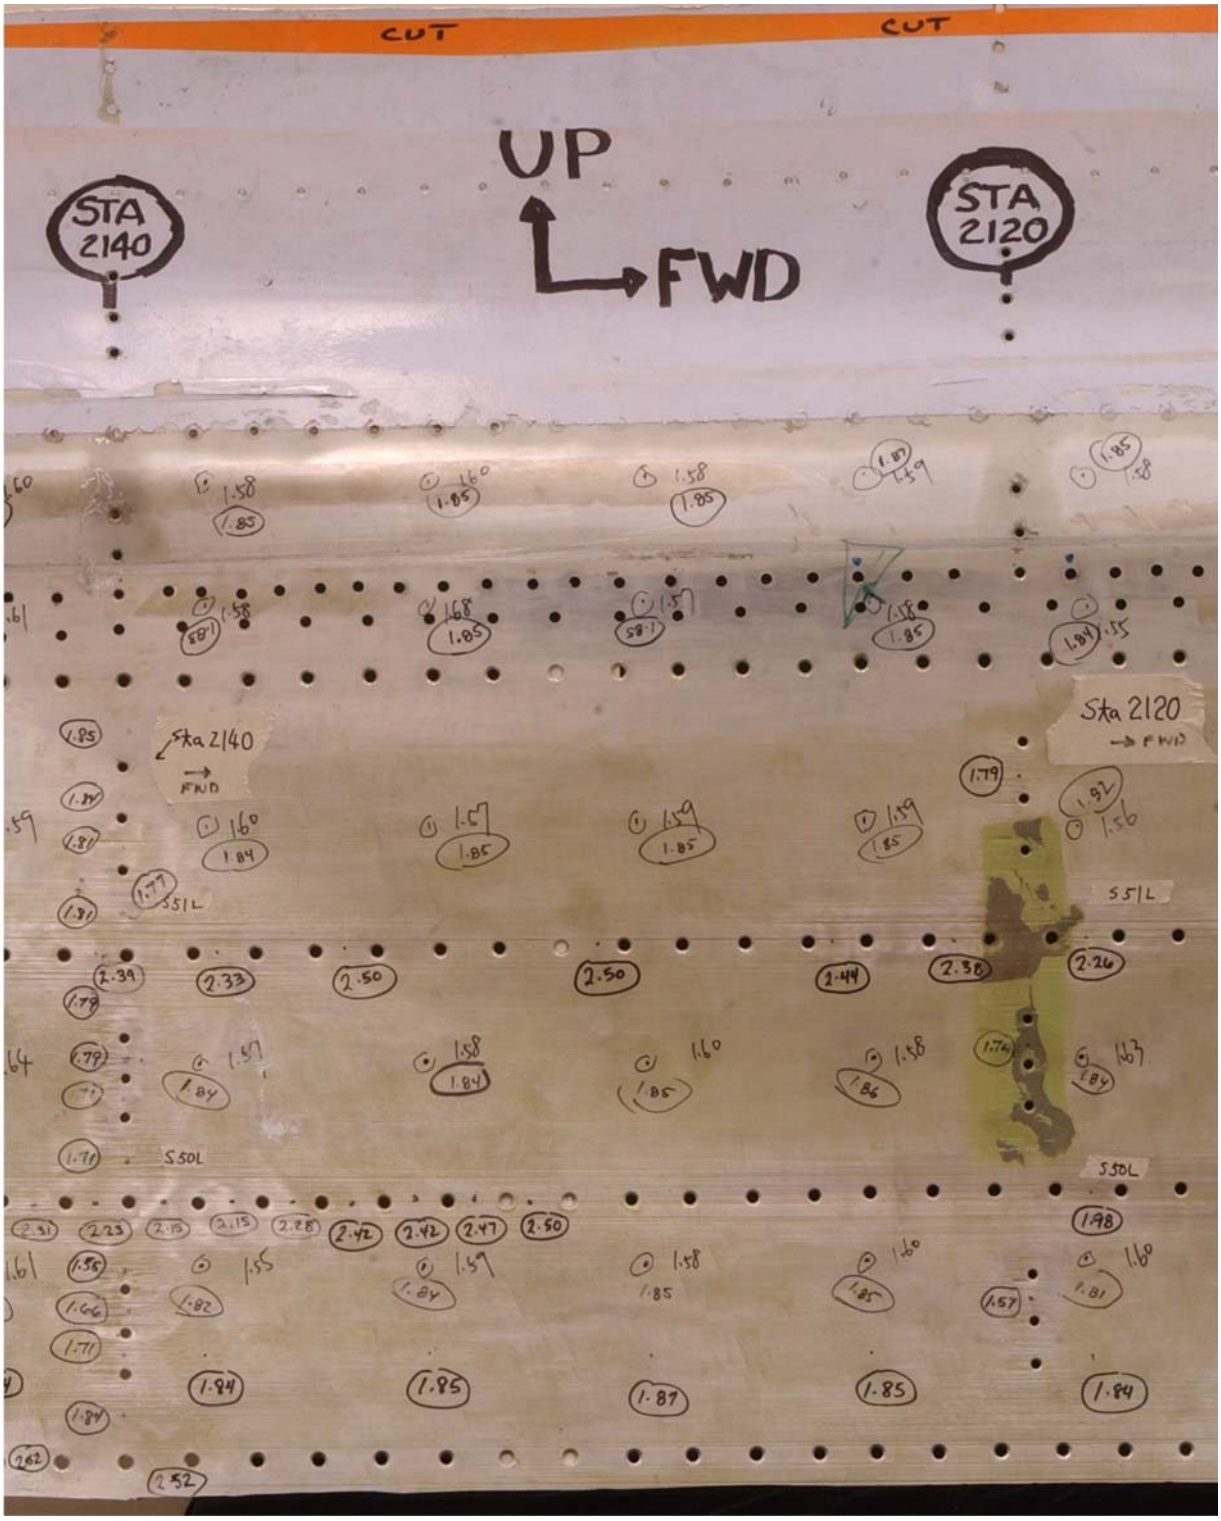
Figure 43. SKIN THICKNESS MEASUREMENTS - All measurements are in millimeters. Circled values were performed at Boeing.

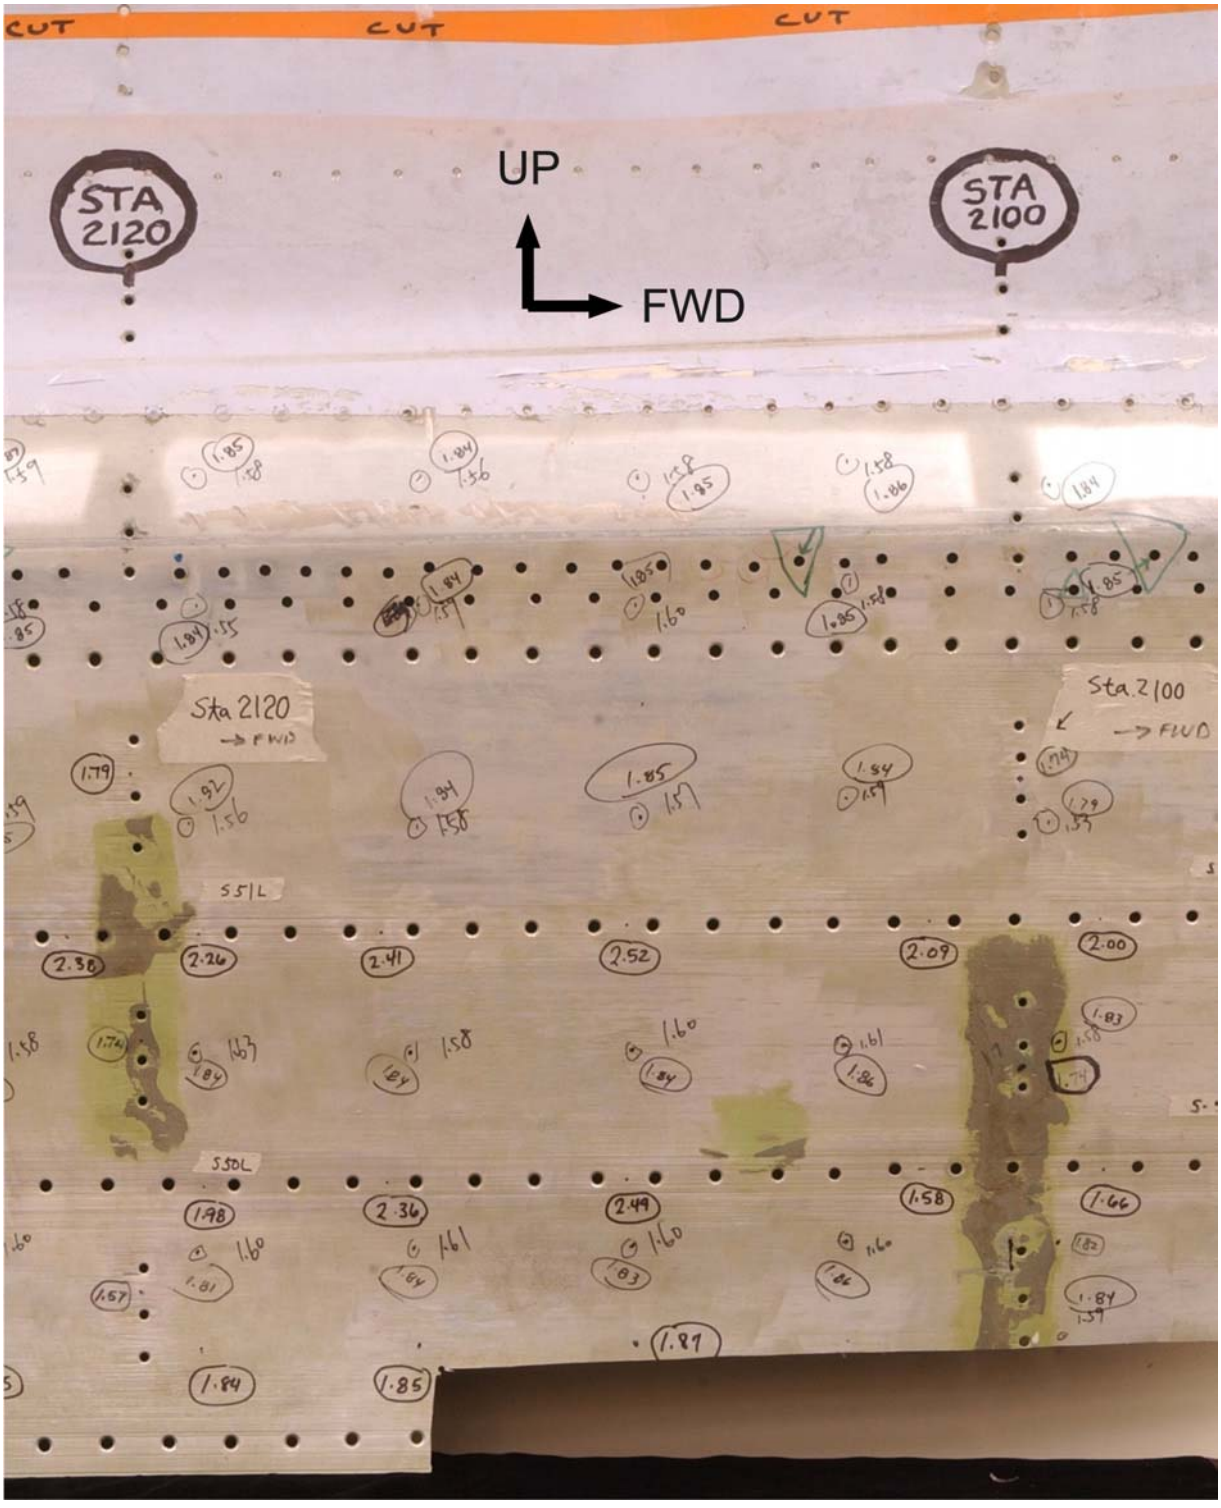
Figure 44. SKIN THICKNESS MEASUREMENTS - All measurements are in millimeters. Circled values were performed at Boeing.

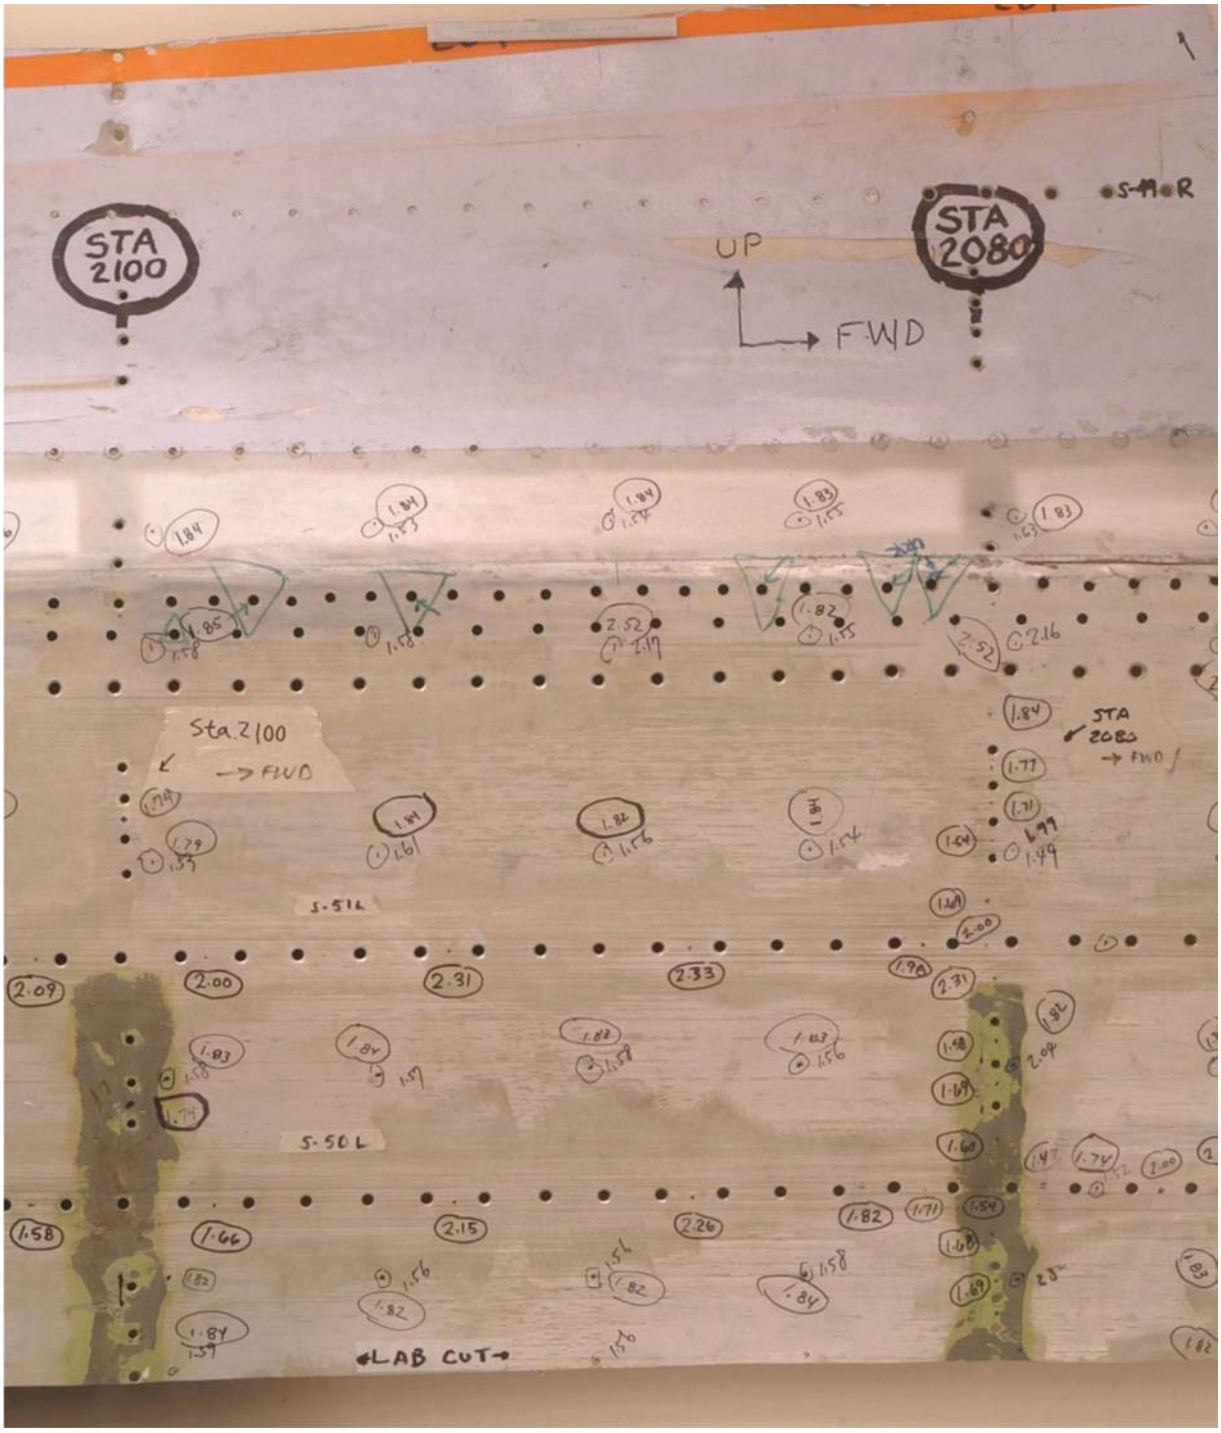
Figure 45. SKIN THICKNESS MEASUREMENTS - All measurements are in millimeters. Circled values were performed at Boeing.

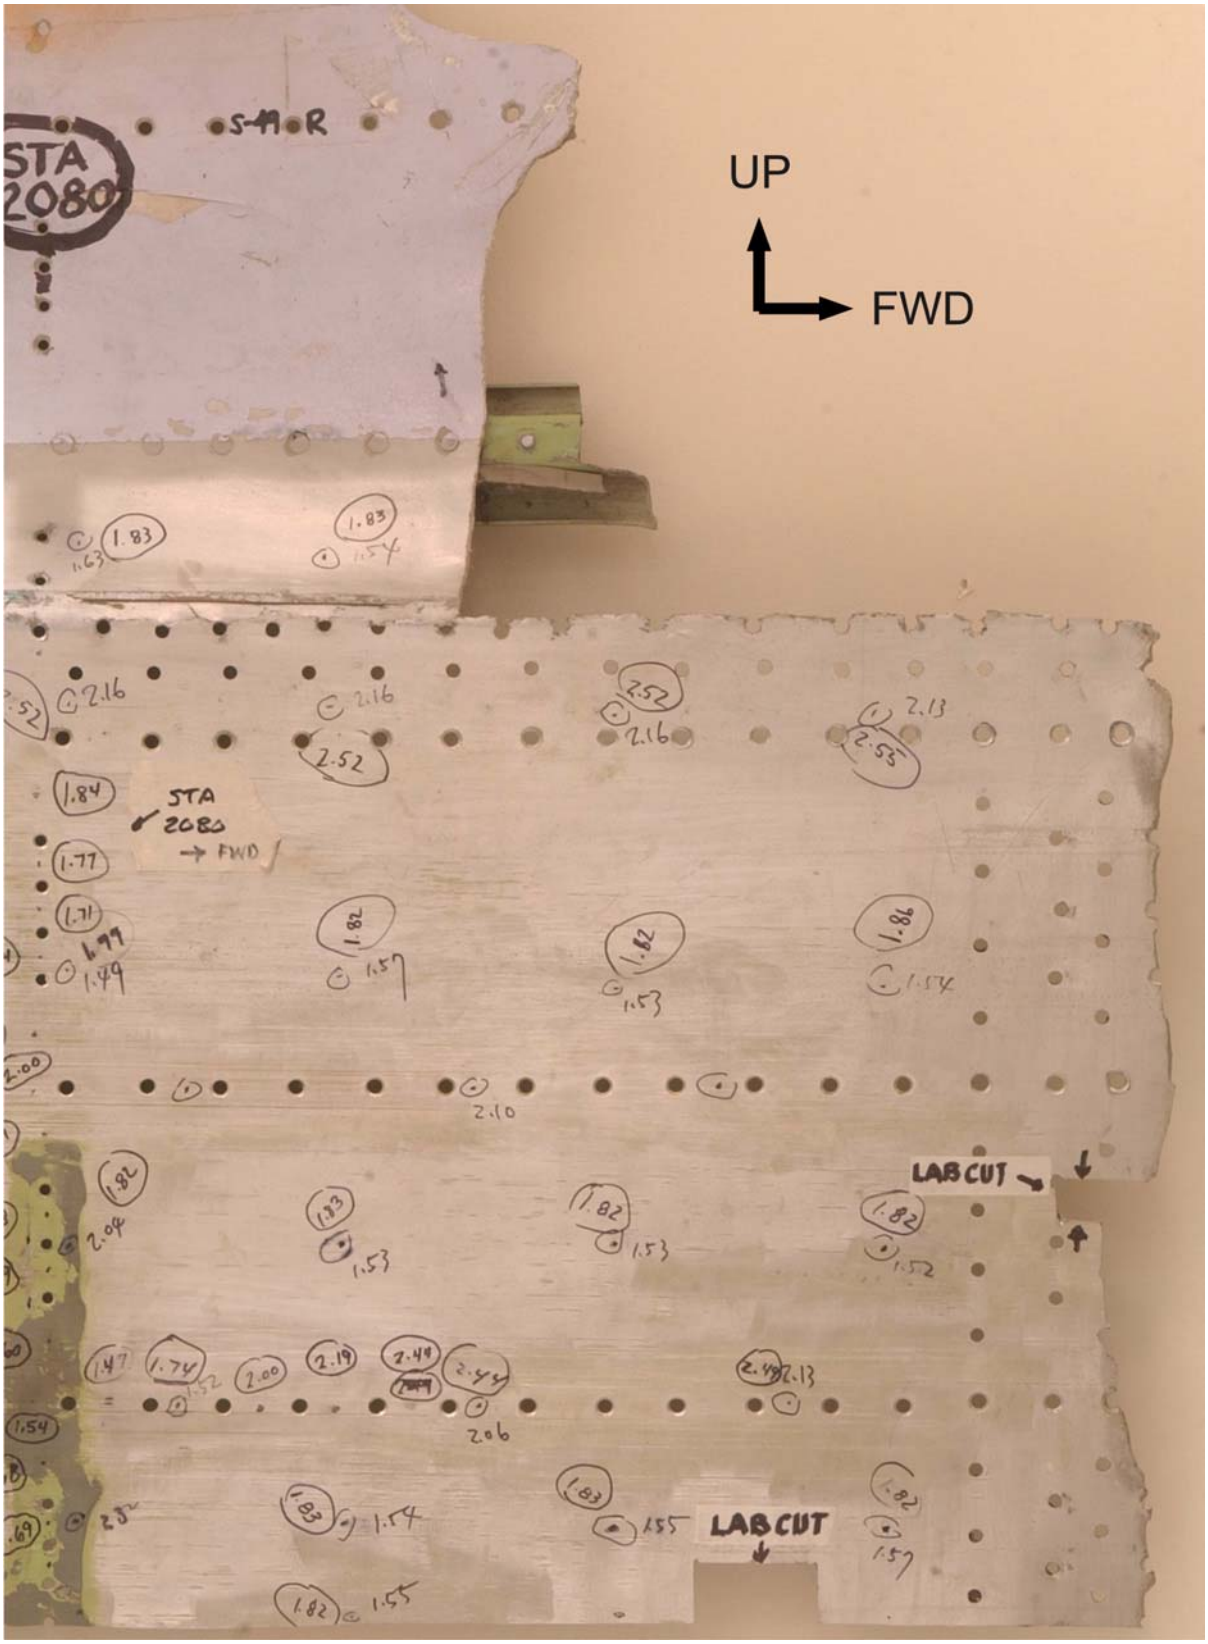
Figure 46. SKIN THICKNESS MEASUREMENTS - All measurements are in millimeters. Circled values were performed at Boeing.
