Aviation Occurrence Report Volume II

ASC-AOR-05-02-001

IN-FLIGHT BREAKUP OVER THE TAIWAN STRAIT

CHINA AIRLINES FLIGHT CI611

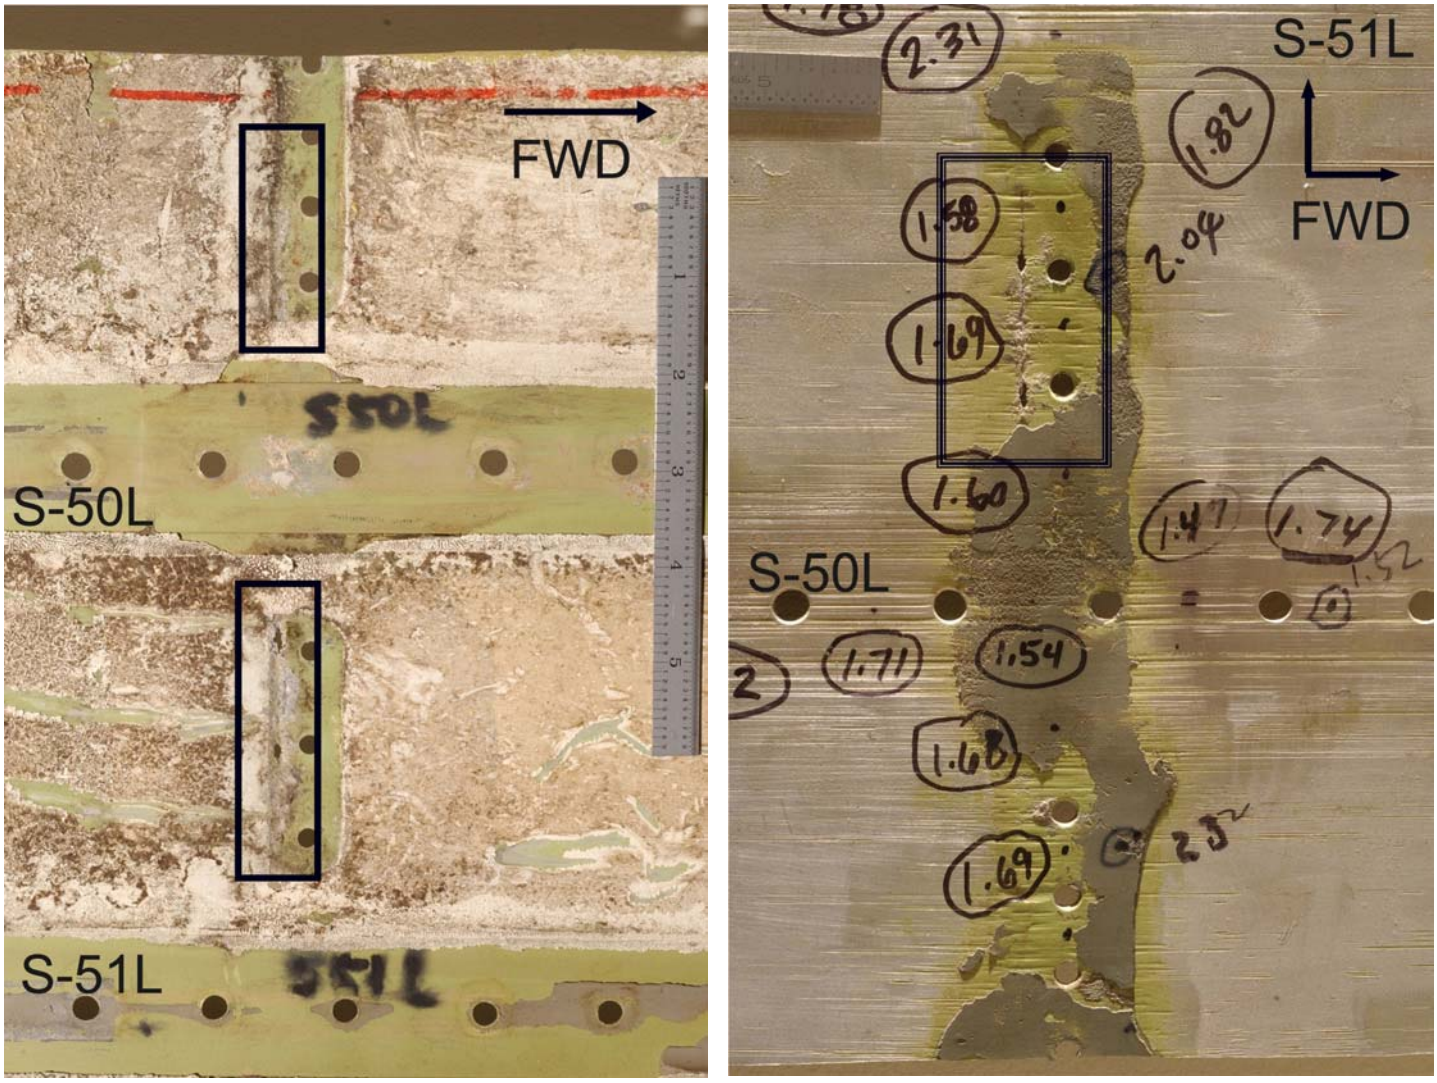
Figure 47. SKIN CORROSION FEATURES AT STA 2080 - Areas of corrosion are identified with rectangles above. Corrosion penetrated completely through the skin thickness at the shear tie located between S-50L and S-51L.

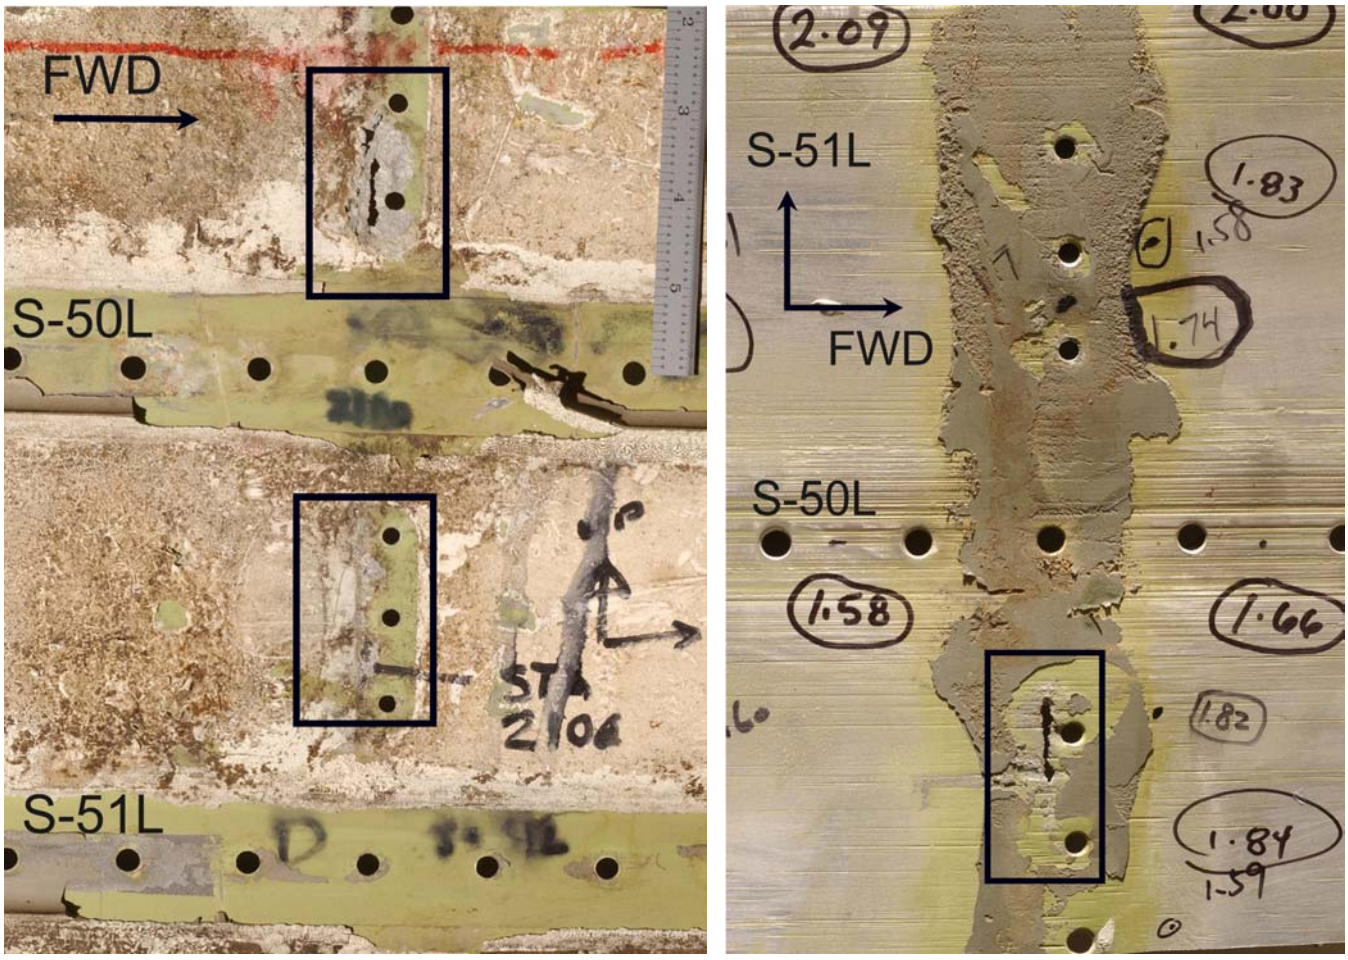
Figure 48. SKIN CORROSION FEATURES AT STA 2100 - Areas of corrosion are highlighted with rectangles. Corrosion penetrated completely through the skin thickness between S-49L and S-50L.

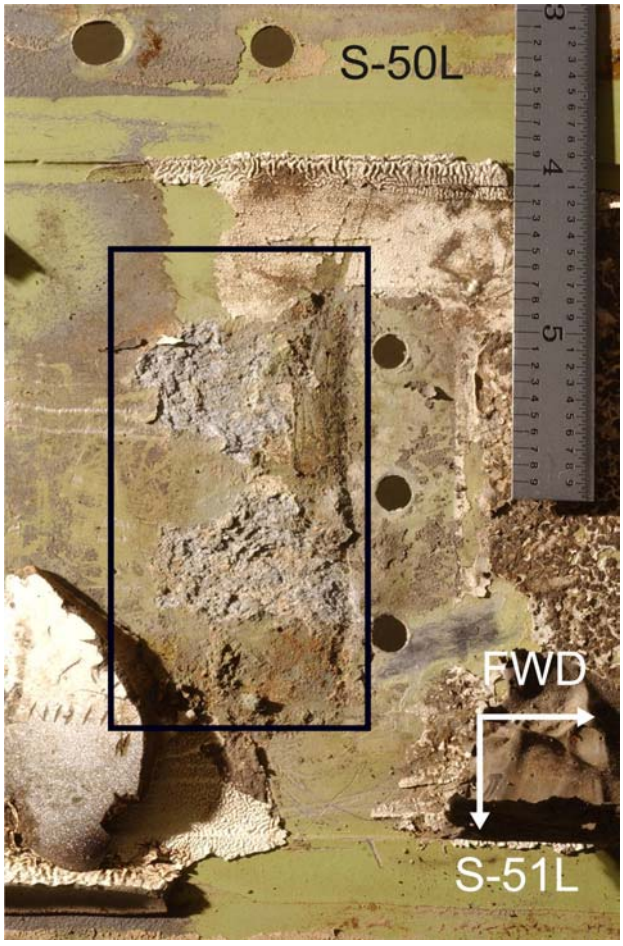
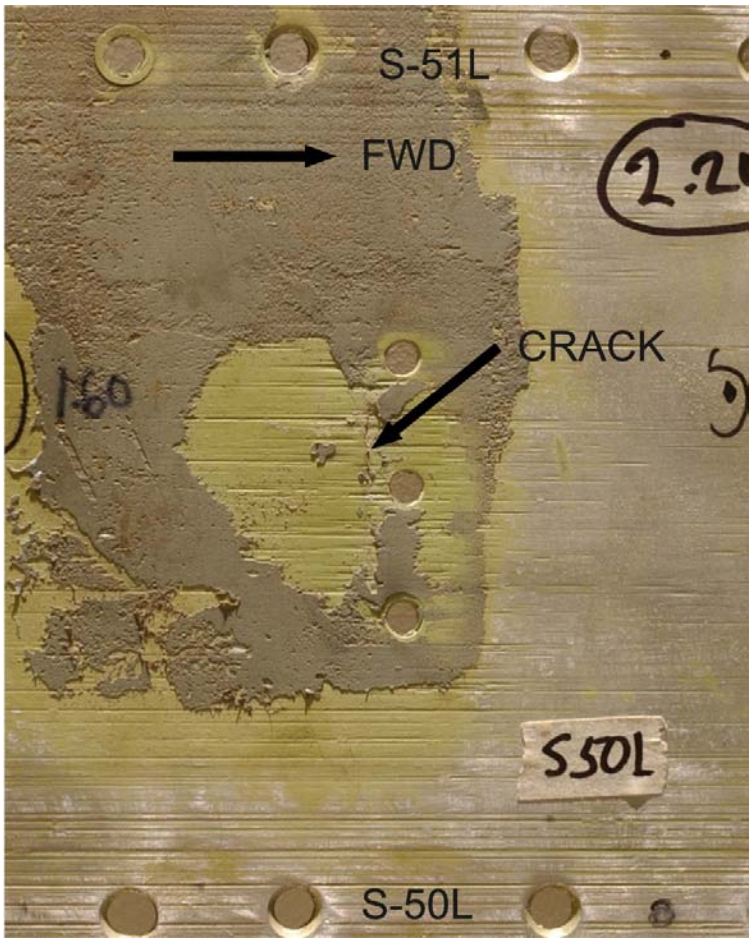
Figure 49. CORROSION FEATURES AT STA 2160, INBOARD SURFACE - The area of corrosion is identified with a rectangle above. A crack noted on the skin faying surface may have been the result of exfoliation corrosion penetrating from the skin inboard surface.

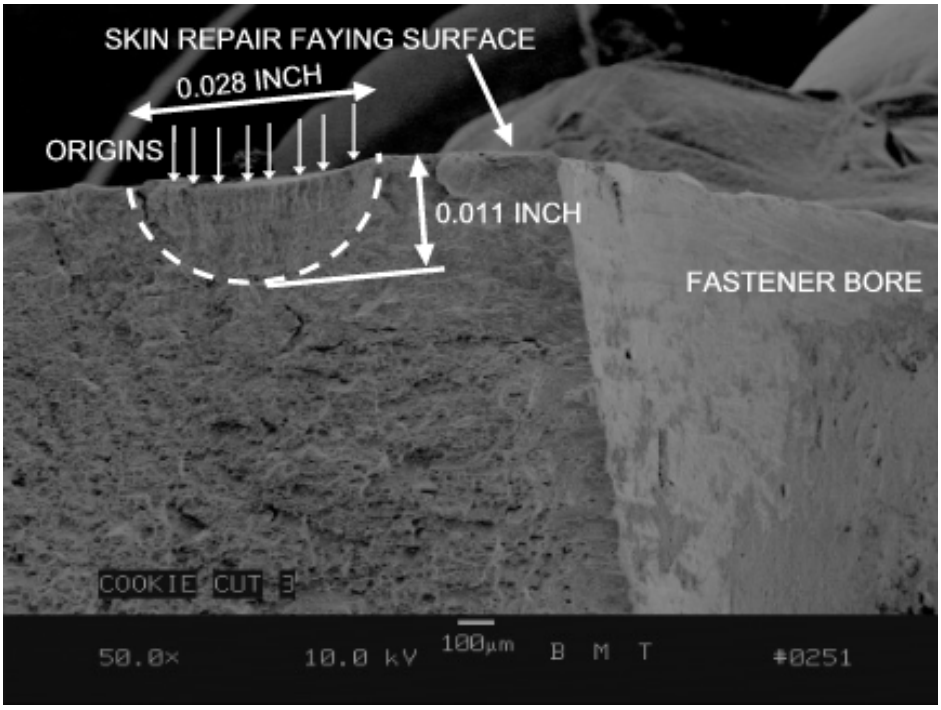
Figure 54. COOKIE CUT # 3 FATIGUE CRACK FEATURES – The extent of fatigue cracking is identified with a dashed line. Multiple fatigue origins are denoted with arrows.

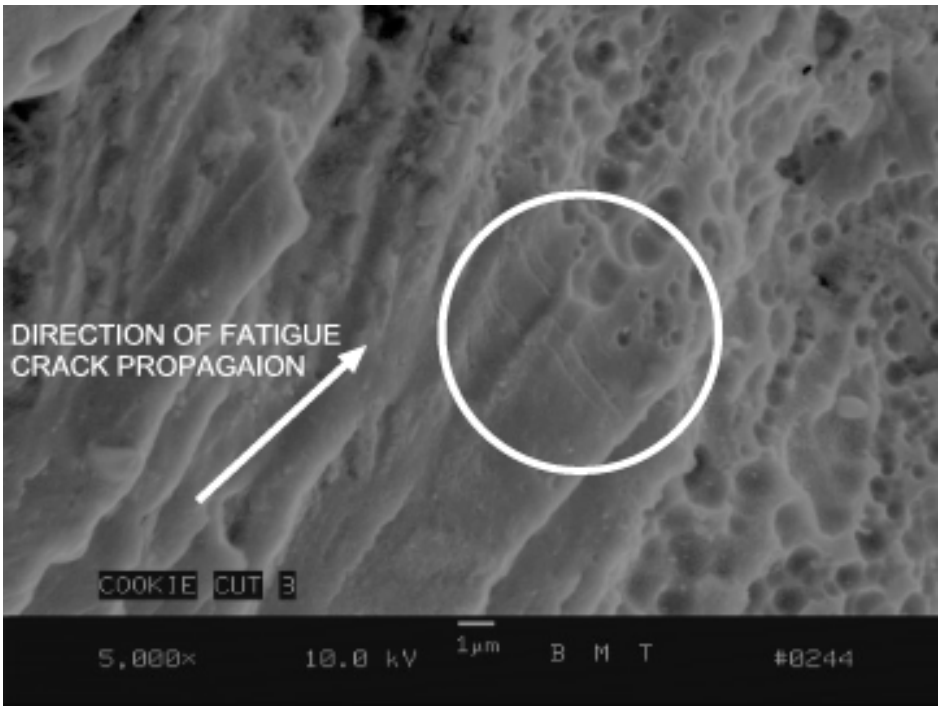
Figure 55. FATIGUE FEATUES FOUND IN CRACK AT COOKIE CUT #3 - Circled area identifies typical fatigue striations characteristic of fuselage pressure cycles observed at the maximum depth of cracking in Cookie Cut #3

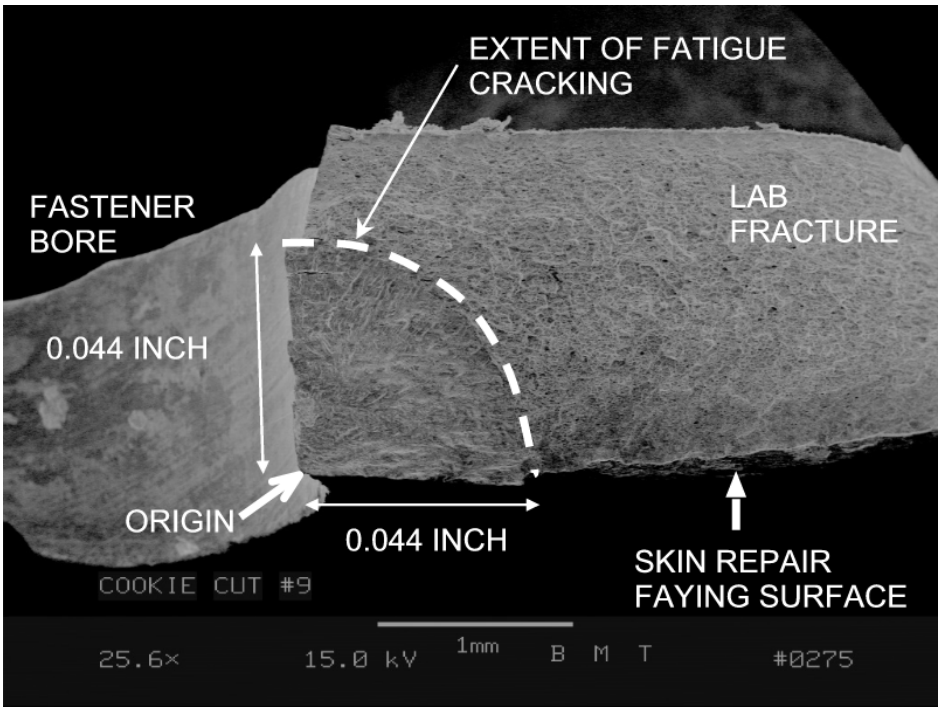
Figure 56. COOKIE CUT #9 FATIGUE CRACK FEATURES - Cracking initiated from the single origin noted above.

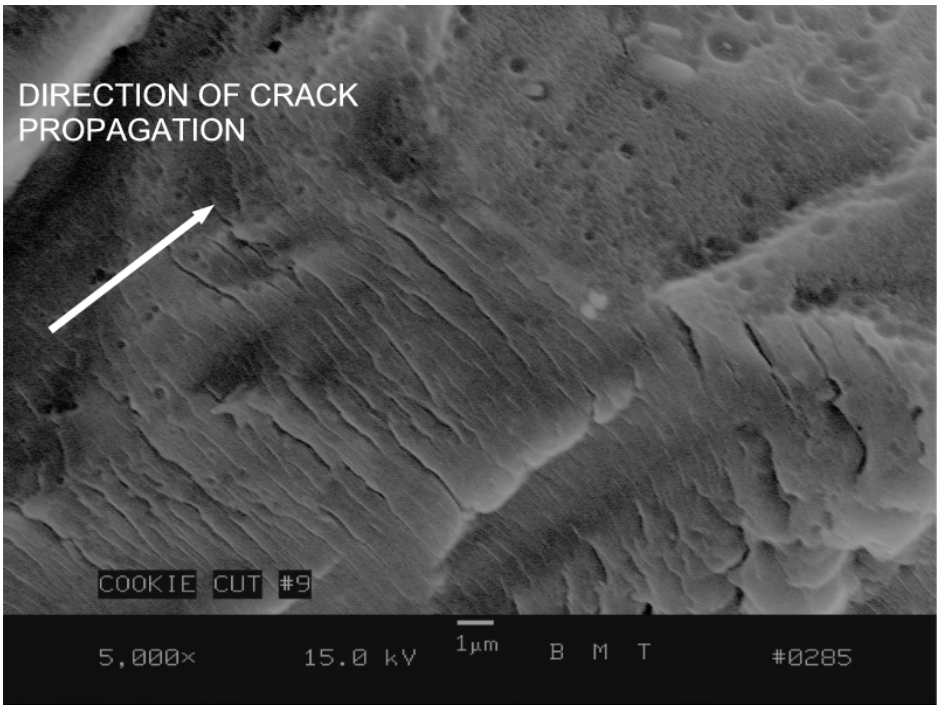
Figure 57. COOKIE CUT #9 FATIGUE STRIATIONS – The above features were located at the maximum extension of the fatigue crack.

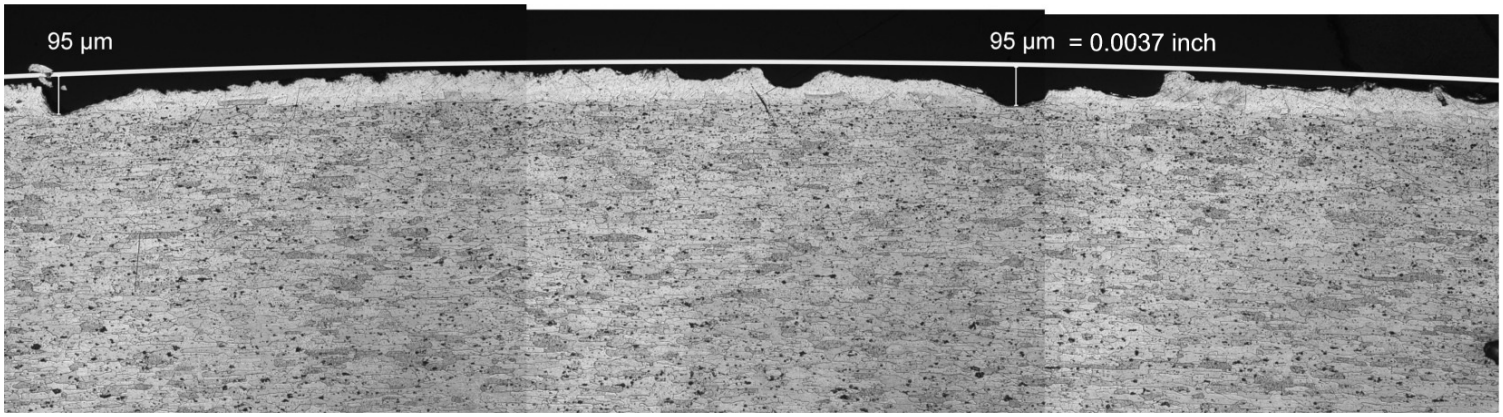
Figure 58. FILLET SEAL SCRATCH FEATURES - These skin surface features were observed at Plane A-A Figure. The clad layer of the skin appears to be penetrated at both measurement locations.

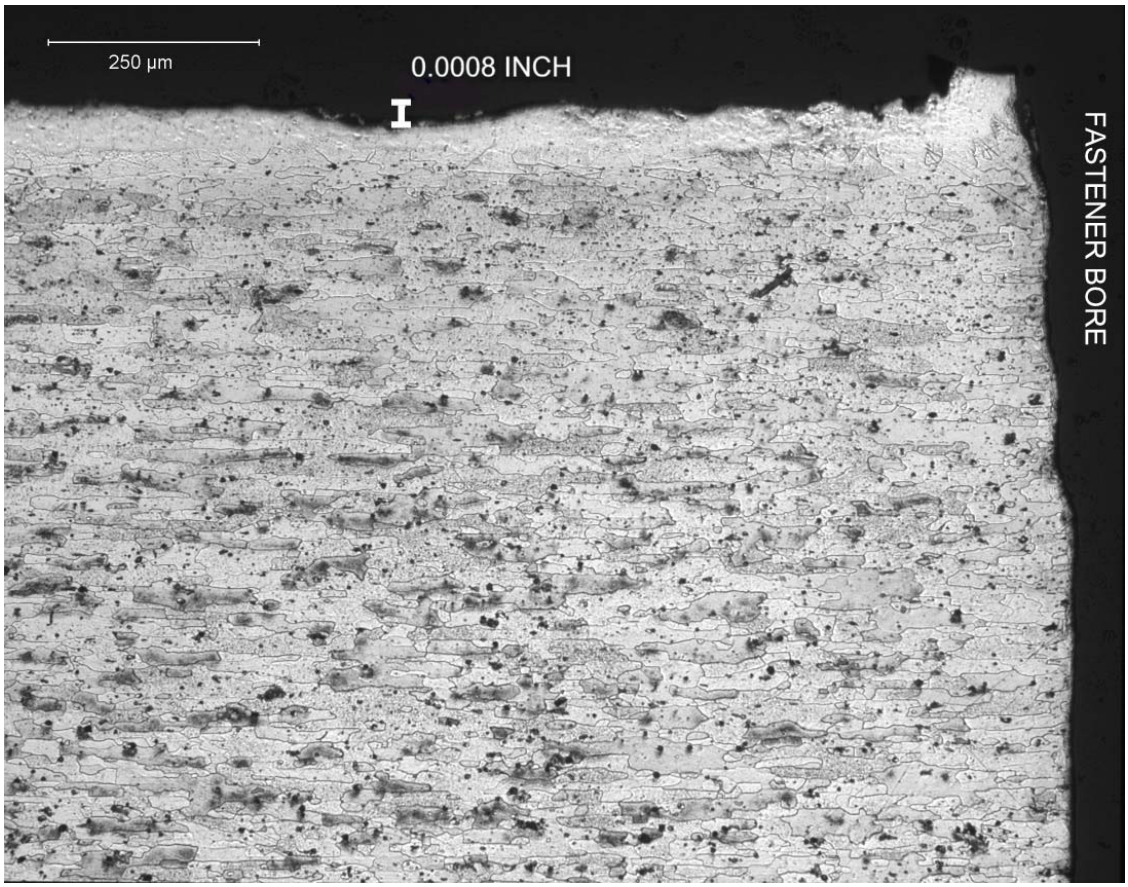
Figure 59. OUTER FASTENER ROW SCRATCH FEATURES AT PLANE A-A – Skin damage at this location was much less severe than on the left hand side of repair doubler. Skin cladding was not compromised by surface damage in this view.

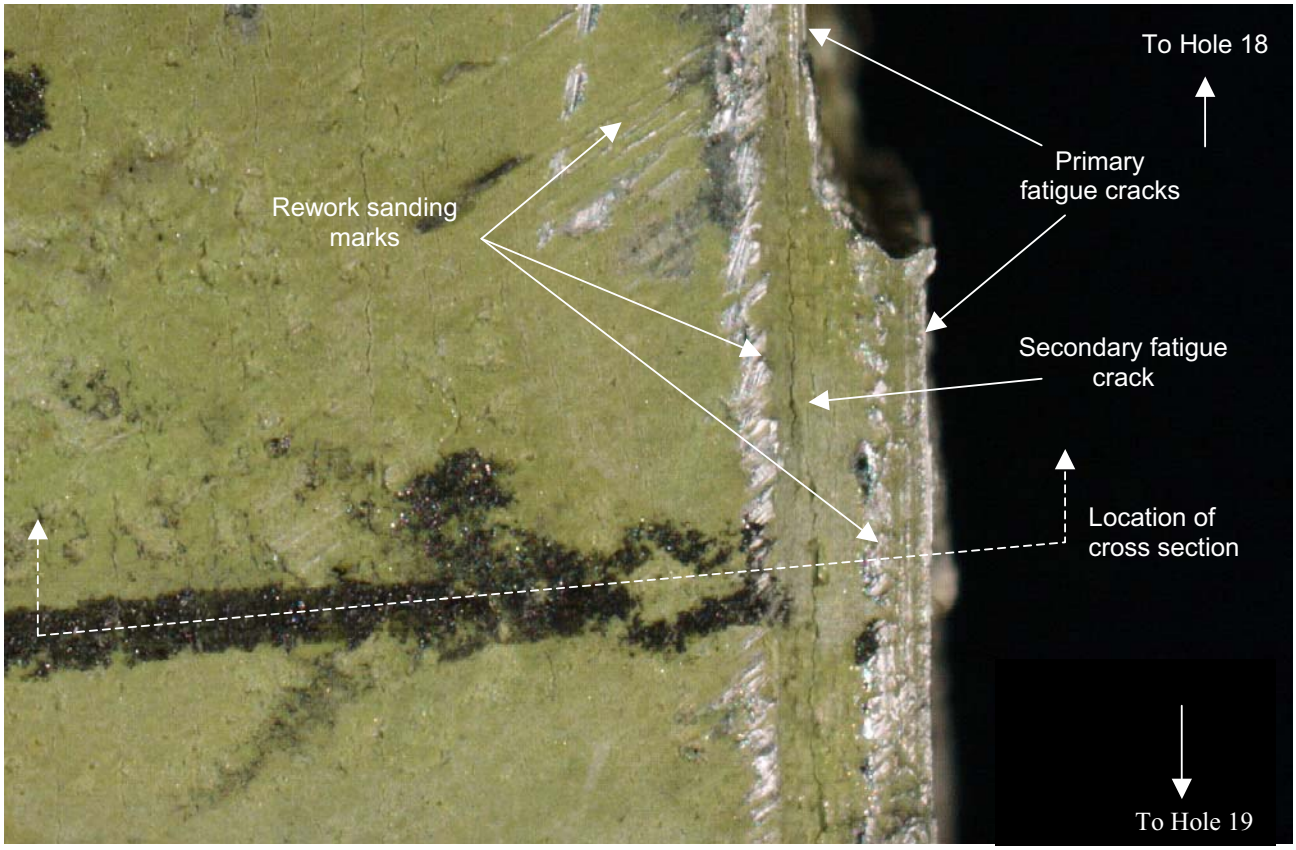
Metallographic specimens were taken through the main fatigue region to characterize the depth and geometry of the longitudinal scratches initiating the through-thickness fatigue cracks. The cross sections were taken in the vicinity of STA 2100 between holes 18 and 19 and between holes 19 and 20. Figure 61 provides the location of the cross section taken between holes 18 and 19. At this location two longitudinal scratches were visible with one being the initiation site for the primary fatigue crack forward of hole 19 and another scratch being the site for initiation of the primary fatigue crack aft of hole 18. A secondary fatigue crack under that primary fatigue crack aft of hole 18 was also present. Evidence of rework blending (sanding) was present in the vicinity of the scratches. To accurately determine the depth of these scratches a line was projected back to an area of undisturbed clad material. At this location the depth of the scratches measured from 0.0043 inch (110 microns) to 0.0046 inch (118 microns) (see Figure 62). The cross section taken between hole 19 and 20 represented an area with a number of scratches where the primary fatigue crack aft of hole 20 and secondary fatigue crack initiated. Figure 63 provides the location where the cross section was taken. Rework sanding was also present at this location and therefore a similar projection technique was employed to accurately determine the depth of the scratches in this area. The depth of scratches ranged from 0.0056 inch (143 microns) at the primary fatigue crack to 0.0025 inch (63 microns) at the secondary fatigue crack origin (see Figure 64)

Figure 61.Location of cross section taken to characterize the scratch depth and geometry in the main fatigue region between holes 18 and 19.

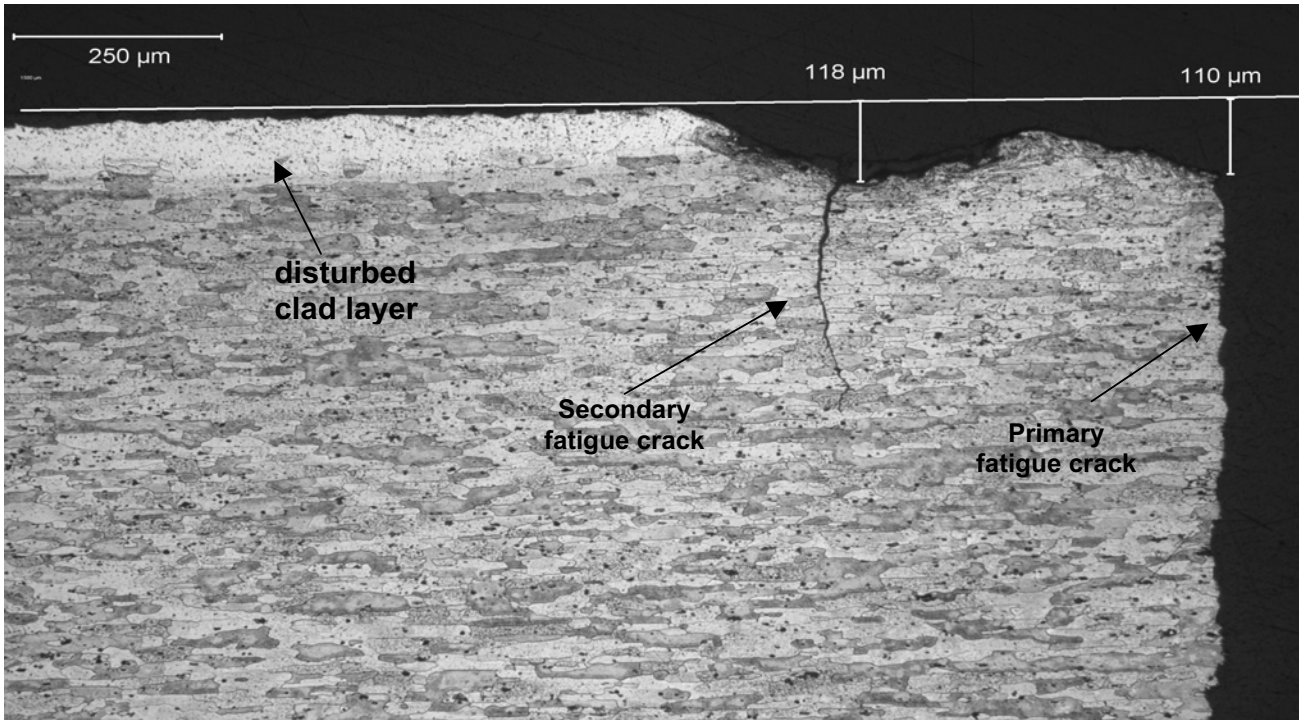
Figure 62. Metallographic specimen through the area indicated in Figure 61 above. The line shown was projected back to an area of undisturbed clad material to determine the depth of the scratches at the primary and secondary fatigue cracks present in this area.

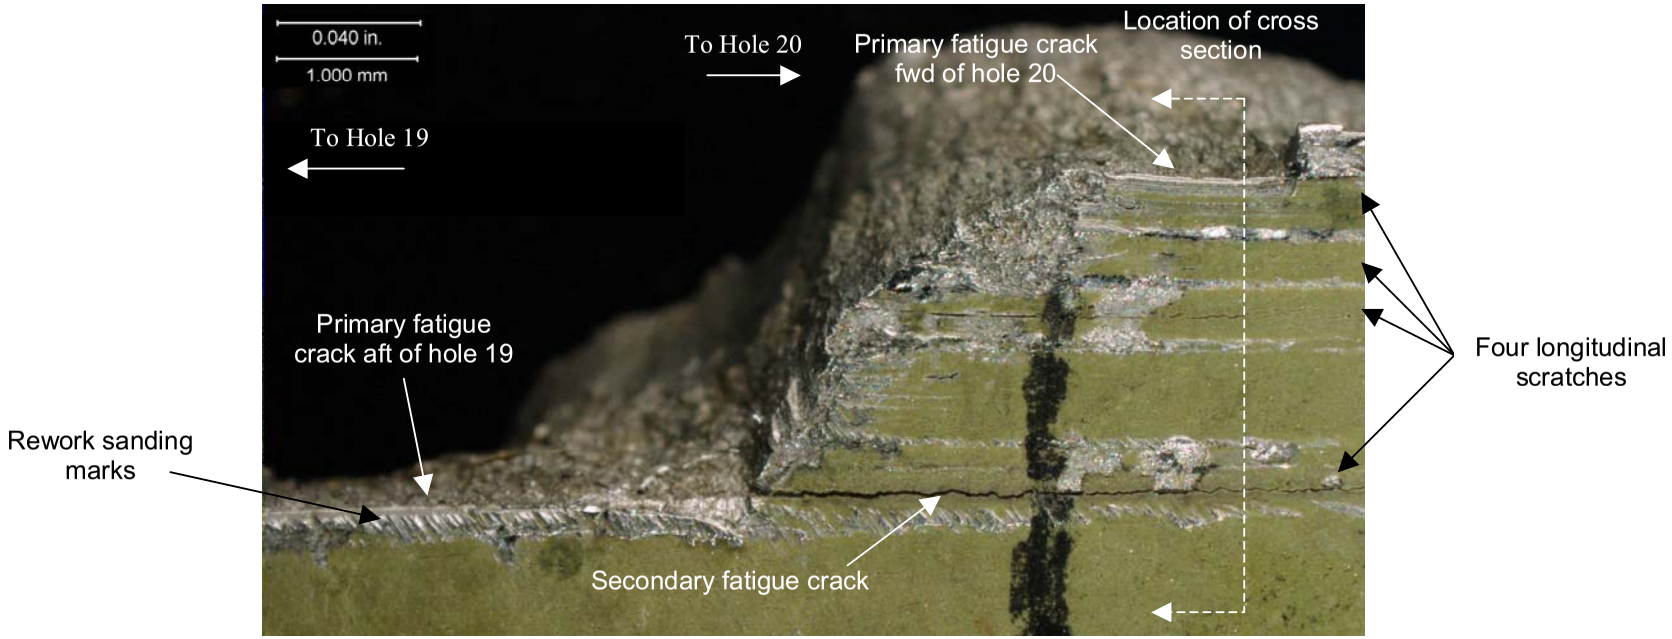
Figure 63.
Location of cross section taken to characterize the scratch depth and in the main fatigue region between holes 19 and 20.

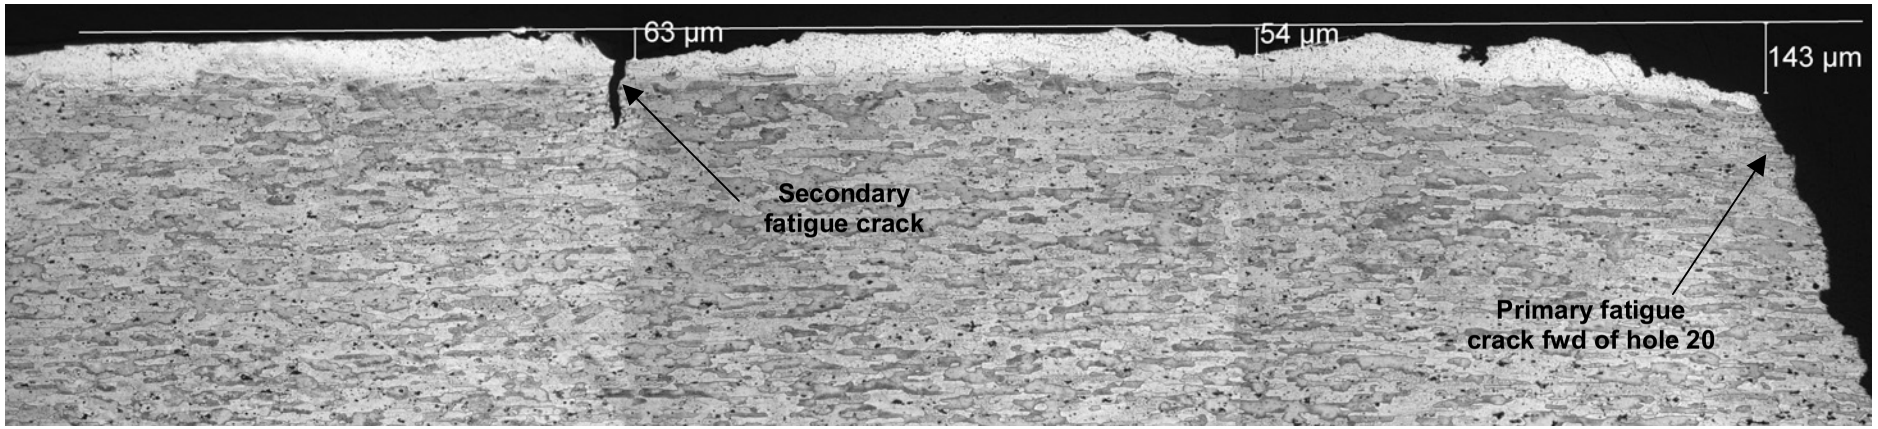
Figure 64.
Metallographic montage through the area indicated in Figure 63 above. The line shown was projected back to an area of undisturbed clad material to determine the depth of the scratches at the primary and secondary fatigue cracks present in this area.

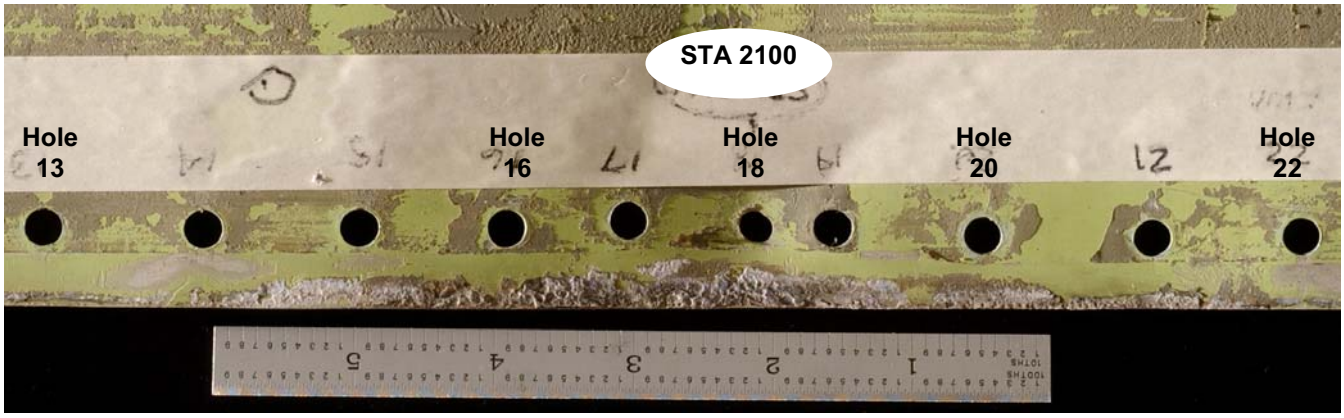
Visual examination revealed a light colored deposit on the overhanging portion of the faying surface of the doubler (mating surface with skin) above the fracture surface at S-49L. Low power optical examination of this area revealed that this light colored deposit had a similar appearance to the light blue exterior paint applied to the doubler. This light colored deposit was on top of what appeared to be the sealant used during installation of the doubler to the skin. The deposit was present between holes 10 and 25 with the largest area observed between holes 14 and 22 (see Figures 65 and 66). Two samples of this deposit were removed in the vicinity of hole 18 (STA 2100) and subjected to organic analysis utilizing Fourier Transform Infrared Spectroscopy (FT-IR). A sample of the exterior paint on the doubler was also removed as well as the sealant on the faying surface for baseline comparisons. FT-IR analysis of the deposit revealed that the spectra of the light colored deposit was an excellent match to the reference light blue exterior paint on the doubler (see Figure 67). Optical examination of the deposits showed that the paint had cured in place and therefore must have flowed between the doubler and skin while wet. As noted in the CSIST report the doubler in the vicinity STA 2100 was deformed locally in an outward direction with the fractured skin. This observation, along with the confirmation of paint on the doubler faying surface at STA 2100, would suggest that the doubler was displaced from the unrecovered portion of the skin during the last repaint of the airplane. As was previously noted, the main fatigue crack was centered about STA 2100 from hole 10 to 25.

Figure 65.
Faying surface of doubler with skin showing the light colored deposit present from hole 14 to 22.

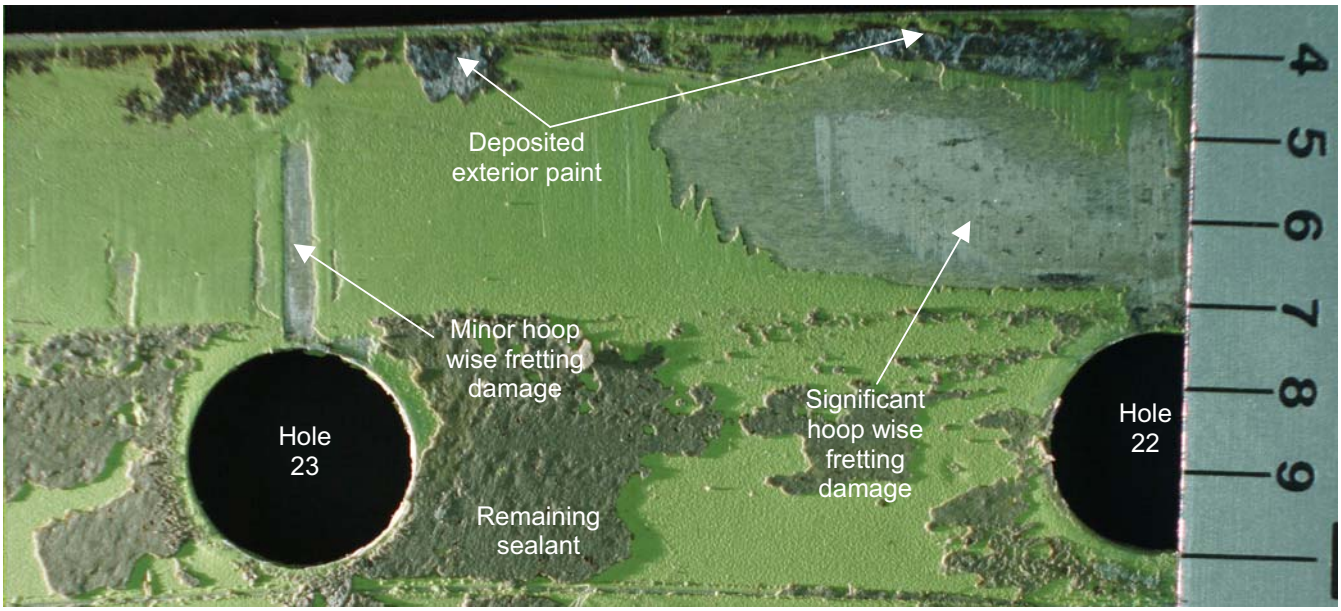
Figure 69.
Faying surface of the doubler showing an example of minor fretting at the 12:00 clock position of hole 23 and significant fretting at the 10:00 to 12:00 clock position of hole 22. Note the presence of deposited paint near the edge of the doubler.

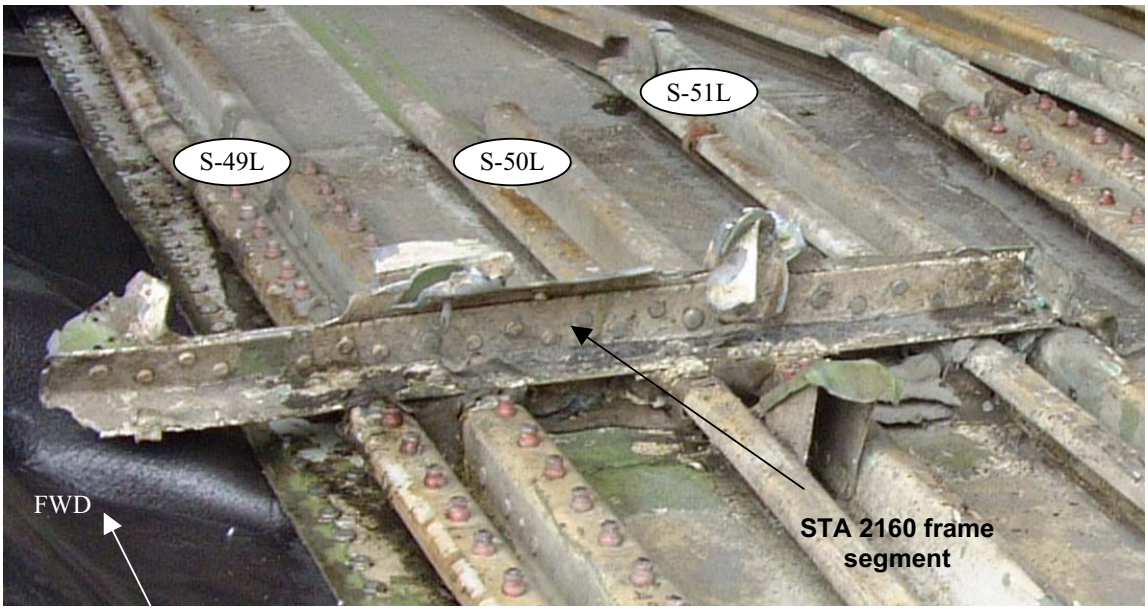
This frame segment was part of the recovered item 640C1 skin panel and was removed during disassembly at the CSIST laboratory (see Figure 70). The overall condition of the submitted frame segment as received by BMT is shown in Figures 71 and 72. The frame segment contained three shear ties, the failsafe chord, a portion of a stringer clip and a portion of the web. A repair existed at the shear tie between S-51L and S-50L. The repaired shear tie exhibited no corrosion, however, the mating interior surface of the fuselage skin as previously described in Figure 49 displayed two pockets of exfoliation corrosion with corresponding cracks visible on the exterior surface of the original skin (faying surface with repair doubler). A significant lump of sealant was found attached to the aft side of the shear tie free flange and skin flange. An impression of the skin corrosion was evident in the surface of the sealant faying with the interior surface of the skin. The shear tie between S-50L and S-49L was heavily corroded with no remaining skin flange attachment provided for examination. The associated mating interior surface of the fuselage skin displayed no evidence of corrosion. The shear tie between S-49L and S-48L was heavily corroded with no remaining skin flange attachment. The skin at this location was free of corrosion on the interior surface mating with the shear tie skin flange, however this represents only a small portion of the mating interior surface. The rest of associated mating interior surface has not been recovered to date.

Figure 70.
Condition of the STA 2160 frame segment prior to disassembly from the Item 640C1 skin panel at the CSIST.

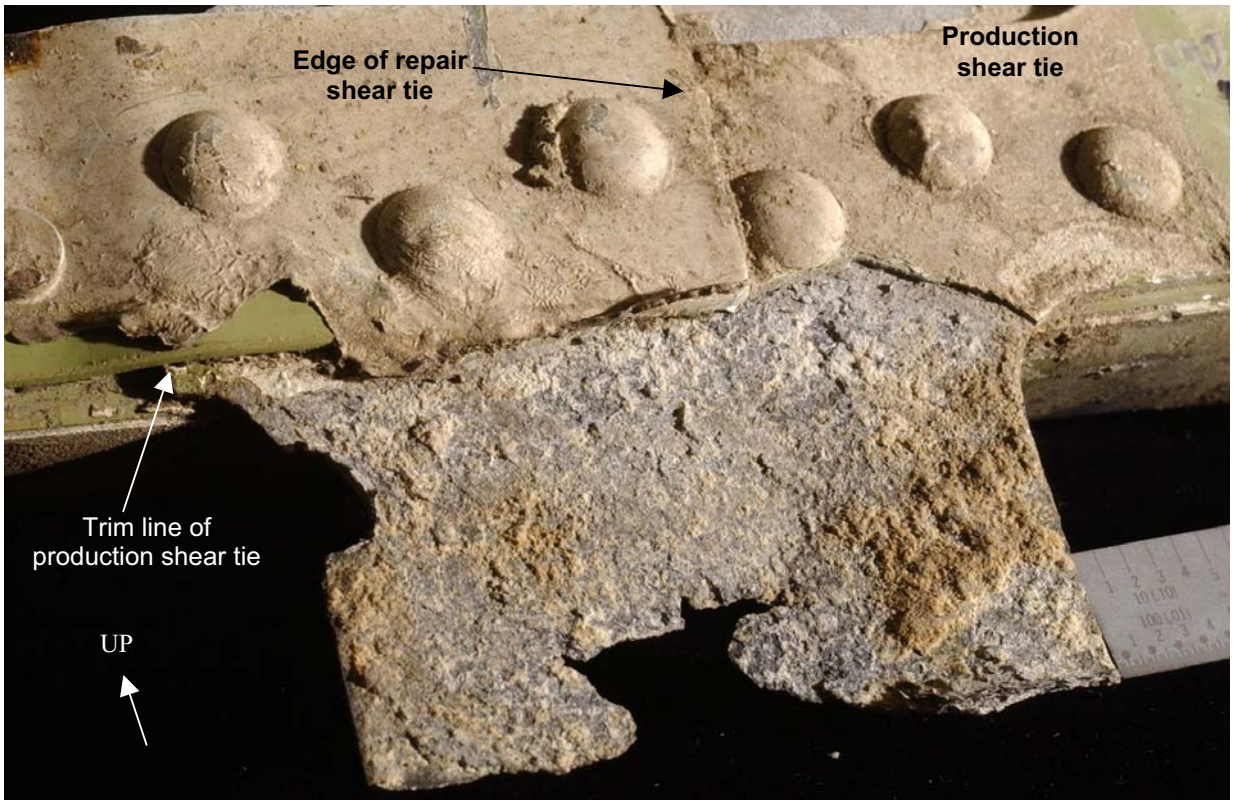
Figure 73.
Exfoliation corrosion present at shear tie between S-50L and S-49L of STA 2160 frame segment.

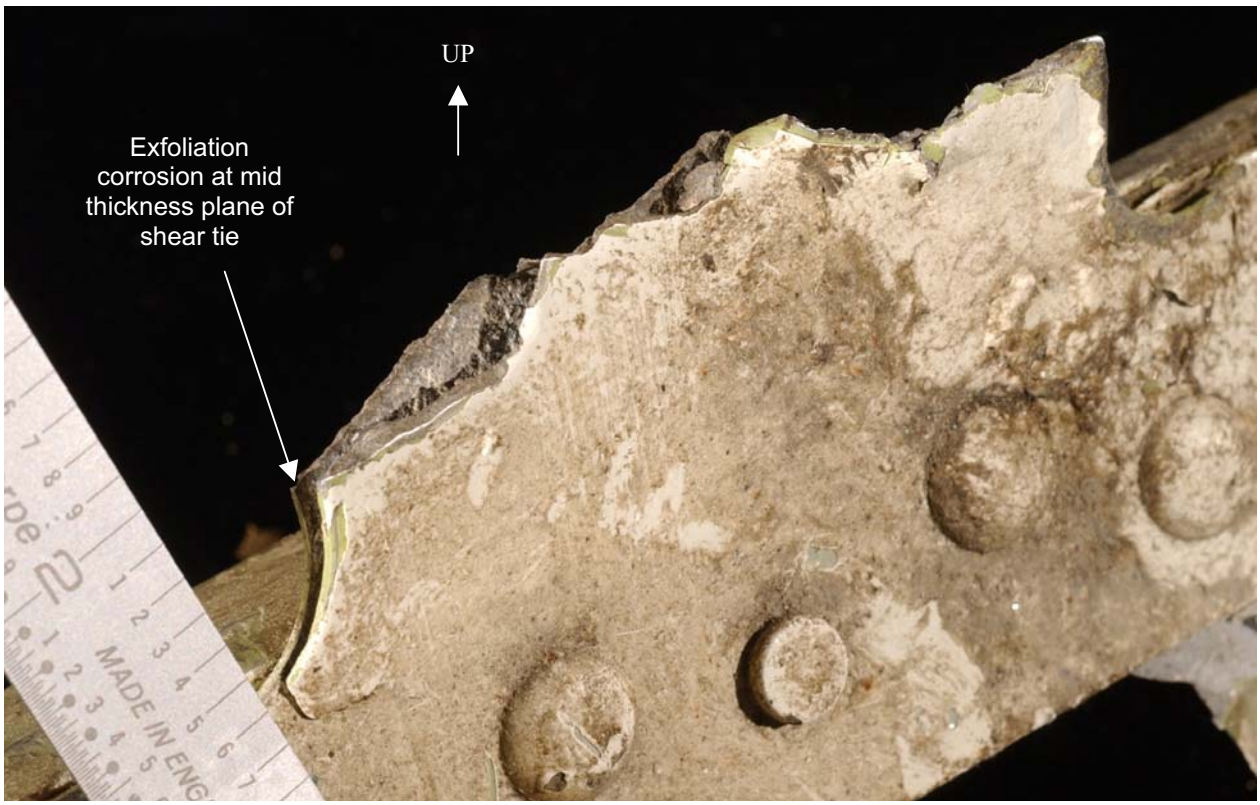
Figure 74.
Exfoliation corrosion present at shear tie between S-49L and S-48L of STA 2160 frame segment.

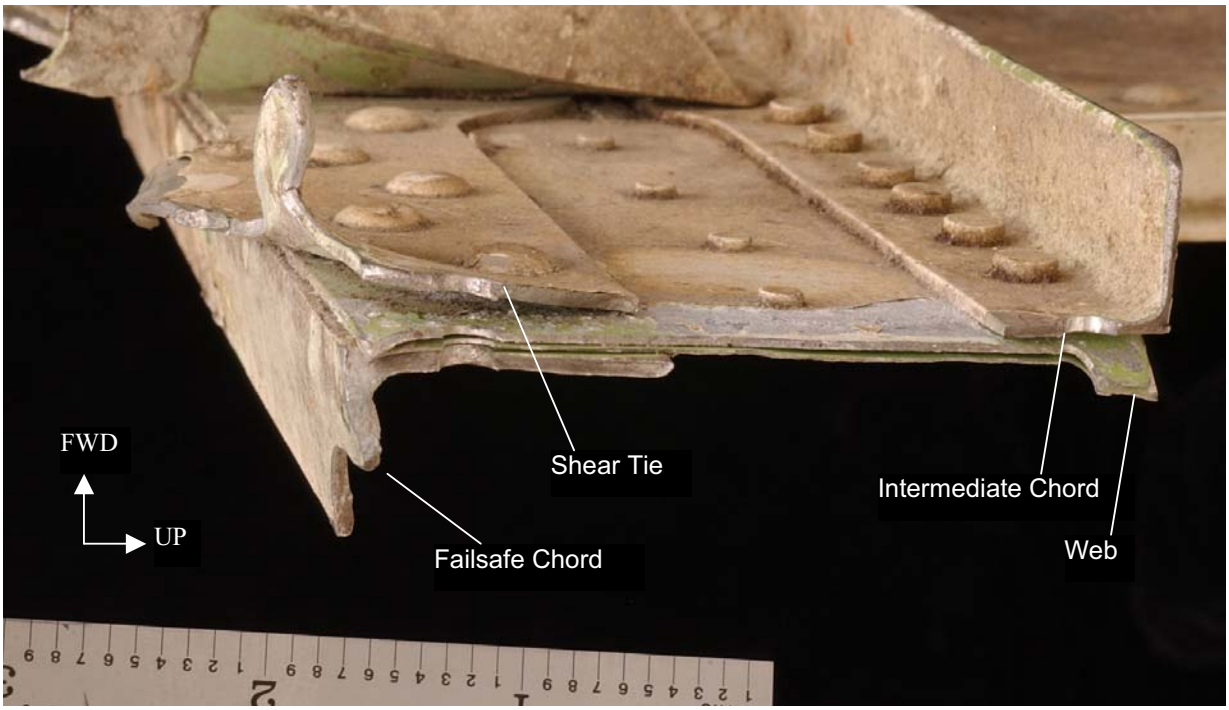
Figure 77.
Fracture at S-49L of the STA 2100 frame segment showing deformation in shear tie and web.

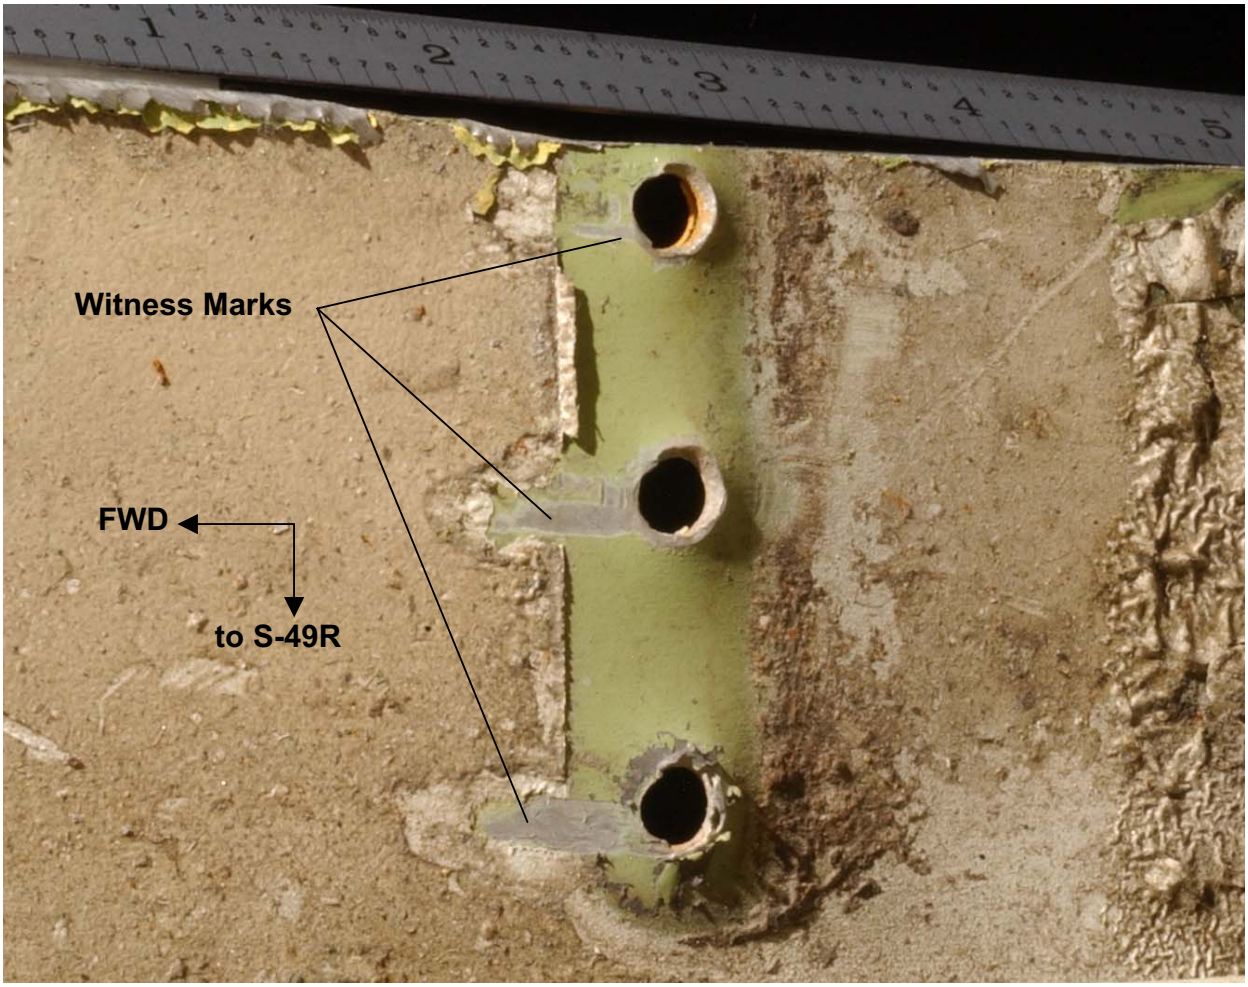
Figure 79.
Witness marks and deformation in skin at shear tie fastener holes common to S-49R /S-48R at STA 2100.

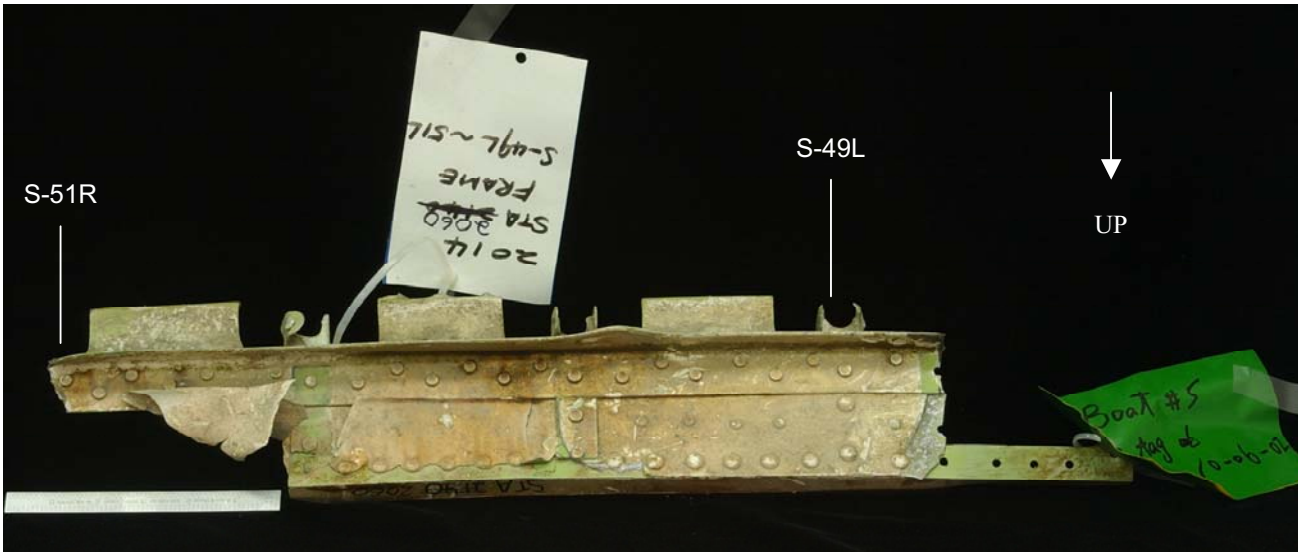
The as-received condition of this frame segment is shown in Figures 80 and 81. This frame segment contained three stringer clips, two shear ties, the failsafe chord, the intermediate chord and a portion of the web.

Figure 80. As received condition of the STA 2060 frame segment. The aft surface is shown in this view.

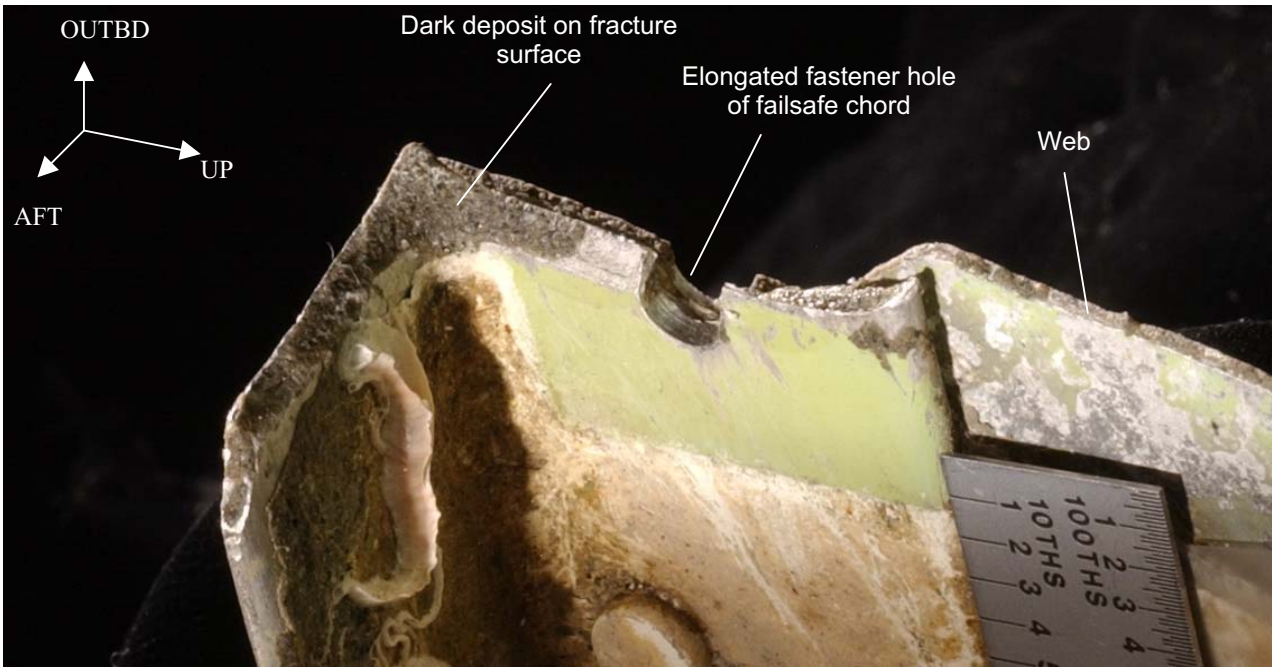
Figure 82.
Fracture surface of failsafe chord and web common to S-49L of the STA 2060 frame segment.
