Aviation Occurrence Report Volume II

ASC-AOR-05-02-001

IN-FLIGHT BREAKUP OVER THE TAIWAN STRAIT

CHINA AIRLINES FLIGHT CI611

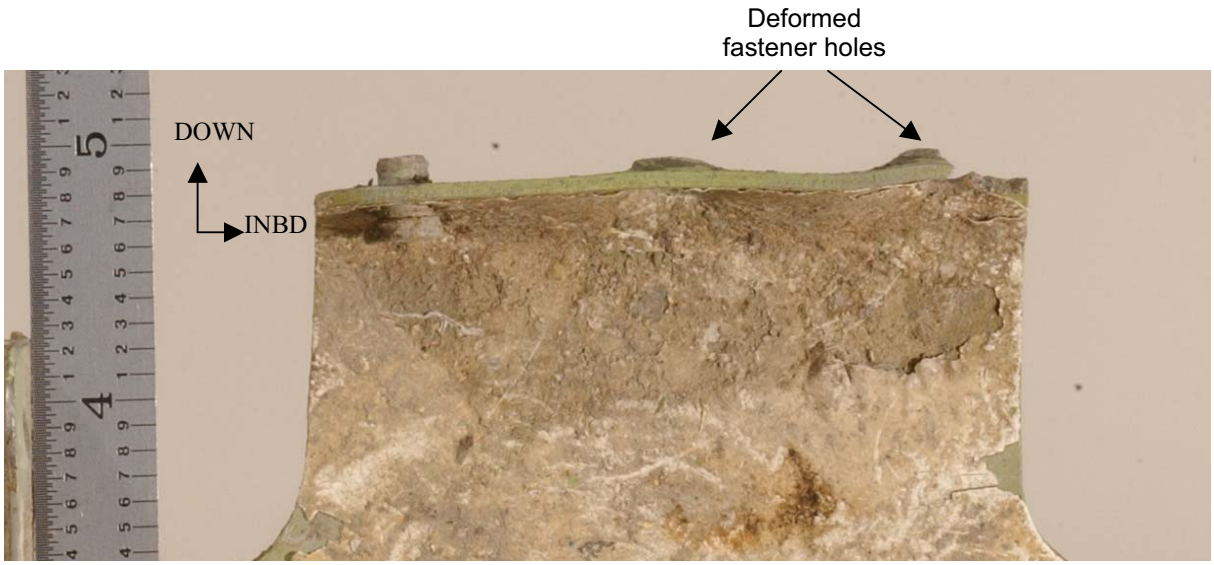
Visual examination of the shear ties from this frame segment was performed to determine the direction of separation from the skin. The shear tie between S-51R and S-51L was missing the skin attachment rivets and contained no fractures, however, the skin flange was bent in the downward direction. The shear tie between S-51L and S-50L was fractured at the inboard most fastener hole common to the skin flange. The middle fastener hole was deformed in the downward direction. The outboard most rivet remained in the skin flange with the manufactured countersink head pulled off (see Figure 83). This shear tie also exhibited downward deformation of the skin flange. The shear tie between S-50L and S-49L was also missing the skin attachment rivets and exhibited downward deformation of the middle skin flange fastener hole. In addition, the stringer clip at S-51L exhibited a bearing fracture through one of the attachment lugs. All these observations were consistent with the application of a straight tensile load on the shear ties of this frame segment.

Figure 83.
Shear tie between S-51L and S-50L of the STA 2060 frame segment showing deformation of skin flange fastener holes in the downward direction.

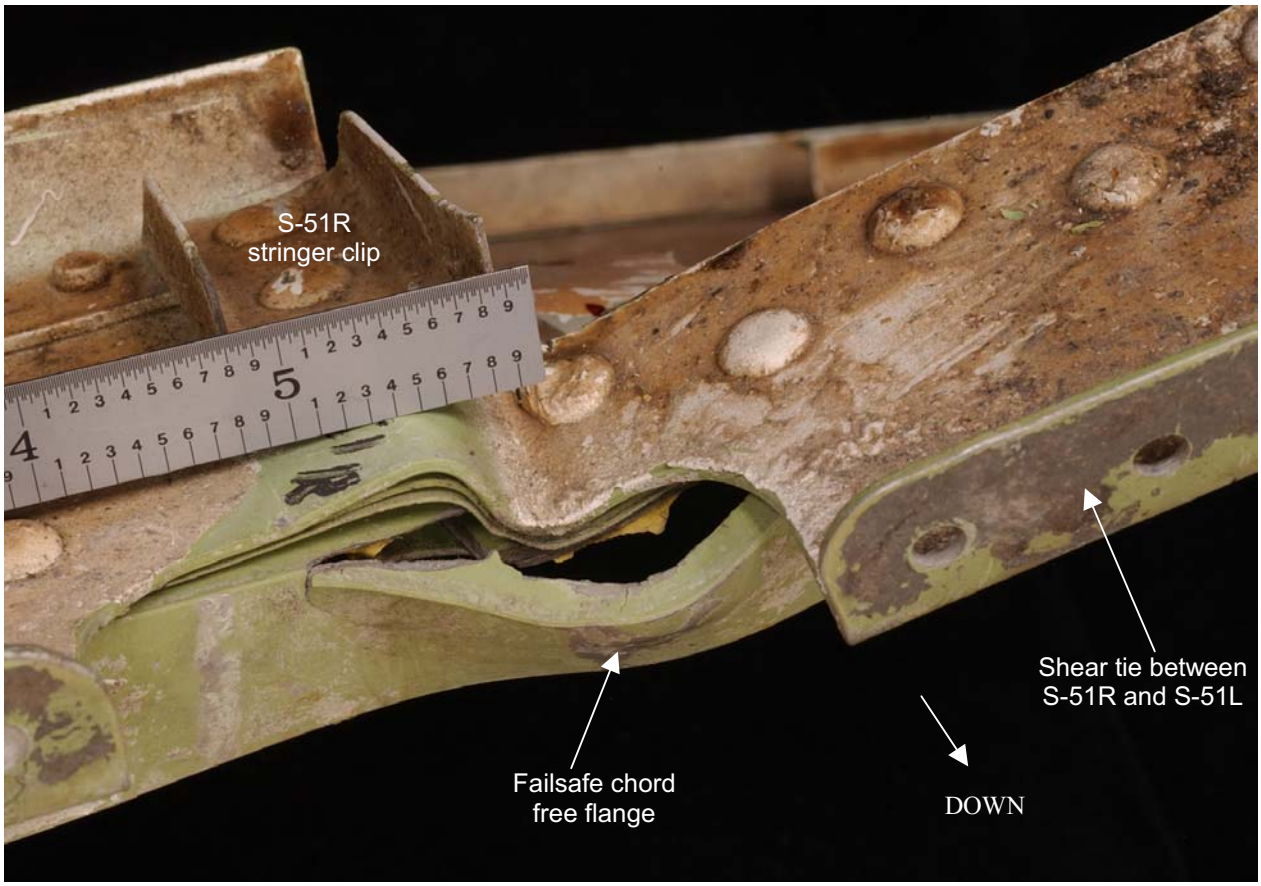
Figure 86. Fracture in failsafe chord free flange radius at S-51R of the STA 2040 frame segment.

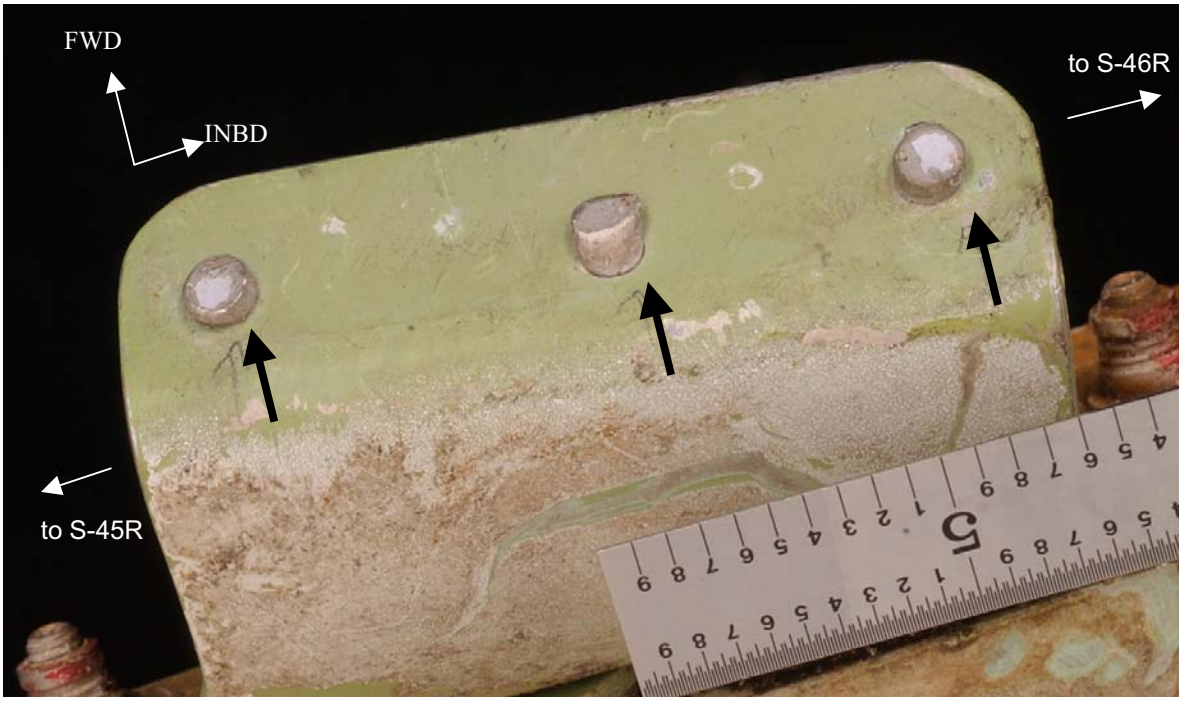
Figure 87.Skin flange rivet fractures at shear tie between S-45R and S-46R of the STA 2040 frame. Black arrows indicate the direction of loading.

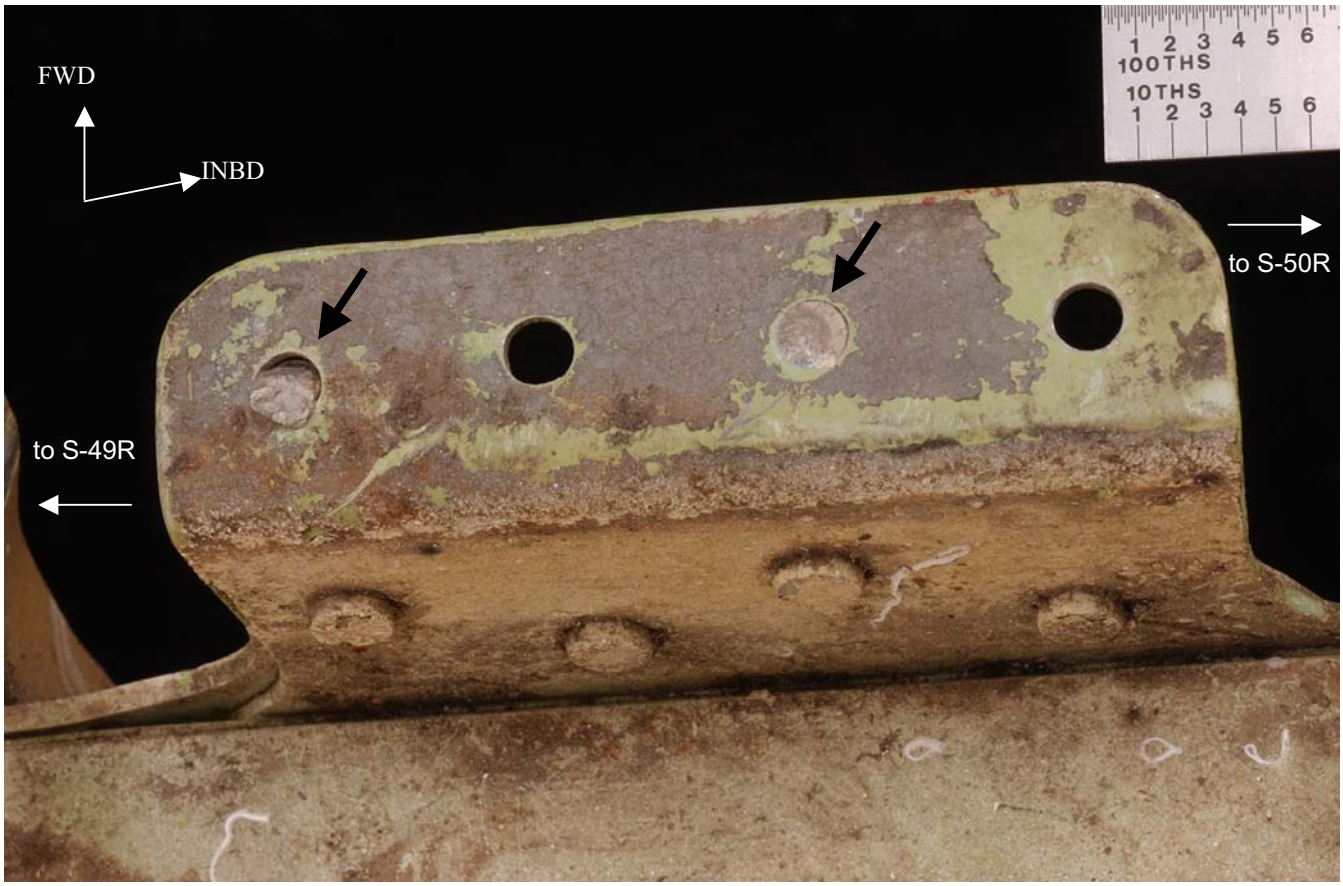
Figure 88. Skin flange rivet fractures at shear tie between S-49R and S-50R of the STA 2040 frame segment. Black arrows indicate the direction of loading.

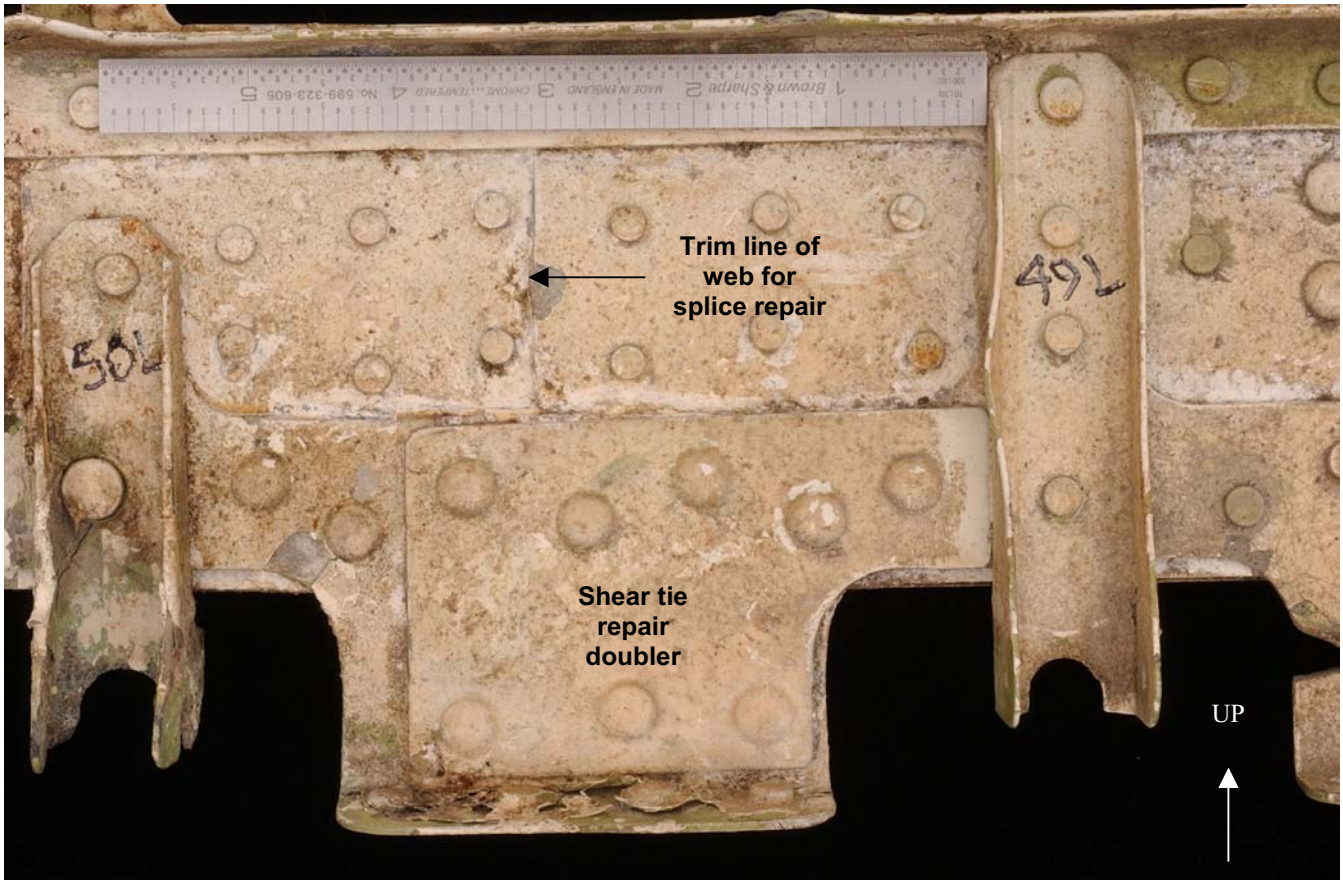
Figure 91.
STA 1940 frame segment showing the shear tie repair doubler and web splice repair
at the location between S-50L and S-49L.

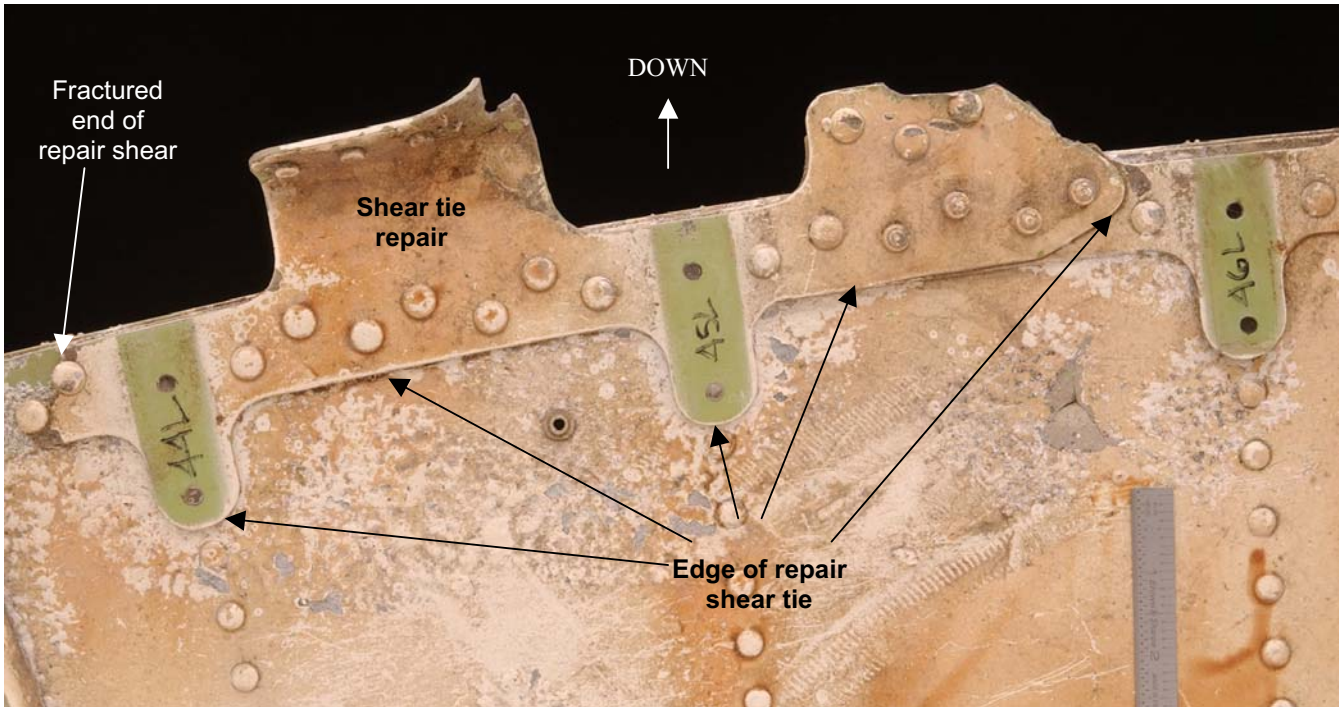
Figure 92.
STA 1940 frame segment showing the shear tie repair between S-46L and S-44L.

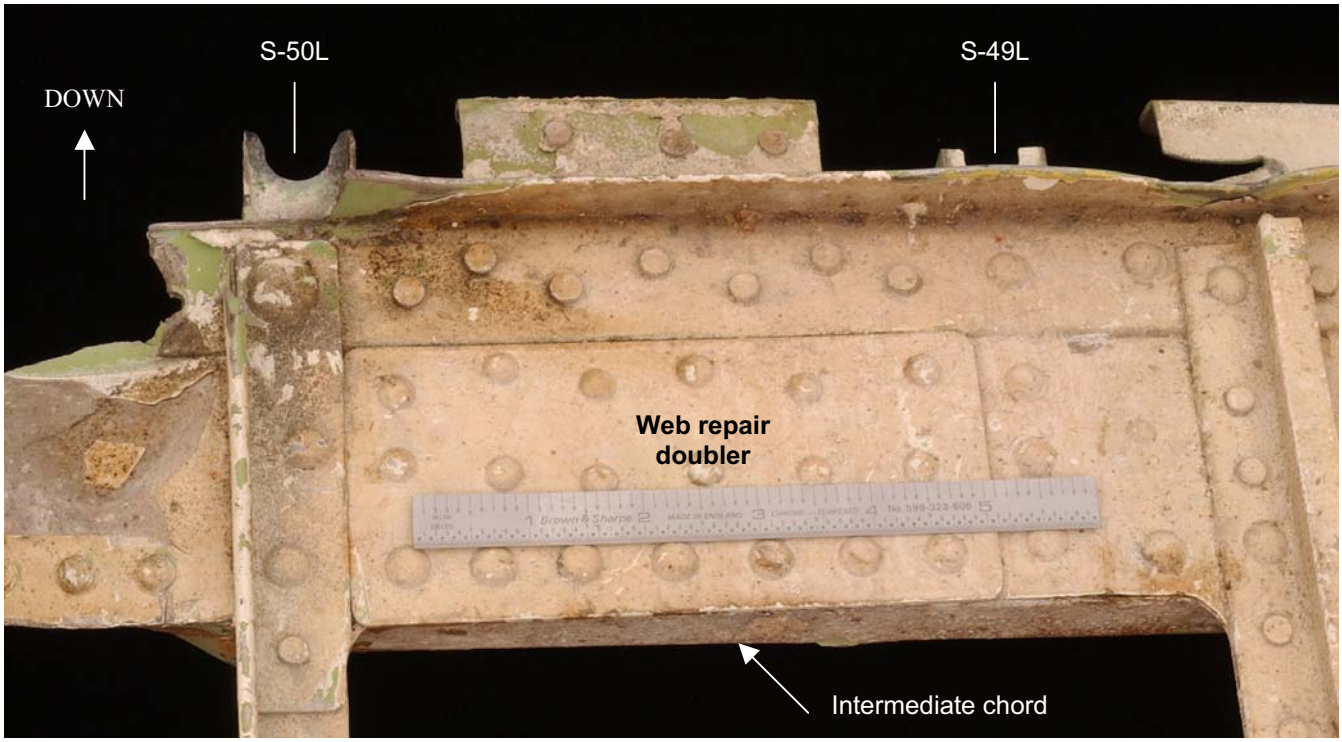
Figure 93.
STA 1940 frame segment showing the web repair doubler on the aft side between S-50L and S-49L.

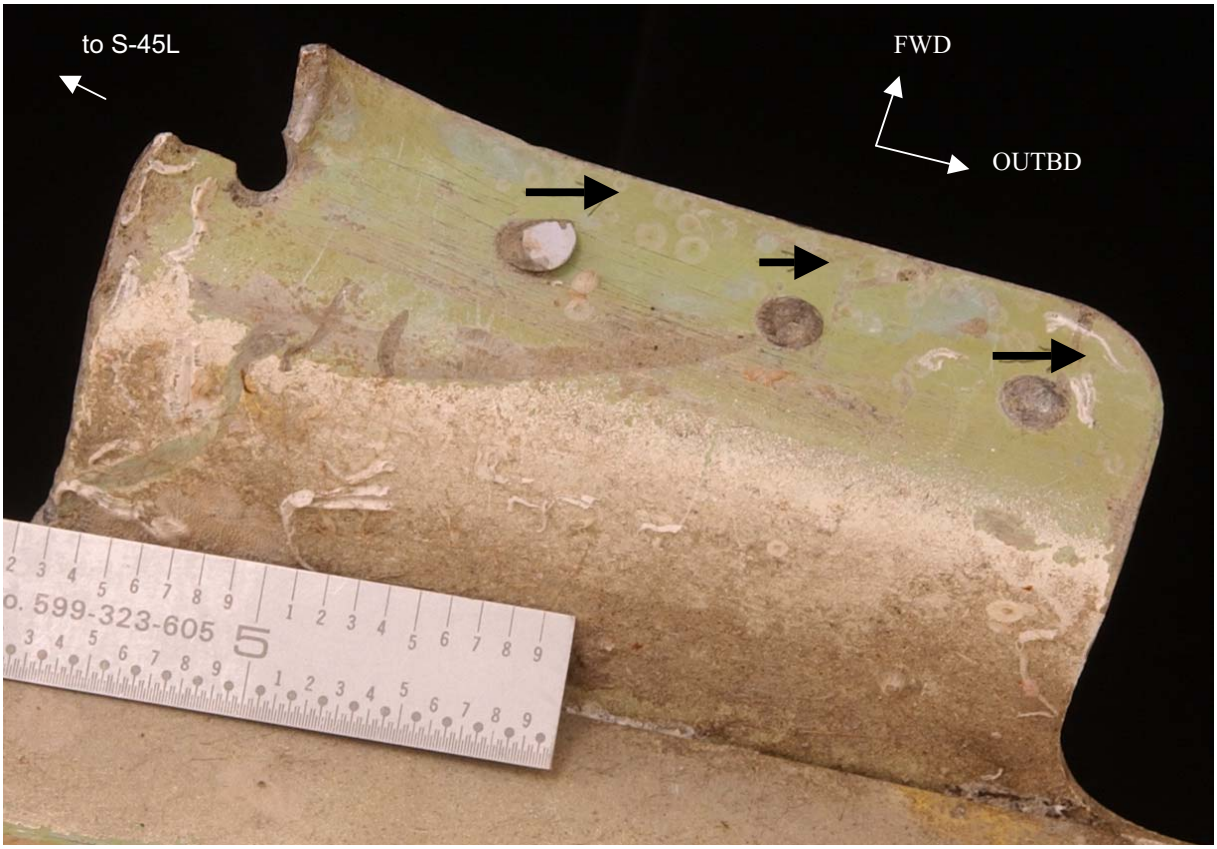
Figure 94. Shear tie between S-45L and S-44L of STA 1940 frame segment.
Black arrows indicate the direction of loading.

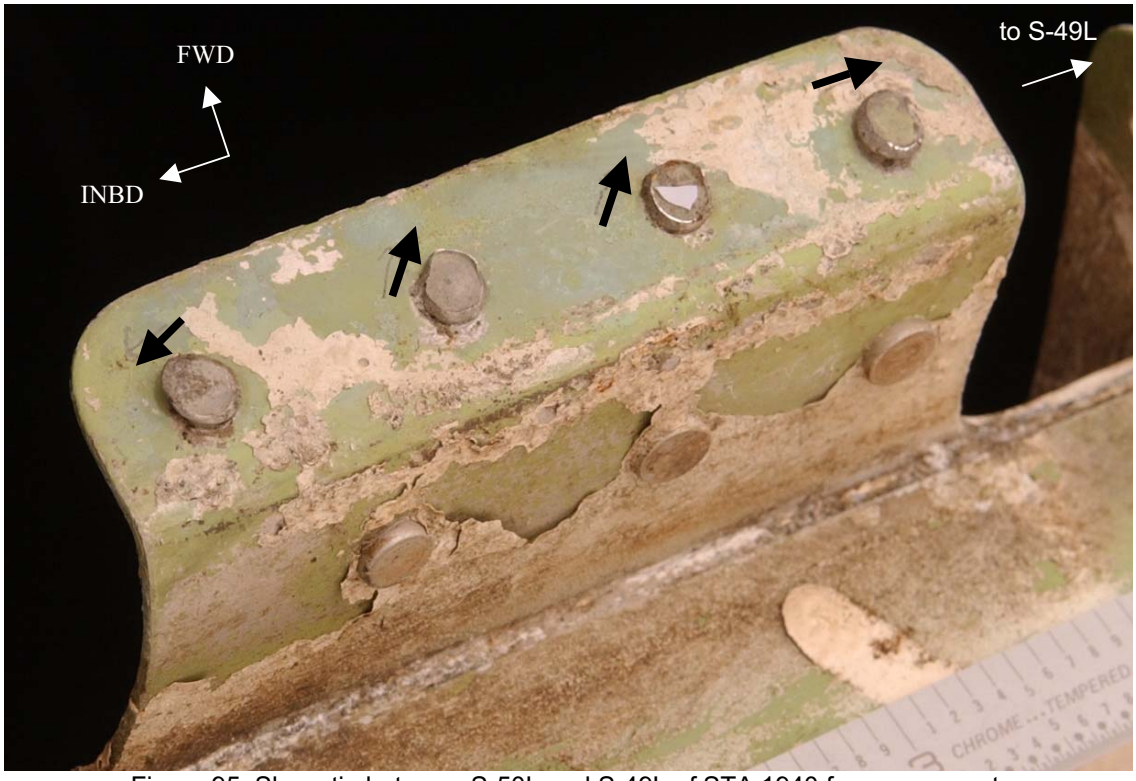
Figure 95. Shear tie between S-50L and S-49L of STA 1940 frame segment.
Black arrows indicate the direction of loading.

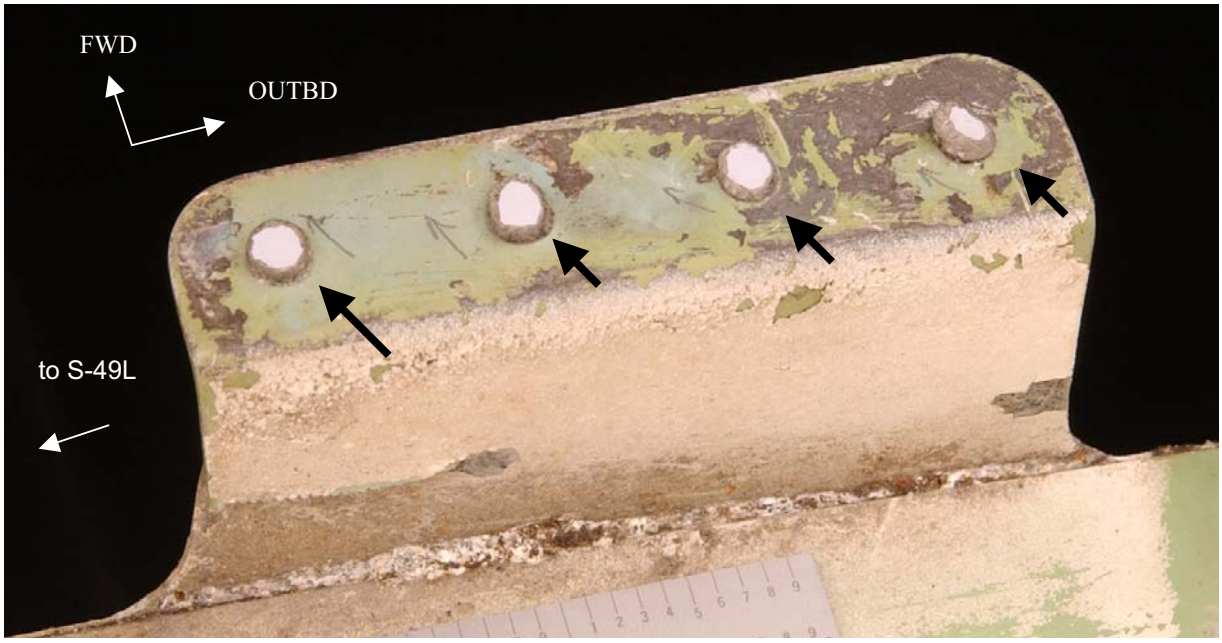
Figure 96.
Shear tie between S-49L and S-48L of STA 1940 frame segment.
Black arrows indicate the direction of loading.

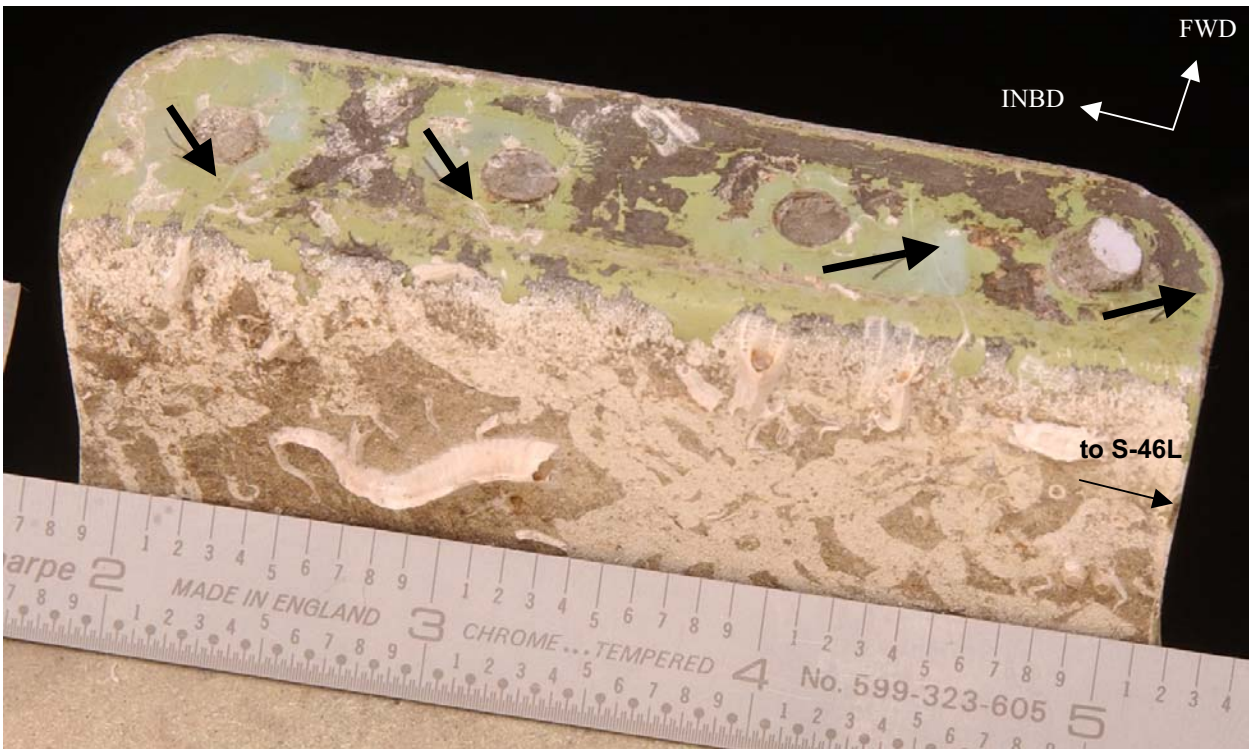
The shear ties present on this frame segment were examined for evidence of separation direction from the skin. This frame segment exhibited fractured shear ties at two locations: between S-45L and S-44L and between S-45L and S-46L. The repair shear tie between S-45L and S-44L was fractured through the inboard most hole by what appeared to be a bearing type fracture. The deformation was observed at this location in the outboard direction. The remaining skin flange attachment rivets were fractured in an outboard direction as well (see Figure 94). The shear tie between S-46L and S-45L was fractured through the free flange of the production shear tie and therefore no separation direction observations were made. Visual and low power optical examination of this fracture surface revealed a slanted profile with a morphology consistent with ductile separation. The remaining shear ties were not fractured but exhibited either fractured skin flange attachment rivets or deformation. These skin flange attachment rivets were examined using visual and low power optical techniques to determine if any evidence of loading direction was present. On the shear tie between S-50L and S-49L three of the skin flange attachment rivets were fractured in the forward to outboard direction while the inboard most rivet exhibited evidence of an inboard direction of loading (see Figure 95). All the skin flange attachment rivets of the shear tie between S-49L and S-48L showed signs of fracture in the forward to inboard direction (see Figure 96). The skin flange attachment rivets for the shear tie between S-48L and S-47L were not fractured but the shear tie exhibited general deformation in the aft direction. On the shear tie between S-47L and S-46L the two outboard most skin flange attachment rivets were fractured in the forward to outboard direction while the two inboard most rivets exhibited evidence of an aft to outboard direction of loading (see Figure 97).

Figure 97.
Shear tie between S-47L and S-46L of STA 1940 frame segment.
Black arrows indicate the direction of loading.

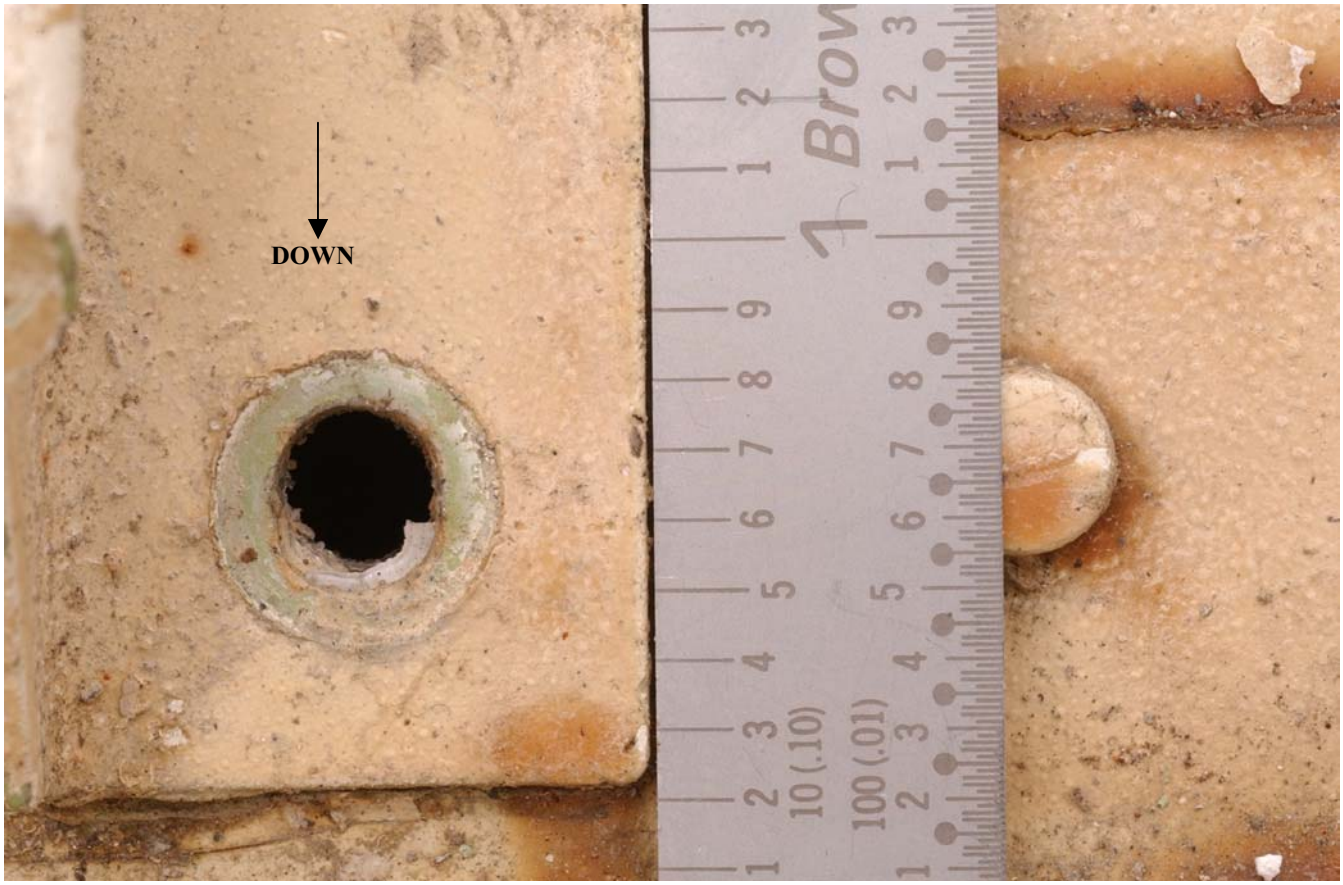
Between S-47L and S-44L the stringer clips were missing from this frame segment. The rivet fractures and or hole deformation at these locations were examined to determine if any evidence of separation direction was present. At all of these stringer clip locations the rivets were fractured and remained in the shear tie except at the lower attachment hole at S-47L which was missing the rivet. All of the fractured rivets that could be viewed (some of the fractures existed at the web/shear tie interface) exhibited signs of loading in the downward direction. The lower attachment hole at S-47 exhibited elongation in the downward direction as well (see Figure 98).

Figure 98.
FWD view of STA 1940 frame segment showing downward deformation of the lower attachment hole of shear tie at S-47L clip.

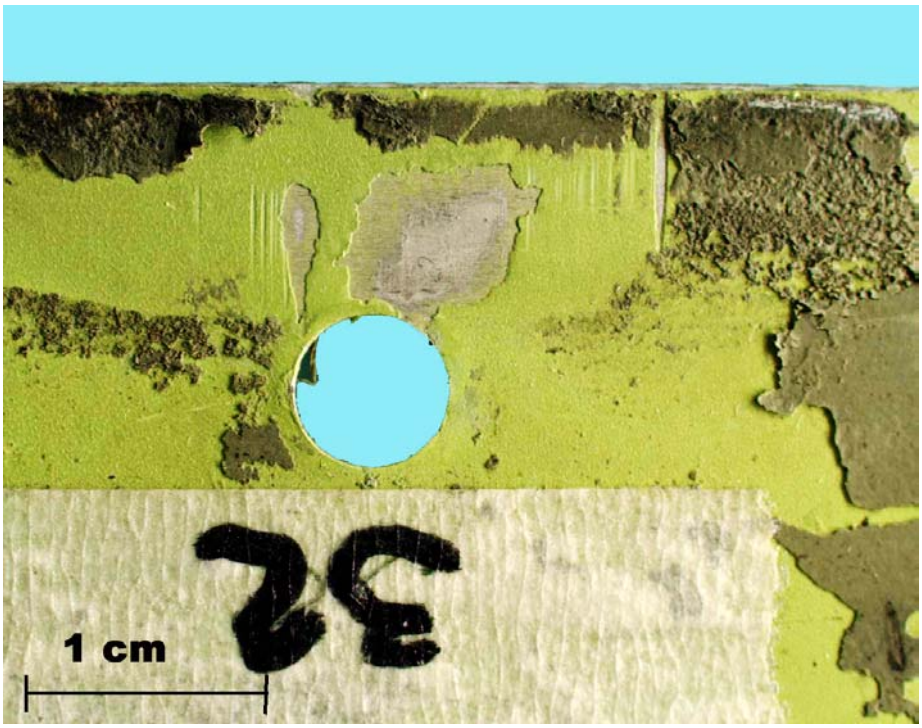
(1) The surface markings near hole 32 are presented in Figure 1, and an optically magnified photograph of the subject area is shown in Figure 2. Figure 1 shows that the surface markings at the suspected area of contact exhibit many colors. Figure 2 shows that some hoop-wise scratches (marked by arrows) were visible on the surface of the suspected area of contact.

Figure 1, Surface markings adjacent to hole 32, showing the different colors on the metal surface.

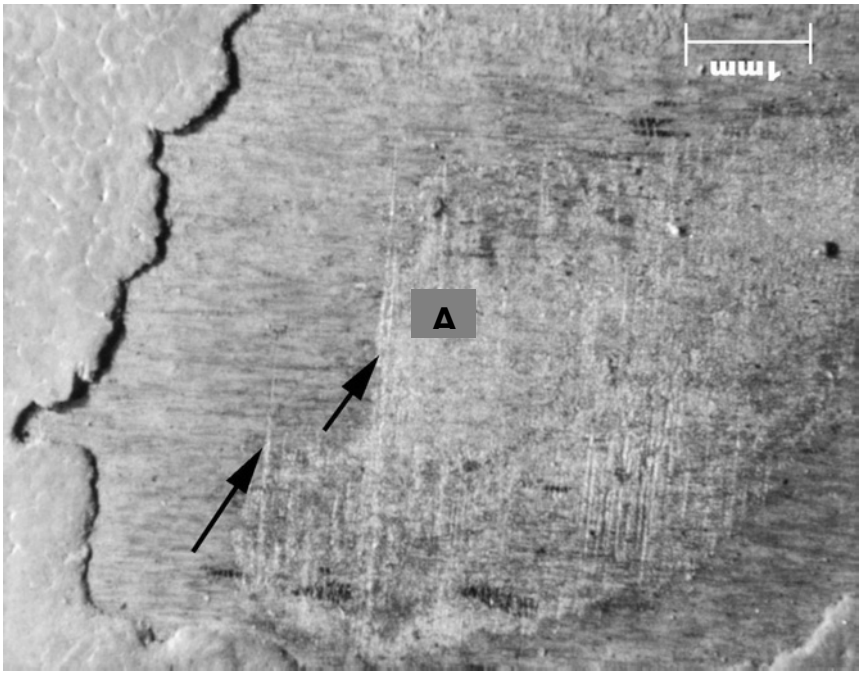
Figure 2, Optical magnification photograph of the marking area in Figure 1.

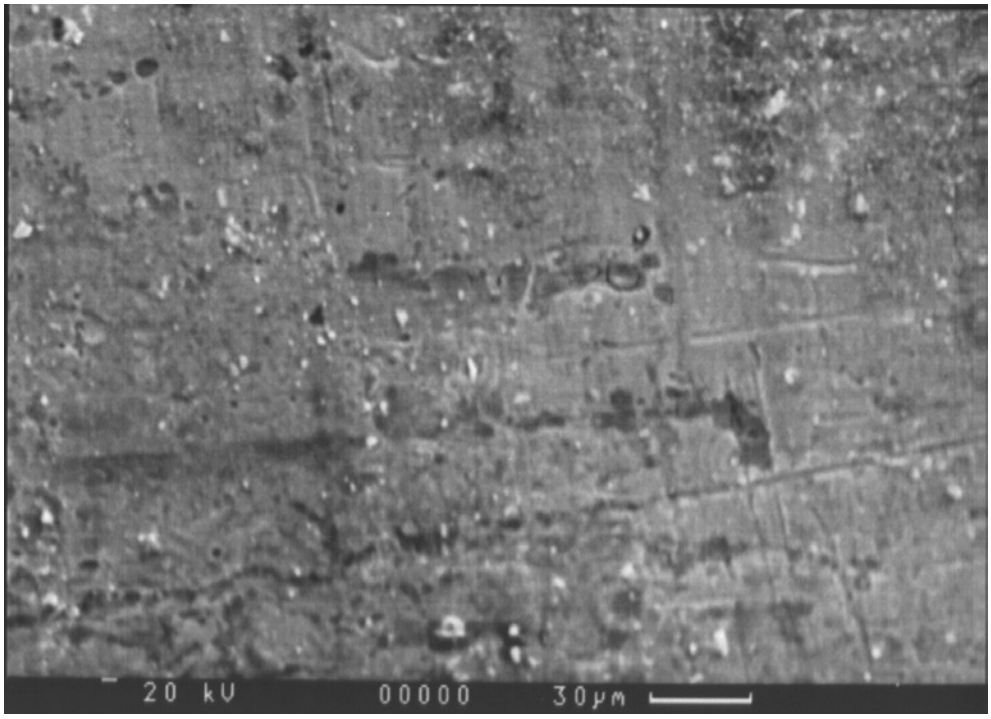
(2) Figure 3 is an SEM photograph at point A in figure 2, indicating that the grooves of the scratches were covered by some material(s).

Figure 3, SEM photograph at point A in figure 2, indicating that the grooves of some of the scratches were covered by some material.

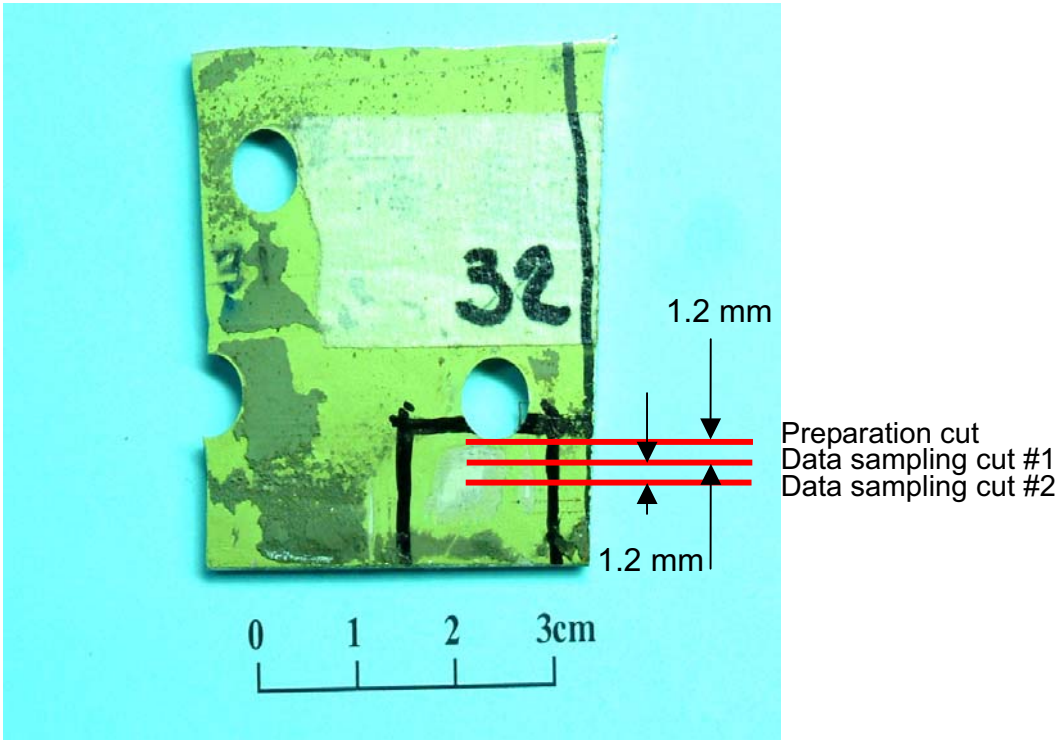
(3) Two cross section locations were chosen to characterize the surface markings. Figures 5 and 6 are the metallographic photographs through the area marked by the data sampling cut #1 and data sampling cut #2 respectively, shown in Figure 4, showing that there was some material superimposed over the grooves of the scratches.

Figure 4, Cross section locations - taken to characterize the surface marking contours.

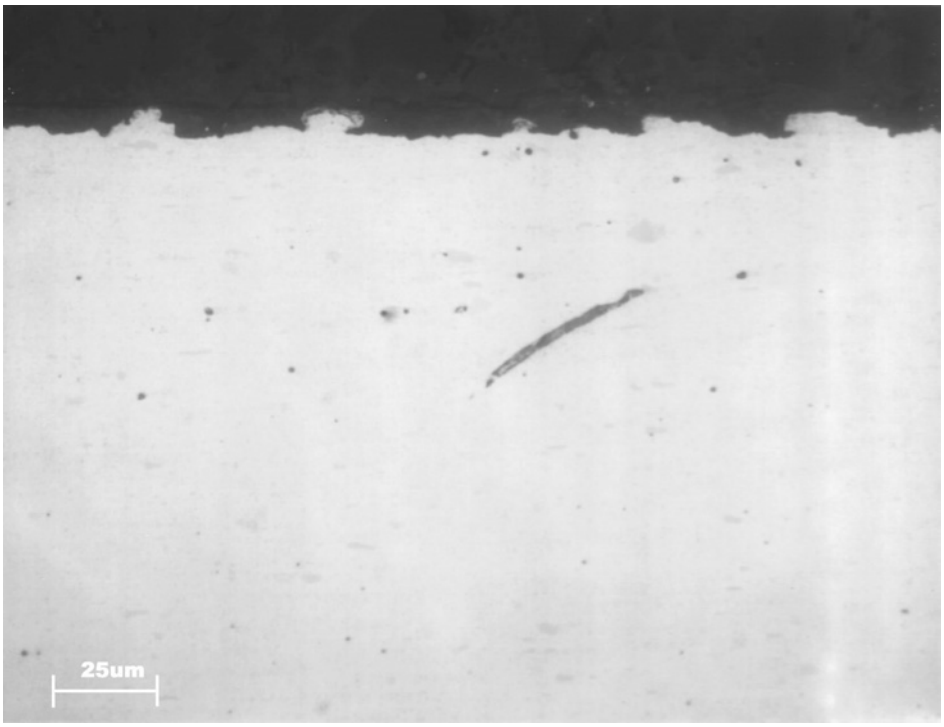
Figure 5, Metallographic photo through the area marked by the data sampling cut #1 in Figure 4.

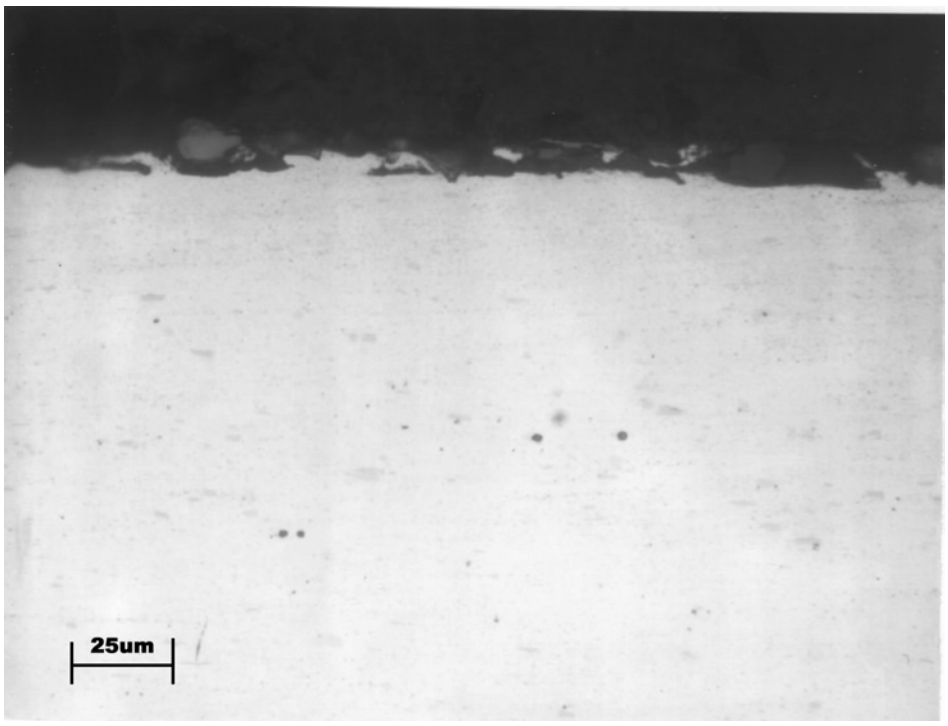
Figure 6, Metallographic photo through the area marked by the data sampling cut #2 in Figure 4.

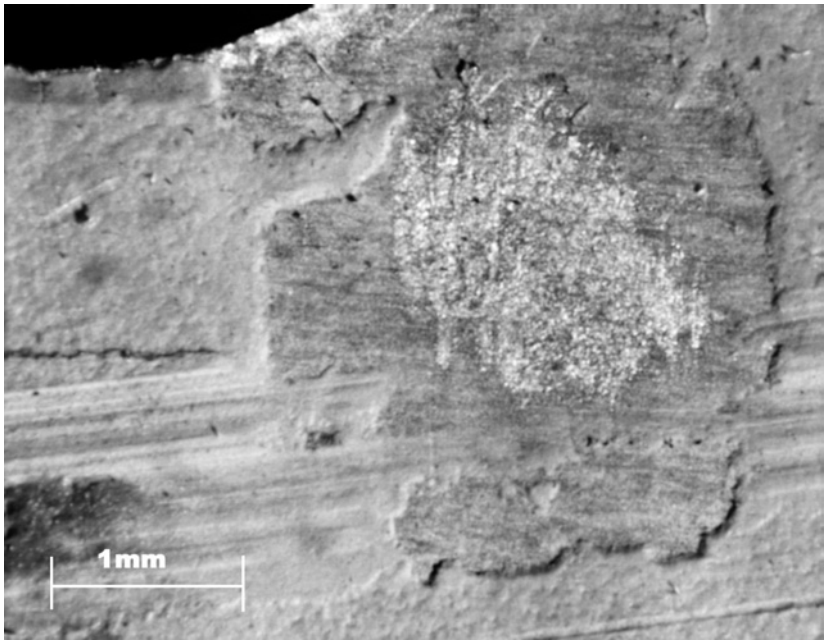
Figure 7 Surface area adjacent to hole 11.

Marking areas of interest adjacent to holes 11, 49 and +16 are shown in Figure 7, 8, 9, respectively; all showing scrape/scratch marks on the surface.

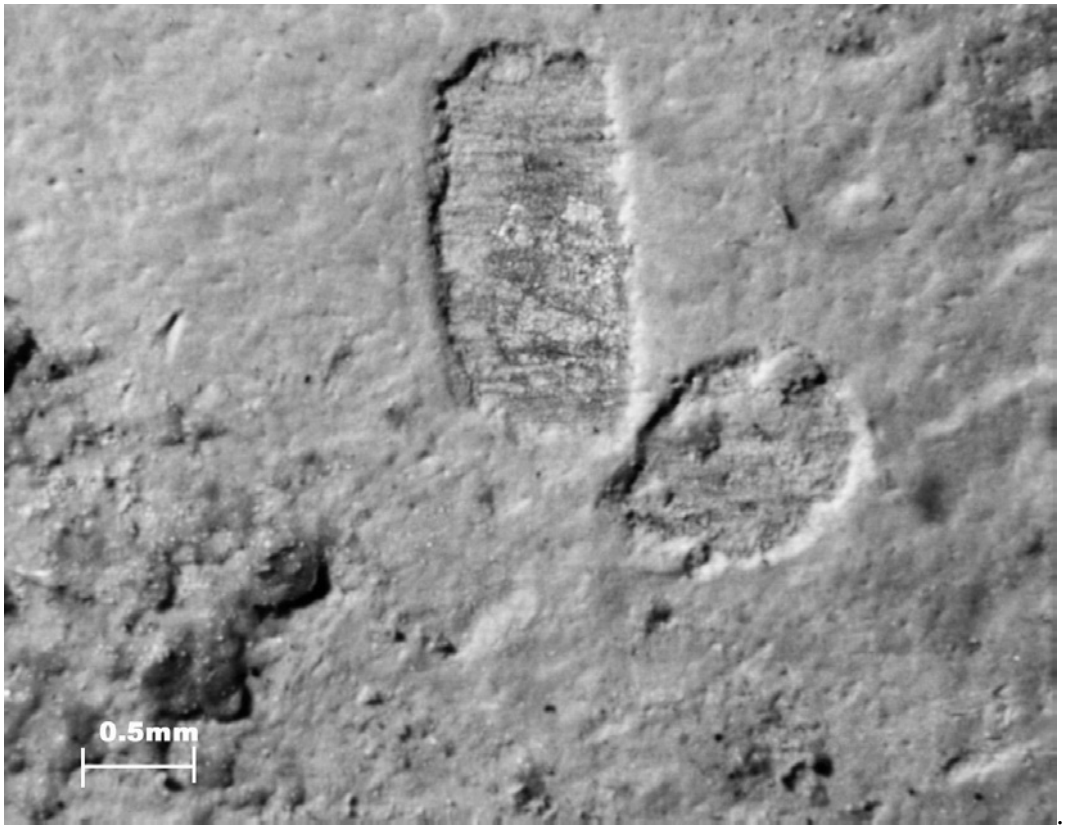
Figure 9 Surface area adjacent to hole +16

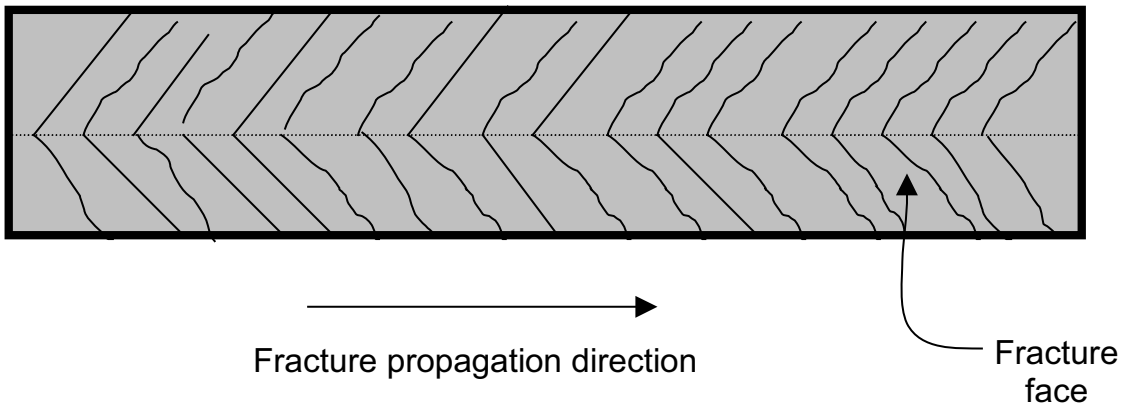
Item 640 S-49L, STA 2100

Multiple crack initiation sites along length
