DOT/FAA/AM-89-8

Performance Evaluation of the Puritan-Bennett Crewmember Portable Protective Breathing Device as Prescribed by Portions of FAA Action Notice A-8150.2

May 1989

Final Report

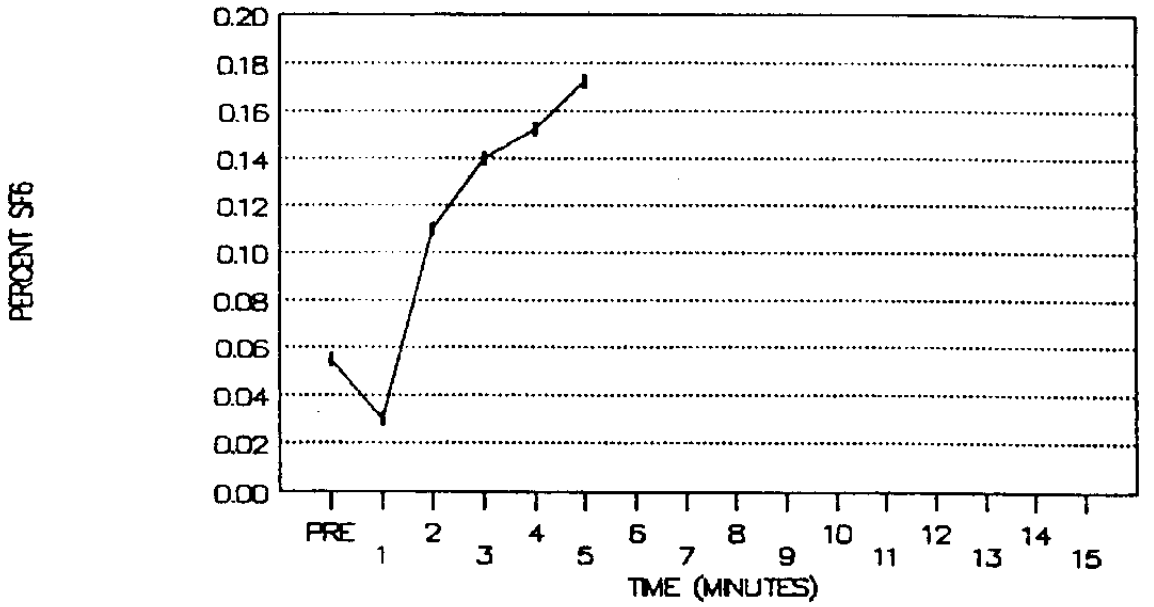
-Figure 1-

The second phase of testing began September 14, 1988. Initially, the modified neck seal was made of 0.012" latex with a neck opening of 3.00". This appeared to solve the problems associated with the neck seal leakage, until subjects F-5 and F-6 (Figs. 1 and 2, p. A-3) were tested and the neck seal leakage reappeared. The diameter of the neck seal opening was then reduced to 2 1/2" and these two subjects retested. This eliminated the neck seal leakage problem for these subjects (Figs. 7 and 8, p. A-6).

PURITAN CREW PBE INFILTRATION
SUBJECT F-5, 3.0 INCH NECKSEAL

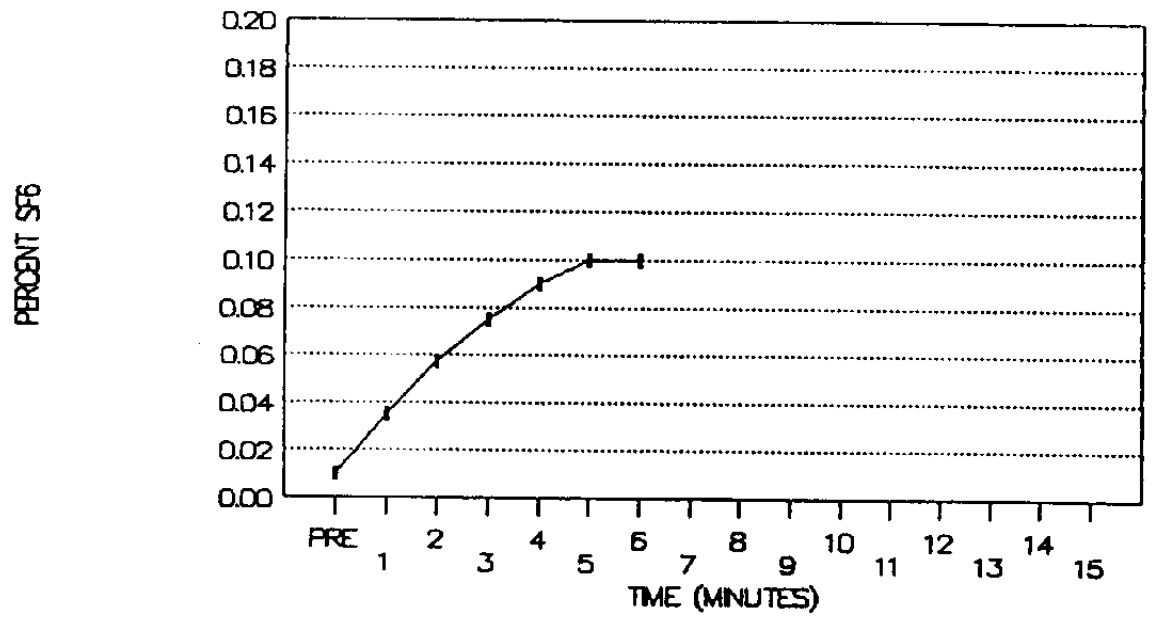
-Figure 2-

PURITAN CREW PBE INFILTRATION
SUBJECT F-6, 3.0 INCH NECKSEAL

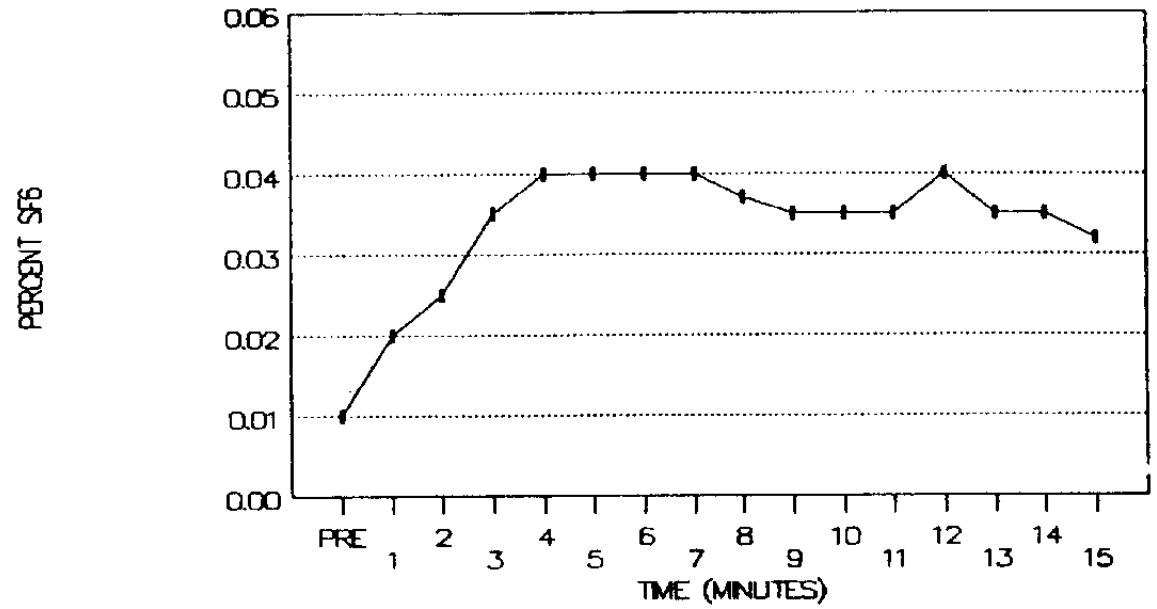
-Figure7-

PURITAN CREW PBE INFILTRATION SUBJECT F-5

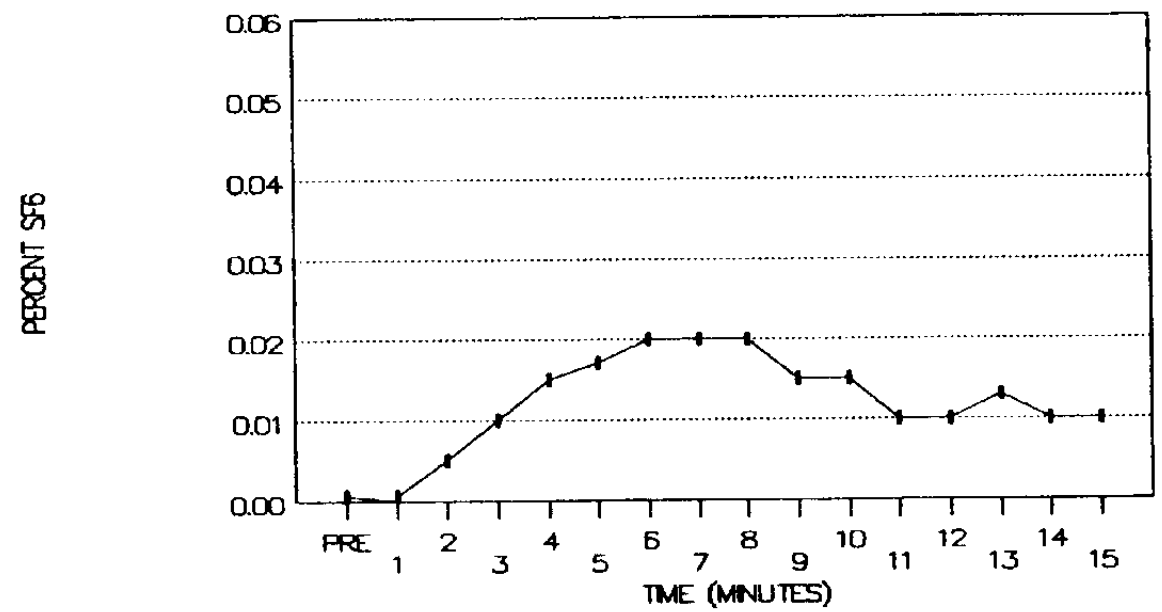
-Figure 8-

PURITAN CREW PBE INFILTRATION SUBJECT F-6

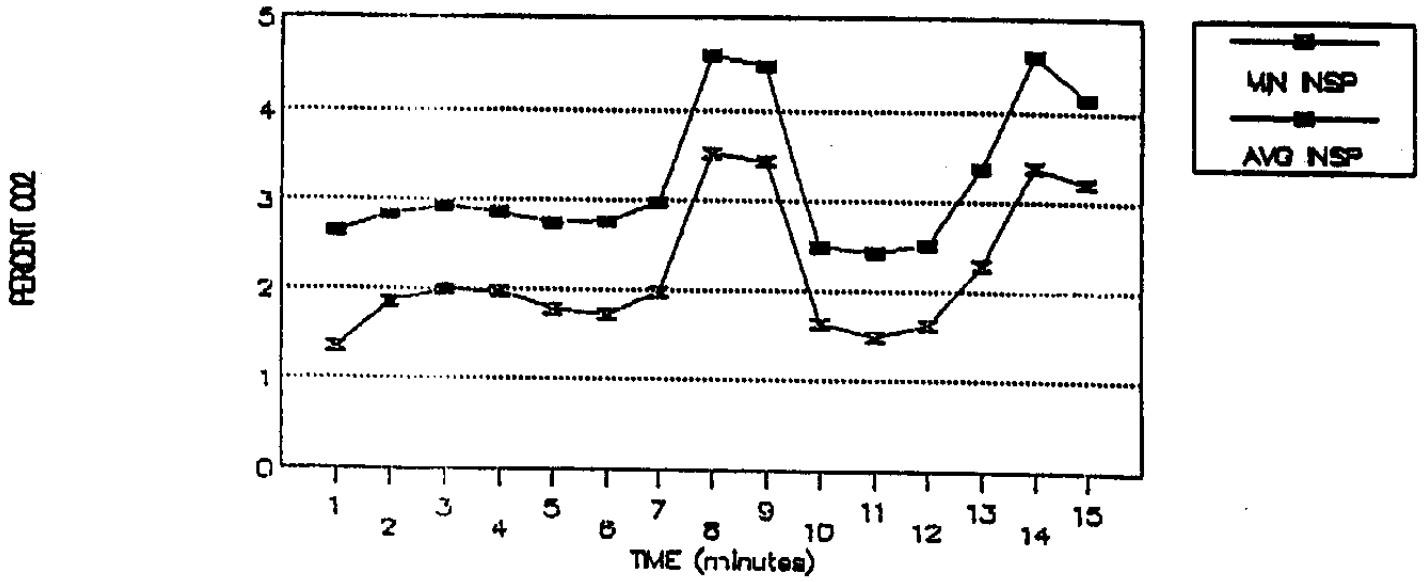
At least two of the devices failed because of excessive CO_2 concentrations within the oral-nasal mask. On visual inspection, it was found that the flapper on one of the exhalation valves was inverted on its support ring (probably caused by the flushing action of the initial surge of O_2 from the chlorate candle), thus preventing the complete clearance of the exhaled breath from the mask. (The graphs of the CO_2 concentrations for these two tests are on page C-3 of Appendix C).

INSPIRATORY CO2 VALUES
MALE 4/15/88, HIGH CO2 LEVEL

The modifications made for added support of the exhalation valve were satisfactory and no new problems with CO_2 were found. Only one test resulted in an unsatisfactory SF_6 leakage and this subject was retested with another PBE.

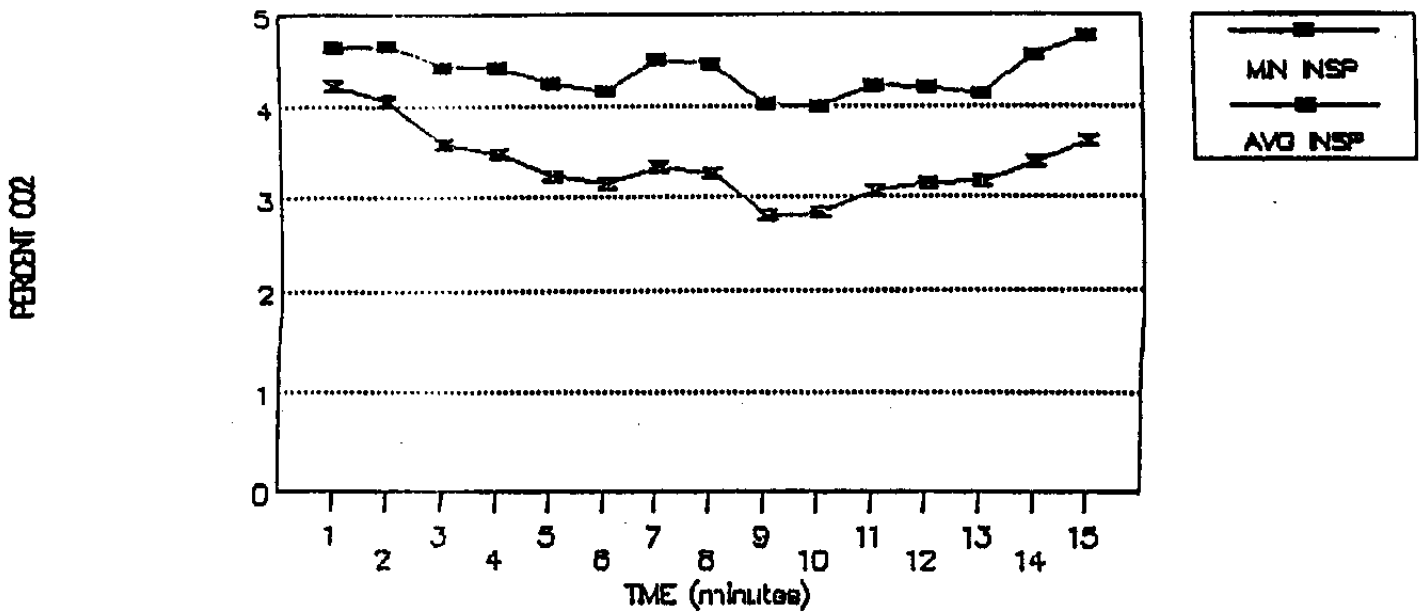
-Figure 54-

INSPIRATORY CO2 VALUES
FEMALE 9/23/88, HIGH CO2 LEVEL
