NATIONAL TRANSPORTATION SAFETY BOARD

RUNWAY OVERRUN DURING LANDING
AMERICAN AIRLINES FLIGHT 1420
MCDONNELL DOUGLAS MD-82, N215AA
LITTLE ROCK, ARKANSAS
JUNE 1, 1999

**NTSB/AAR-01/02
PB2001-910402
Notation 7195A
Adopted October 23, 2001**

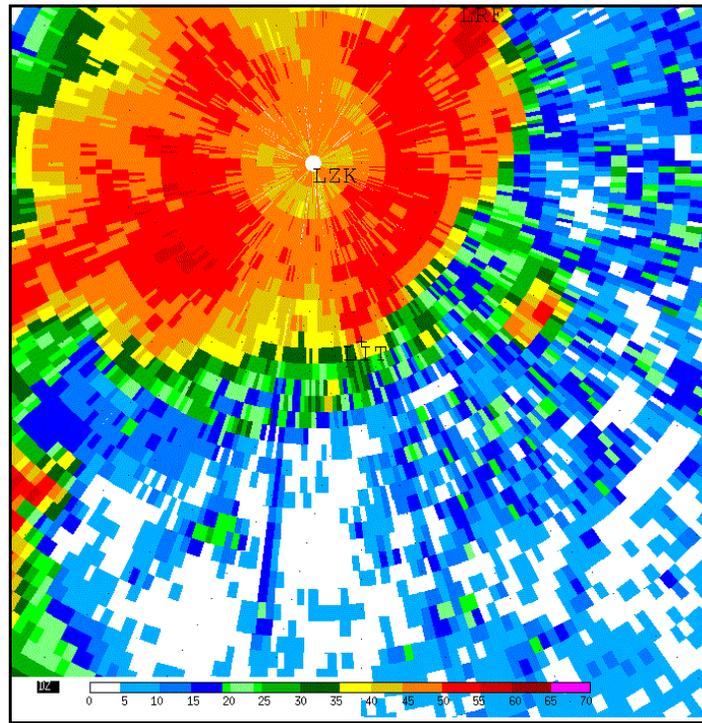
Figure 7. 0.4° Base Reflectivity Scan at 2334:27

The WSR-88D's base reflectivity images provided the radar reflectivities at the individual elevation scans. The images documented the line of thunderstorms moving across the Little Rock airport area during flight 1420's approach. The WSR-88D 0.4° elevation scan of base reflectivity that was completed at 2334:27 depicted reflectivities of 50 dBz, or NWS level 5 (intense) activity over the northwest section of the airport. By 2340:28, the 0.4° base reflectivity image depicted a large area of activity over the airport with reflectivities of 45 dBz, or level 4 (very strong) activity, and greater. The two strongest areas of activity were located approximately 5 miles west-northwest and northeast at this time. Another area of activity located approximately 3 miles southwest of Little Rock was beginning to move toward the east-southeast with reflectivities reaching 54 dBz, or level 6 (extreme) activity. Figures 7 and 8 show the base reflectivity products for 2334:27 and 2340:28, respectively.

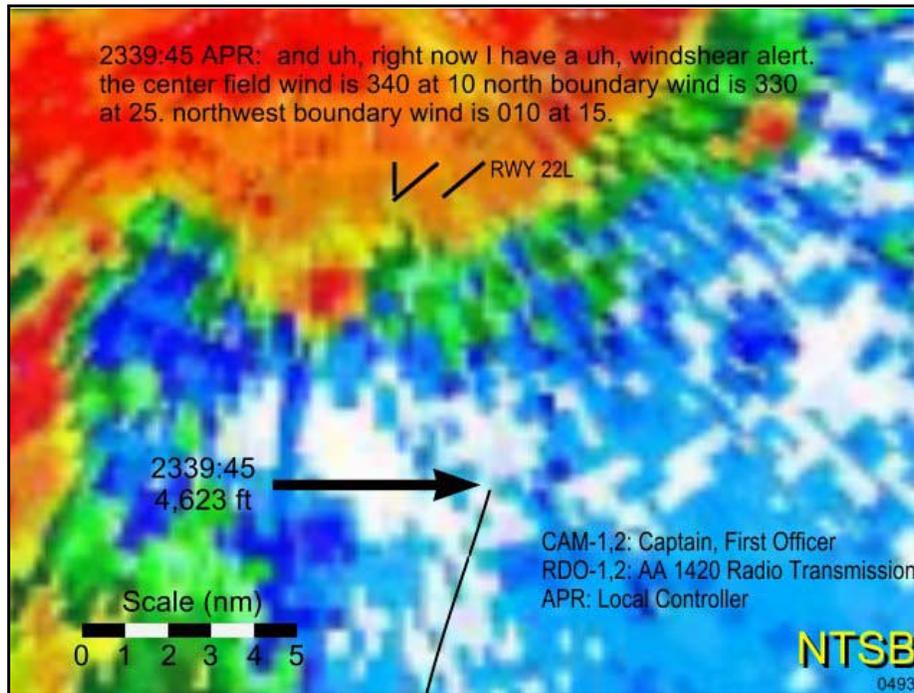
Figure 19. Weather and Flight Information for 2339:45

The flight crewmembers had been previously told by the controller to expect an instrument landing system (ILS) approach to runway 22L. At 2339:45, the local controller broadcast the first of two windshear alerts, reporting that the centerfield wind was 340° at 10 knots.¹⁷⁸ At this point, the airplane was about 8 miles from the airport. Afterward, the flight crew requested a change in runways from 22L to 4R because the winds had shifted to the northwest. The use of runway 22L could have resulted in a tailwind at the time of landing, so runway 4R was a more appropriate choice because of the expectation of a headwind. (NWS radar data indicated that the leading edge of a line of thunderstorms was over the airport at this time with the heaviest activity located northwest through northeast 5 miles from the runway.)¹⁷⁹ Figure 19 shows a map of the weather conditions at 2339:45 and flight 1420's location.

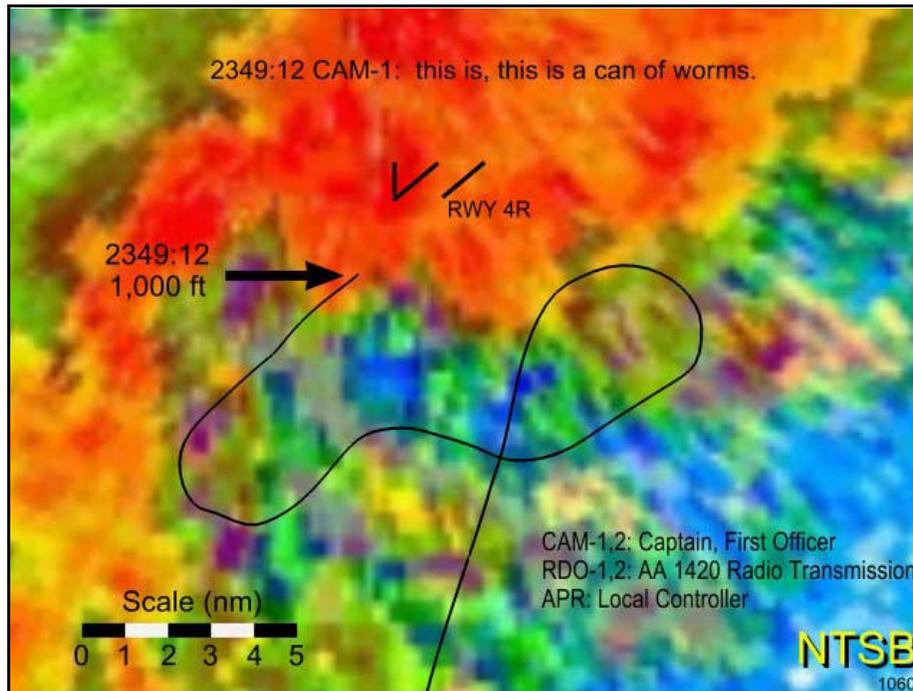
Figure 25. Weather and Flight Information for 2349:12

At 2349:10, the controller indicated that the winds were 330° at 28 knots. About 2 seconds later, the captain stated, “...this is a can of worms.” FDR data indicated that the airplane was about 1,140 feet msl (880 feet afl) at this time and that the captain was making active control inputs to keep the airplane on the localizer and glideslope. Also, the FDR data showing fluctuating airspeed (± 5 knots, with one excursion to +8 knots and one to -10 knots) and vertical acceleration (± 0.2 G with occasional excursions to ± 0.25 G)¹⁸⁶ were consistent with the presence of gusty and turbulent winds. Figure 25 shows a map of the weather conditions at 2349:12 and flight 1420’s location.
