**Airframe Breakout Session**  
Seattle DER Recurrent Seminar – November 6, 2003  
**“Lusaka: An Accident Worth Revisiting”**

**LOOKING AT LUSAKA’S  
LESSONS**

Seattle DER Conference  
6 November 2003

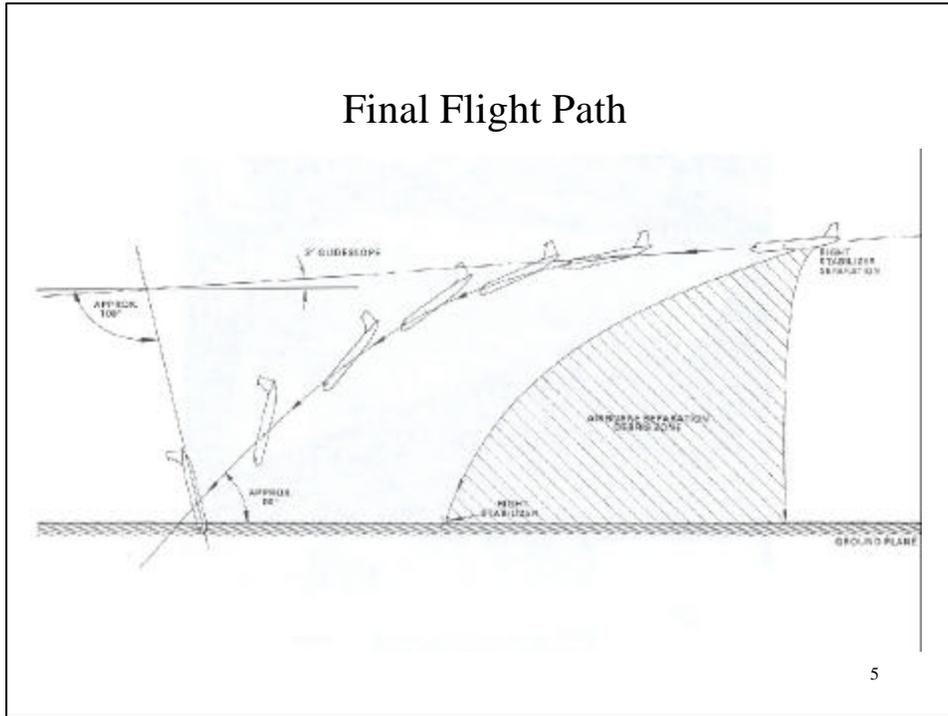
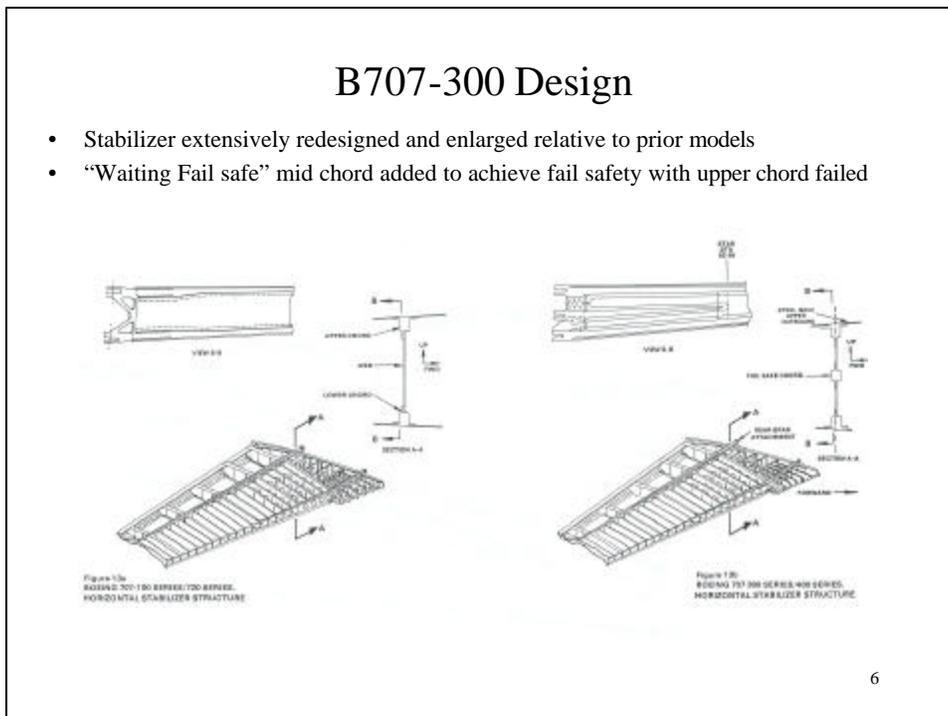
- May 14, 1977
- Boeing 707-321C operated by Dan-Air
- UK registry G-BEBP on non-scheduled cargo flight
- 47,621 hours/16723 flights at failure
- Right hand horizontal stabilizer and elevator departed aircraft subsequent to selection of landing flap during approach to Lusaka Airport
- All six occupants killed
