Report Number NTSB-AAR-82-8

Report Title Air Florida, Inc., Boeing 737-222, N62AF, Collision with 14th Street Bridge, Near Washington National Airport, Washington, D.C., January 13, 1982.

Report Date August 10, 1982

Organization Name National Transportation Safety Board Bureau of Accident Investigation Washington, D.C. 20594

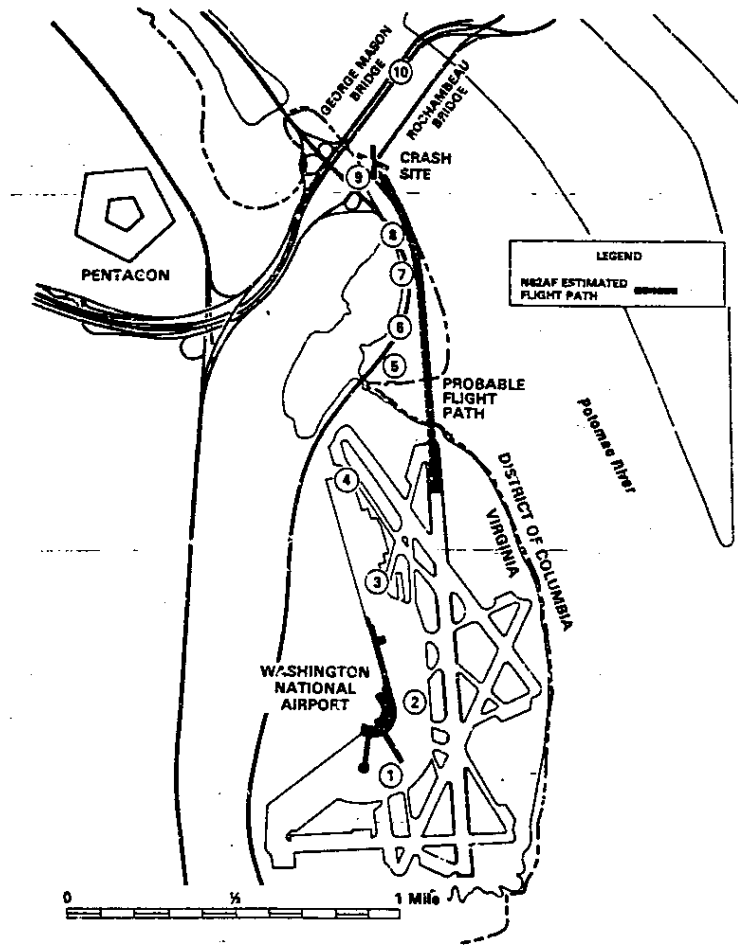
Figure 1.—Flightpath and witness locations.

Safety Board investigators interviewed more than 200 witnesses to establish the sequence of events from the start of the takeoff until impact, and more than 100 written statements were obtained. ([See figure 1](#) for witness locations and flightpath. Numbers correlate to the locations of 10 of the witnesses interviewed.)

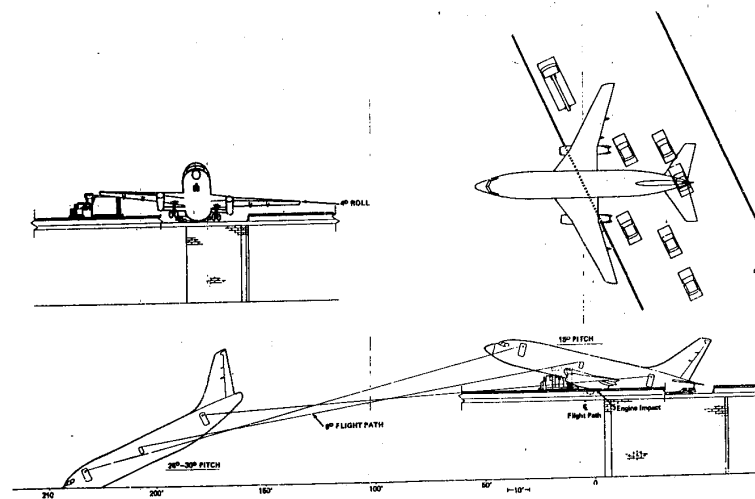
Figure 2. -- Aircraft Impact Attitude.

Ground witnesses generally agreed that the aircraft was flying at an unusually low altitude with the wings level and attained a nose-high attitude of 30° to 40° before it hit the bridge. ([See figure 2.](#)) Four persons in a car on the bridge within several hundred feet from the point of impact claimed that large sheets of ice fell on their car.

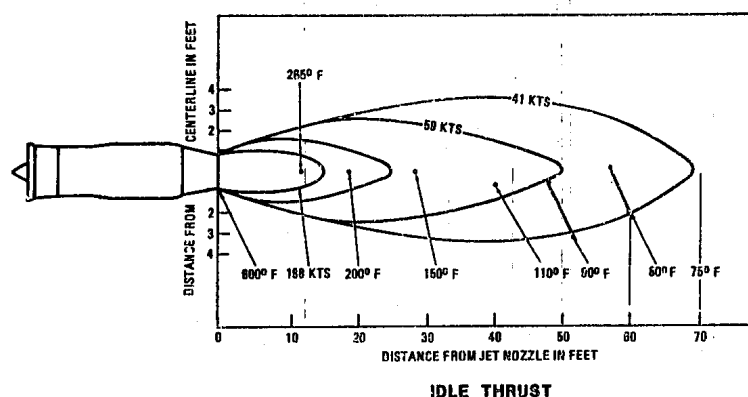
Figure 7.--JT8D turbofan exhaust gas temperatures and velocities.

Jet exhaust temperatures and velocities at given distances and power setting behind the exhaust nozzles of JT8D turbofan engines were determined to provide an indication of their effects on following aircraft. [\(See figure 7.\)](#)
