09/20/81 World Airways, Inc.

Official Accident Report Index Page

Report Number	NTSB-AAR-82-1
Access Number	PB82-910401
Report Title	Airways Inc., Flight 32, McDonnell Douglas DC-10-30CF, N112WA, Over North Atlantic Ocean, September 20, 1981.
Report Date	January 12, 1982
Organization Name	National Transportation Safety Board Bureau of Accident Investigation Washington, D.C. 20594
WUN	3378A
Sponsor Name	NATIONAL TRANSPORTATION SAFETY BOARD Washington, D. C. 20594
Report Type	Aviation Accident Report
Sup Notes	The subject report was distributed to NTSB mailing lists: 1A, 8A and 8B.
Distribution Status	This document is available to the public through the National Technical Information Service-Springfield, Virginia 22161 (Always refer to number listed-in item 2)
Report Class	UNCLASSIFIED
Pg Class	UNCLASSIFIED
Pages	54
Keywords	DC-10, galley lift system, design deficiencies, operations procedures.
Abstract	About 0245 G.m.t. on September 20, 1981, a flight attendant on board World Airways Flight 32, a DC-10-30CF, was fatally injured as a result of being trapped between a service cart in the galley personnel lift and the ceiling of the lower galley as the lift raised. There were 331 reve

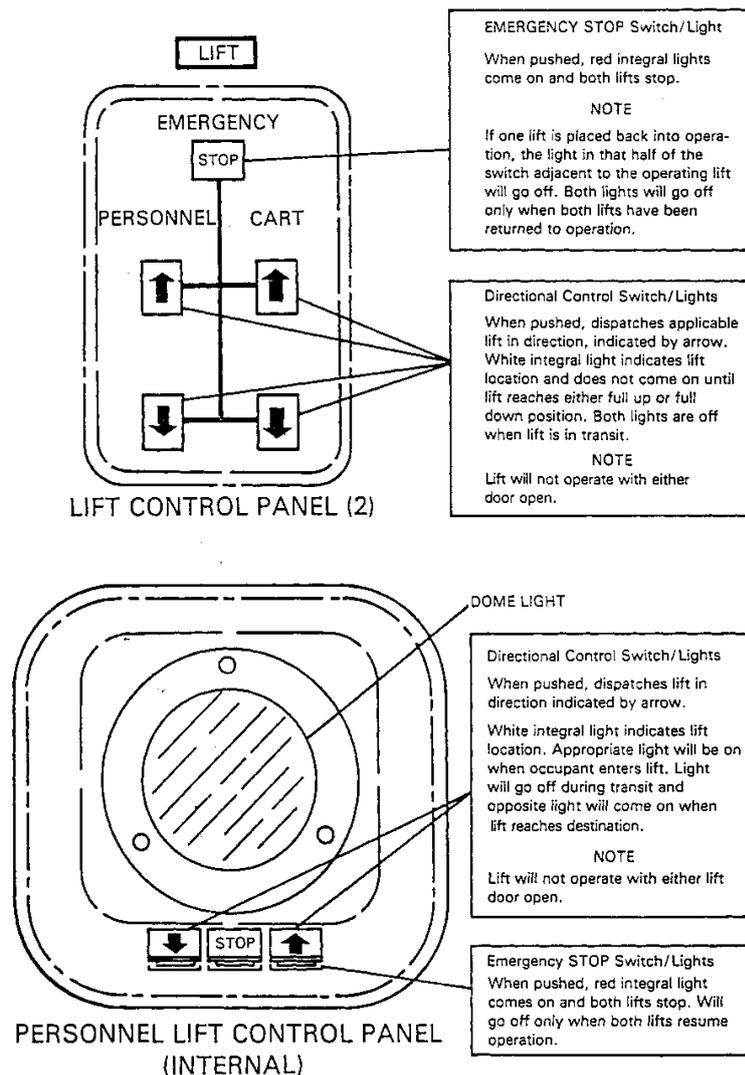
Figure 2.--Personnel and cart lifts.

The galley lift system consists of two lifts used to transport personnel and service carts between the lower galley and the cabin level service center. The system includes a personnel lift, a service cart lift, a drive unit for each lift with individual mechanisms, and controls for operation and safety. The personnel lift can transport personnel or service carts. The cart lift can be used only for service carts due to the reduced height of the lift compartment in the service center. The lifts operate independently. [\(See figure 2.\)](#)

The lower galley personnel lift door frame was deformed and battered in the area where the electrical interlock switches are mounted(see [figure 2](#)). The uppermost electrical interlock switch on the lower galley personnel lift door, S1-450(see [figure 1](#)), was found with the switch roller assembly twisted and the roller striker arm jammed in the depressed (switch closed) position. The damage to the lower galley lift door frames was the result of repeated bumping by food and liquor carts.
