04/28/88 Aloha Airlines

Official Accident Report Index Page

Report Number	NTSB/AAR-89/03
Access Number	PB89-91C404
Report Title	Aircraft Accident Report--Aloha Airlines, Flight 243, Boeing 737-200, N73711, near Maui, Hawaii, April 28, 1988
Report Date	June 14, 1989
Organization Name	National Transportation Safety Board Bureau of Accident Investigation Washington, D.C. 20594
WUN	4886A
Sponsor Name	NATIONAL TRANSPORTATION SAFETY BOARD Washington, D.C. 20594
Report Type	Aircraft Accident Report April 28, 1988
Distribution Status	This document is available to the public through the National Technical Information Service, Springfield, Virginia 22161
Report Class	UNCLASSIFIED
Pg Class	UNCLASSIFIED
Pages	262
Keywords	decompression; disbonding; fatigue cracking; corrosion; multiple site damage (MSD); FAA surveillance; maintenance program; nondestructive inspection
Abstract	<p>On April 28, 1988, at 1346, a Boeing 737-200, N73711, operated by Aloha Airlines Inc., as flight 243, experienced an explosive decompression and structural failure at 24,000 feet, while en route from Hilo, to Honolulu, Hawaii. Approximately 18 feet of the cabin skin and structure aft of the cabin entrance door and a

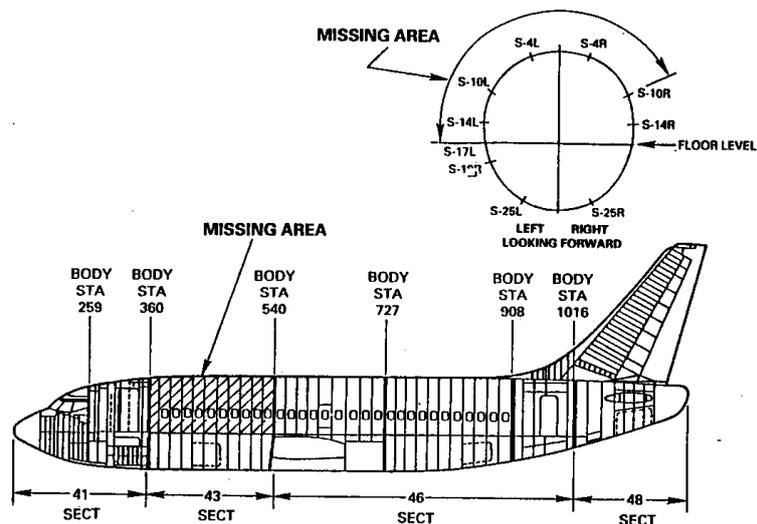
Figure 1.--Boeing 737-200--Body Stations, Stringers, and Section Locations.

A major portion of the upper crown skin and structure of section 43 separated in flight causing an explosive decompression¹ of the cabin. (See [figure 1](#) and [figure 2](#).) The damaged area extended from slightly aft of the main cabin entrance door, rearward about 18 feet to the area just forward of the wings and from the left side of the cabin at the floor level to the right side window level.

The area where the structure was missing extended from body station⁴ (BS) 360 aft to about BS 540, and circumferentially from just above the floor on the left side of the airplane (at S-15L), across the crown and down the right side to a position above the window belt (at S-10R). The structure from the top of the window belt to the floor on the right side was distorted severely and bent outward more than 90°. The skin had peeled in this area leaving the frames, stringers, and window forgings in place. On the left side below the floor level, the skin had peeled off the structure in large V-shaped areas.

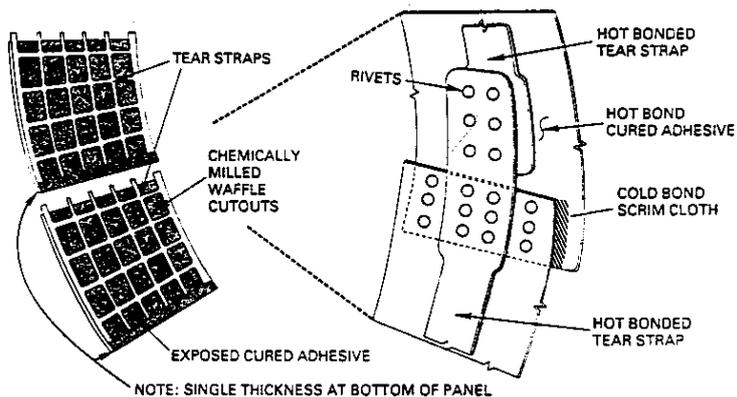
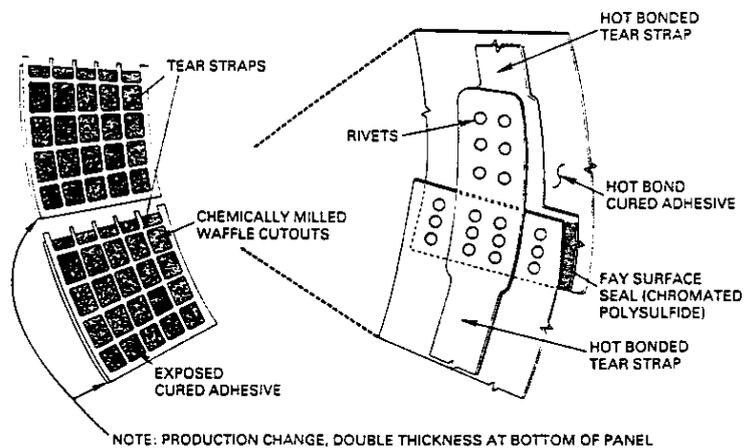
Figure 3.--B-737 Lap splice configuration

On the early model airplanes (through production line number 291), the doubler sheet was milled away chemically at the lap joint locations; for production line number 292 and the subsequent numbers, the doubler sheet was retained on the outer panel of each lap joint to provide an extra 0.036 inch of material thickness in the joint. (See [figures 3](#), [4a](#) and [4b](#).) Additionally, for production line number 465 and the subsequent numbers, an improved bond surface pretreat process using a phosphoric acid anodize was employed.

According to Boeing engineers, when disbond occurs in the bonded lap joint, as designed for the B-737, the hoop load transfer through the joint is borne by the three rows of countersunk rivets that mechanically fasten the skin panels together. Because of the single thickness skin surface that was facilitated by the bonded construction, the countersink for the flush rivet heads extended through the entire thickness of the outer 0.036-inch sheet. A knife edge was created at the bottom of the hole which concentrated stresses. These stresses were cyclic with pressurization loads, and fatigue cracking ultimately occurred at the site.

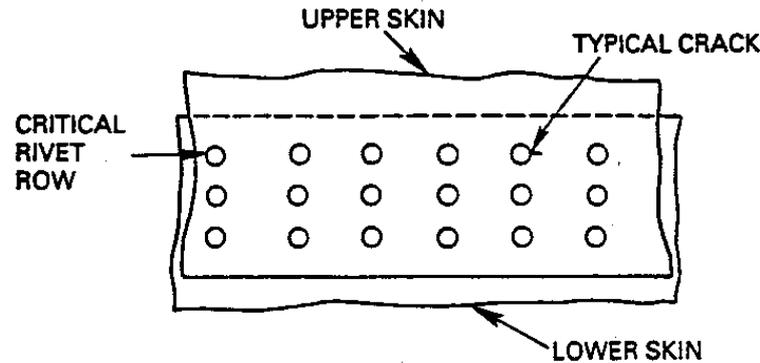
Figure 6a.--Typical lap joint

The lap joint piece, S-4L, from BS 519 to BS 536, exhibited fatigue cracking from 16 consecutive rivet holes along the upper row of lap joint rivets. The largest single fatigue crack in one direction measured 0.18 inch from the knife edge of the countersink. (See figure 6.) The longest total combined crack length in both directions across a rivet hole (end to end of the crack including the hole) measured 0.53 inch. Both the cold-bonded lap joint and the hot-bonded tear straps in this area had disbonded. Light to moderate corrosion was present on the previously bonded surfaces.
