Report Number NTSB-AAR-79-17

Report Title American Airlines, Inc. DC-10-10, N110AA, Chicago-O'Hare International Airport Chicago, Illinois, May 25, 1979

Report Date December 21, 1979

Organization Name National Transportation Safety Board Bureau of Accident Investigation Washington, D.C. 20594

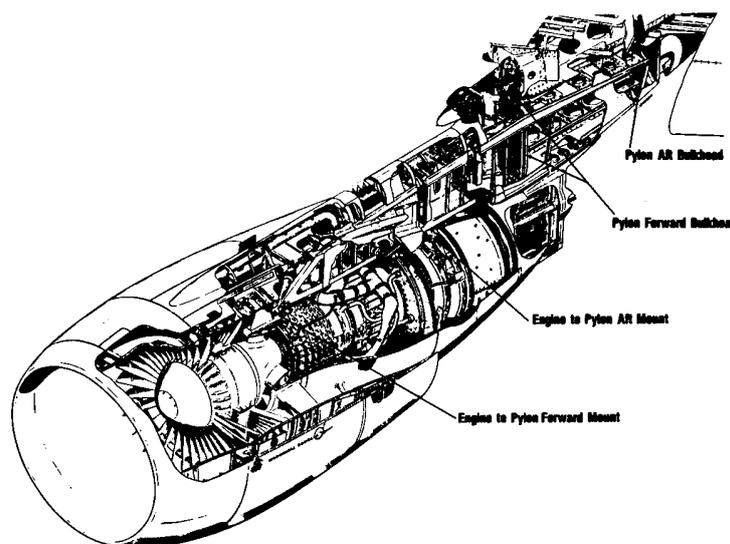
Figure 2. Engine and pylon assembly.

The pylon is attached to the wing using spherical ball joints in three different structural elements. Two of the spherical joints are aligned vertically in a forward bulkhead which is attached to structure in the wing forward of the front spar. Another spherical joint behind the forward bulkhead transmits thrust loads from pylon structure into a thrust link which in turn is connected through another spherical joint to structure on the lower surface of the wing. The third attachment point is a spherical joint in the pylon aft bulkhead which attaches to a clevis mounted on the underside of the wing. The pylon forward bulkhead and portions of the flange from the pylon aft bulkhead either remained with the separated No. 1 pylon or were scattered along the runway. (See [figure 2](#) and [figure 3.](#)) The No. 1 pylon's aft clevis attach assembly and portions of the pylon aft bulkhead, wing thrust angle assembly and thrust link, and pylon forward bulkhead attach assembly remained with the wing.

The pylon forward bulkhead was bent forward about 30° and most of the bolts which held the bulkhead upper plates were missing. The upper 12 inches of the forward plate were bent forward an additional 10° to 15°. The aft plate was broken below the thrust fitting connection, and a large piece of the upper left corner was missing.

The wing's forward support fitting, which attached the pylon forward bulkhead to the wing at the upper and lower plugs and spherical bearings, was found at the main wreckage site. The upper and lower plugs and their attaching hardware were intact, and the upper and lower spherical bearings were attached to the fitting.

The pylon thrust fitting remained attached to the forward portion of the pylon's aft upper spar web. The pylon thrust link, which attached the pylon thrust fitting to the wing thrust angles, was found at the main wreckage site attached to a portion of the wing thrust angles. Its forward spherical bearing was cocked to the extreme left, and a segment of the bearing which had broken away was found on the runway.

The thrust bushing bolt had broken in two parts, both of which were found in the grass adjacent to the runway. The bolt nut was attached to one of the broken pieces, and the faces of the nut were gouged severely. Except for one lubrication retainer washer, which was not found, the remaining portions of the thrust bushing bolt assembly were found along the runway. One shim spacer from the assembly was crushed severely while the other was relatively undamaged.
