07/19/89 United Airlines

Report Number	NTSB/AAR-90/06
Access Number	PB90-910406
Report Title	United Airlines Flight 232, McDonnell Douglas DC-10-10, Sioux Gateway Airport, Sioux City, Iowa, July 19, 1989
Report Date	November 1, 1990
Organization Name	National Transportation Safety Board Office of Aviation Safety Washington, D.C. 20594
WUN	5158D
Sponsor Name	NATIONAL TRANSPORTATION SAFETY BOARD Washington, D.C. 20594
Report Type	Aircraft Accident Report July 19, 1989
Distribution Status	This document is available to the public through the National Technical Information Service, Springfield, Virginia 22161
Report Class	UNCLASSIFIED
Pg Class	UNCLASSIFIED
Pages	126
Abstract	This report explains the crash of a United Airlines McDonnell Douglas DC-10-10 in Sioux City, Iowa, on July 19, 1989. The safety issues discussed in the report are engine fan rotor assembly design, certification, manufacturing, and inspection; maintenance and inspection of engine fan rotor assemblies; hydraulic flight control system design, certification, and protection from uncontained engine debris; cabin safety, including infant restraint systems; and aircraft rescue and firefighting facilities. Safety recommend

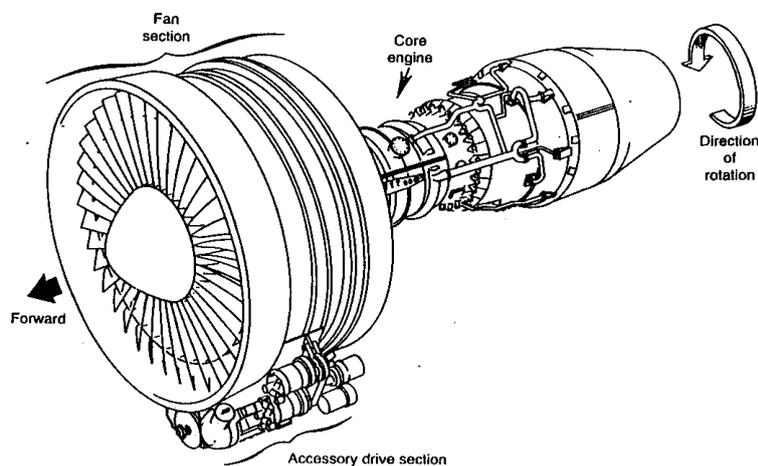
Figure 4.--CF6-6 engine.

Photographs of the airplane were taken by observers on the ground during its final approach to Sioux Gateway Airport. They showed that the No. 2 engine fan cowling and the fuselage tail cone were missing. The remainder of the No. 2 engine appeared intact. Postcrash examination of the wreckage revealed that the No. 2 engine fan rotor components forward of the fan forward shaft, as well as part of the shaft, had separated from the engine in flight. (See [figure 3](#), [figure 4](#), [figure 5](#)).

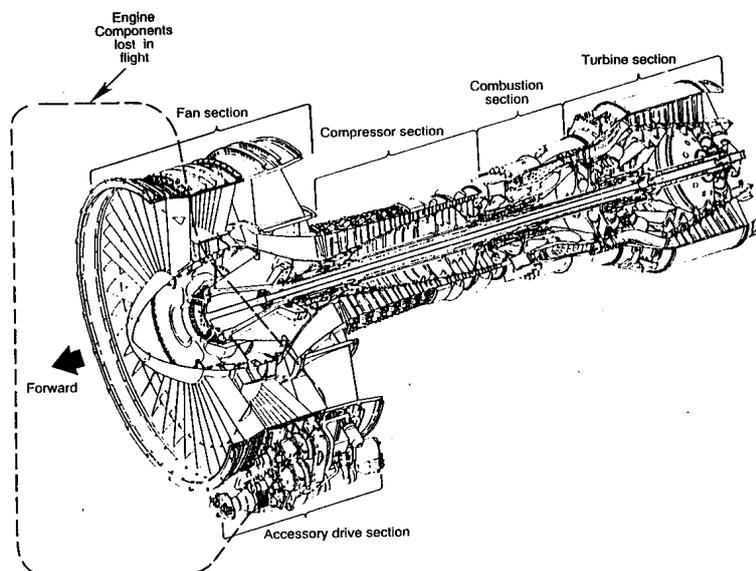
Figure 7.--CF6-6 engine cutaway.

Figure 7 contains a cutaway sectional drawing of the flow path and construction of the CF6-6 engine. The figure also shows the fan and accessory drive sections. Figure 8 displays the CF6-6 rotating assemblies. The portion of the No. 2 engine that departed the airplane is outlined by the dashed lines.
