MITSUBISHI MU-2 AIRPLANES; Availability of Special Certification Review

Subject: ACTION: Mitsubishi MU-2 Special Certification
Review (SCR) Program

SPECIAL CERTIFICATION REVIEW OF MITSUBISHI MU-2

FINAL REPORT

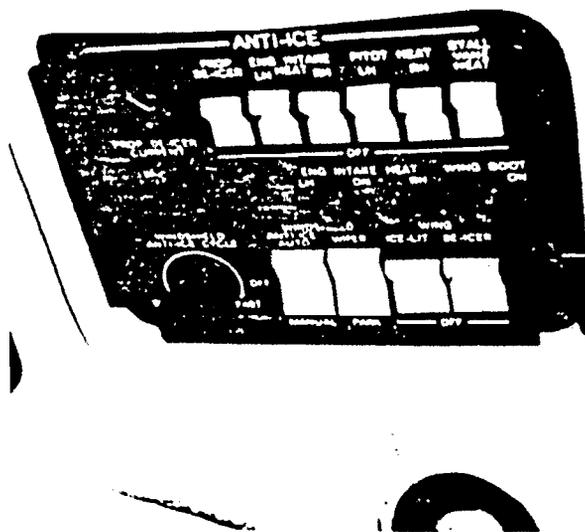
The combination of circuit breaker reliability, circuit protection for each switch/circuit breaker controlled load and the power monitoring capability provided by the PROP DEICE current meter and ENG INTAKE heat lights were and are considered adequate in meeting the CAR 3.681, 3.690, and 3.691 requirements. In addition there is no adverse service history showing this installation to be unsafe. The power monitoring capability of this system is designated in the following photograph of the OVERHEAD PANEL.

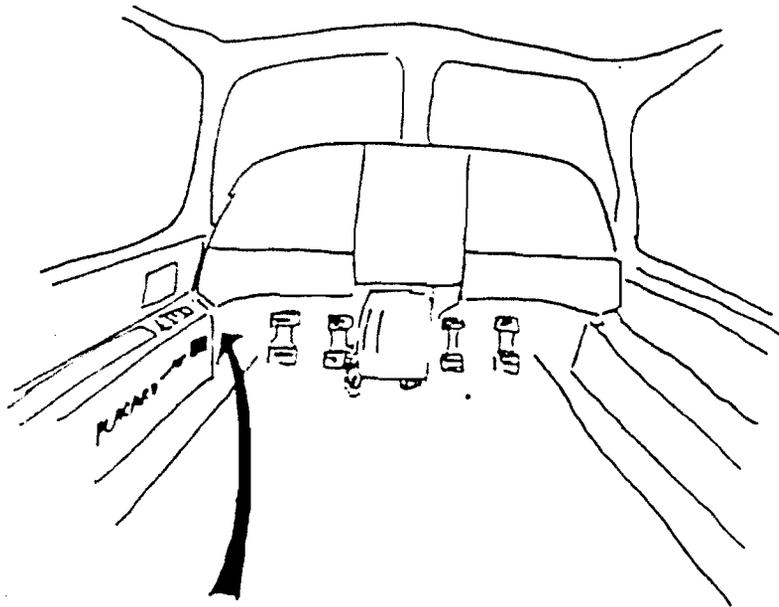
Field Approved Alternate Static Source Selector Location

The other alternate static system that may be installed on the MU-2 was a "field approved" installation. The location of this alternate static source selector is on the left side panel close to the left-hand corner of the lower instrument panel. See sketches of the installation.

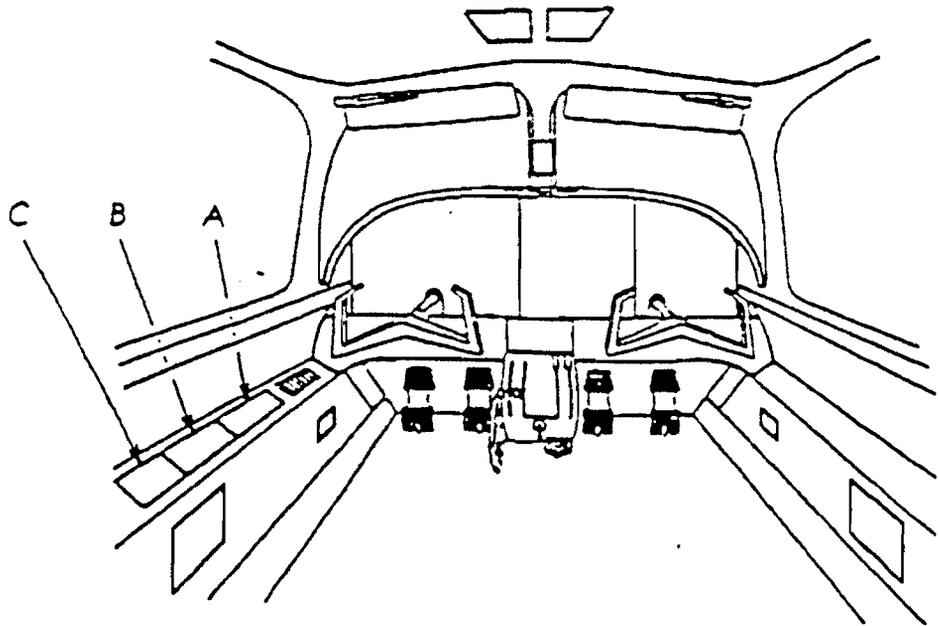
FIG 1. Circuit Breaker Panel Arrangement (See TABLE 1)

As shown on following pages, all circuit breaker panels are proper marking and grouping.
