General Aviation Airworthiness Alerts

AC No. 43-16

**ALERT NO. 235
FEBRUARY 1998**

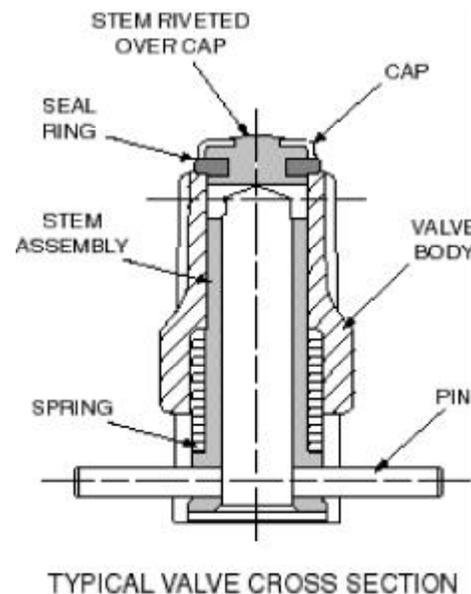
The following recommendations were offered to preclude age-related failures. During scheduled inspections, inspect the external portions of the drain valves for leakage, damage, and condition. If the age of the valve can be determined, it will be a good indicator of the condition of the seal. If defects are found, the valve should be removed for inspection of the seal ring and cap for condition and security. When operating the drain valves, slight hand pressure should be used to oppose the spring force when closing the valve. This reduces the impact force on the seal ring and cap that occurs if the valve is allowed to "snap" closed. If there is any doubt concerning the condition of a drain valve, it should be replaced.
