U.S. Department
of Transportation
**Federal Aviation
Administration**

ADVISORY CIRCULAR

43-16A

AVIATION MAINTENANCE ALERTS

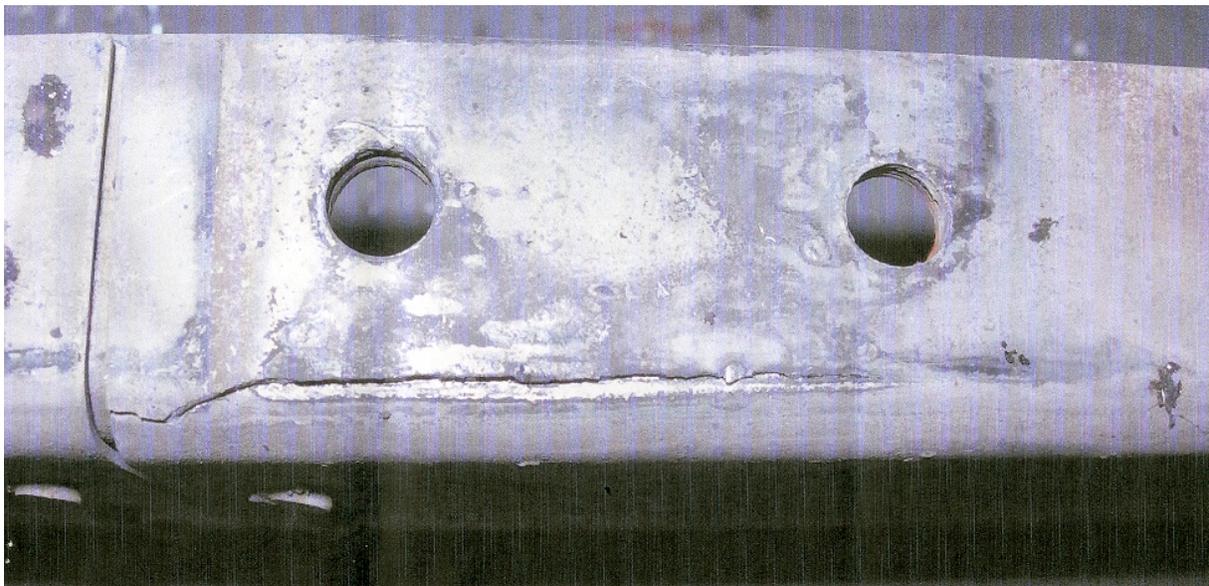
CESSNA**Cessna: 152; Cracked Horizontal Stabilizer Spar; ATA 5511**

A mechanic writes, “On a routine 100 hour inspection a crack was found on the horizontal stabilizer’s front apex: (*specifically*) the lower angle (P/N 0432001-44: see photo number 1) and the reinforcement plate (P/N 0432001-44: photo number 2). The lower skin rivet seam (*was also found*) fretted and loose (photos 3 and 3A.) Upon removal and disassembly (*additional defects*) ...were discovered: cracked skin (P/N 0432001-55: photo 4) and a cracked spar (P/N 0432001-56: photos 5 and 6).
