U.S. Department
of Transportation

**Federal Aviation
Administration**

ADVISORY CIRCULAR

AVIATION MAINTENANCE ALERTS

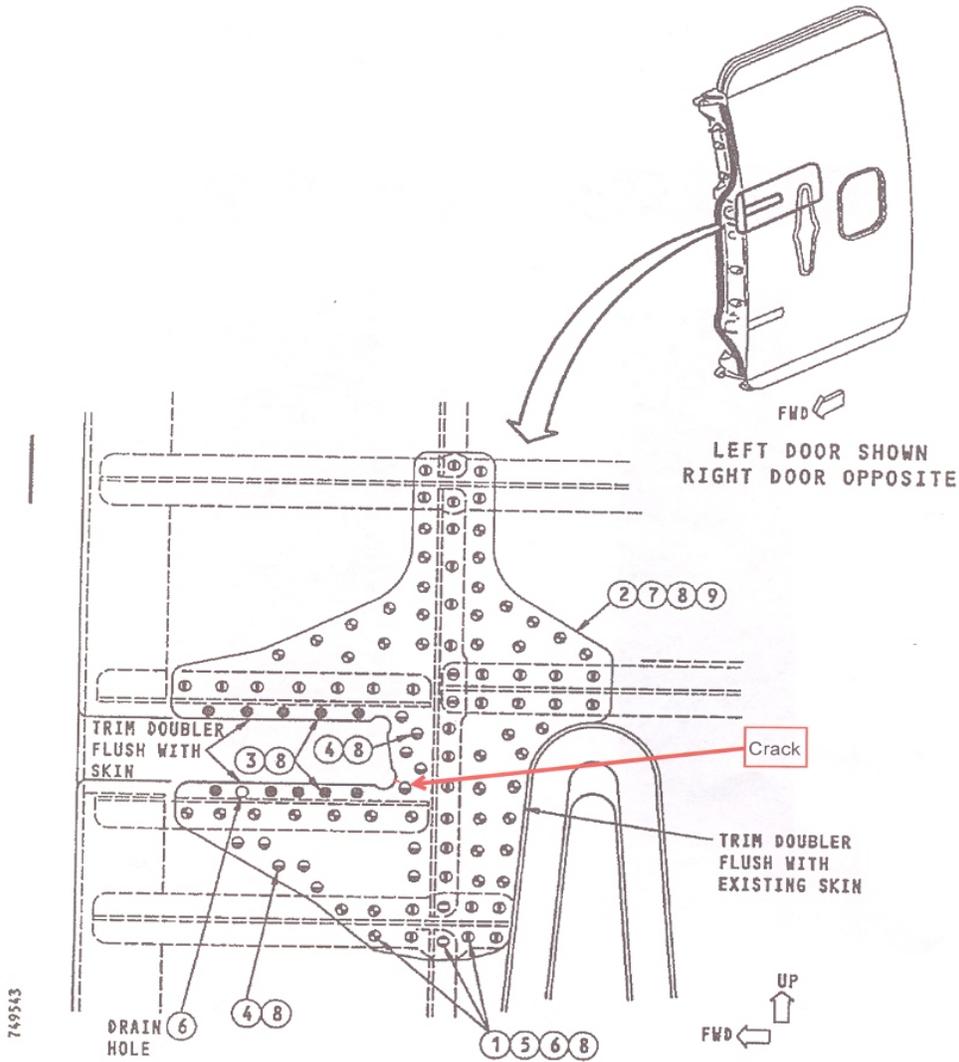
FIGURE 3. MAIN ENTRY DOOR NO. 1 UPPER OUTER SKIN HINGE CUTOUT MODIFICATION, GROUP 1 THRU 4 AIRPLANES

A very short submission from an unknown source writes, "The main entry door's number one upper outer skin doubler (*has a*) crack 0.35 inches at the upper hinge door (*mount*)."

RR551 MED No 1LH – Hinge Cut Out Doubler Crack

BOEING SERVICE BULLETIN 747-52-2144
