**Federal Aviation
Administration**

ADVISORY CIRCULAR

AVIATION MAINTENANCE ALERTS

**ALERT
NUMBER
390**

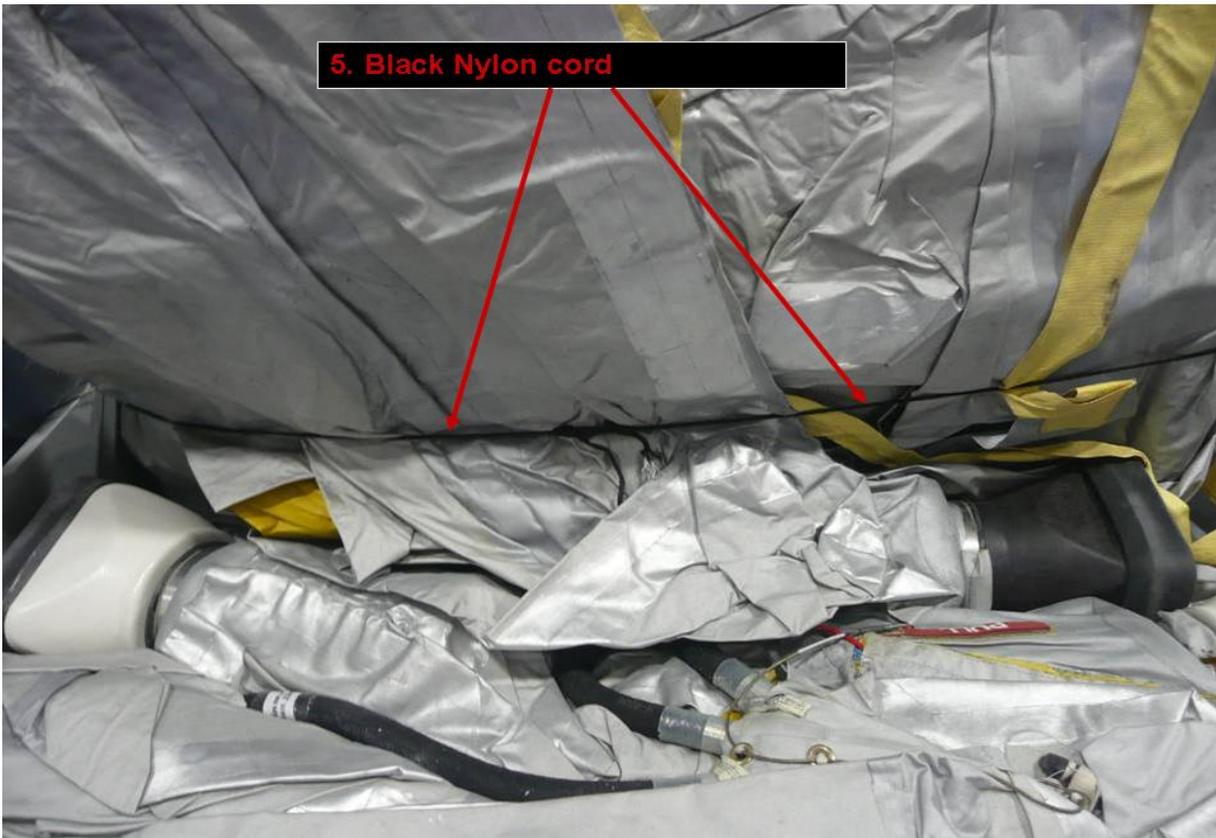
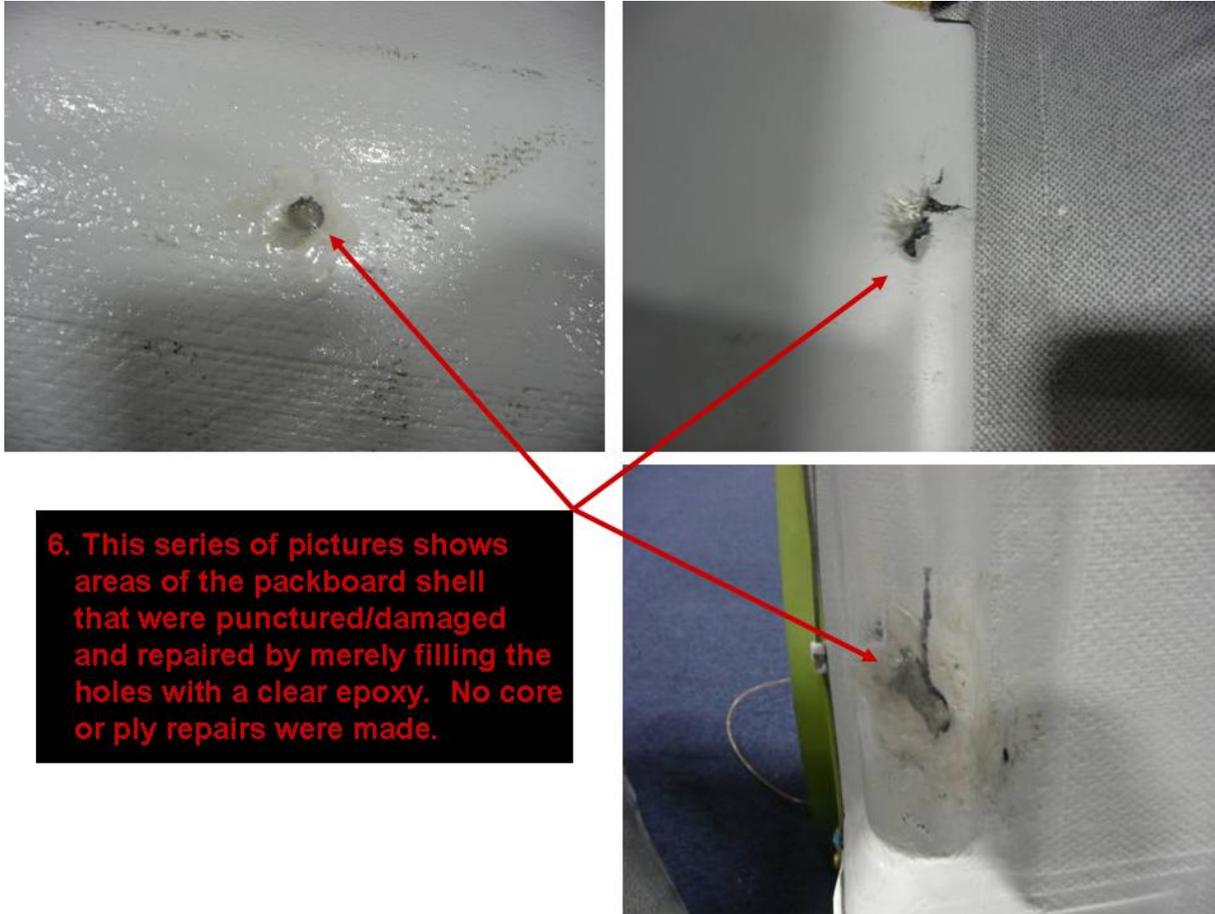
- 1) The main pack cover was installed backwards.
- 2) The proper pack contour (dimensions) were not achieved.
- 3) The slide pack release cables were incorrectly routed.
- 4) Roughly 80 % of the corrosion resistant coatings were missing from the aluminum Release Rod Assembly.
- 5) A length of round black cord was discovered wrapped around the inflatable inside the slide pack. This black cord was drawn tight around the inflatable folds and securely tied off. It is believed the black cord was used as a folding aid during slide packing.

5. Black Nylon cord
