## ADVISORY CIRCULAR

43-16A

# AVIATION MAINTENANCE ALERTS

**ALERT  
NUMBER  
400**

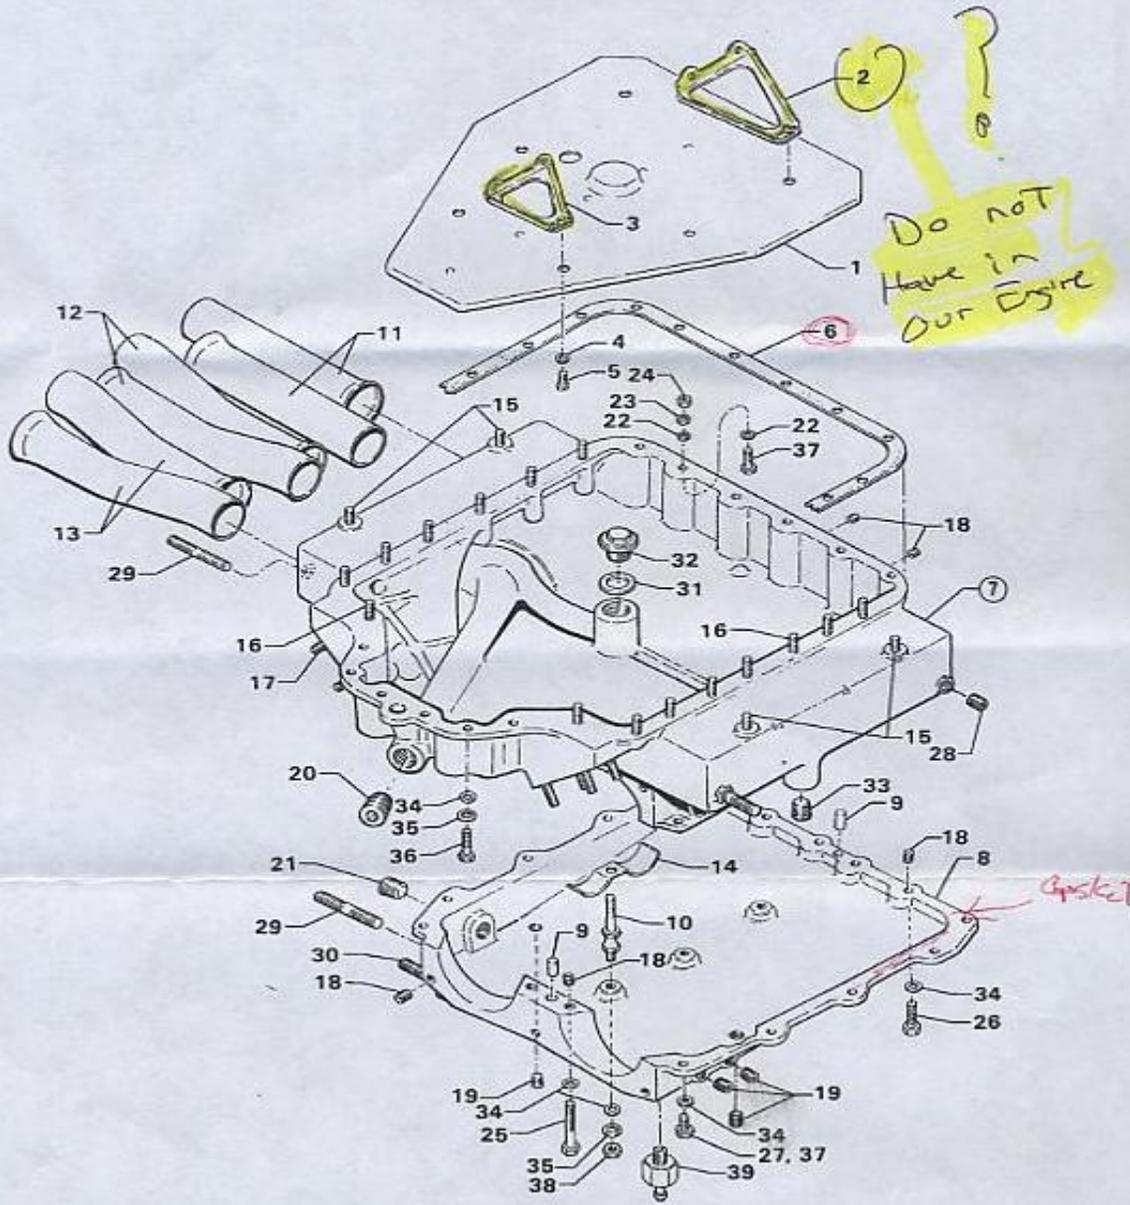
Figure 23. OIL SUMP AND INDUCTION HOUSING ASSEMBLY

"This baffle (P/N LW-13383) has been replaced by a second (P/N 56G23399) and a third (P/N 56G26069)," states this mechanic. "During the first 50 hour inspection, the suction oil screen was removed for condition inspection. (I) found the head of a steel rivet in the screen. I consulted the parts catalogue figure 23 (*for the broken rivet's possible original location*) and found baffle (item 1) to have a rivet assembly. I then removed the oil sump and induction housing." "The oil baffle had one rivet head missing, and I noted three of the six attaching holes had circular cracks emanating from under the washers. After removal of all the attaching bolts and washers, it was noted all (*housing*) attaching (*points*) had been (*scored*) by the sharp edges of the washers."
