AC NO: 20-78 DATE: 11 July 72

MAINTENANCE INSPECTION NOTES FOR MCDONNELL DOUGLAS DC-8 SERIES AIRCRAFT

DEPARTMENT OF TRANSPORTATION FEDERAL AVIATION ADMINISTRATION

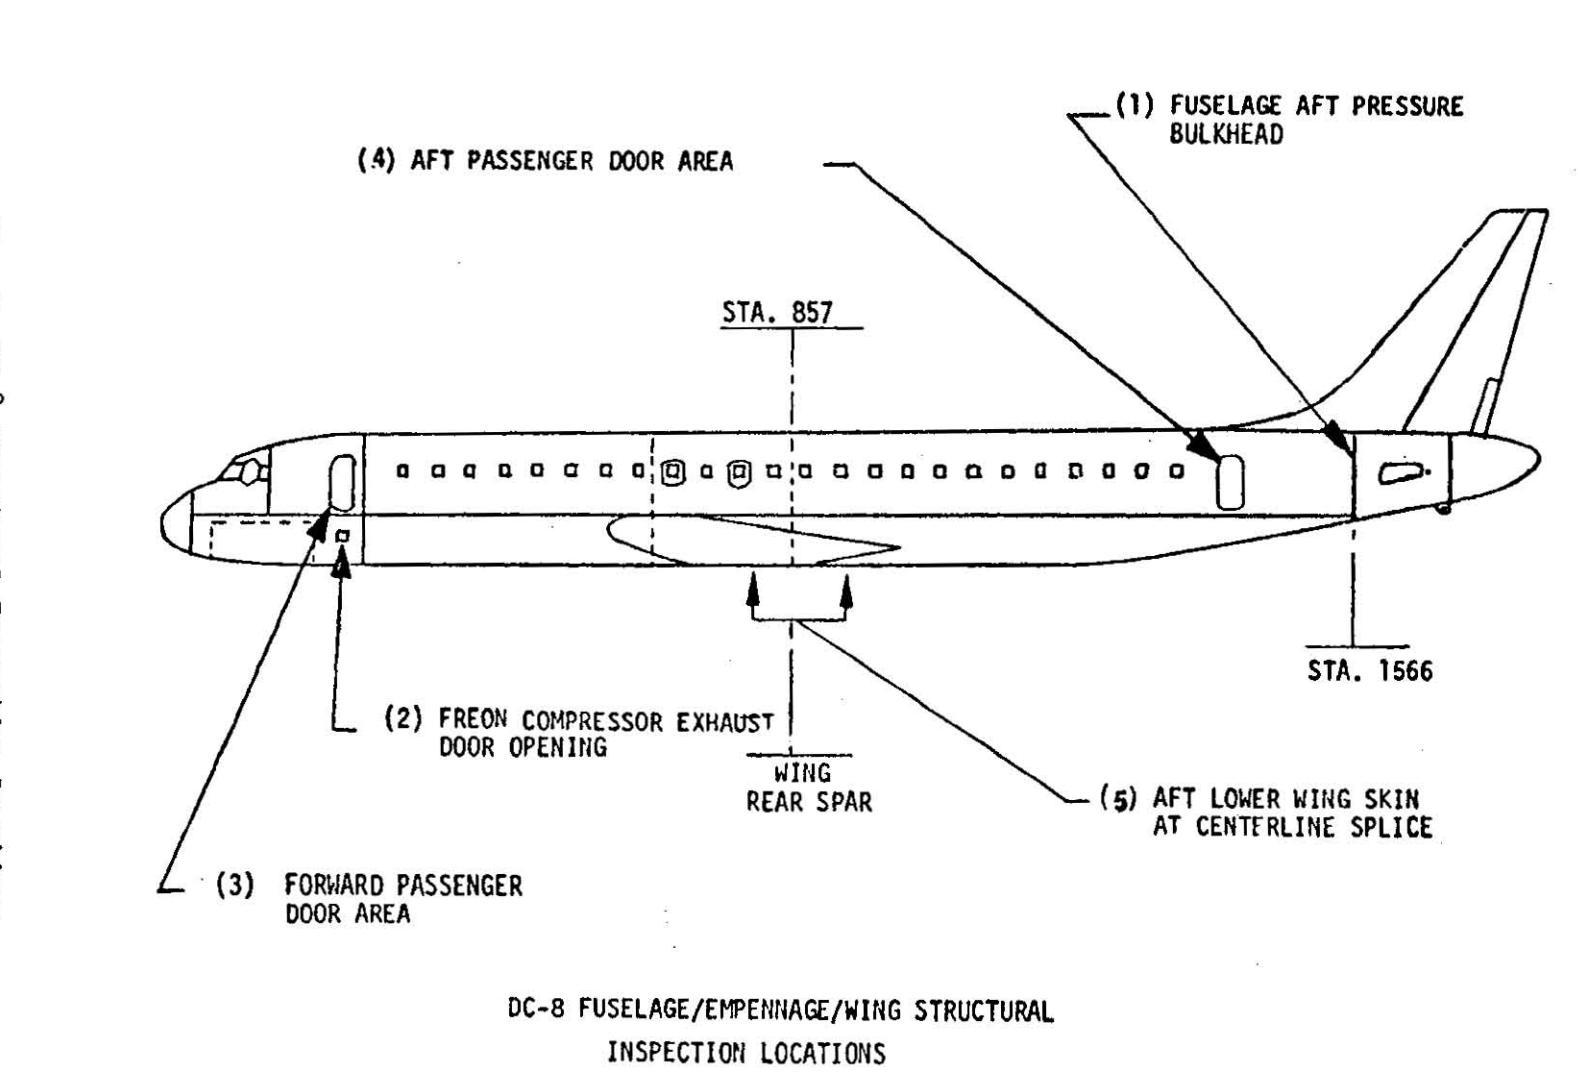
Fig. 7 DC-8 Structural Inspection Locations

- 1. <u>DESCRIPTION</u>. Five significant structural items are discussed in this appendix. If in a high time DC-8 aircraft a crack occurs in one of these items and is allowed to exist for an extended period of time, the continued airworthiness of the aircraft may be adversely affected In Figure 7, the general location of these items are described.
