AIA Project Report

**High Bypass Ratio Turbine Engine
Uncontained Rotor Events**

Small Fragment Threat Characterization

Volume 1

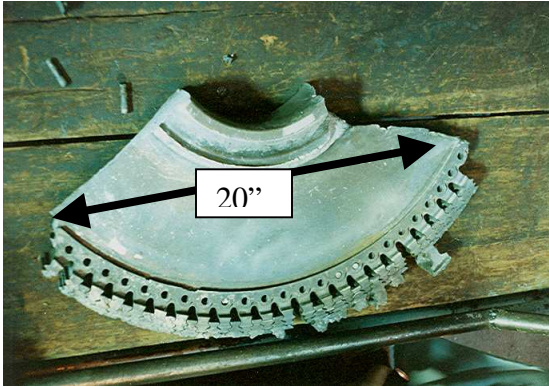
Figure 2.2 Example of a large fragment

Large Fragment: A large fraction of a disk, 20% to 100%. This is modeled in the AC by 1/3 disk.

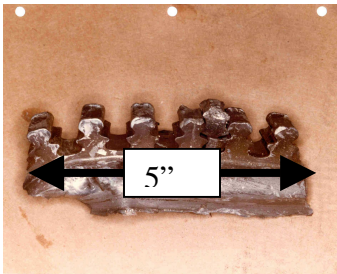
Figure 2.3 Example of an intermediate fragment

Intermediate fragment: A disk piece typically generated when the disk rim peels away from the web and /or bore, resembling a “bite” out of the rim. Arc lengths of 30 to 60 degrees have been typical. This is modeled in the AC by a piece with “a maximum dimension corresponding to one-third of the bladed disc radius...or 1/30 of the bladed disk mass”

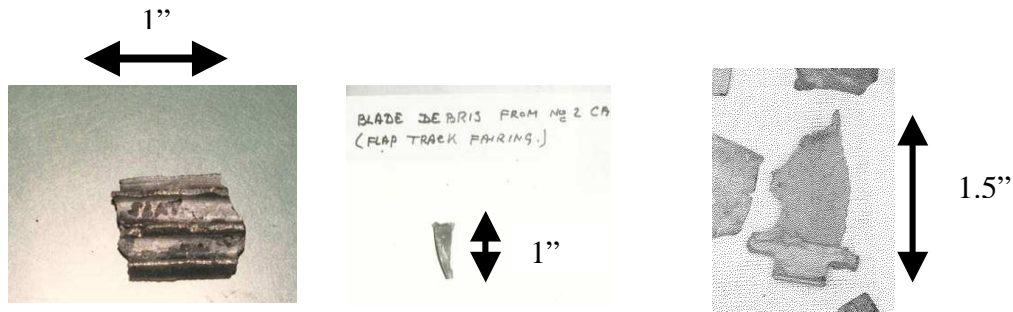
Figure 2.4 Examples of small fragments.

Small fragment: A “shrapnel” type piece of airfoil or disk (or associated hardware); generally deformed or fragmented. The examples observed are generally equivalent to a blade chord in one dimension, and twice that in the second dimension. This fragment is modeled in the AC by the outer half of a blade airfoil, or the outer 1/3 airfoil in the case of a fan blade.

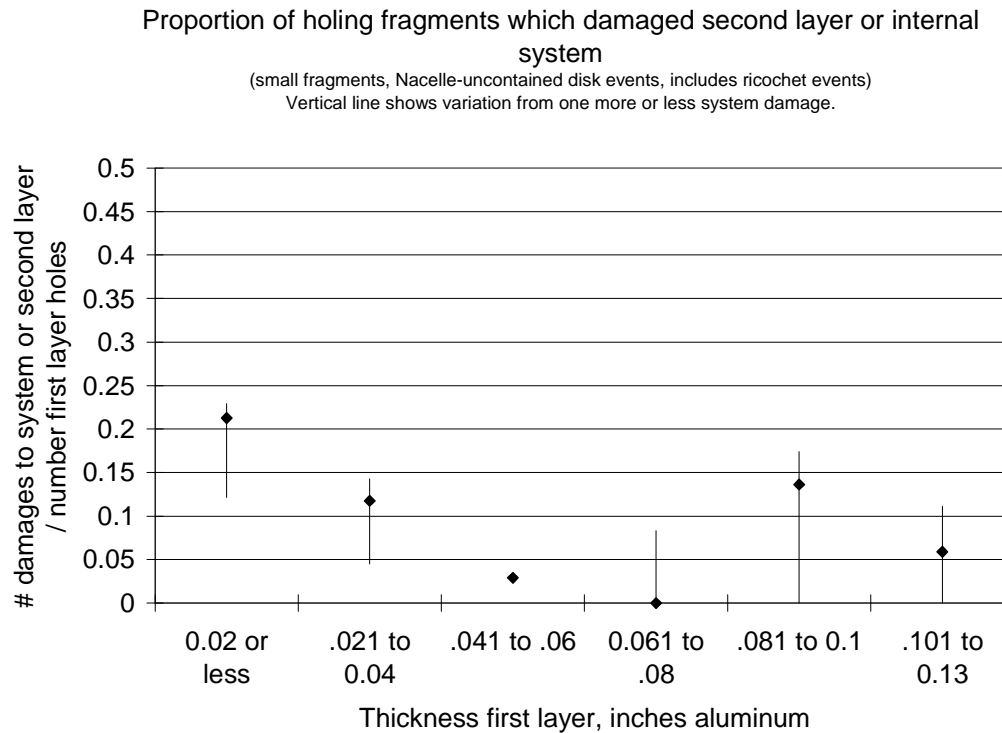
Figure 4.12 Damage to a second layer of structure by small fragments

- The empennage is typically .02” thick aluminum skin, riveted to .02” thick doublers. There were five events in which small fragments holed the empennage skin, with a total of 63 holes. Twelve of these fragments had sufficient residual energy to pass completely through the empennage – through a second layer of .02 to .04 aluminum. In two cases the fragment also dented and bent ¾” diameter stainless steel hydraulic lines in transit .

The results of Figure 4.12 are very consistent with the observation of Reference 2 that only 10% of fragments which make holes are able to cause damage to systems inside. Figure 4.11 showed that a first layer of .08" aluminum (similar to fuselage pressure skin) provides enough energy attenuation that between 80% and 90% of small fragments do not make a hole in the skin. Figure 4.12 shows that of the small fragments making a hole, 80% to 90% of them are unable to damage a second layer of structure or a system. In summary, a layer of .08 aluminum provides sufficient energy attenuation to protect against systems damage for at least 96%²⁶ of small fragments.

- Most small fragments which make holes in the airplane do not have enough residual energy to damage systems or additional structural layers inside the hole. Of 450 small fragment holes, 27 fragments went on to damage systems or structure inside the hole. (Figure 4.12) .

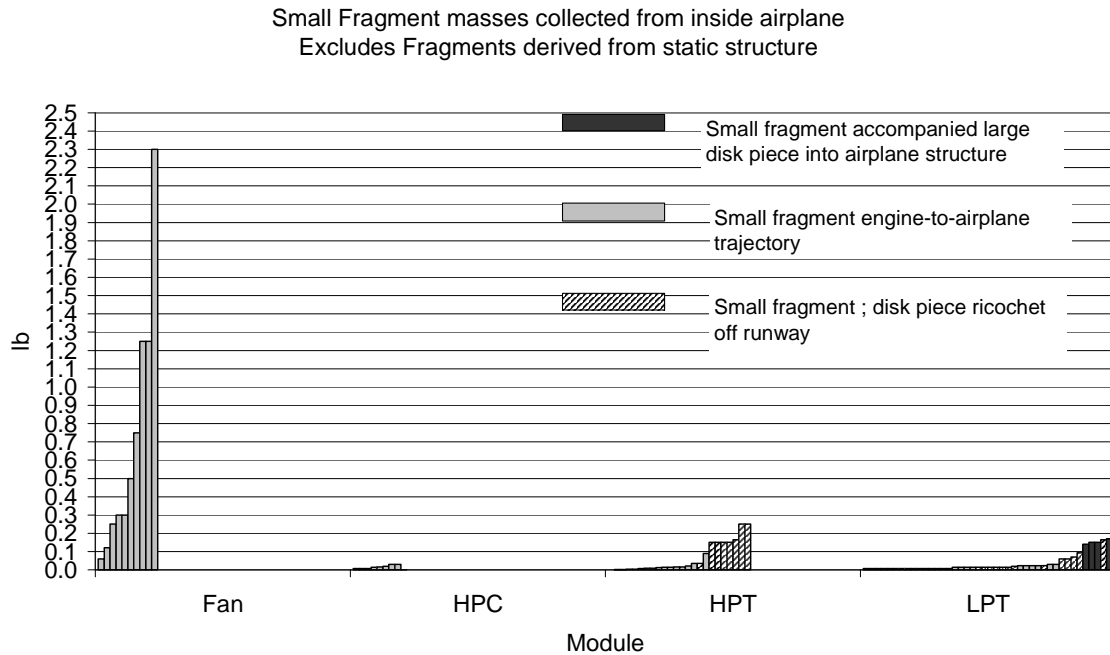
Figure 4.15 Masses of small fragments retrieved from inside the airplane

Figure 4.15 shows the absolute mass of the fragment retrieved from inside the airplane, each bar representing one fragment.

For both charts, the fragments collected after events involving disk ricochet are shaded with a diagonal stripe, and the fragments which accompanied a large disk piece into the airplane structure – in other words, the large piece made the hole, and small pieces were retrieved from inside the hole – are shaded black, so that they can be distinguished from the remaining data (shaded grey).

- The masses of small fragments, collected from holes in the airplane, indicate that the extent to which blades break up is influenced by their initial size and construction. A larger blade will break into more pieces than a small blade, in the course of a disk burst. (Figures 4.15 and 4.16).

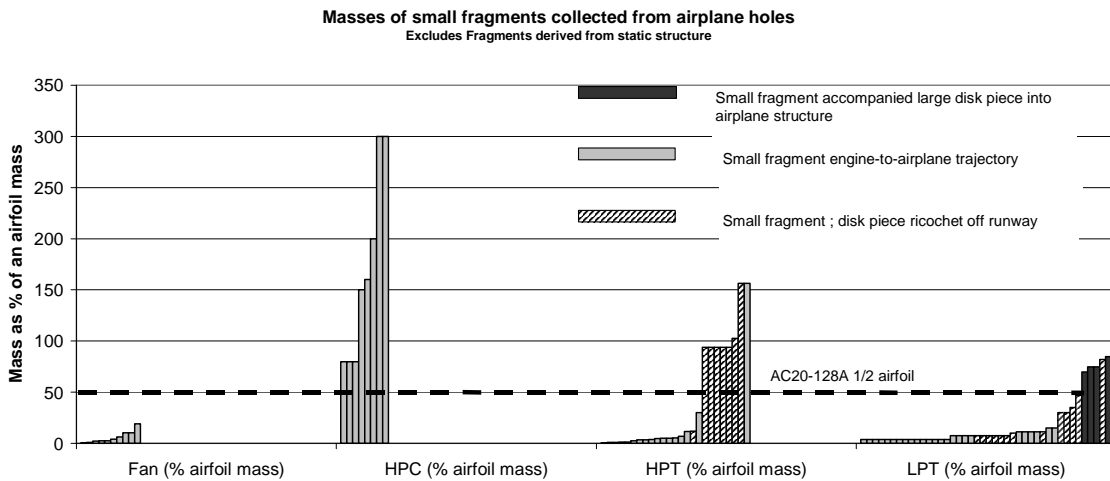
Figure 4.16 Normalized masses of small fragments retrieved from inside the airplane

Figure 4.16 shows the fragment as a percentage of a blade airfoil (relating the data to the guidance given in AC 20-128A, which advises that a small fragment be modeled as the outer half of a blade airfoil, or in the case of a fan blade, the outer 1/3 of the airfoil.)

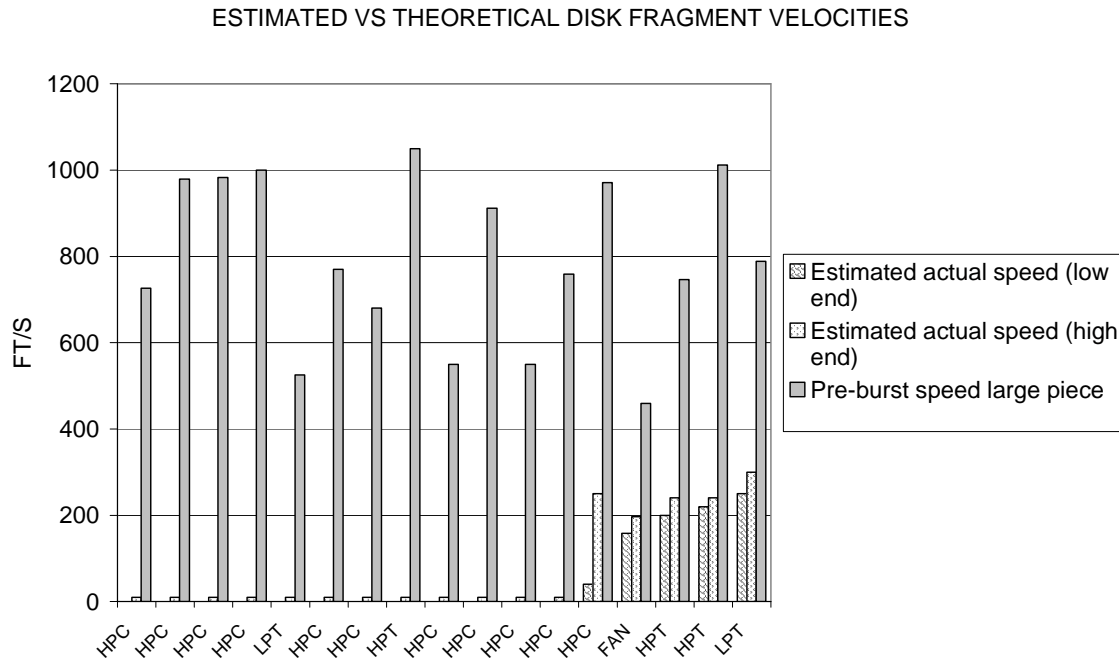
Figure 4.17 Velocities of large disk fragments at escape from nacelle

As noted above, technical opinions have varied regarding the speed with which fragments leave the engine. In an effort to understand the release speeds of small fragments, the release speeds of large disk fragments were assessed. The disk uncontained events were reviewed to establish whether the speeds of the large disk fragments could be deduced from the evidence collected. In many cases, there was not enough evidence to establish the track of the disk fragment with regard to the airplane. However, 17 events had enough evidence to allow an estimate of the speed at which one or more of the large disk pieces departed the engine. This includes the 12 nacelle-contained or partially nacelle-contained events for which details were available. The details of this analysis are documented in Appendix 7. The results are summarized in Figure 4.17 (patterned bars). Figure 4.17 also shows, for comparison, the tangential speeds of those fragments just before the burst event, based on measured engine parameters (rotor rpm) and on the radius from engine centerline of each fragment centroid.

Note: Fragments with zero or near-zero speed are plotted with 10 ft/second as a visual aid. Events are ranked by estimated actual speed.

- Very few disk bursts occur with the spool running at or above red line; the range 90 to 95% of red line appears more typical. (Figure 4.4).
- Analysis of a limited set of large disk fragment trajectories indicates that they were released from the engine at considerably lower speed than their tangential speed immediately prior to burst. Speeds based on trajectories, for this limited set, were less than 30% of pre-burst speeds. (Figure 4.17). Consequently, small fragments may also have much lower speeds than their tangential speed prior to burst.

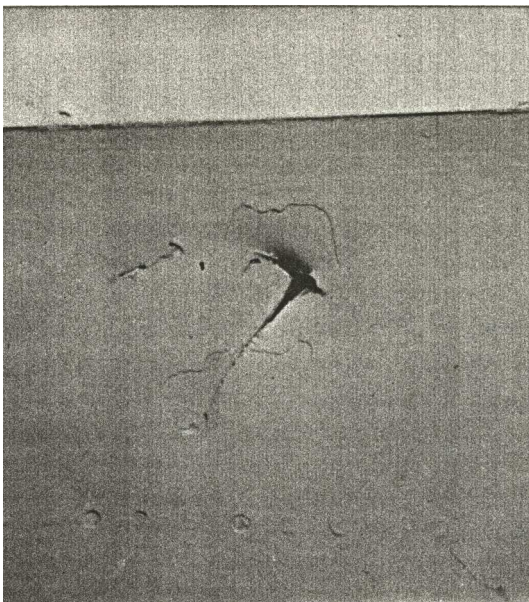
Figure A3.2.12 4" tear in fuselage skin (forward arc)

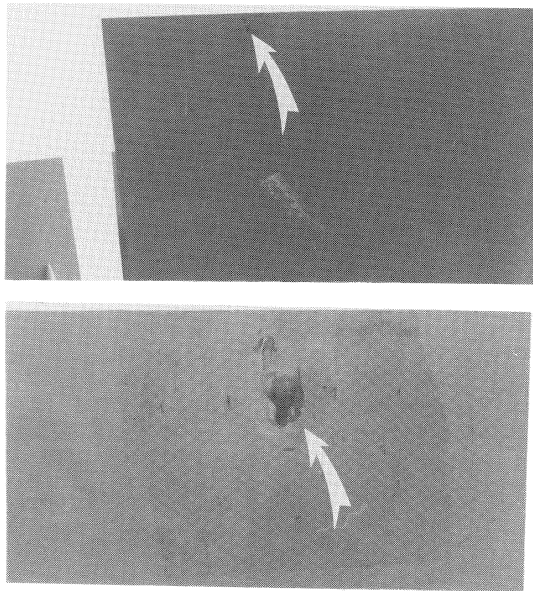
Figure A3.2.14 Aileron dent (forward arc)

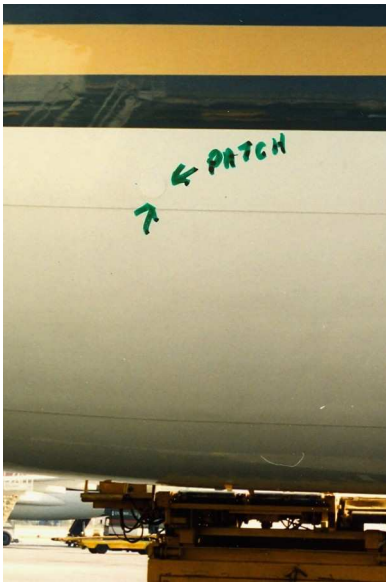
Figure A3.2.16 Fuselage patch over puncture (forward arc)

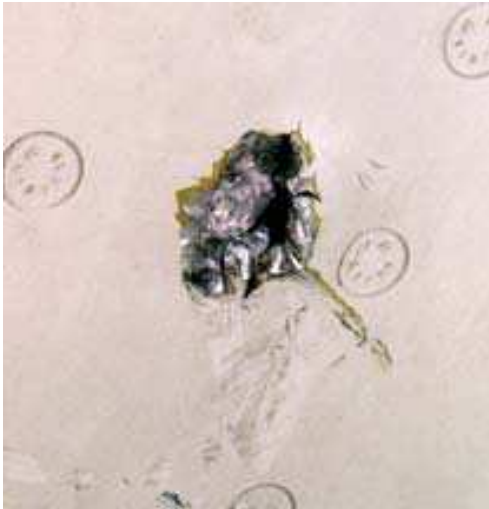
Figure A3.2.19 2cm fuselage puncture (forward arc)

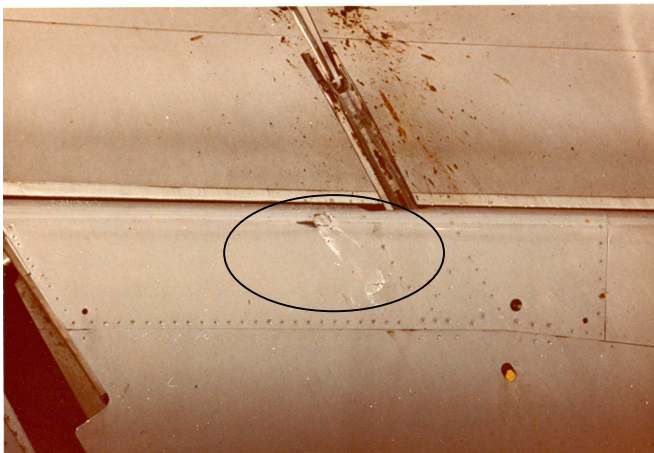
Figure A3.5.2 Elevator dent (tailpipe debris)
