COMMISSION OF  
INQUIRY INTO THE  
AIR ONTARIO CRASH  
AT DRYDEN, ONTARIO

Final Report

Volume I

The Honourable Virgil P. Moshansky  
Commissioner

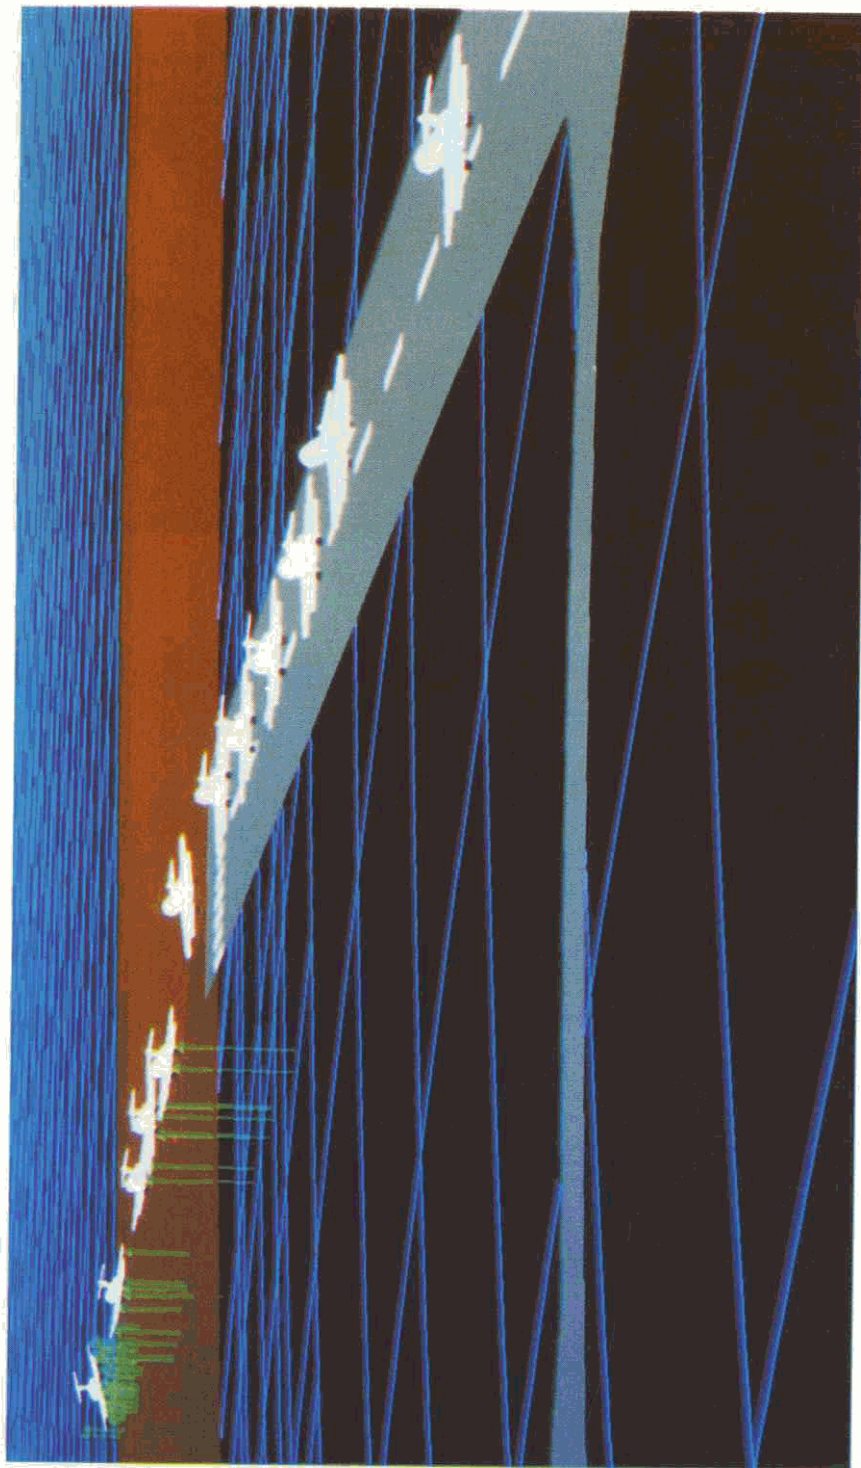
Computer-generated reconstructions of the takeoff were prepared for the Commission of Inquiry by the Canadian Aviation Safety Board (CASB) as part of the investigation of the crash. The first shows the aircraft from the perspective of the terminal: passing taxiway Alpha, attempting liftoff, settling back onto the runway, lifting off again towards the end of the runway, and contacting trees.

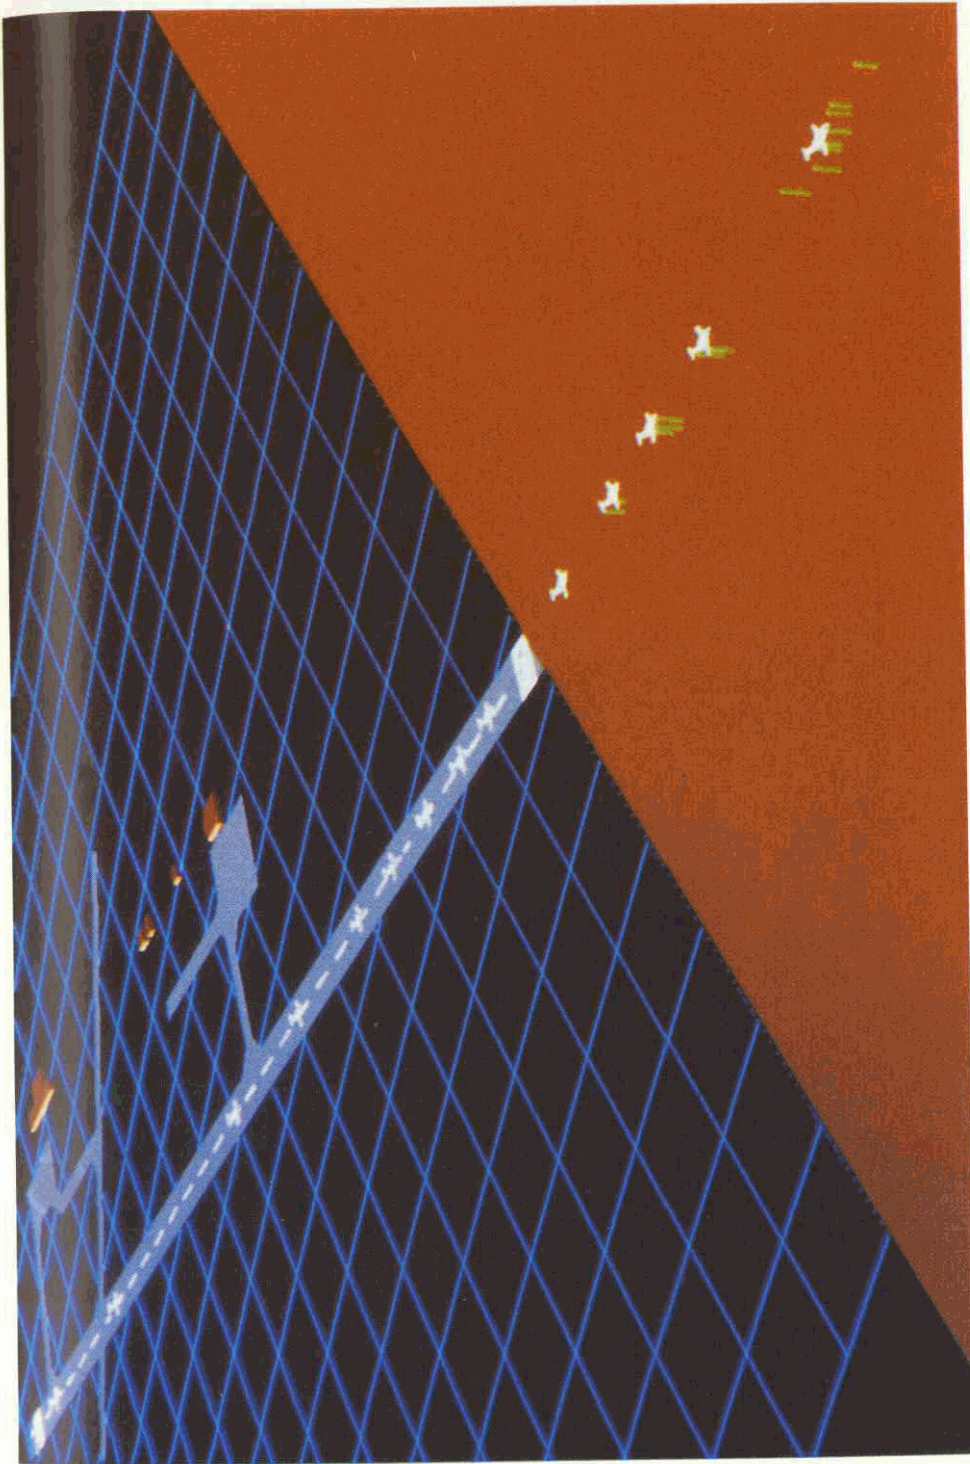
This reconstruction gives an aerial view of Dryden Municipal Airport and the takeoff attempt of flight 1363 on runway 29 on March 10, 1989.

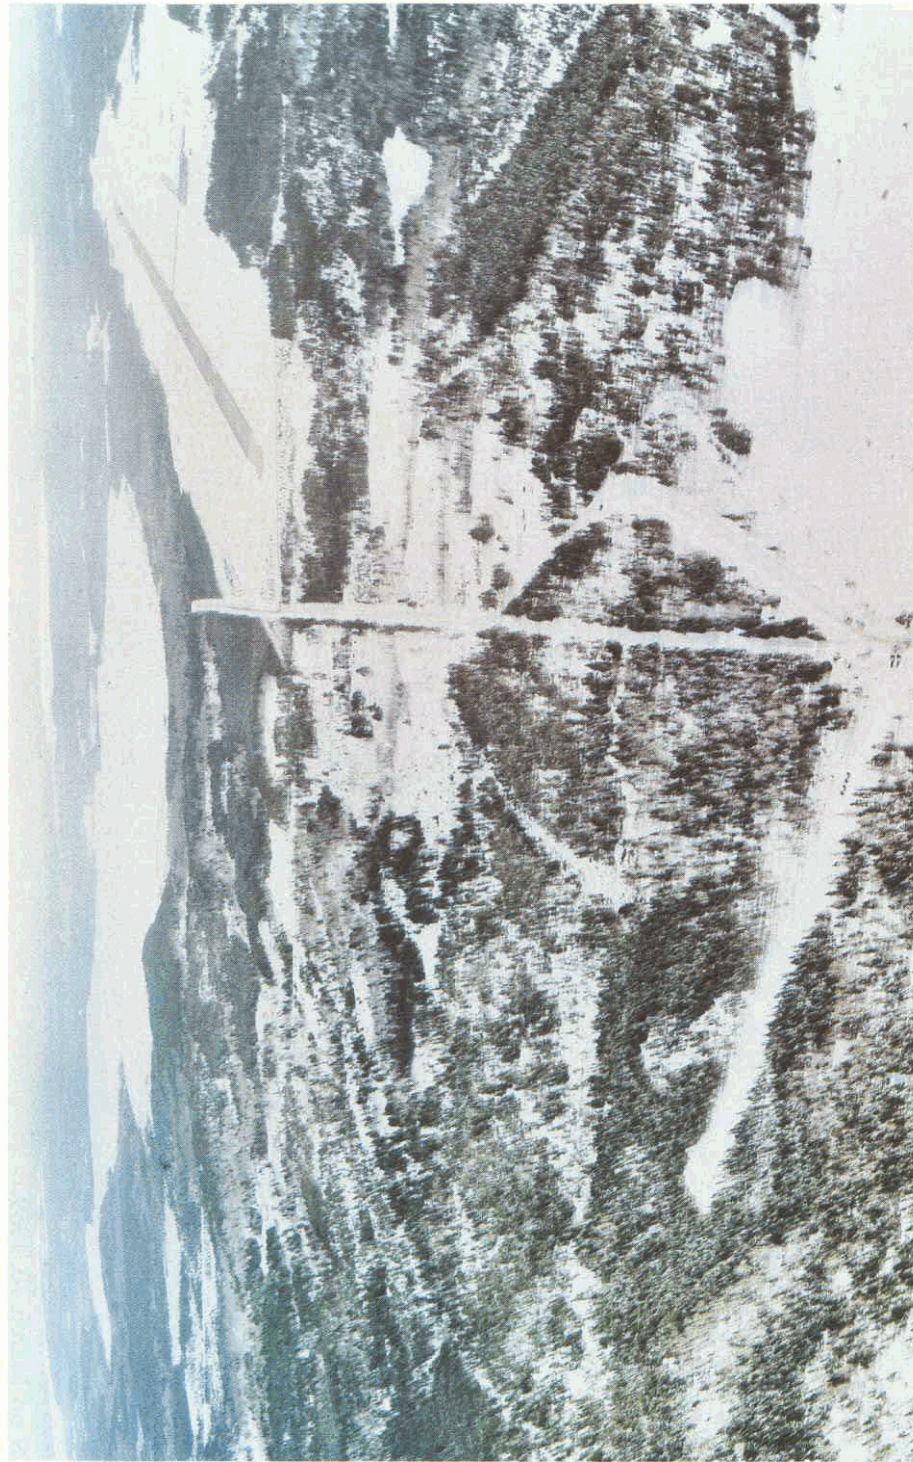
An aerial view, showing the flight path of C-FONF on March 10, 1989.

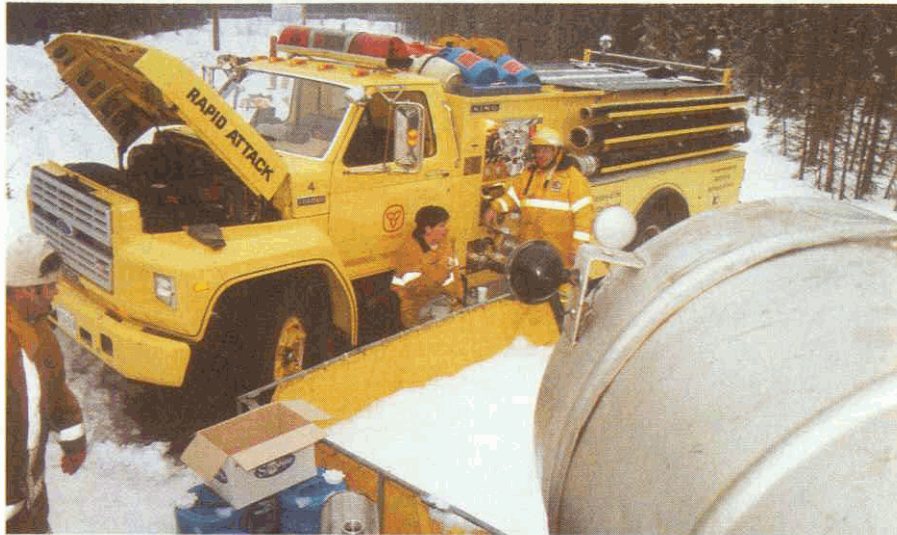
These photographs, taken by one of the fire-fighters in mid-afternoon March 10, 1989, convey the intensity of the fire which, by this time, is nearly extinguished.

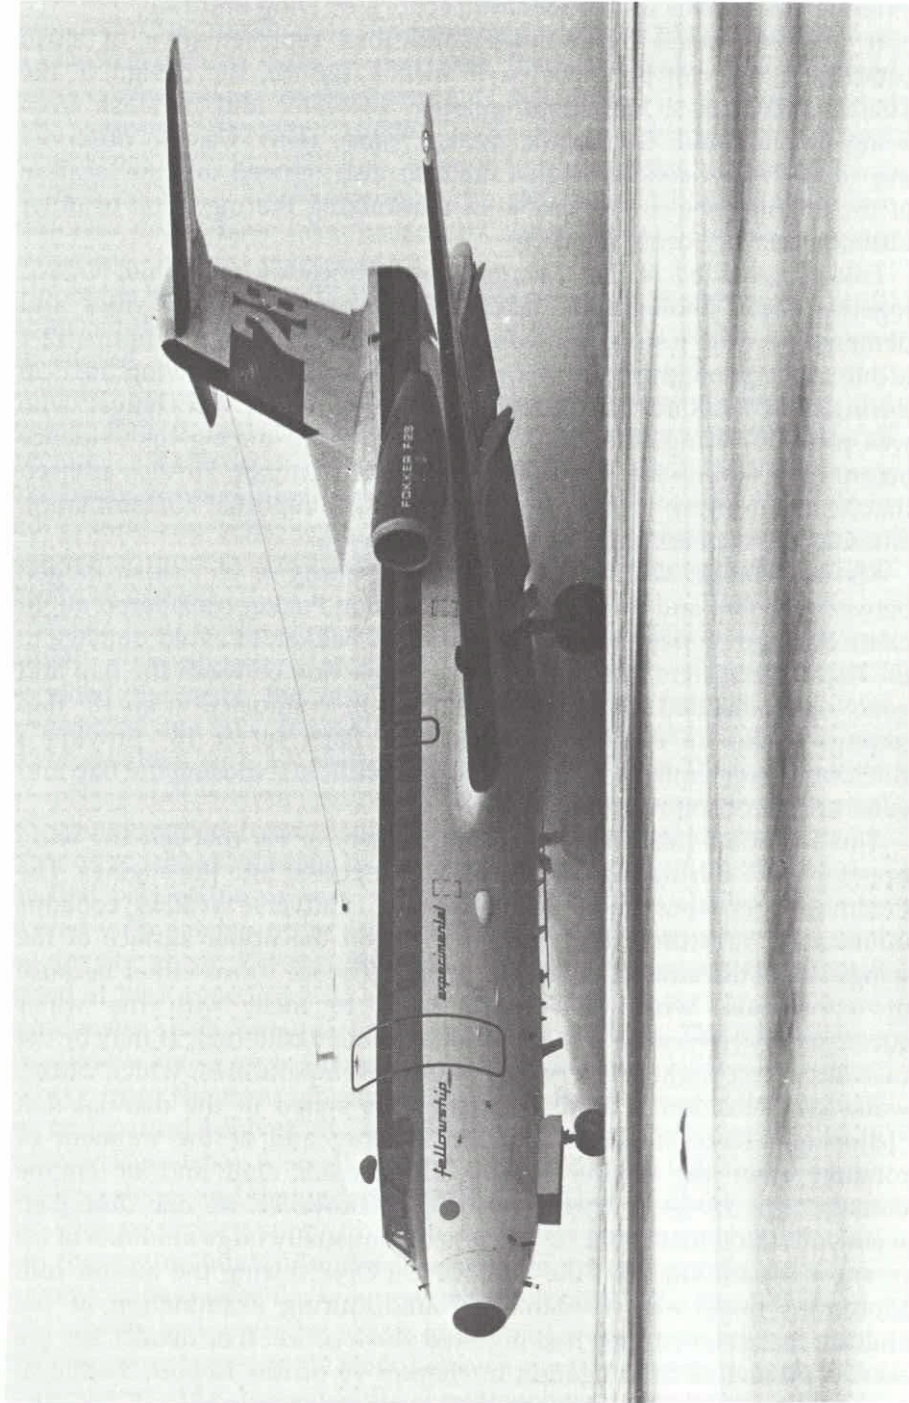
Figure 12-1 F-28 during Slush Test, February 5, 1968

There is some possibility that snow, slush, or ice that left the wing upper surface during the takeoff run was ingested into the engines. The Piedmont operations manual, in the section on adverse weather, contains information regarding ice that may form on the upper surface of the wings while the aircraft is on the ground. The ice forms either because of warm fuel, which can cause snow to melt, with the water subsequently refreezing; or because of extremely cold fuel, as may be the case after long flights at very low ambient temperatures, which causes water condensation or rain to freeze. It is stated in the manual that "[d]uring take-off this ice may break away and at the moment of rotation enter the engine causing compressor stall and/or engine damage" (p. 3A-24-1). During testimony, however, no one described seeing anything that could be taken to be unusually large amounts of ice or snow separating from the wing of C-FONF during the takeoff roll. Moreover, there was no damage found during examination of the engines that showed they had ingested slush or ice. (For details, see the section on engine investigation in chapter 10 of this Report, Technical Investigation.) During manufacturer's certification tests of the F-28 Rolls-

Royce engines, as described in chapter 10, it was demonstrated that the engines were able to ingest great quantities of water with no apparent difficulty. Bearing this point in mind along with the fact that most witnesses testified that the engines were operating normally throughout the takeoff run, it is probable that if the engines ingested snow, slush, or ice from the wings during takeoff, the ingestion could have caused only a fleeting abnormality and perhaps an uncommon noise.

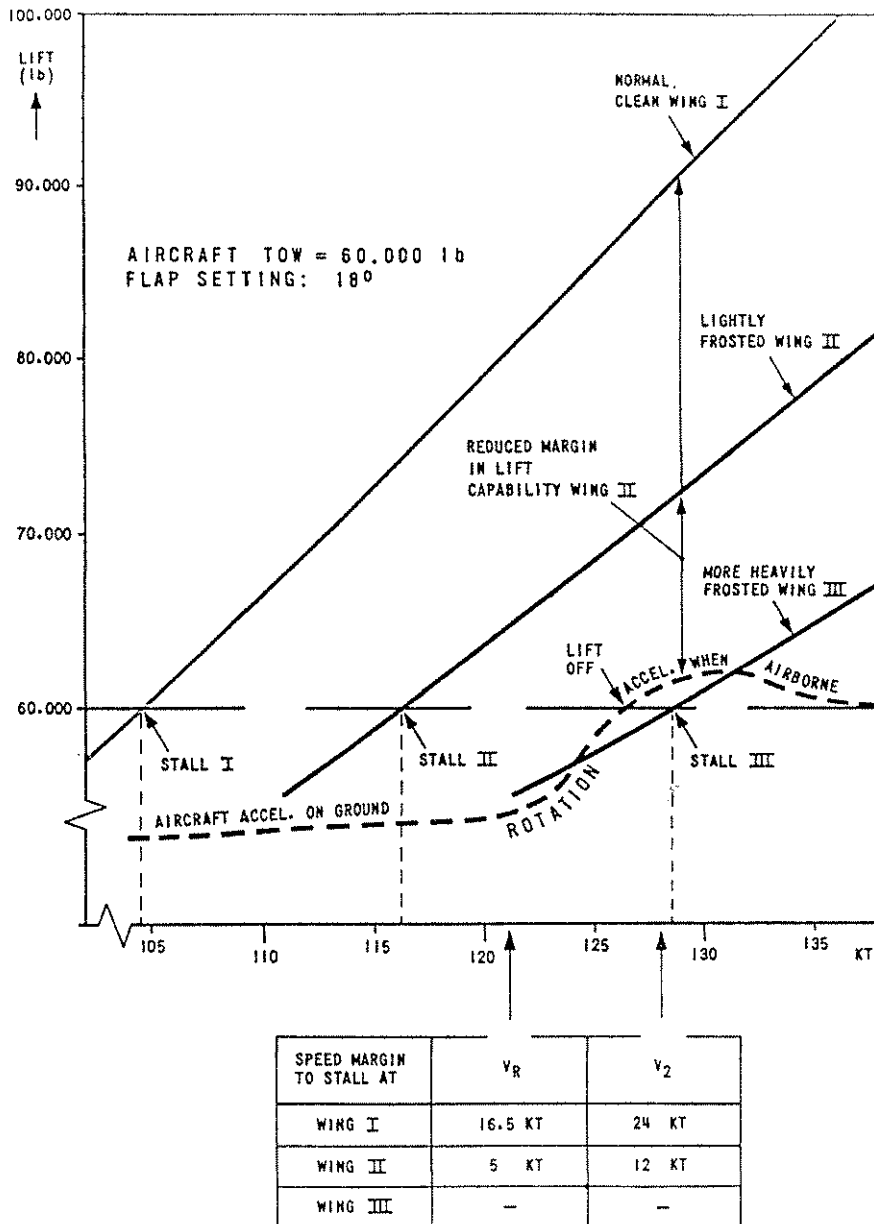
Figure 12-3 Comparative Margins for Two Arbitrarily Chosen Frost-Contaminated Wings and the Normal Clean Wing

Up to a point, as figure 12-3 indicates, the more the wings were contaminated the greater the loss of lift. For example, during takeoff at a weight of 60,000 pounds, with  $18^\circ$  of flap and with a clean wing, the stalling speed of the aircraft was about 104 knots. With the wing lightly frosted, the stalling speed was about 117 knots, and with the wing heavily frosted, about 128 knots. The  $V_R$  speed (takeoff rotation speed)<sup>5</sup> for the aircraft was 121 knots and the  $V_2$  (takeoff safety speed)<sup>6</sup> was 127 knots. With a clean wing, the speed margin at rotation speed before stall was approximately 17 knots. With a lightly frosted wing, the margin was 5 knots. With a heavily frosted wing, the wing was in a stalled condition as it was rotated.

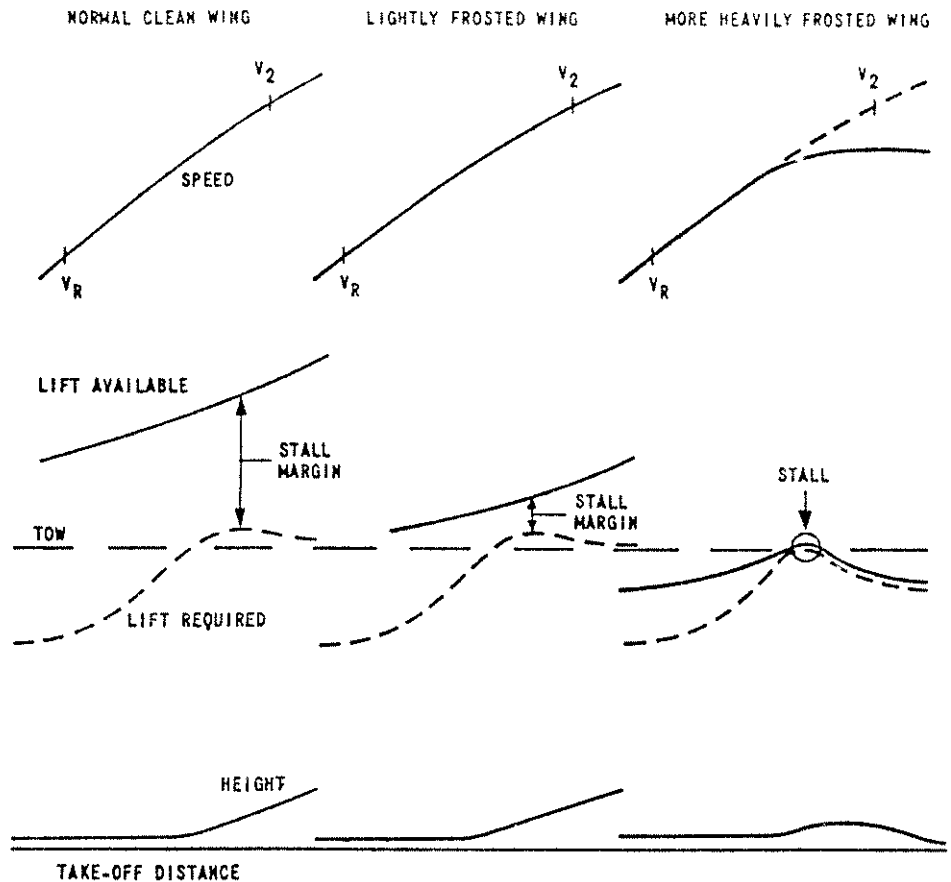
Figure 12-4 Comparative Stall Margins<sup>1</sup>

Figure 12-4 describes the decrease in stall margin between a normally clean wing and a lightly frosted wing and demonstrates that an aircraft

<sup>1</sup> Illustrates differently the comparative stall margins for the same (figure 12-3) two arbitrarily chosen frost-contaminated wings and the normal clean wing.

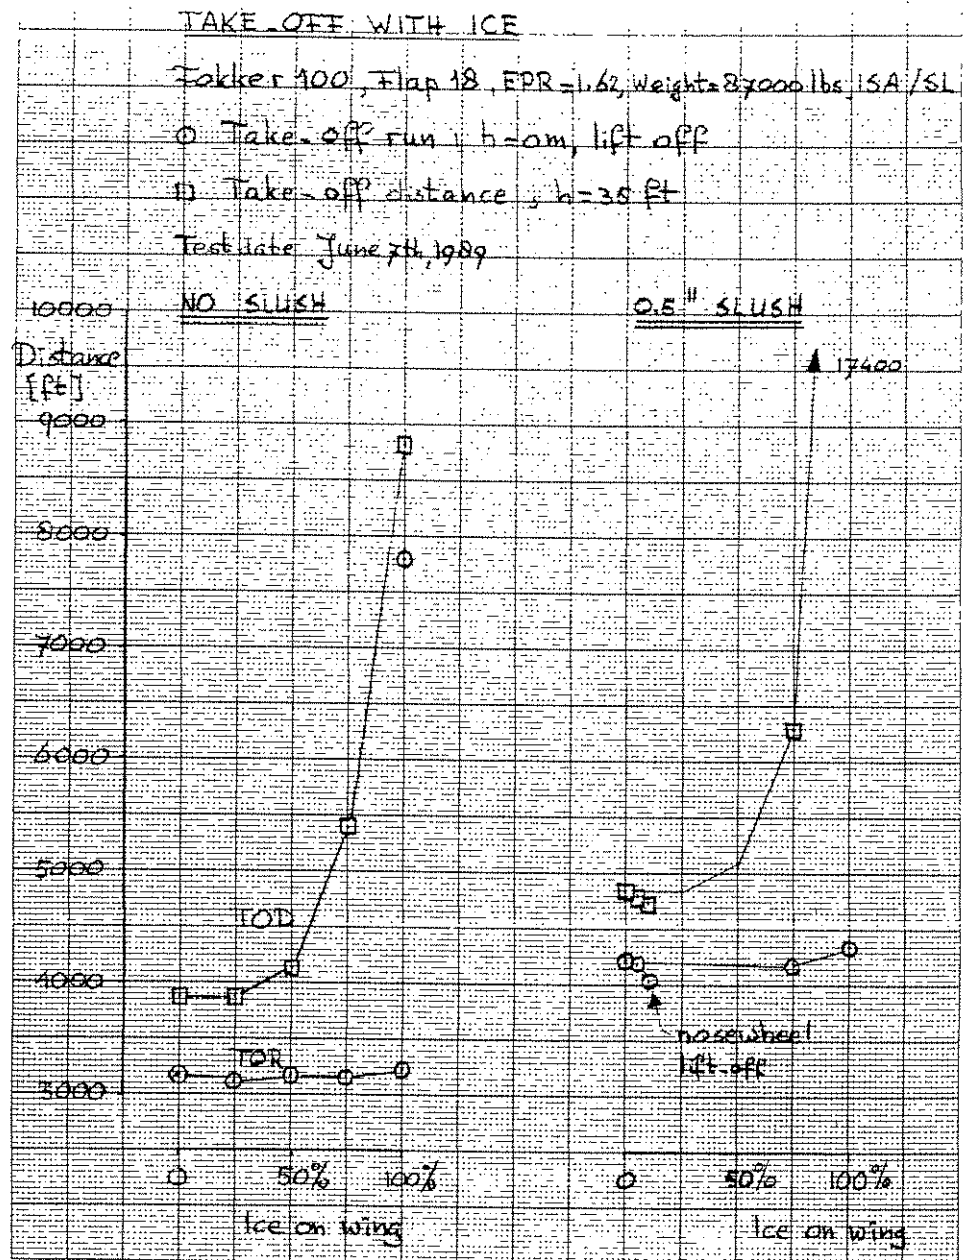
Figure 12-5 Fokker 100 Simulation of Takeoff with Ice, Flaps 18°

Figure 12-5 describes the Fokker 100 simulator with  $18^\circ$  of flap at sea level taking off with power and weight equal to full power on an F-28 at 63,500 pounds. By loading up the wing with contamination from 0, representing a clean wing, to 1.00, representing contamination in an amount equal to 1–2 mm diameter particles per square cm of wing surface, but with no runway slush, the takeoff run of the F-28 ranged between 3100 and 3250 feet. However, as contamination on the wing increased from 0.5 to 1.00, the takeoff distance increased from approximately 4150 to 8800 feet.

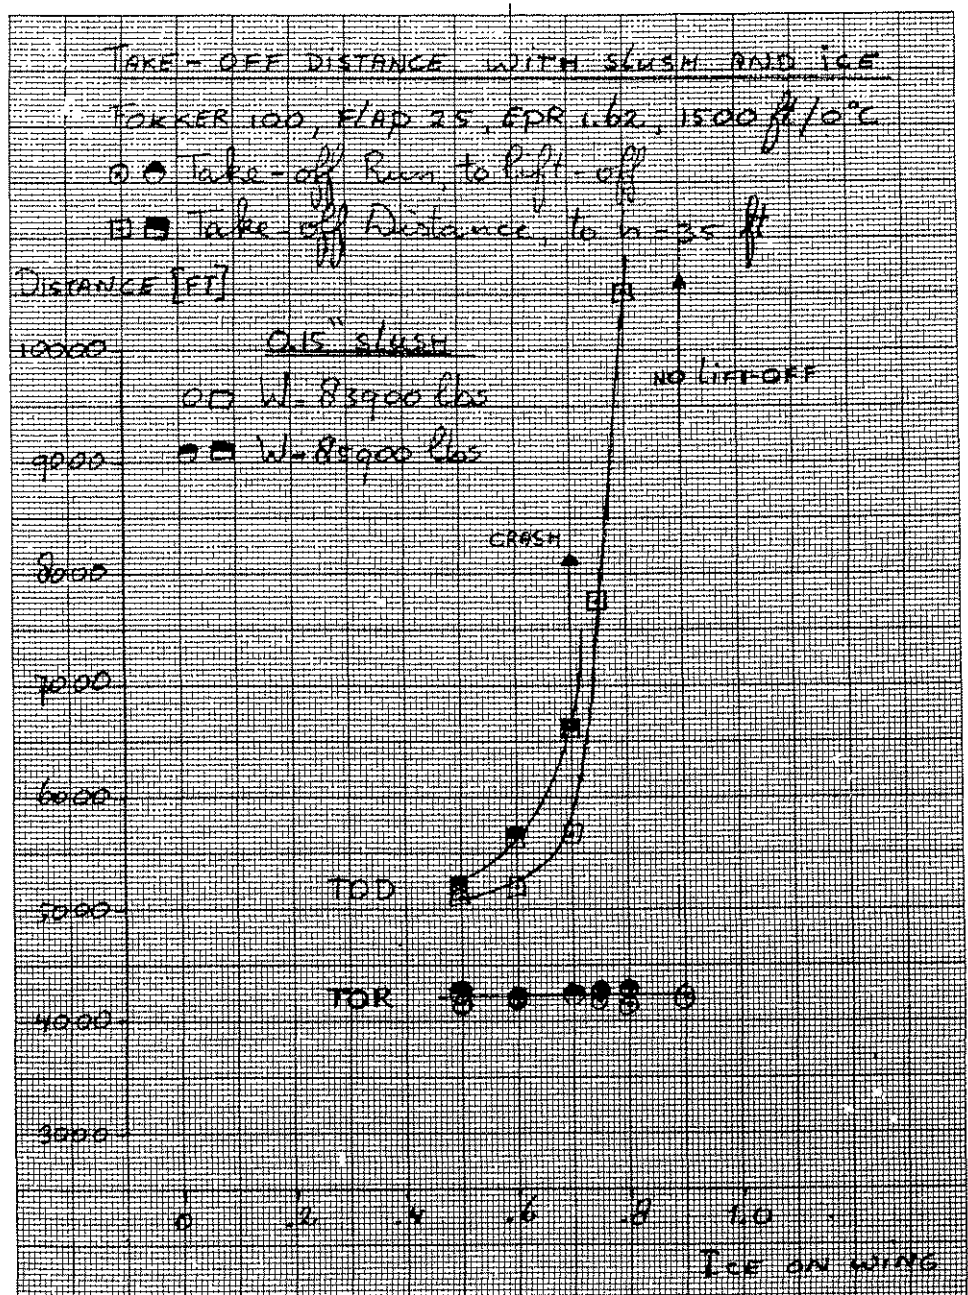
Figure 12-6 Fokker 100 Simulation of Takeoff with Slush and Ice, Flaps 18°

It was clearly revealed from the tests that by rotating the aircraft at a slower rate at  $V_R$ , the takeoff run increases slightly but the takeoff distance actually decreases. It was noted that, under similar conditions

of slush and wing contamination, with a slow rotation the takeoff run increased by 10 m (32.8 feet) from 1545 m (5070 feet) to 1555 m (5100 feet) while the takeoff distance actually decreased 435 m (1427 feet) from 2285 m (7495 feet) to 1850 m (6070 feet).

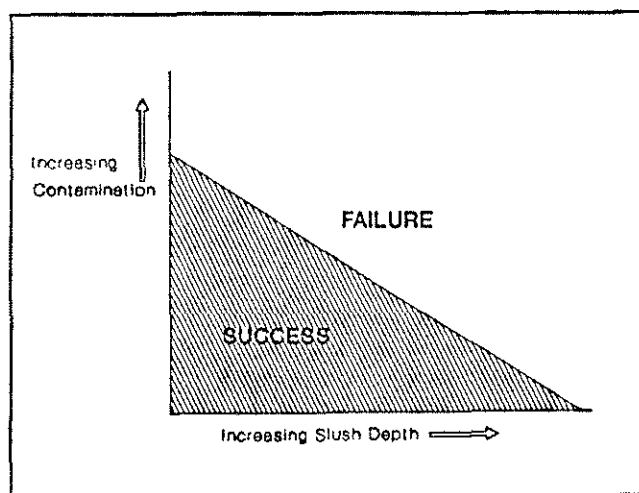
Figure 12-8 A Boundary Condition Plot for Successful Takeoff

Figures 8a-10b of the "Flight Dynamics" report illustrate in detail the various test runs. A review of the figures reveals that there are well-defined boundaries of slush depth and contamination level that either allow or prevent the aircraft from flying successfully. For example, with a rotation speed ( $V_R$ ) of 122.5 knots, a slush depth of 0.25 inches, and a wing-contamination level of 0.65, the aircraft flies away. At 0.68 wing contamination, the aircraft gets airborne, but, 500 feet beyond the end of the runway, it is only at 10 feet. At 0.69 contamination, the aircraft returns to the runway and runs off the end. In another example, with a rotation speed of 127.5 knots, a slush depth of 0.10 inches, and a wing-contamination level of 0.823, the aircraft flies away despite two bursts of stick-shaker. At 0.824 wing contamination, the aircraft height never exceeds 5 feet, and it eventually returns to the surface 1100 feet beyond

the end of the runway. The figures also demonstrate that pilot technique can have a marked effect on the success or failure of a takeoff.

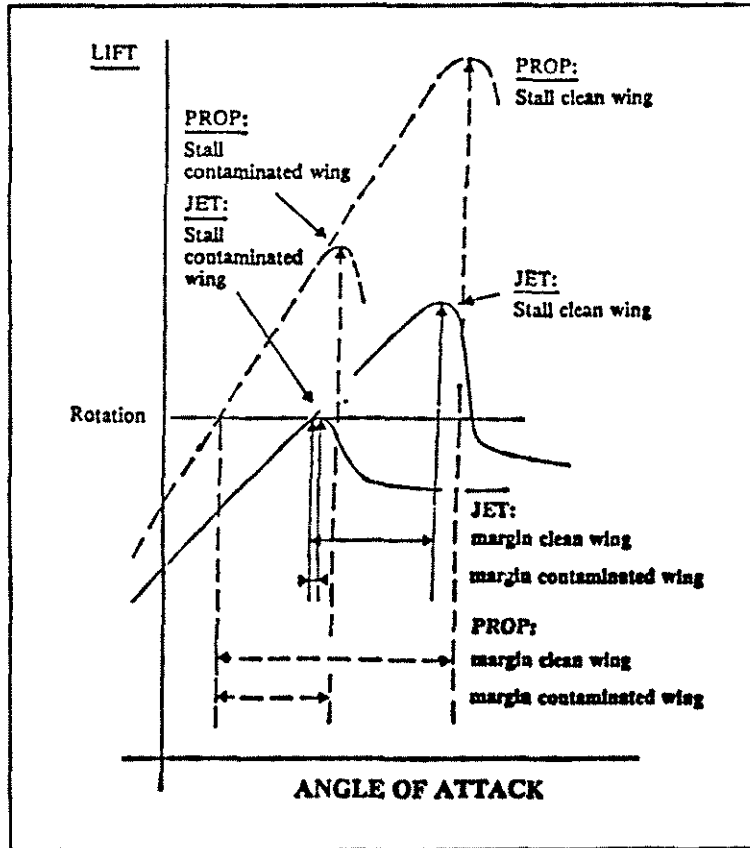
Figure 12-9 Jet- and Propeller-Driven Aircraft Comparison

this class, that is, to any jet-propelled, swept-wing aircraft. There is, however, a more severe performance penalty paid for contamination of a jet-propelled aircraft than for contamination of a propeller-driven aircraft. The shallower lift curve slope and the reduced maximum coefficient of lift of the swept wing make its performance more readily degradable. As well, the jet aircraft does not have the advantage of a relatively large area of its wing being immersed in high-velocity air from the propeller slipstream. The jet aircraft's only lift-producing capability is the result of the aircraft motion relative to the air. Diagrams in Fokker's Report no. L-28-222 (technical appendix 2 to the Final Report) and the "Flight Dynamics" report (technical appendix 4) show performance comparisons between jet- and propeller-driven aircraft when their wings are contaminated. Figure 12-9, from the "Flight Dynamics" report, depicts the comparison.

It was determined that a clean wing with the benefit of high-energy propeller-driven airflow would achieve about 25 per cent additional maximum coefficient of lift ( $C_{LMAX}$ ) at takeoff speeds compared with the same wing without the benefit of propeller airflow. For a contaminated wing with propeller airflow, the  $C_{LMAX}$  would be similar to that of the

same clean wing without propeller airflow. For a contaminated wing of a propeller-driven aircraft where the propeller airflow is lost (engine stoppage), the  $C_{LMAX}$  would be approximately the same as that of a contaminated wing of an aircraft that does not have the benefit of propeller airflow (jet aircraft).

As can be seen, if one engine of a propeller-driven twin-engine aircraft fails, the wing that loses the propeller airflow loses the increased  $C_{LMAX}$  created by the airflow. Where there are clean wings and the aircraft is flying at high airspeeds, there should be little difficulty controlling the aircraft. However, if the wings are contaminated and the aircraft is at low speed with the engines producing high power, the reduction in the  $C_{LMAX}$  caused by the engine stoppage could cause the wing that loses the propeller airflow to stall. The aircraft would then experience a rolling moment towards the failed engine. This scenario would be particularly
