LYCOMING SPECIAL CERTIFICATION REVIEW TEAM (SCRT)

Final Report

September 30, 2004

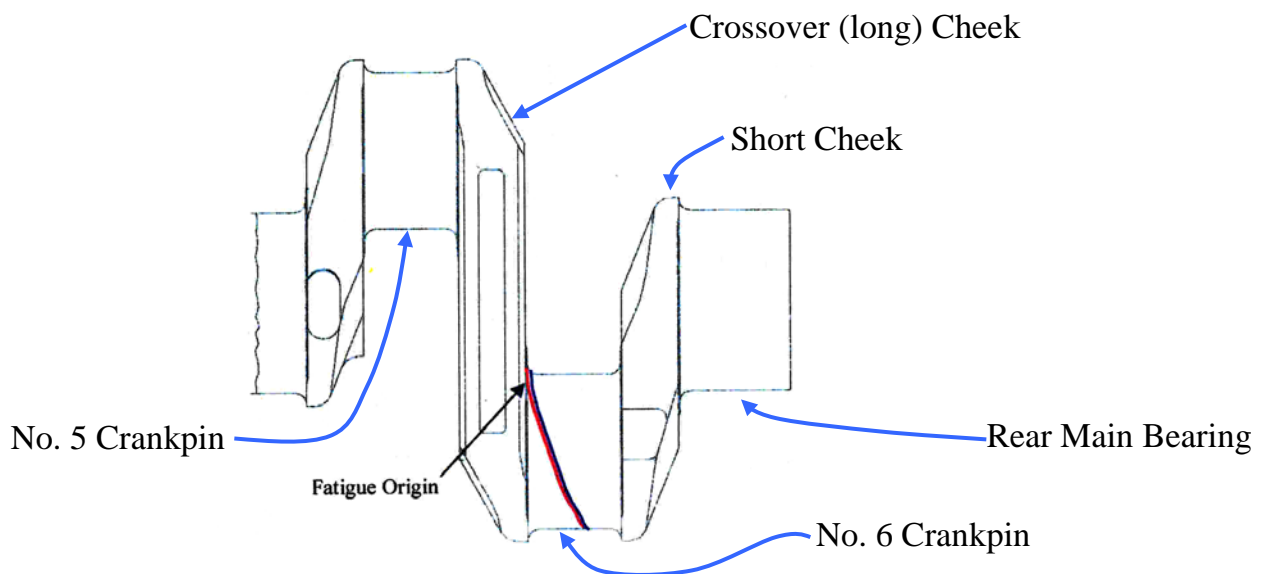
Figure 3-2

Beginning in 2000, failures of crankshafts in the TIO-540 series turbocharged engines rated at 300 horsepower and higher began occurring. The failures all occurred in the area of the rear cross over cheek between the number five and six crankpin journals, and all were fatigue type in nature from subsurface origins (as observed when the origin was not mechanically damaged). Figures 3-1 through 3-4 graphically depict the location of the crack through the crankshaft geometry.

**Location of Crankshaft Cracking
(Side View of Crankpin Section)**

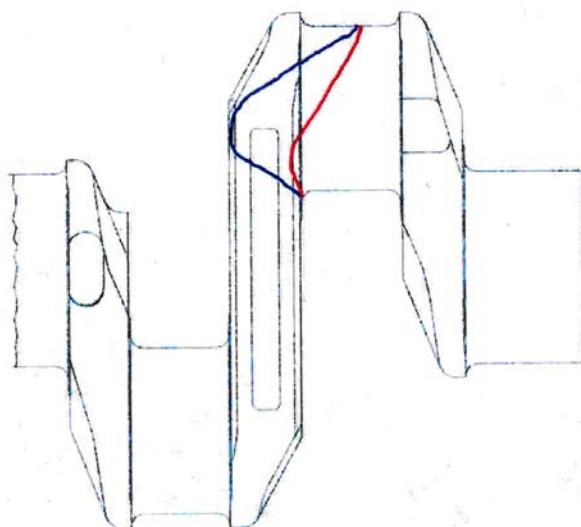
Figure 3-3

**Location of Crankshaft Cracking
(Side View of Crankpin Section)**

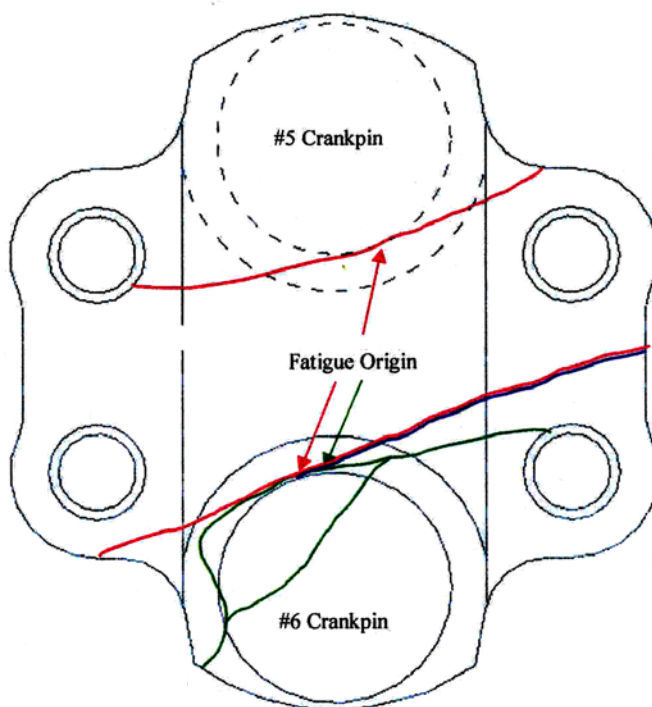
**Location of Crankshaft Cracking
(Aft Looking Forward)**

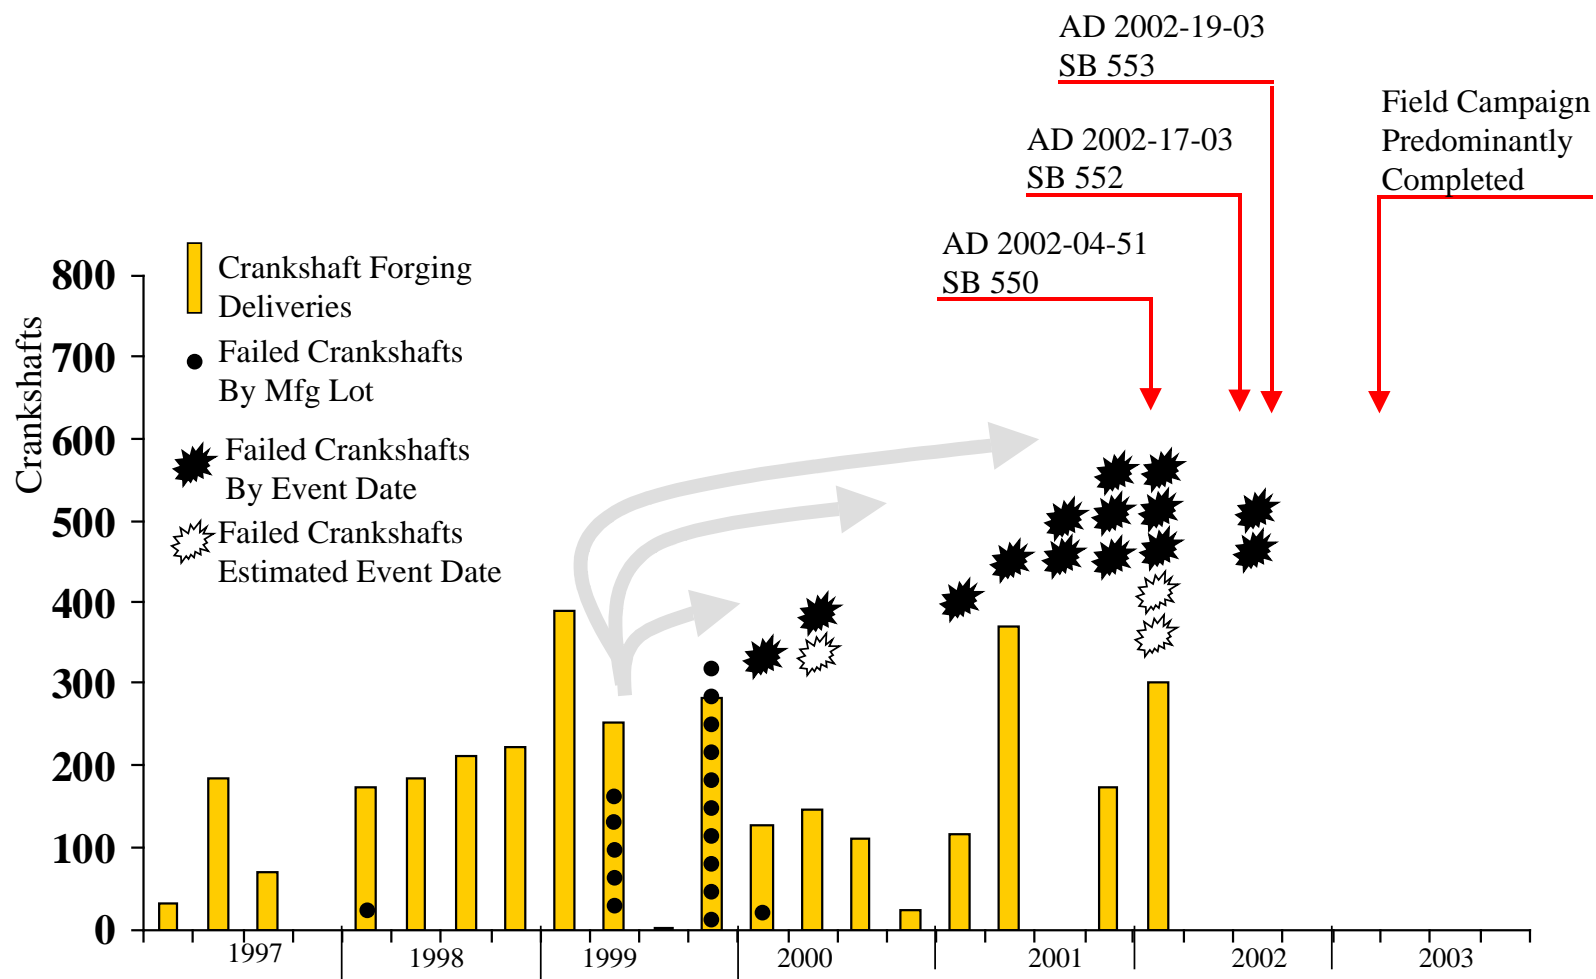
Figure 3-7
Overview of Corrective Action Program

The initial service failures of the crankshafts began in May 2000. Figure 3-7 shows three events in this time period, but it's important to note that there can be a significant lag between the occurrence of a General Aviation (GA) service event and the receipt of the report by the engine manufacturer. In this case, Lycoming was only investigating one of the initial three events in 2000, and the cause of this event was initially assumed to be a main bearing failure. Corrective action was in place for main bearing failures, so no further action was considered necessary.

As more events began occurring in 2001, Lycoming's investigation shifted from main bearing failures to fatigue overload, thought to be caused by propeller strikes or improper engine operation. Towards the end of 2001, the honeycomb feature was identified in one of the failed shafts. Service problems with Teledyne Continental Motors (TCM) crankshafts two years earlier had prompted Lycoming to examine their shafts for this manufacturing defect. By early 2002, a suspect manufacturing lot had been identified by Lycoming that included crankshaft forgings produced from March 1999 to December 1999. Lycoming's investigation concluded that there must have been a substantial variation in temperature control during the forging operation to cause the formation of honeycomb in these manufacturing lots.

In February 2002, Lycoming issued Service Bulletin 550 and the FAA issued AD 2002-04-51 that recalled crankshaft forgings produced from March 1999 to December 1999. At that time, incidents of broken crankshafts were restricted to that time period. In August, a broken crankshaft occurred outside the initial recall range and prompted SB 552 and AD 2002-17-03. These actions included the crankshafts already replaced under SB 550/AD 2002-04-51 as well as those produced from the end of the initial recall period up to March 2002, when the process changed to press forging and induction heating. Lycoming data also indicated that some significant variation existed in the forging process prior to the date of the original recall. In September 2002, Lycoming issued SB 553 and the FAA issued AD 2002-19-03 that required an inspection of the crankshafts manufactured by Interstate prior to March 1999. The inspection entailed the drilling of a small specimen from the propeller flange and sending this specimen to a Lycoming laboratory for a Charpy test and examination for honeycomb. Evidence of honeycomb was discovered in approximately 30% of these shafts.

The crankshaft forging has been changed to a press forged process with more rigorous control of forging temperature. In addition, a prolong has been added to the crankshaft forging design. The prolong is removed from completed crankshaft forgings and undergoes a Charpy examination for evidence of honeycomb. No honeycomb has been found in these new production crankshafts.

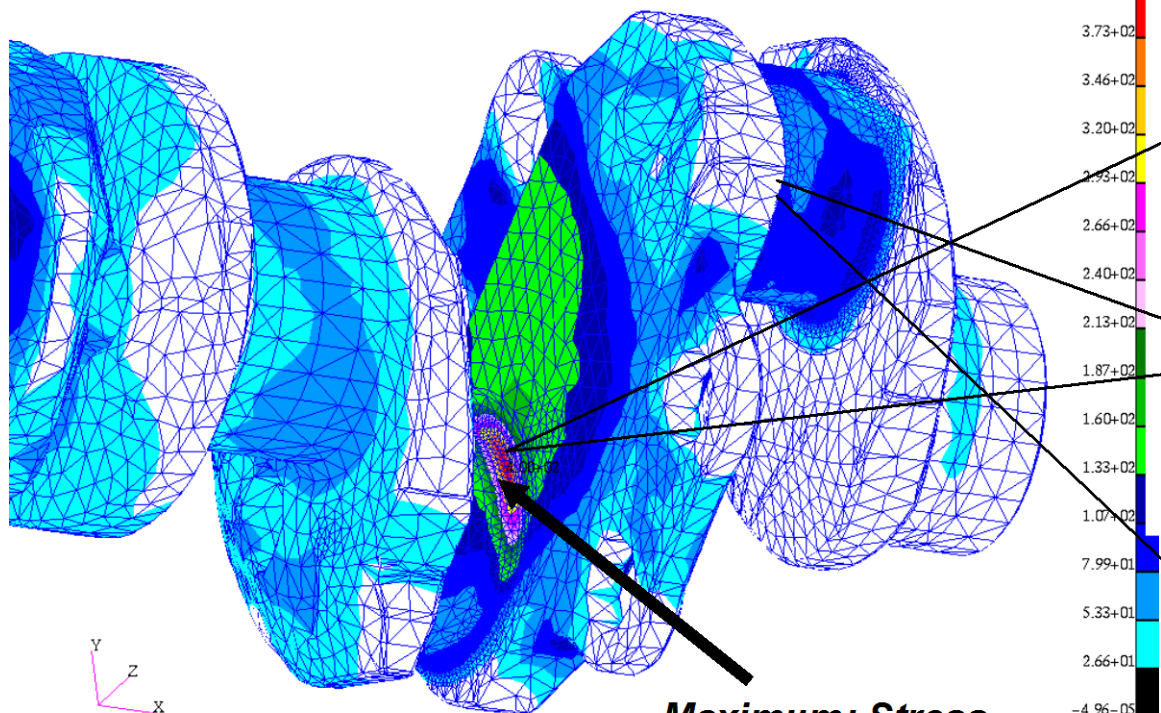
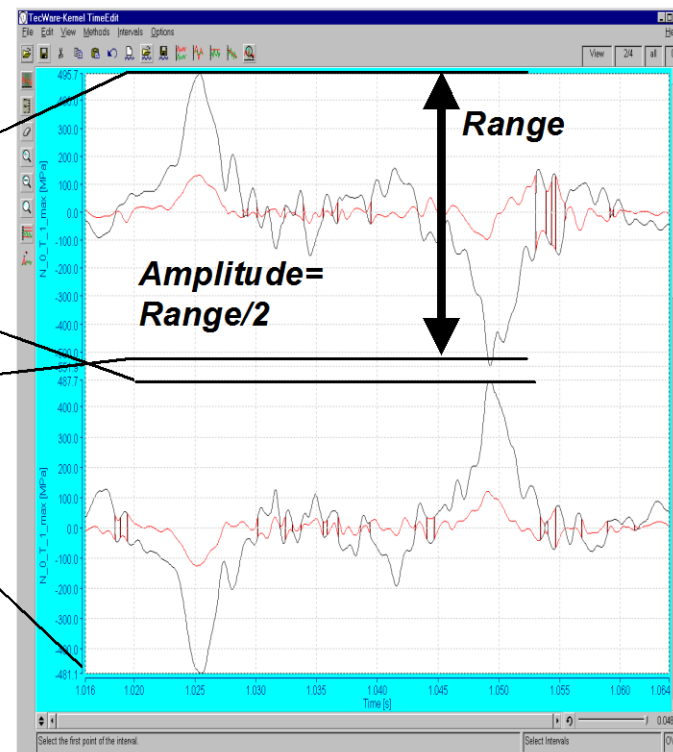
**Location of Maximum Stress
Figure 6-15**

The critical location was found to be at the number five crankpin fillet radius (see Figure 6-15). The maximum surface stress of 89.2KSI occurred at the max power condition (350HP, 2500 RPM). The stress calculated does not include residual stress effects. In addition, the maximum surface stress in the number six crankpin fillet radius (on opposite side of crossover cheek, see Figure 3-3 in Chapter 3) was found to be 79.9KSI.

Maximum: Stress Concentration near Rosette 9-10-11

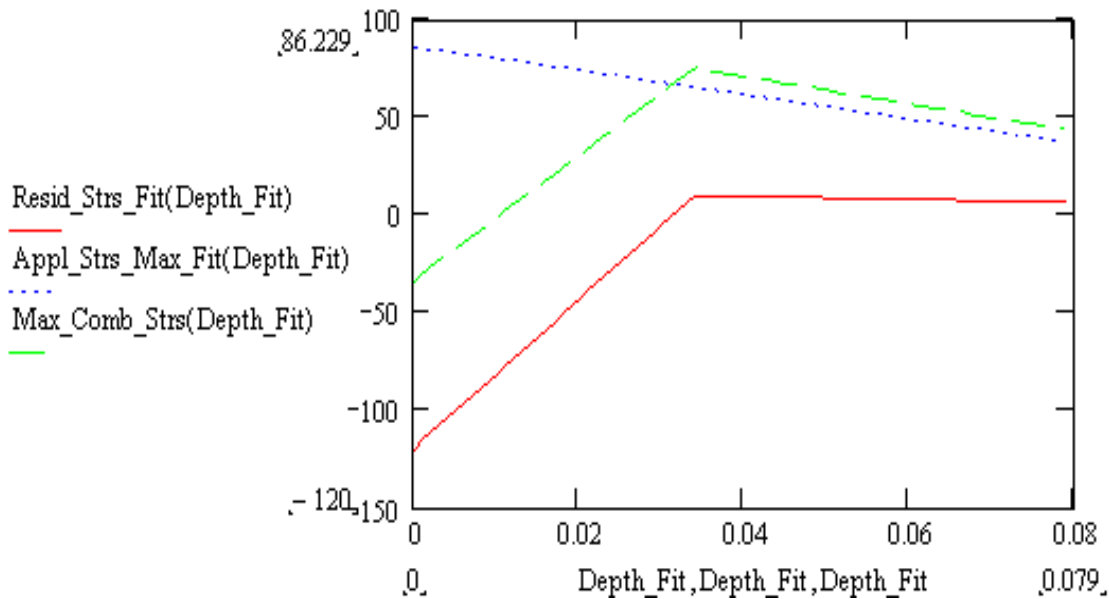
**Figure 6-18
Combined Operating and Residual Stresses**

The resulting peak combined stress at the critical subsurface location was found to be + 75.1 to - 55.1 KSI (see Figure 6-18) at .034 inches below the surface. (Or +/- 65.1 KSI alternating stress with a +10 KSI mean stress offset.) This is also sufficiently low when compared to the minimum estimate of the subsurface material endurance limit of (+/- 125 KSI) for infinite fatigue life. This equates to a fatigue safety factor of 1.66 for defect-free crankshafts.

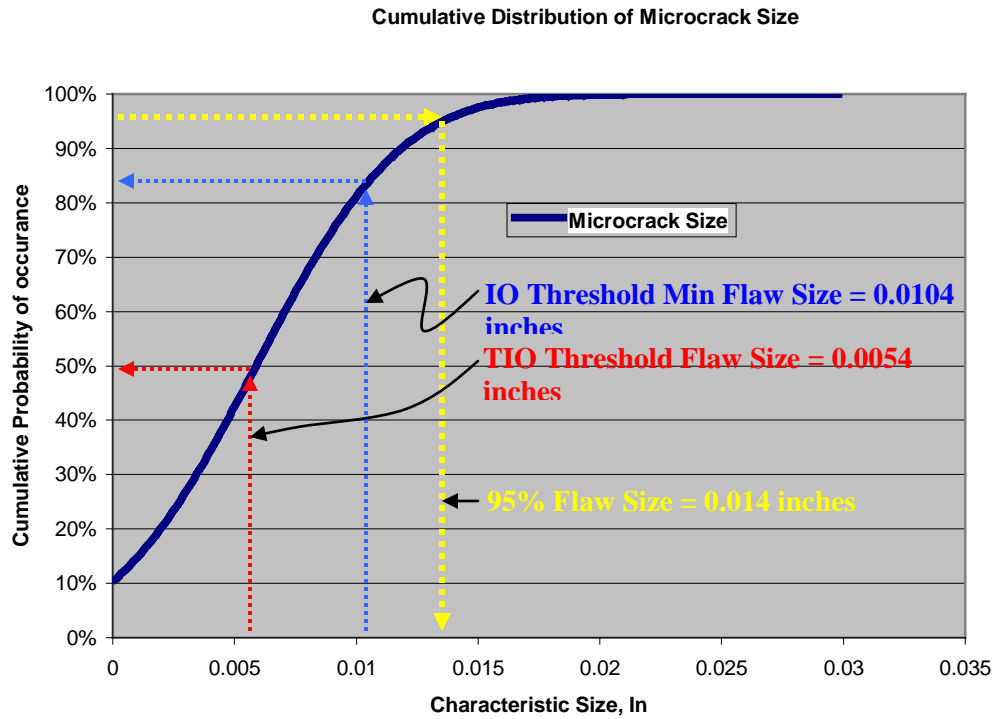
1. Defect Size Distribution: A distribution of honeycomb related microcrack sizes was derived by SEM examination of specimens taken from crankshafts. Analysis of this data revealed that the probability distribution of microcrack size shown in Figure 6-22. The minimum flaw sizes from the fracture mechanics analyses and the 95% flaw size are annotated on this curve. The 95% flaw size is a commonly used threshold for crack propagation studies. Figure 6-22 confirms that the 95% flaw size of 0.014 inches is in fact greater than the flaw sizes necessary for crack propagation in both the IO (0.0104 inches) and TIO (0.0054 inches) engine models.

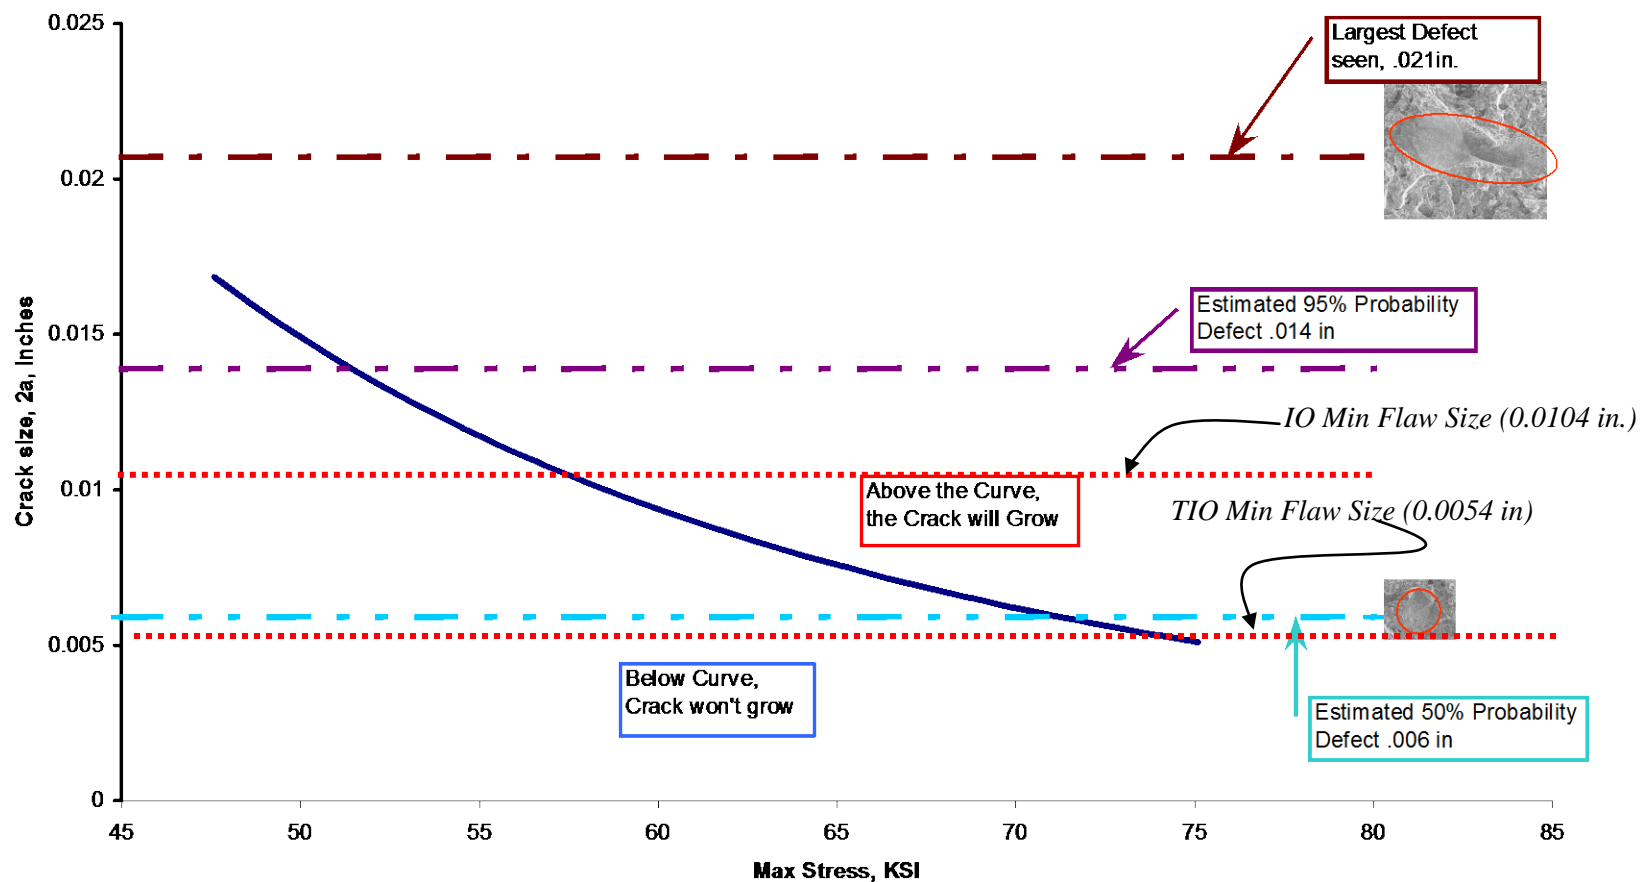
Figure 6-23

2. Operating Stress Required for Crack Growth: The results from the NASGRO analysis for the minimum flaw size for crack growth at max power were extrapolated to relate smaller flaw sizes to the operating stress necessary for propagation (see Figure 6-23). The operating stress required for growth of the 95% flaw was derived from this curve and found to be 52 KSI. Therefore, any engine operating condition that produces an operating stress greater than 52 KSI can be expected to cause a 95% flaw to propagate. Note that this stress is lower than that required for propagation of the minimum flaw in both the TIO and IO engine models.

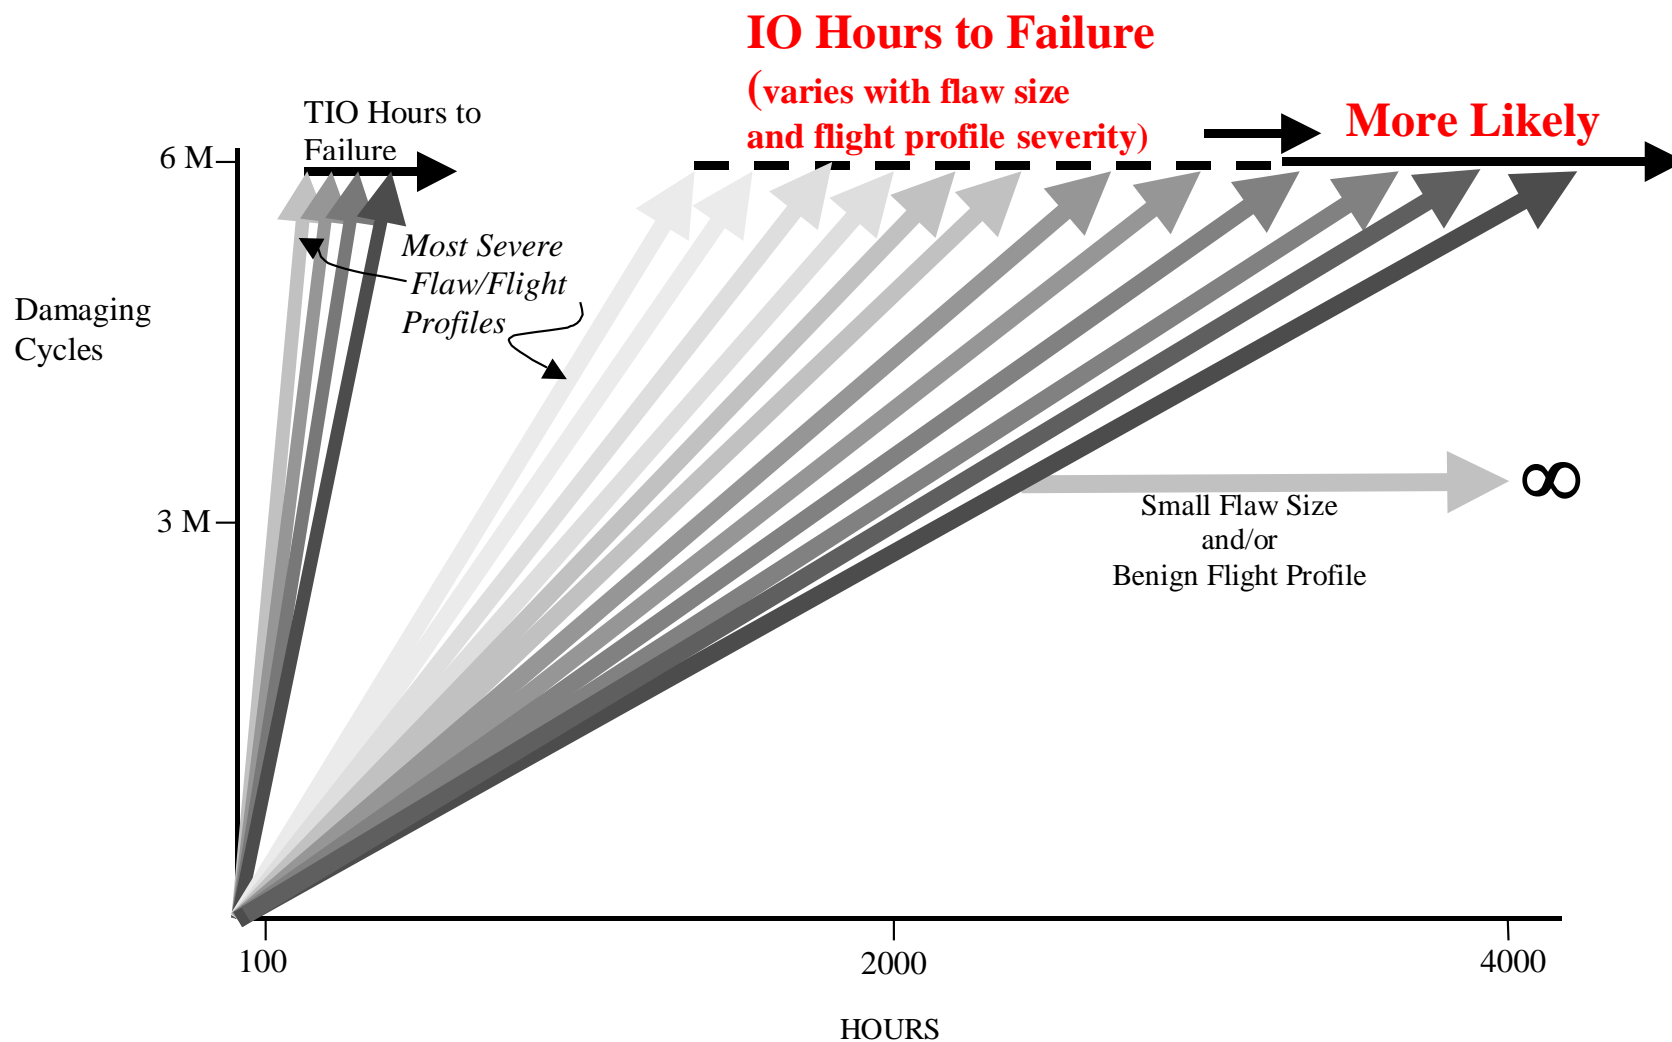
Figure 6-26
Service Life Assessment

An estimated number of flight hours until crankshaft failure for those shafts with a 95% flaw was derived from the damaging stress cycle rate per flight and the service experience of the TIO-540 engines (see Figure 6-26). Given the worst-case failure time of 100 hours for the TIO crankshaft, the total number of cycles to failure was derived from the typical mission profile and found to be approximately 6 million cycles. Only cycles at power levels that produce operating stresses greater than that required to propagate the 95% flaw were counted. These cycles were called “damaging cycles”. The damaging cycle/hour rate for the IO flight profile was then evaluated to determine the range of flight hours required to accumulate the assumed 6 million cycle “life”. This “most severe flight profile” rate resulted in a worst-case IO crankshaft life of approximately 1500 hours. It should be noted that the IO damaging cycle per hour rate is believed to be extremely conservative because environmental conditions (altitude & temperature) will limit most IO engines to operation below the 95% flaw operating stress at all times and therefore would never generate operating stresses necessary to propagate the 95% flaw. The remaining 5% of crankshaft flaws (95-100 percentile flaws) would propagate at lower stress levels if the flaw was the proper orientation but still should only experience stresses high enough to propagate cracks during a limited portion of each flight. Based on expected damaging cycles accumulated per flight and service experience to date, it is believed that IO crankshafts will operate safely beyond the first TBO of 1600 to 2000 hours. However, beyond the first TBO, the combinations of flaw size, flaw location, material endurance limit, engine rating, and operating environment variables make it impossible to accurately predict how many additional overhauls any suspect IO shafts could remain in service.

- d. Damaging Cycle Accumulation: TIO engine models accumulate damaging stress cycles at a much faster rate than IO engine models. Crankshafts with honeycomb features installed in TIO engines will most likely fail prior to the TBO of the engine, whereas crankshafts with honeycomb features installed in IO engine models could operate past TBO.

- a. Subsurface Flaw Inspection: Flaws of the threshold size are not detectable with conventional NDI technology. Therefore, screening of crankshafts and crankshaft material during production for indicators of existing flaws (such as honeycomb), and controlling material properties during manufacture is necessary to prevent in-service crankshaft failures.

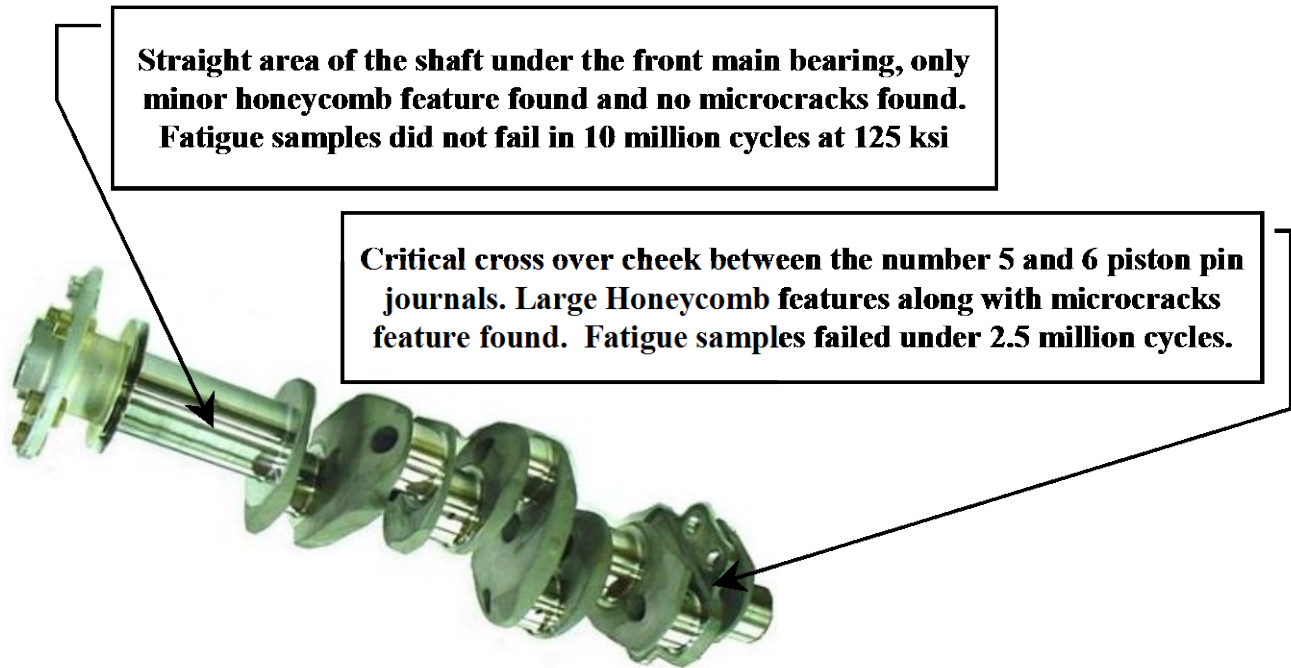
**Figure 7-4a
Distribution Within the Crankshaft of Honeycomb and Microcracks**

Because the forging grain flow is going straight under the front main bearing, there are minimal forging tension stresses. In the crossover cheek, as the material is flowing from the number 5 to the number 6 journal, and has to expand into the crossover cheek during forging, producing tension stresses. This produces the honeycomb feature and the microcrack if the forging is overheated (see Figure 7-4a).

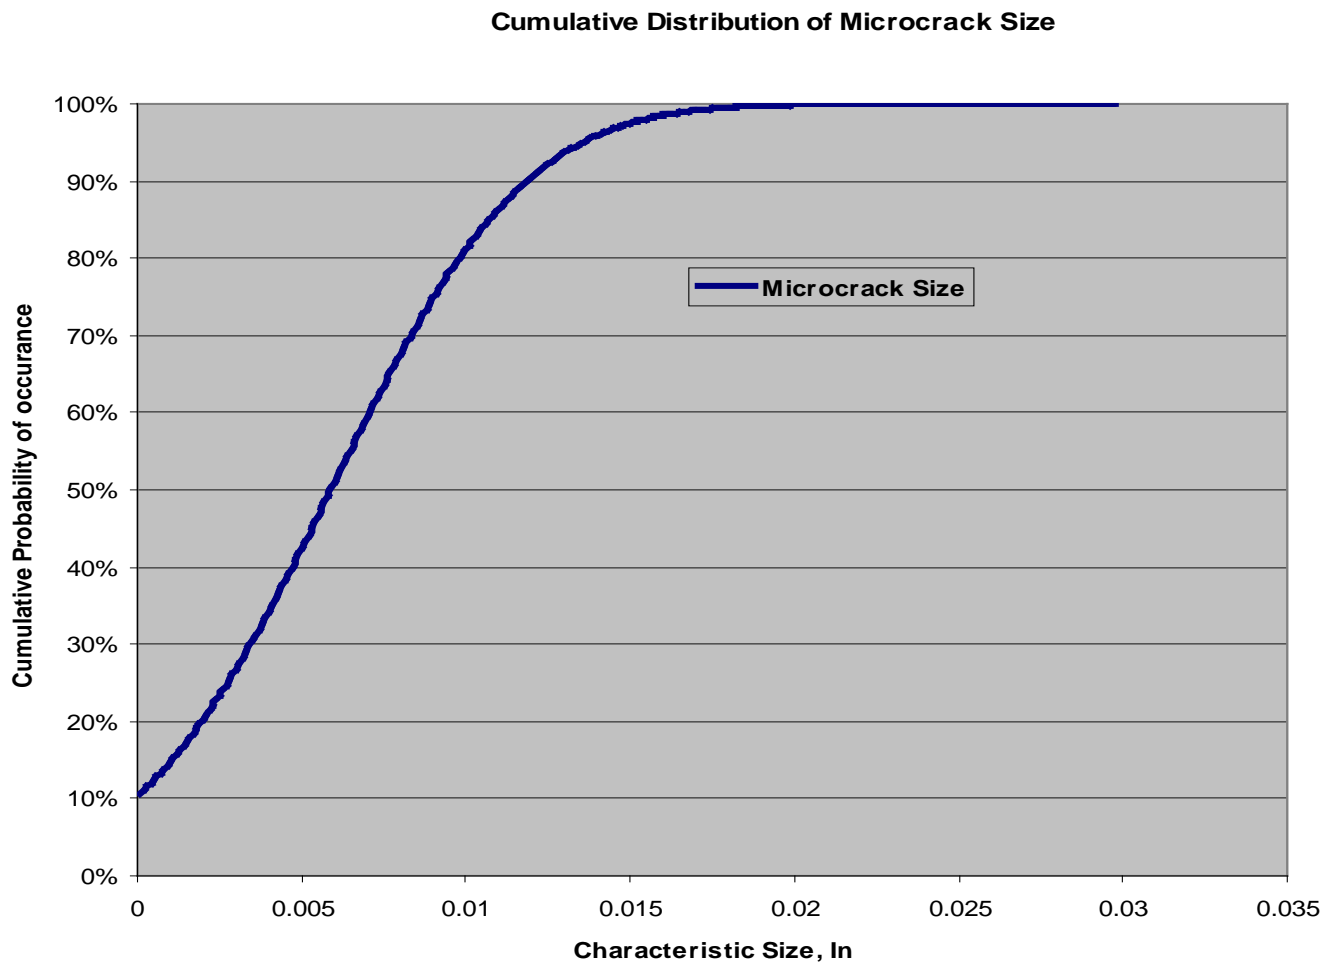
**Figure 7-5, Cumulative Distribution of flaw sizes from study of cracks observed
in SEM**

The data from the examination of SEM photos of microcracks was used to develop the cumulative probability distribution of microcrack size presented in Figure 7-5. The curve crosses the 50% line at .006 inches and crosses 95% at .014 inch.

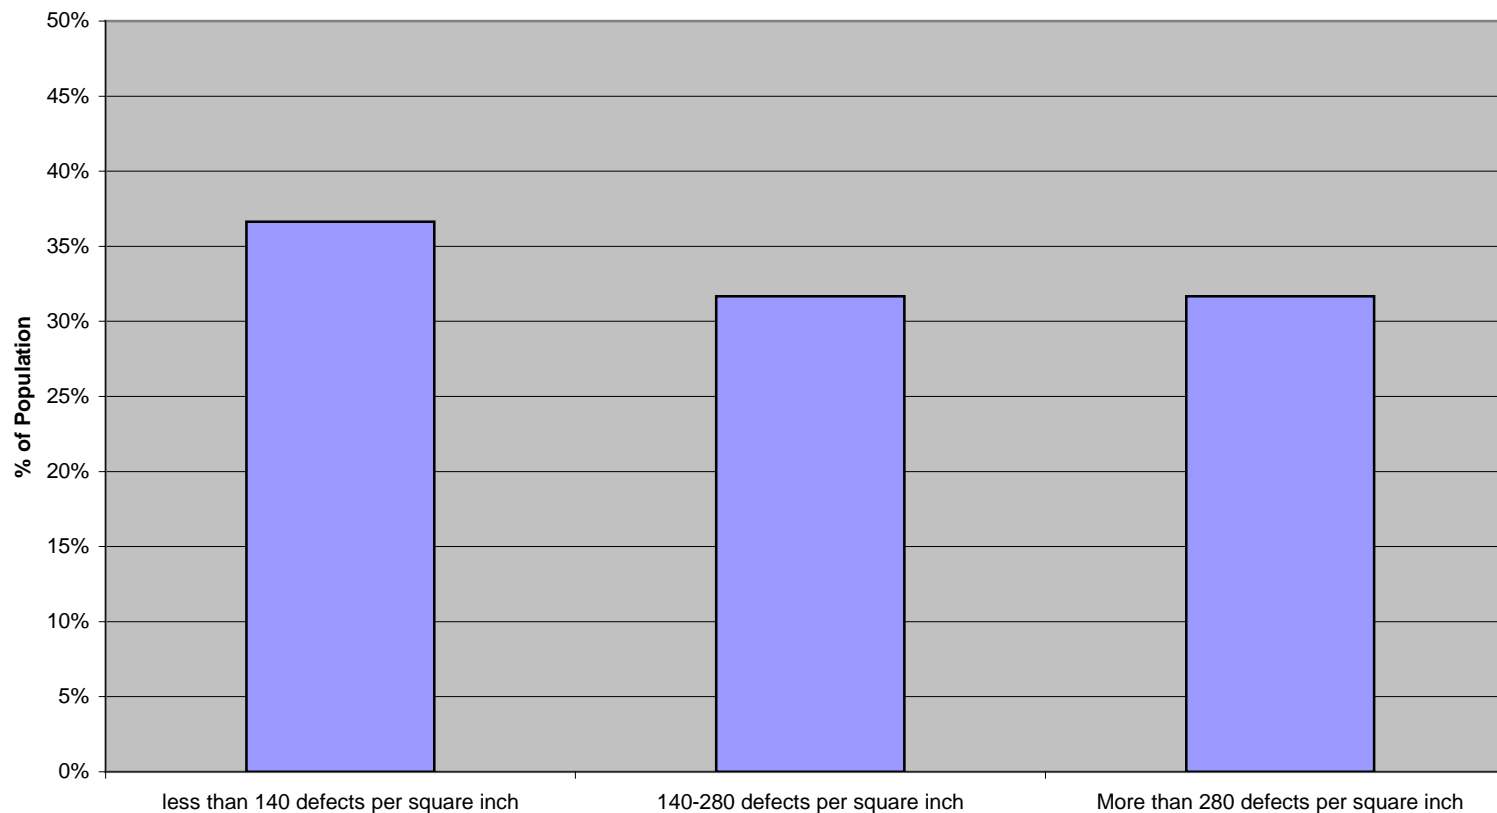
Figure 7-7. Density of Defects found in prop flange samples from Lycoming study

not large enough to propagate unless more than one of them are in the same area. This possibility brings us to the other data available in the Lycoming study. Because we know the number of defects per sample and the sample cross sectional area, we can calculate the number of defects per square inch. These data are presented in Figure 7-7.

From Figure 7-7 we can see that the data are roughly distributed in 1/3 increment with about a third of the population having more than 280 defects per square inch. This means that the chances that two defects are adjacent are quite real. This is supported by the failure of V537912980 where an examination of the fatigue origin revealed two defects, and a third below the surface of the fracture surface.

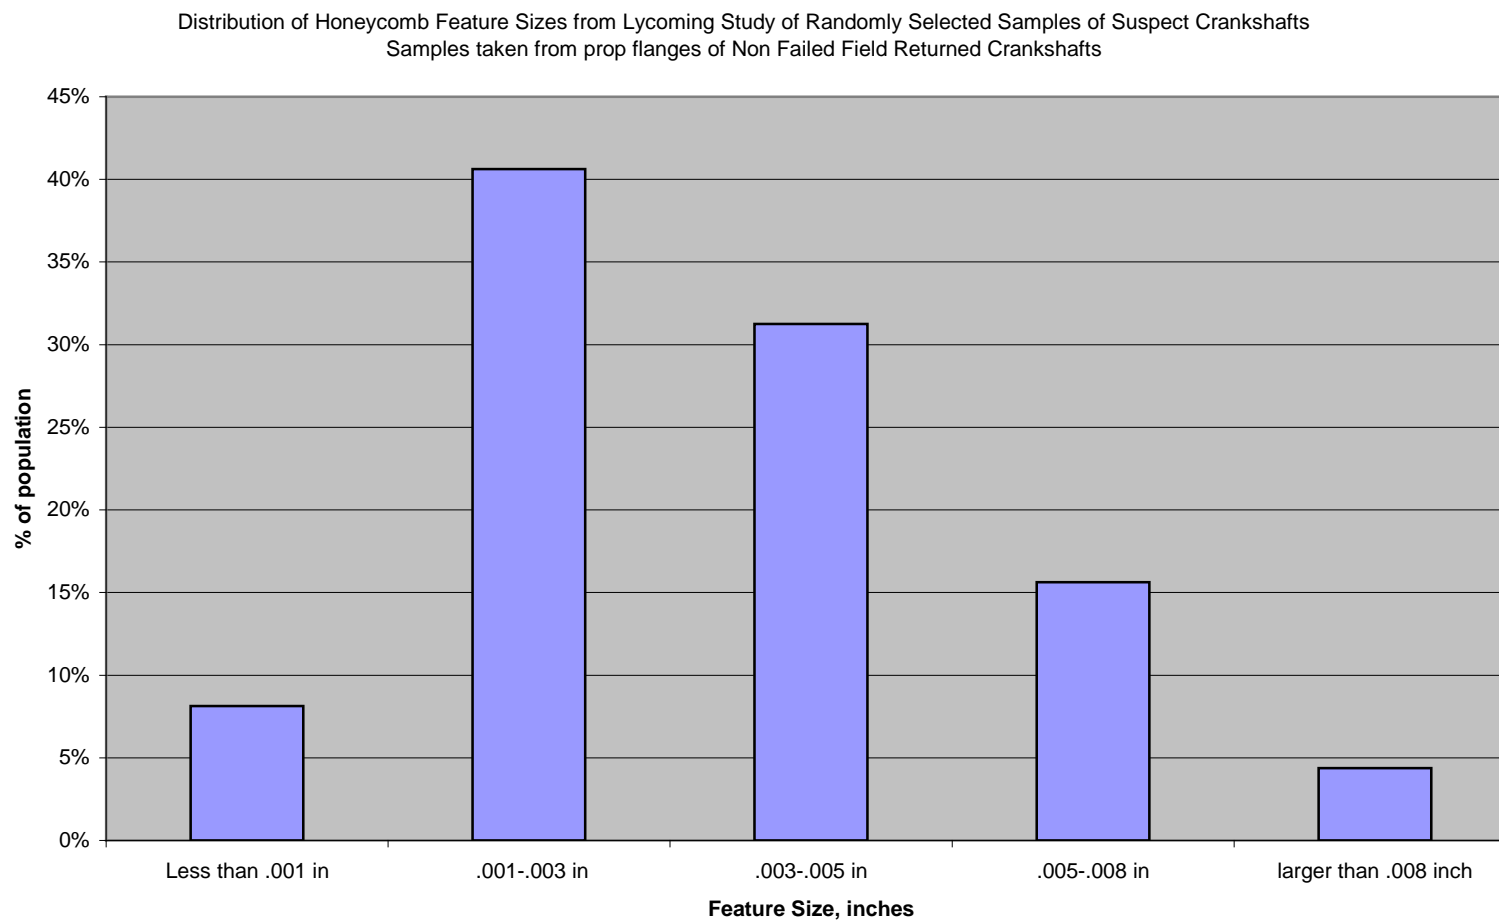
Figure 7-8. Distribution of defect sizes found in prop flange samples. Data from Lycoming study.

These data show us the defect size distribution in the prop flange area, and also give us some indication of the number of defects in a given square cross section. Figure 7-8 presents the data from that study for honeycomb feature size. It shows us that about 5% of the samples taken have a honeycomb feature size larger than .008 inches. Lycoming did not capture the distribution of the sizes within this part of the population; just that the minimum size in this range was .008 inch.

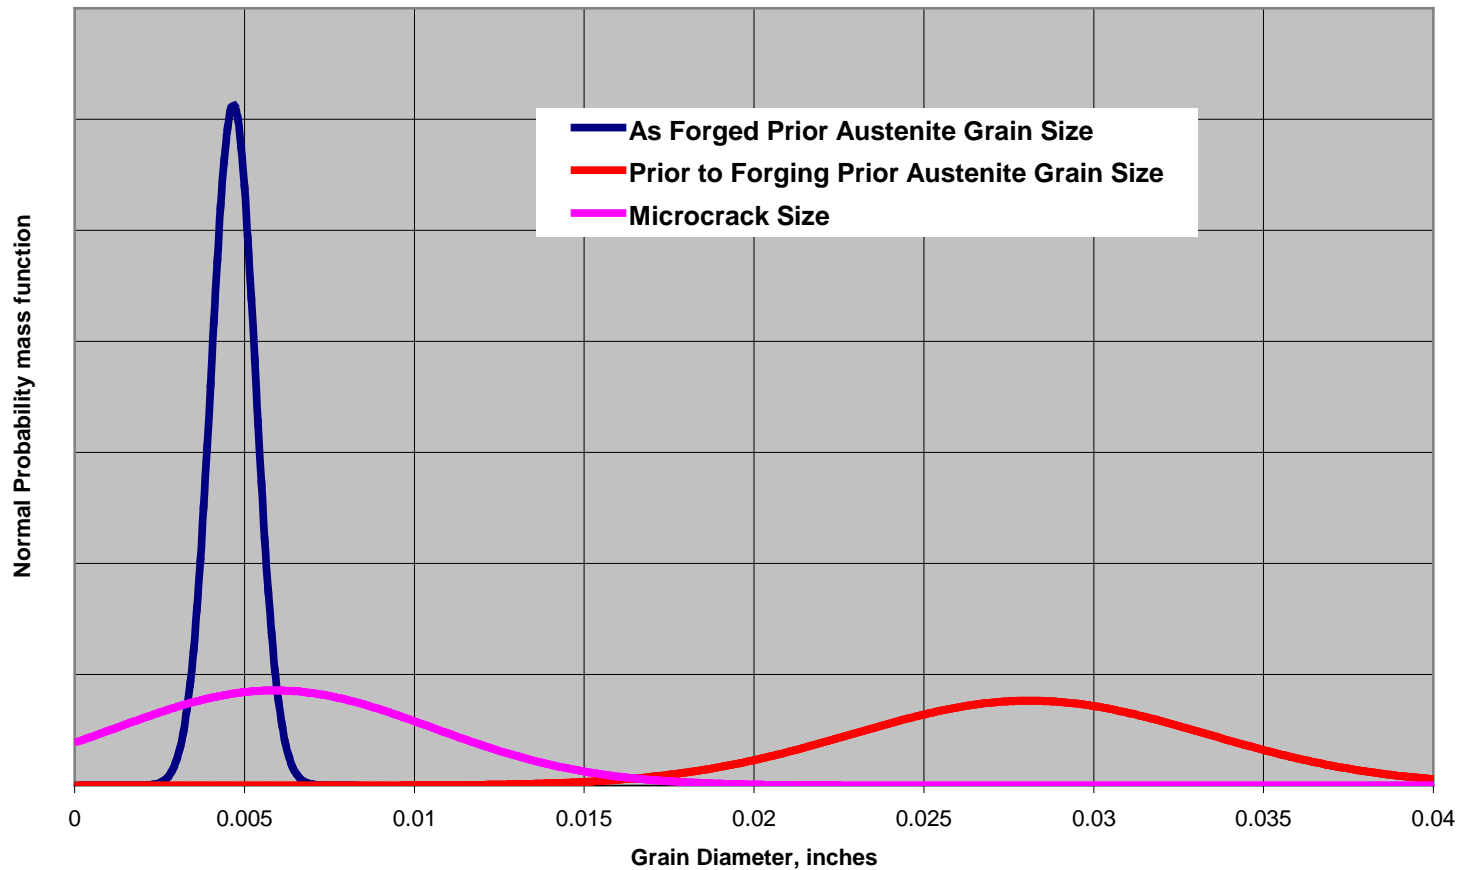
Figure 7-19. Distributions of microcrack size as they relate to the prior austenite grain size that exists after heat treatment. Data from Hinton Study of Honeycomb feature formation.

size appears to be roughly equivalent to the size that grains are when the steel arrives at Interstate (see Figure 7-18). See Figure 7-19 for the statistical distributions of the grain sizes seen and the resulting microcrack size. Note that the distribution of prior austenite grain size prior to forging does not match the distribution of the observed microcracks by nearly a factor of 10.

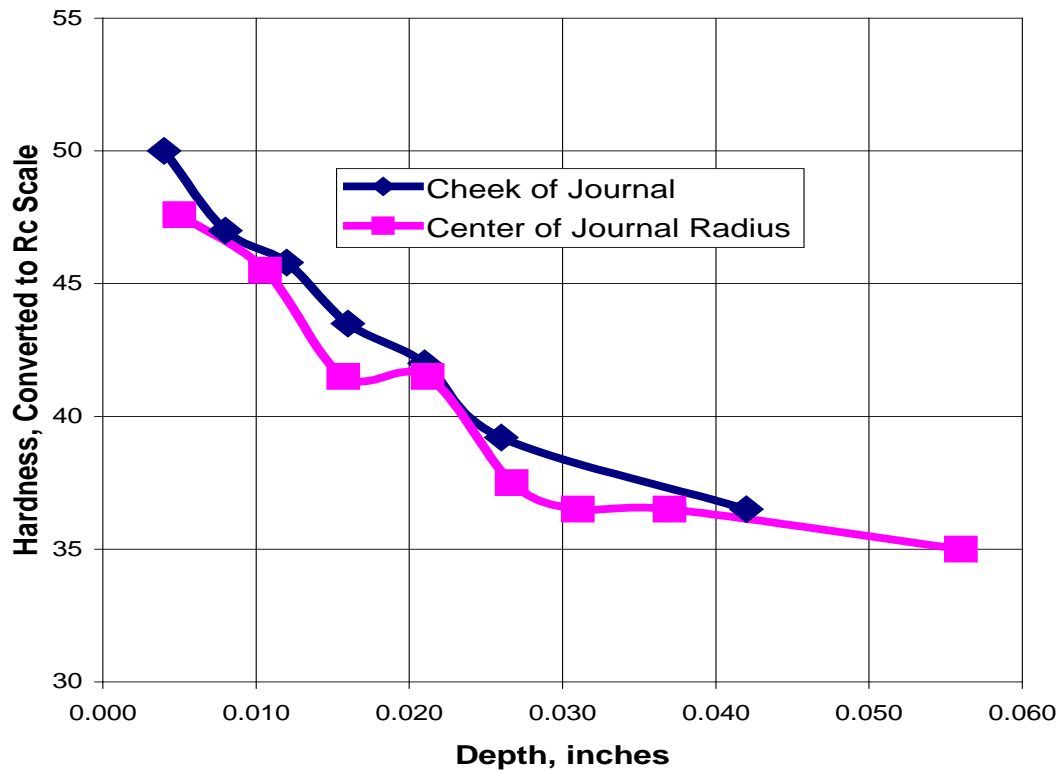
Figure 7-21 Hardness Profile with Depth in the Critical Journal area of the Crankshaft

The depth of penetration and the phase transformations observed in the nitride layer are normal for a nitride process that is under control. Optically measured, the depth of penetration is about .031 inches in this case, which puts the transition between the case and core at the same location as the crack origin. The hardness profile varies somewhat in the cheek area as opposed to the center of the radius as shown in Figure 7-21. The cheek area was very slightly harder and had slightly greater depth of penetration than seen in the center of the radius. This is to be normal due to the nature of the nitrogen diffusion processes responsible for the nitriding and is compliant to the Lycoming process specifications.

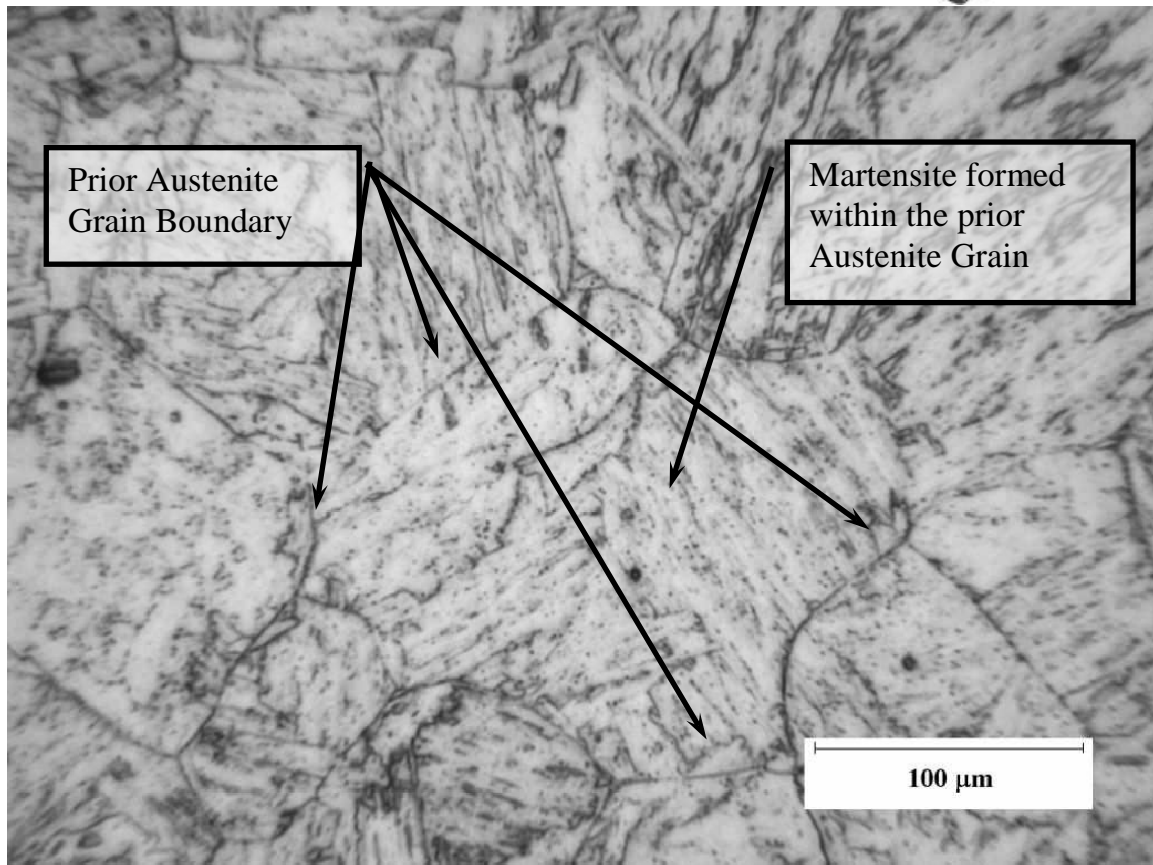
Figure 7-26, Prior Austenite Grain boundaries with Martensite within the grains

In general it appears, with the limited data that exists, that the size of the honeycomb feature is roughly consistent with the facet size of the prior austenite grains, as they existed during forging¹⁶. Each time the steel is heated above the austenitizing temperature, the austenite reforms. Each forging operation refines the austenite, causing the grain to become smaller.

(They are called “prior” Austenite grains because when the material cools to room temperature, the steel transforms to either Pearlite or Martensite.) We believe that the microcracks form along these prior austenite grain boundaries.
