# CIVIL AIRCRAFT ACCIDENT

Report of the Court of Inquiry  
into the Accidents to  
Comet G—ALYP on 10th January, 1954  
and Comet G—ALYY on  
8th April, 1954

Report of the Public Inquiry into the causes and circumstances of the accident which occurred on the 10th January, 1954, to the Comet aircraft G-ALYP

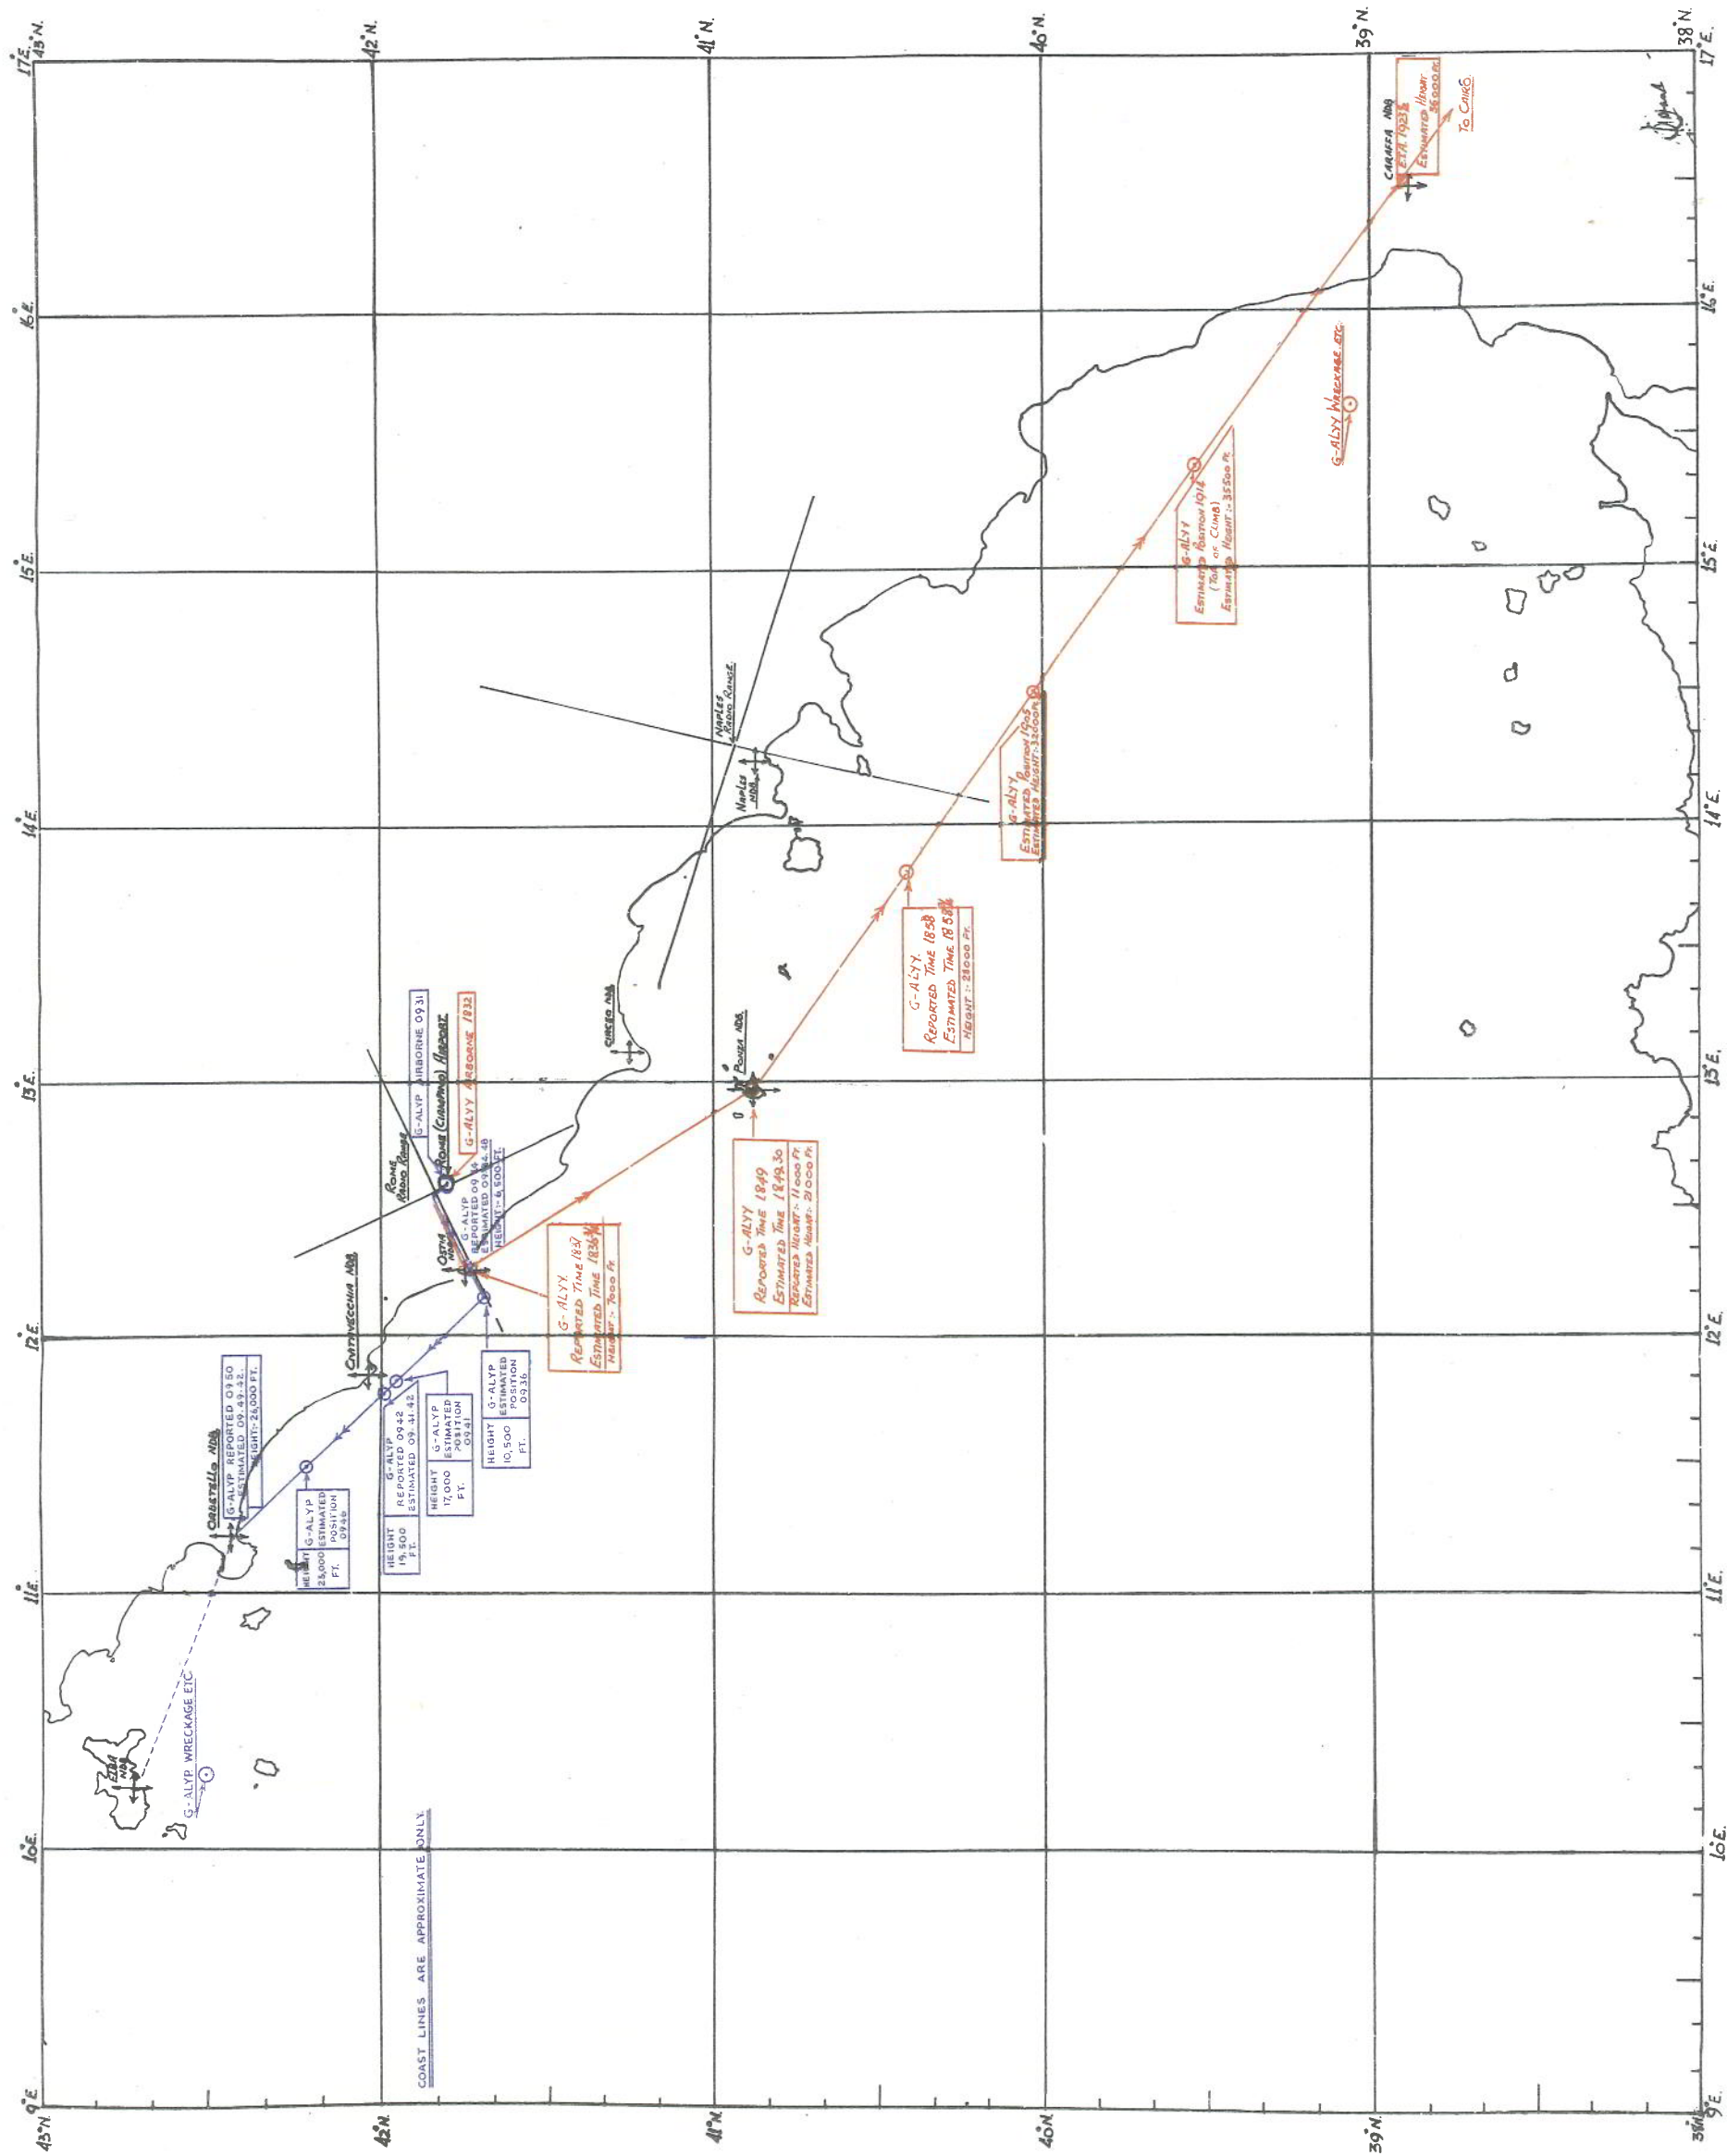
FIG 1:

28. The chart, which is Figure 1 of this Report, was prepared from all the information available and produced by a Navigating Officer from B.O.A.C. The estimated flight track of the aircraft and the position in which bodies and wreckage were found can be seen on the chart and the witness gave it as his opinion that at 0951 hours the aircraft was probably approaching a height of 27,000 feet.

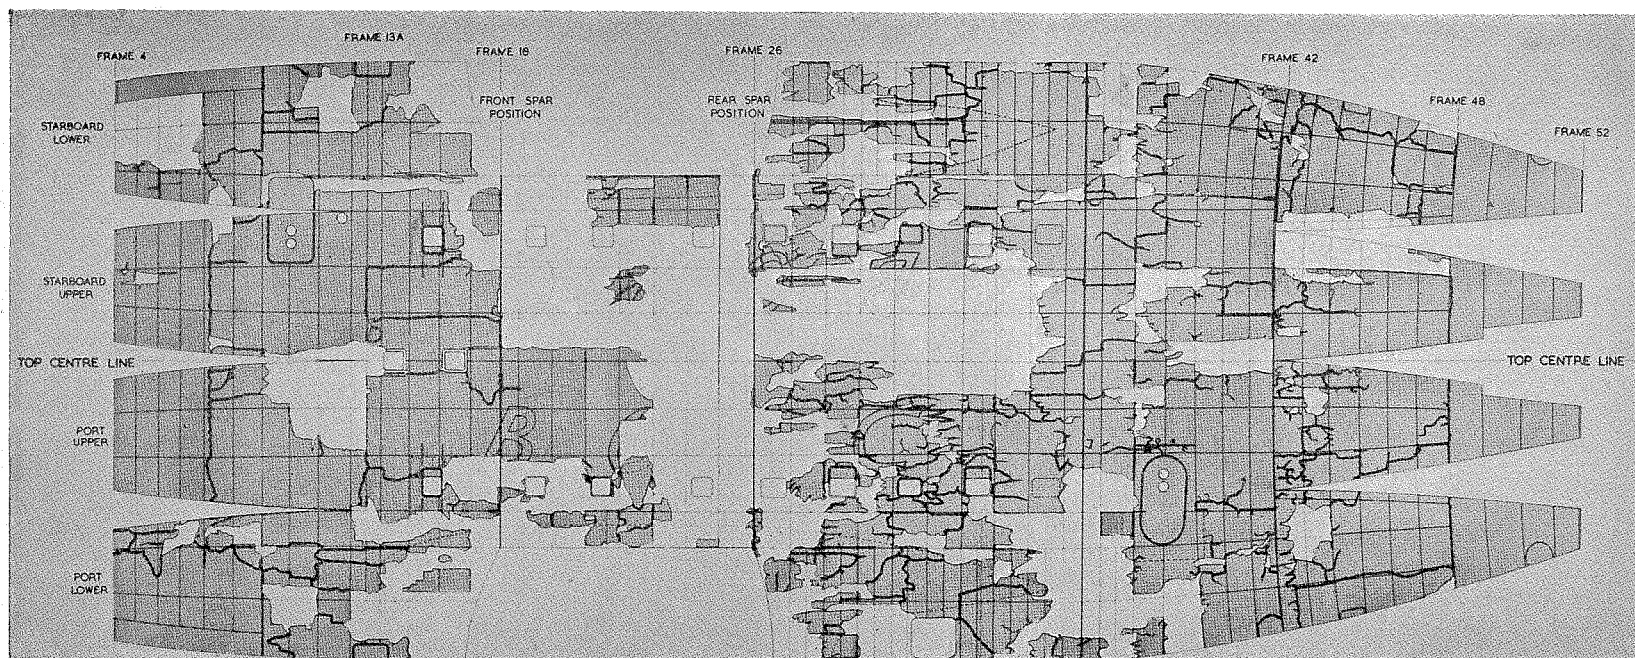
FIG. 2. DIAGRAM SHOWING AMOUNT OF WRECKAGE RECOVERED—G-ALYP.

50. The search was prosecuted at depths varying between 70 fathoms and 100 fathoms. It is noteworthy that this was the first occasion on which television equipment had been used for this purpose. The first date on which anything was located on the bottom by television was the 12th February, 1954. I need not recount in detail the history of the search. Suffice it to say that by the 23rd March, 1954, only the floating wreckage, the pressure dome, and parts of the rear fuselage and the engines and wing centre section had been recovered and that thereafter the search continued until by the end of August, 1954, about 70 per cent. of the empty weight of the aircraft, made up of about 70 per cent. of the structure, 80 per cent. of the power plant and 50 per cent. of the equipment, had been recovered. I have included as Appendix V a table, which was put in evidence, showing the dates of recovery of the main portions of the wreckage and the dates on which they reached Farnborough. Diagrams\* (Figures 2 and 3) give a striking impression of the amount of material which was ultimately recovered, though they

relate only to the external structure. Figure 4 is a photograph showing the reconstruction of the fuselage and tail unit from the wreckage and Figure 5 is a photograph showing the reconstruction of the front fuselage.

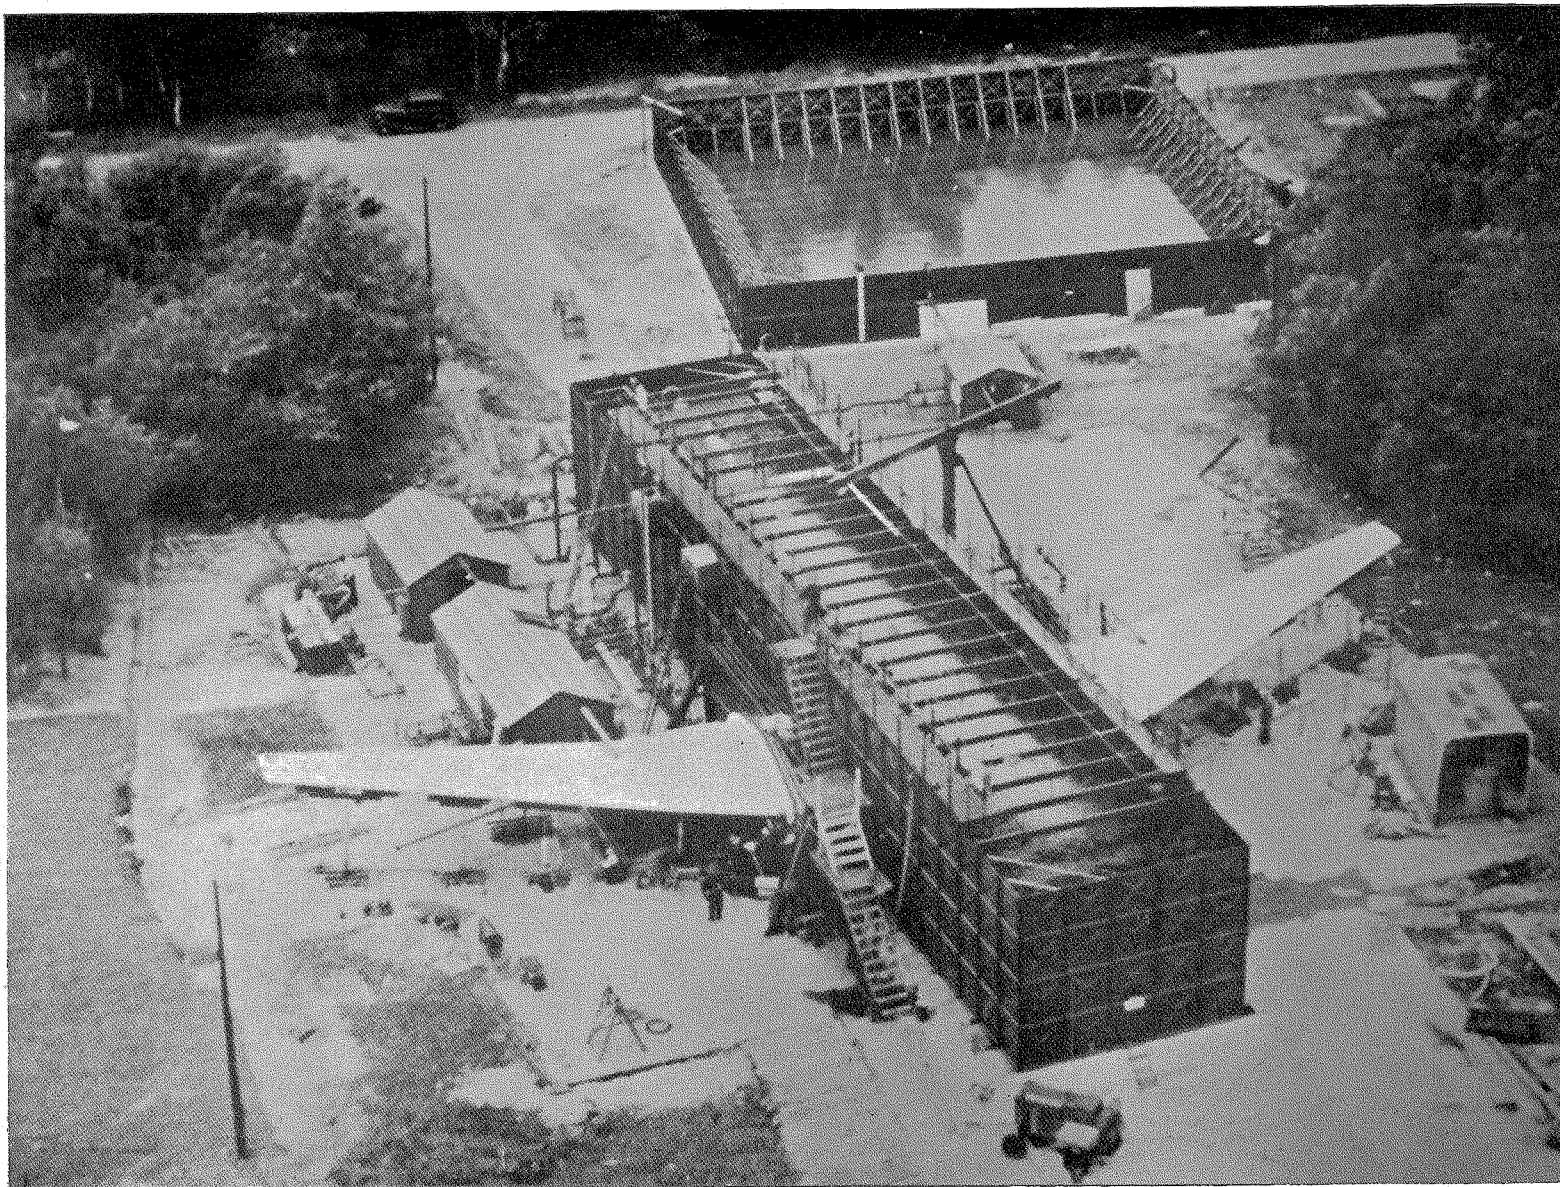
FIG. 6. AERIAL VIEW OF COMET G-ALYU IN TESTING TANK.

63. By a remarkable effort, to which de Havillands and the firms who built the tank (see Figure 6) contributed to the full and by the use of all the resources of R.A.E., repeated loading tests began early in June on aircraft G-ALYU (Yoke Uncle). The object of the tests was to simulate the conditions of a series of pressurised flights. To this end the cabin and wings were repeatedly subjected to a cycle of loading as far as possible equivalent to that to which they would be subjected in the period between take-off and landing. In addition to one application of cabin pressure, fluctuating loads were applied to the wings in bending to reproduce the effect of such gusts as might be expected in normal conditions, although the contribution of gust loads to the stresses in the cabin structure, compared with that made by the internal pressure, was in general small. Moreover, the programme of tests included, at intervals of approximately 1,000 "flights" a proving test in which the pressure was raised to  $1\frac{1}{2}$  P (11 lb./sq. in.). It must be understood that there are other sources of fluctuating load and, therefore, of fatigue to which no precise value can be attached. No attempt was made to represent these in the test. Examples are vibration due to irregular airflow, vibration due to the engines and the jet efflux and fluctuating loads occurring during take-off and landing.
