# **NATIONAL TRANSPORTATION SAFETY BOARD**

## **AIRCRAFT ACCIDENT REPORT**

**AMERICAN AIRLINES, INC.,  
BOEING 727-95, N1963**

**REPORT NUMBER: NTSB-AAR-77-1**

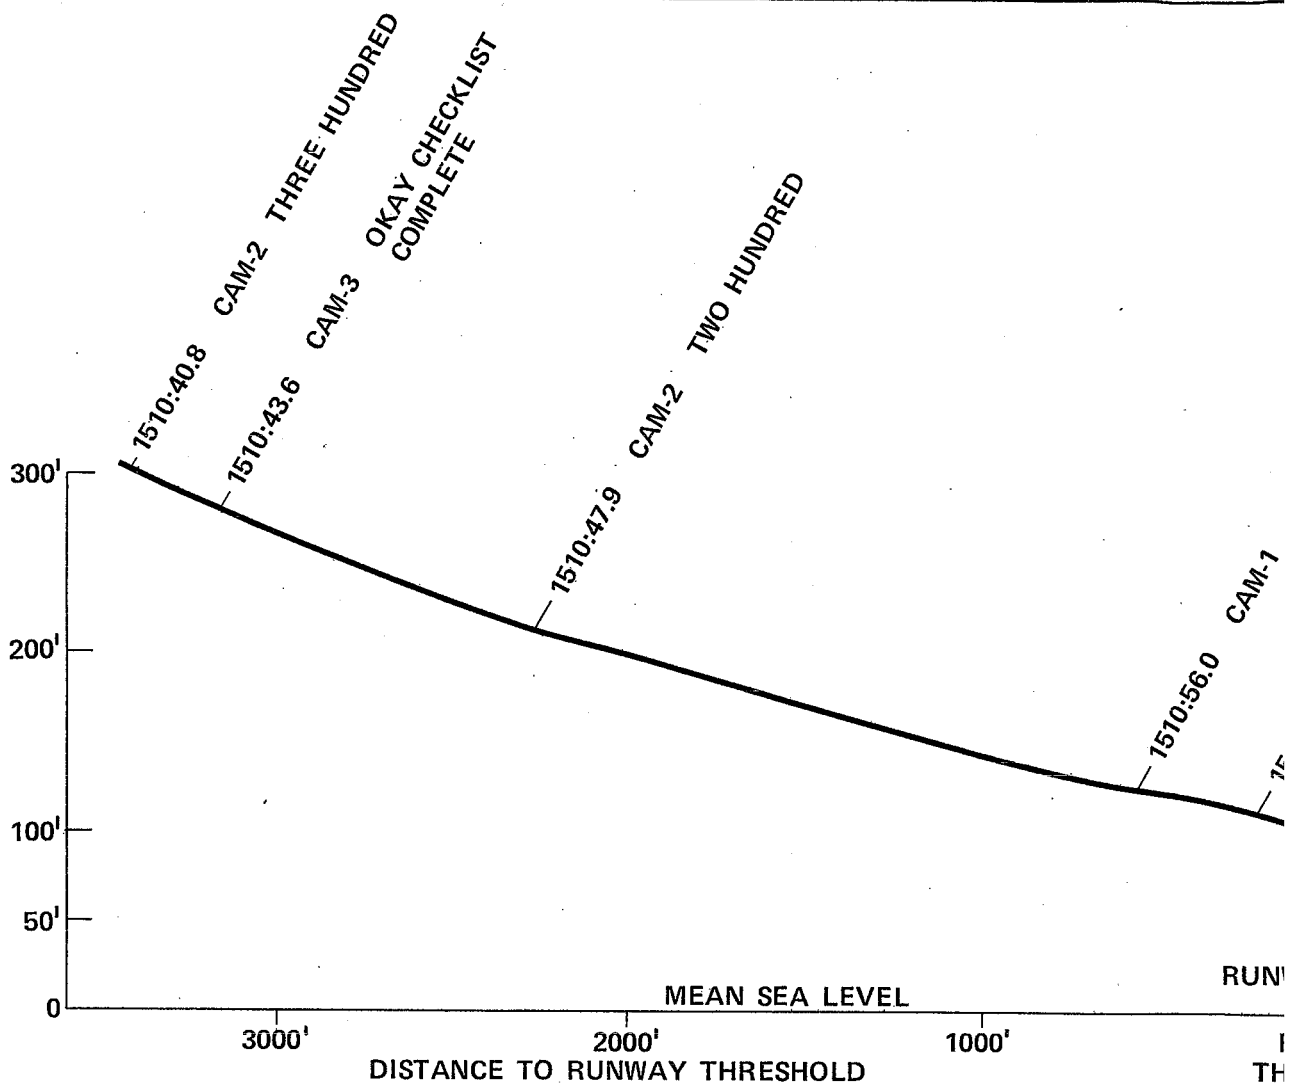
The profile shown in Appendix D was prepared using assumptions which seemed to be most logical to the investigators. These assumptions are noted thereon. This profile shows that the aircraft crossed the threshold at an airspeed of 131 knots and an altitude of about 80 feet. The touchdown was calculated to be about 2,800 feet beyond the threshold. At touchdown, about 1,850 feet of runway and 500 feet of overrun were available on which to stop the aircraft. When the captain stated "Let's go around," the aircraft was about 3,450 feet beyond the threshold, or 1,200 feet of runway and 500 feet of overrun remained.

1. THE DISTANCE PLOT WAS DEVELOPED FROM THE F.D.R. AIRSPEED MEASUREMENT CORRECTION FOR DENSITY ALTITUDE AND WIND. THE FOLLOWING ASSUMPTIONS WERE USED:
  - SEA LEVEL BAROMETRIC PRESSURE - 30.00 IN. HG.
  - SEA LEVEL TEMPERATURE - 84° F.
  - WIND - CONSTANT - 120° TRUE/10 KNOTS
2. THE TIME CORRELATION BETWEEN THE FLIGHT RECORDER DATA AND THE C.V.R. TRANSMISSIONS WAS BASED UPON THE ASSUMPTION THAT A VERTICAL ACCELERATION PEAK THREE SECONDS BEFORE THE END OF THE F.D.R. TRACE CORRESPONDS WITH A SOUND OF THE INCREASING ROAR RECORDED ON THE C.V.R.
3. THE CORRELATION OF THE PLOT TO THE RUNWAY THRESHOLD IS BASED UPON THE ASSUMPTION THAT THE PREVIOUSLY MENTIONED ACCELERATION PEAK AND SOUND OF ROAR OCCUR WHEN THE AIRCRAFT STRUCK AN EMBANKMENT 5369 FEET BEYOND THE RUNWAY THRESHOLD.
