The investigation for this report was conducted by Aircraft and Railway Accidents Investigation Commission about the aircraft accident of Japan Airlines Boeing 747-400D (an approach to JA8546 of the same airline) in accordance with Aircraft and Railway Accident Investigation Commission Establishment Law and Annex 13 to the Convention of International Civil Aviation for the purpose of determining cause of the aircraft accident and contributing to the prevention of accidents and not for the purpose of blaming responsibility of the accident.

Junzo Sato,  
Chairman,  
Aircraft and Railway Accidents Investigation Commission

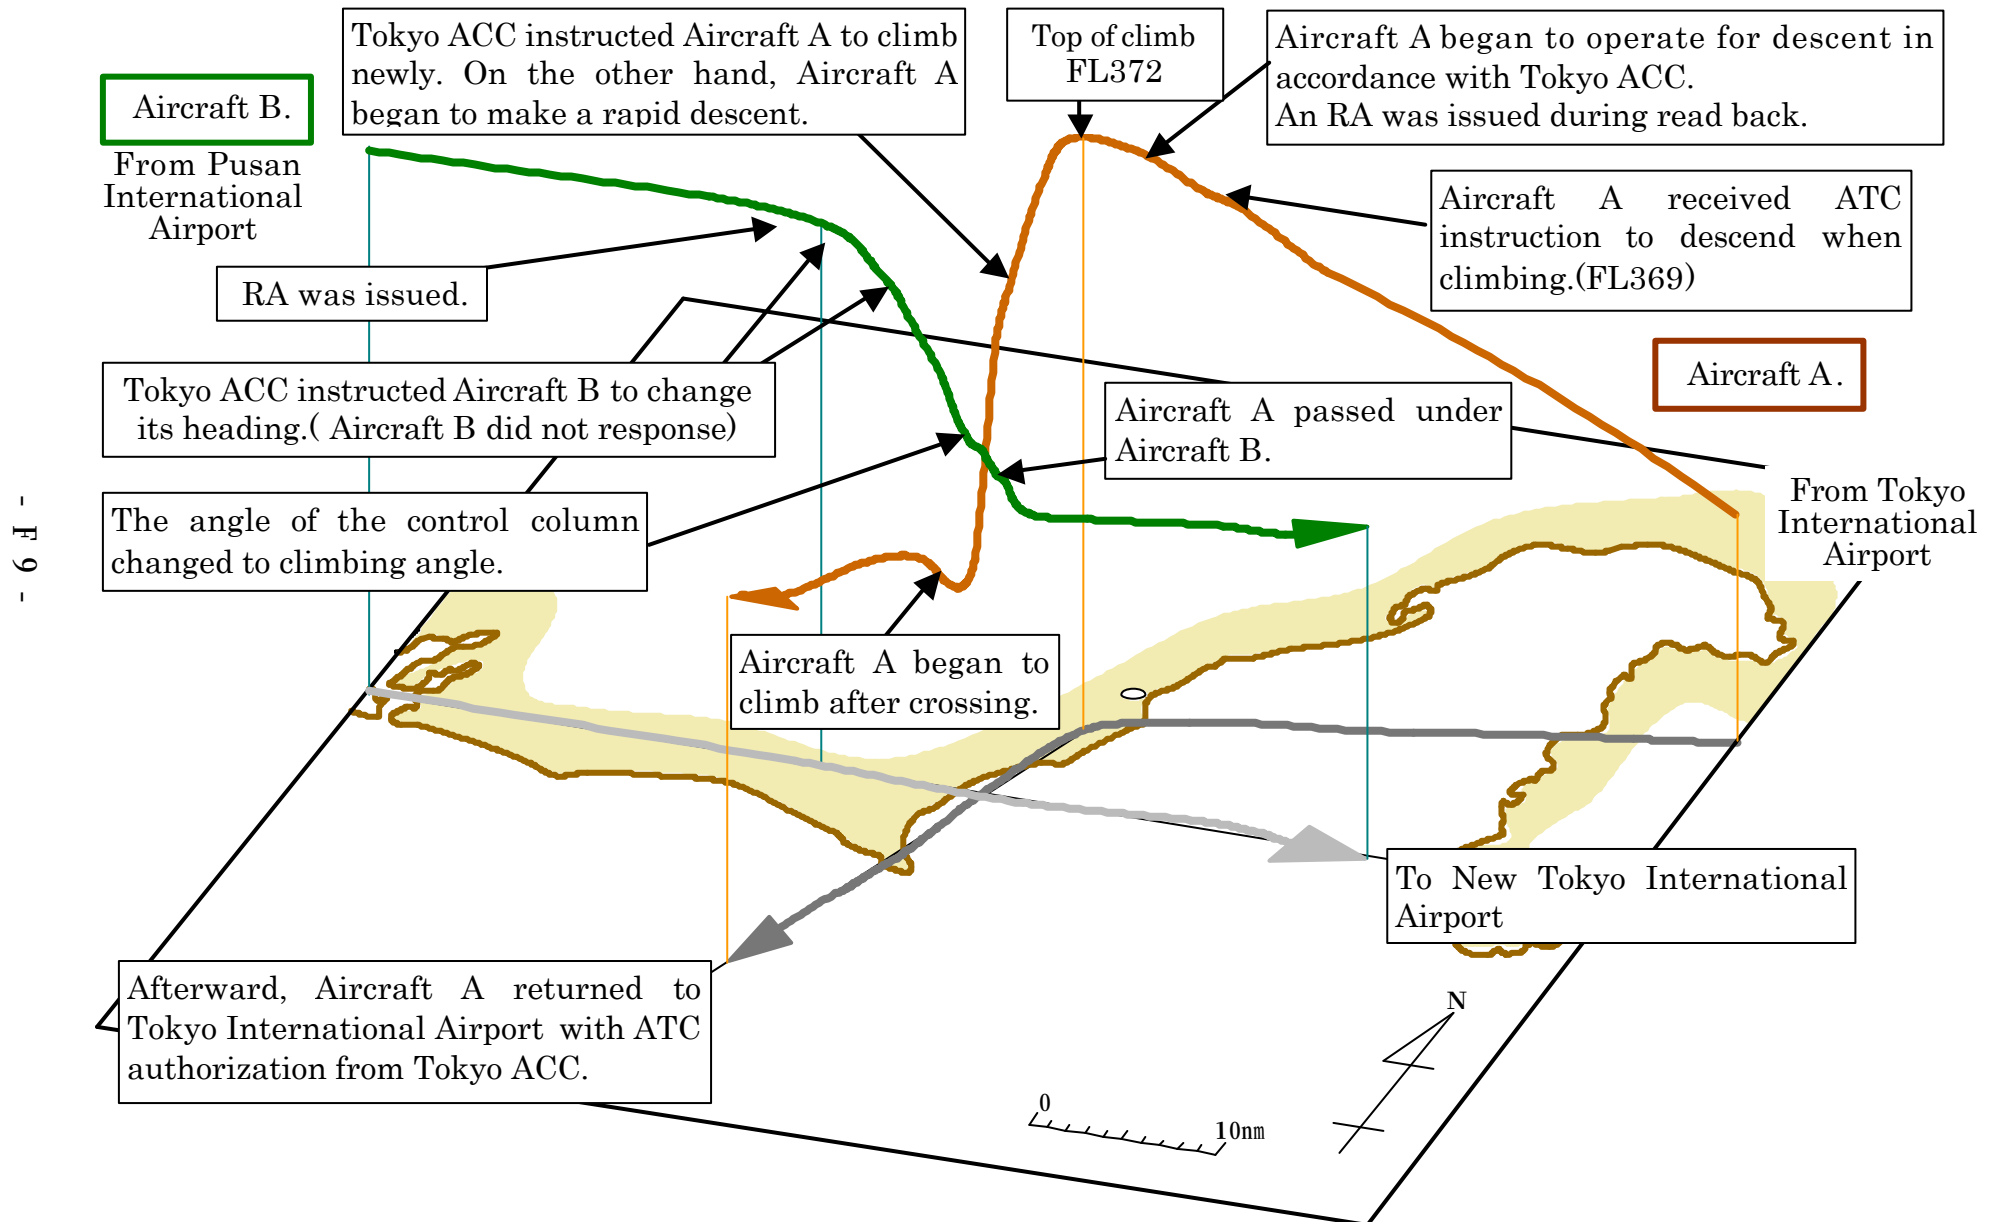
Figure 9 Flight pass around location of accident

Maneuvers executed by Aircraft-A and Aircraft-B based on the DFDR recorded data also given in square brackets for reference. Additionally, the flight paths of the two aircraft from their convergence to avoidance are shown in Attached Figure 9.

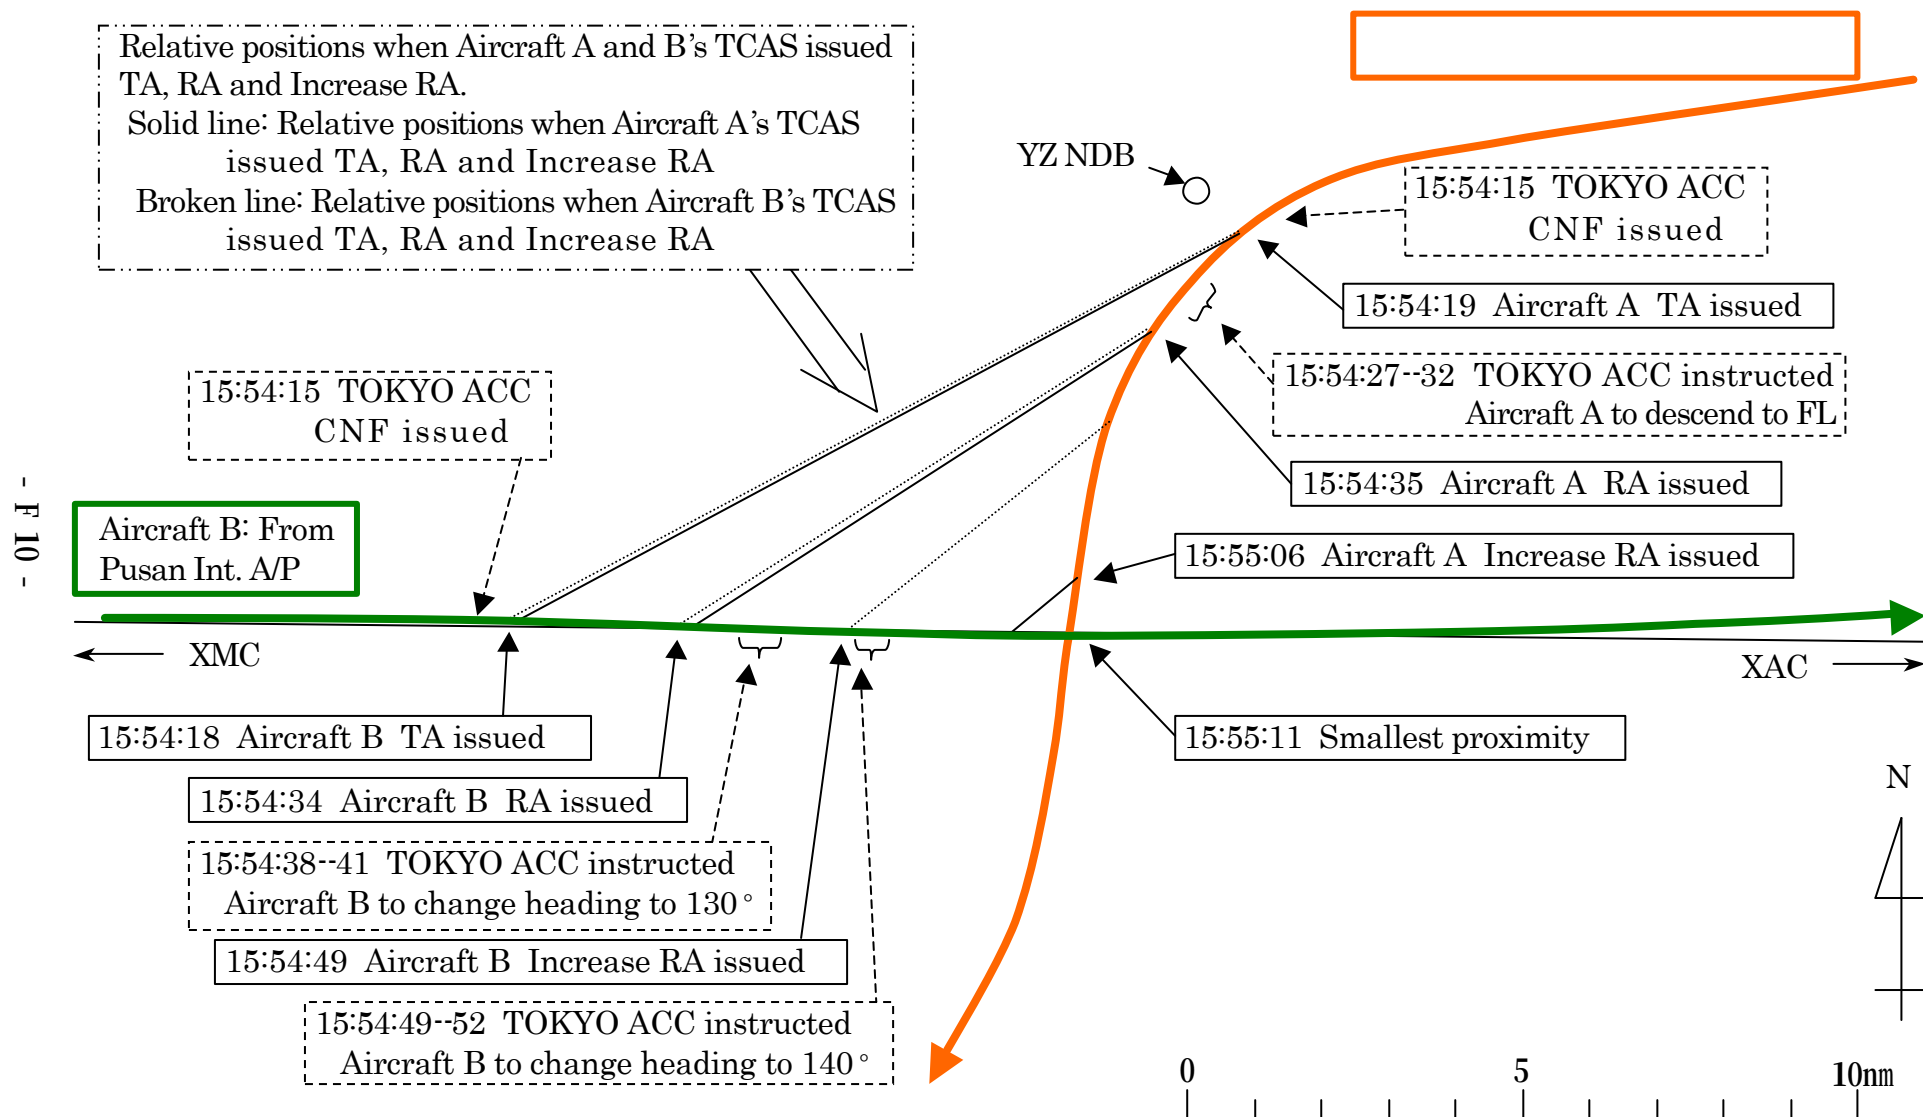
Figure 10 Proximity situation (Plane geometry)

(Refer to Attached Figure 10)

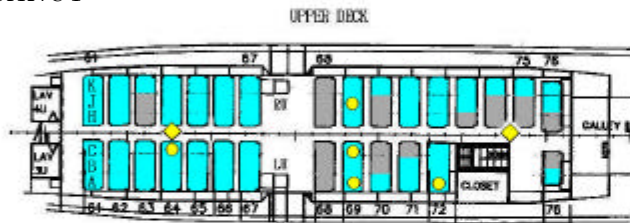
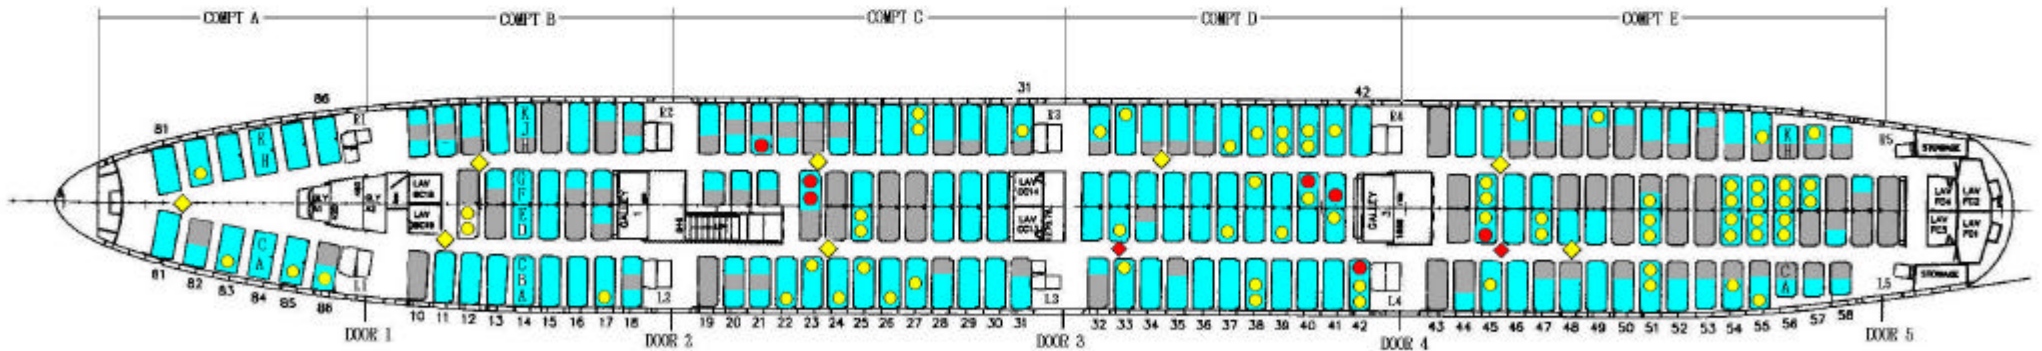
Figure 14 Injuries layout, Aircraft A

(Refer to Attached Figures 14 and 15)

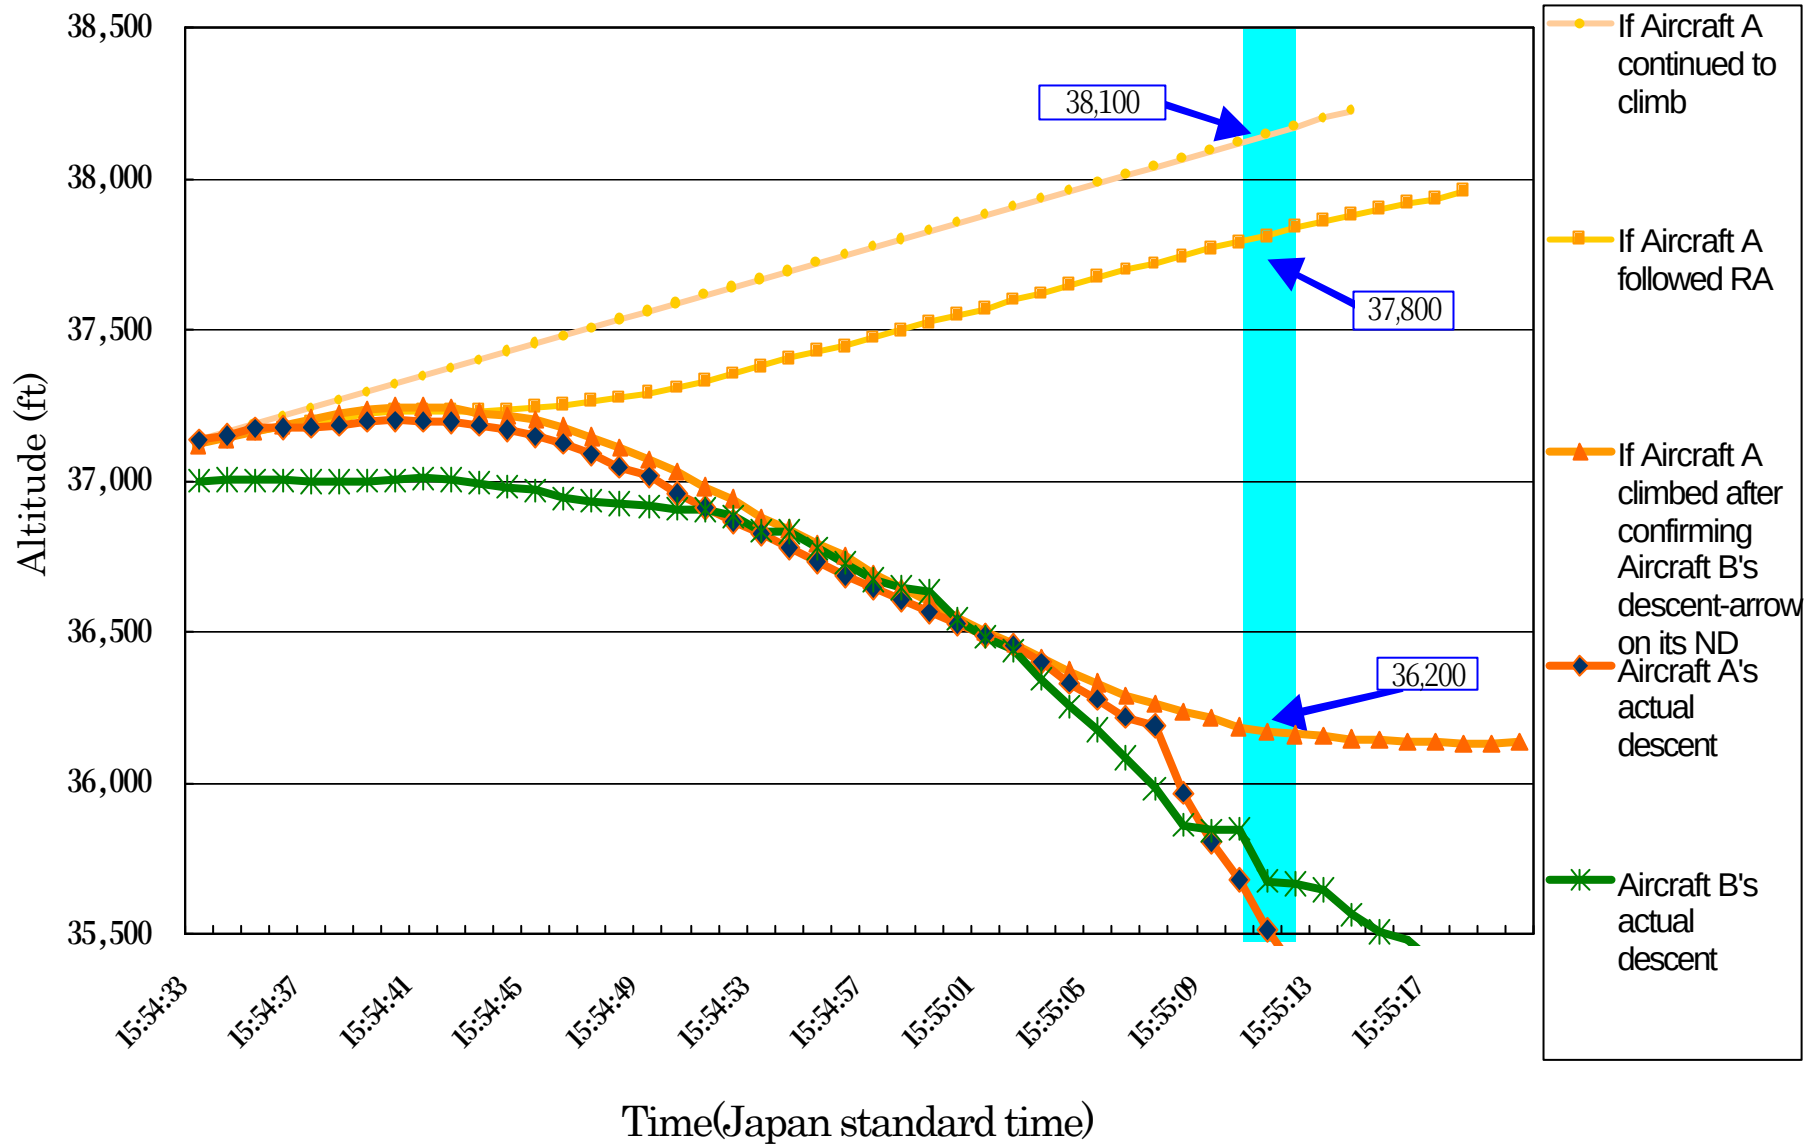
Figure 18 Aircraft A 's altitude simulation

(Refer to Attached Figure 18)

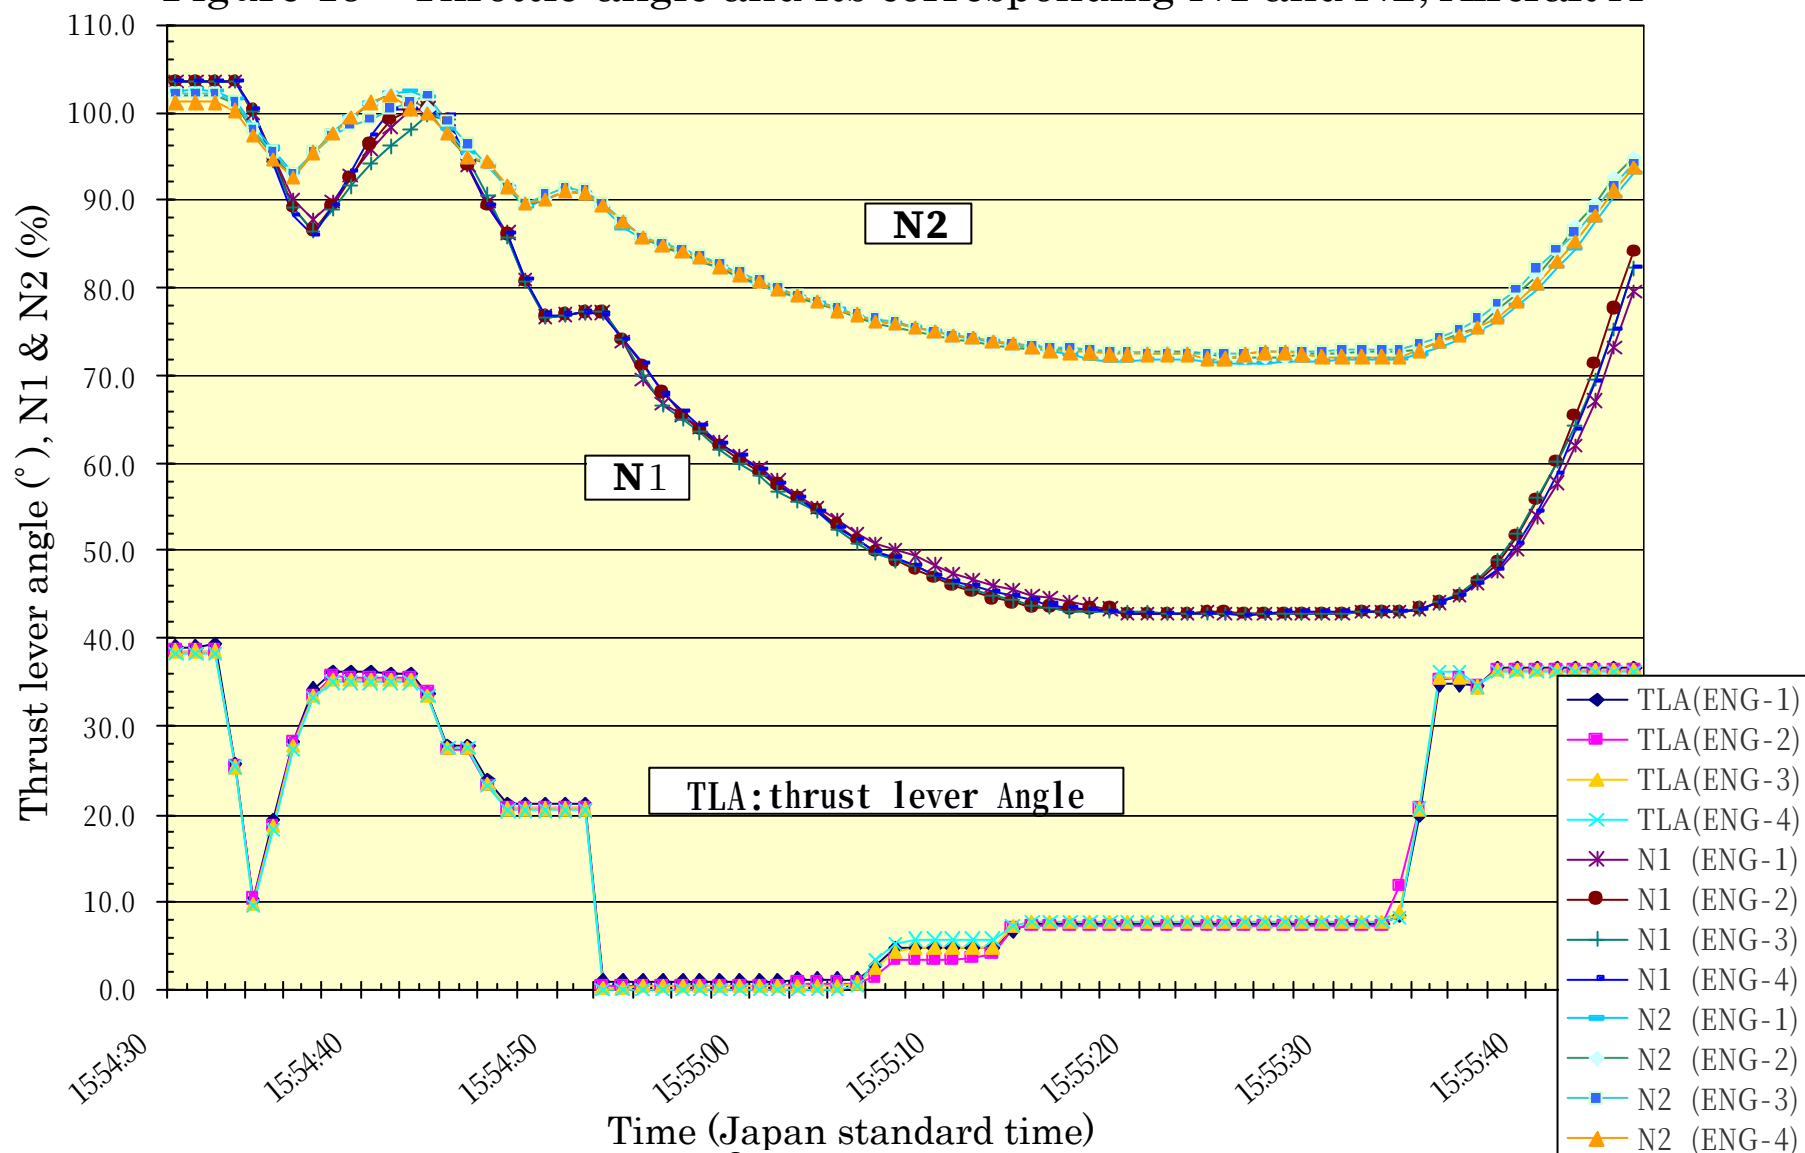
Figure 19 Throttle angle and its corresponding N1 and N2, Aircraft A

In order to confirm characteristics of the engine thrust responsiveness when transiting from descent to climb, plots of changes in N1, N2 and positions of the thrust levers before and after the occurrence of the accident recorded on Aircraft-A's ACMS are shown in Attached Figure 19.

According to data recorded on the Aircraft-A’s ACMS indicating the values of N1 and the angles of the thrust levers, shown in Attached Figure 19, the thrust levers were pulled back from the climb positions. During this period, the time lag from movement of the thrust levers until the N1 started to decrease in response was approximately one second.

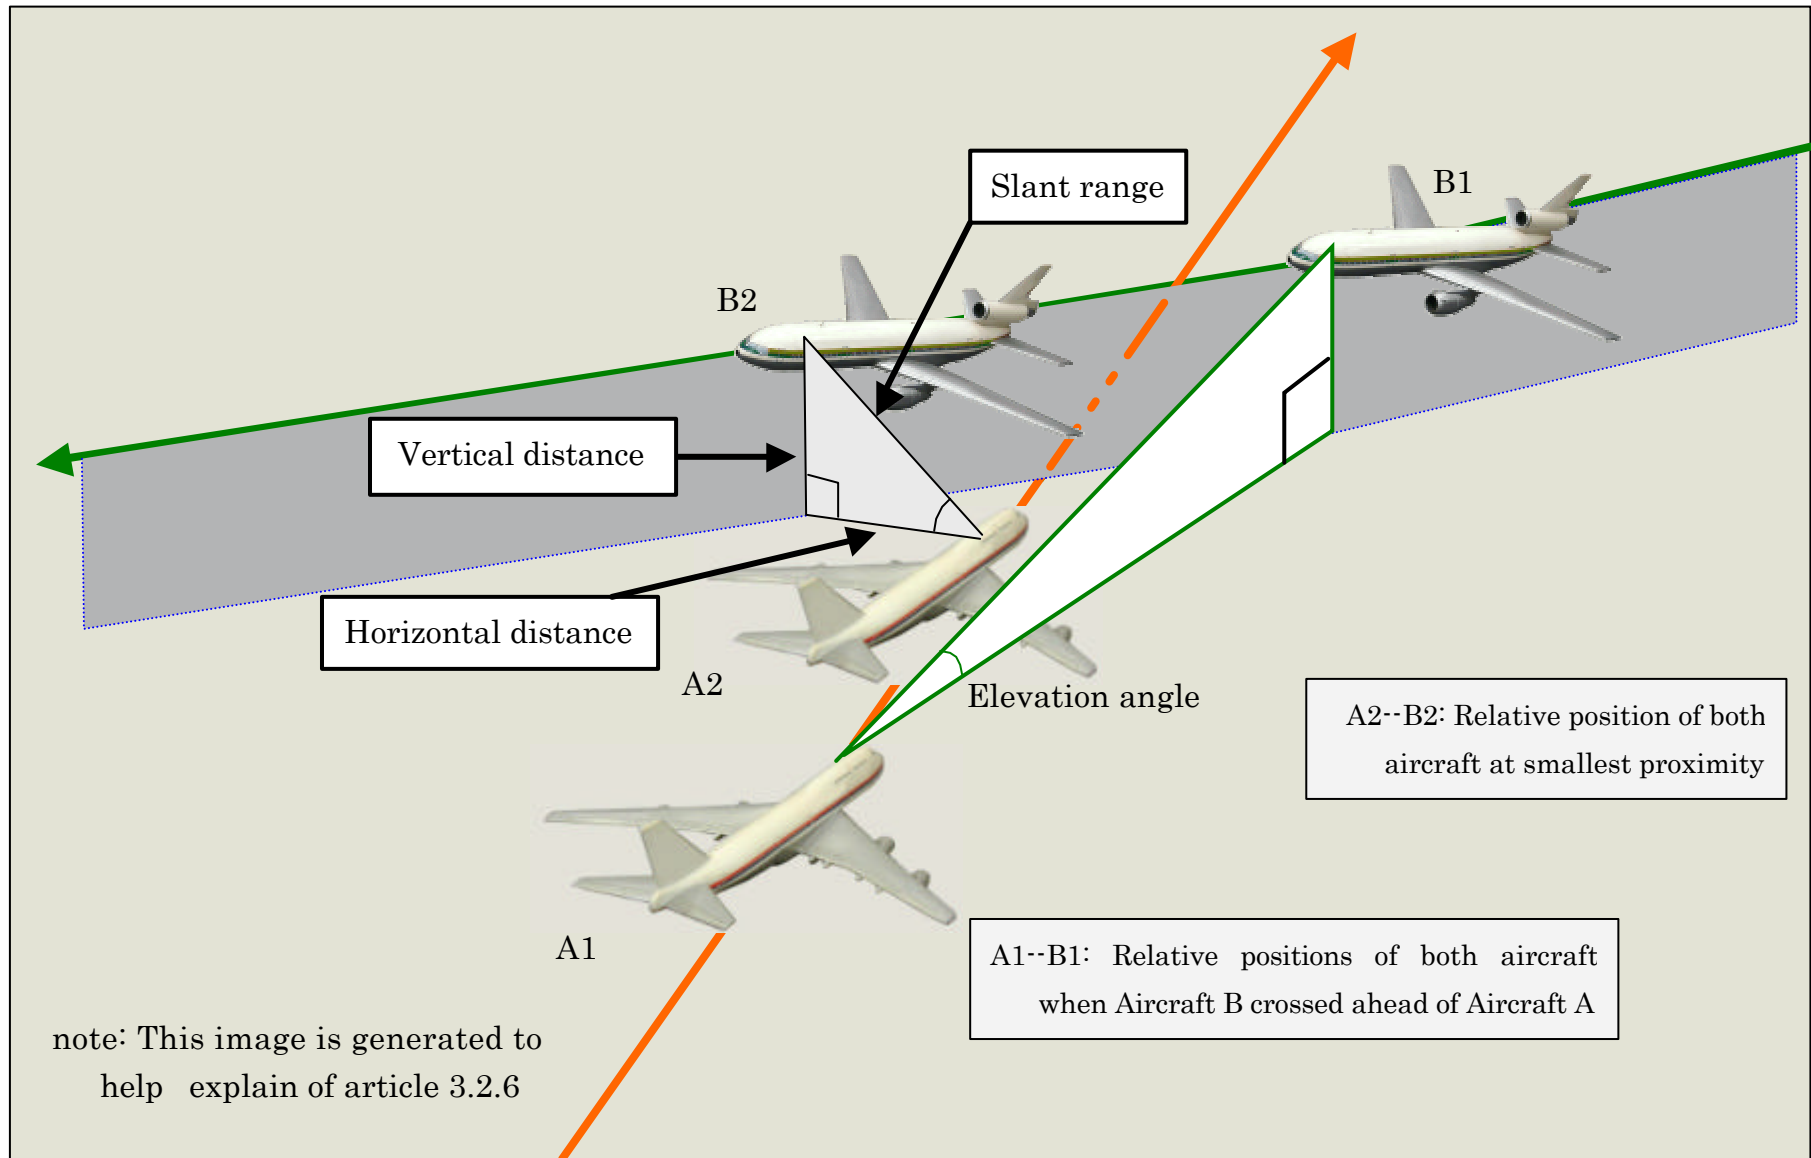
Figure 22 Explanation of closest distance

(Ref. Figure 22)

The datum point is placed on the point of smallest proximity of both aircraft
