# **NATIONAL TRANSPORTATION SAFETY BOARD**

**AIR CANADA FLIGHT 797  
McDONNELL DOUGLAS DC-9-32, C-FTLL  
GREATER CINCINNATI  
INTERNATIONAL AIRPORT  
COVINGTON, KENTUCKY  
JUNE 2, 1983**

**NTSB/AAR-86/02**

The National Transportation Safety Board determines that the probable causes of the accident were a fire of undetermined origin, an underestimate of fire severity, and misleading fire progress information provided to the captain.

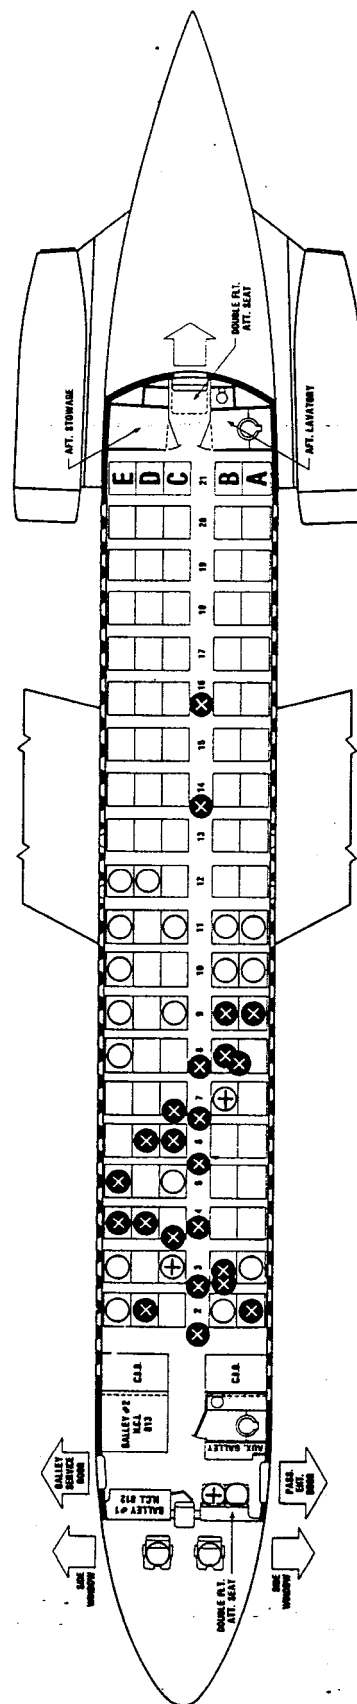
Figure 12.—Diagram of passenger seat locations.

Except for two fatalities found in the aisle at rows 14 and 16, the majority of the fatalities were found either in the aisle or seated in rows 2 through 9. (See figure 12.) The fatalities at rows 14 and 16 had been seated in seats 8-B and 9-B, respectively.
