PB94-910409  
NTSB/AAR-94/07

STALL AND LOSS OF CONTROL ON FINAL APPROACH  
ATLANTIC COAST AIRLINES, INC./  
UNITED EXPRESS FLIGHT 6291  
JETSTREAM 4101, N304UE  
COLUMBUS, OHIO  
JANUARY 7, 1994

**Adopted: October 6, 1994**

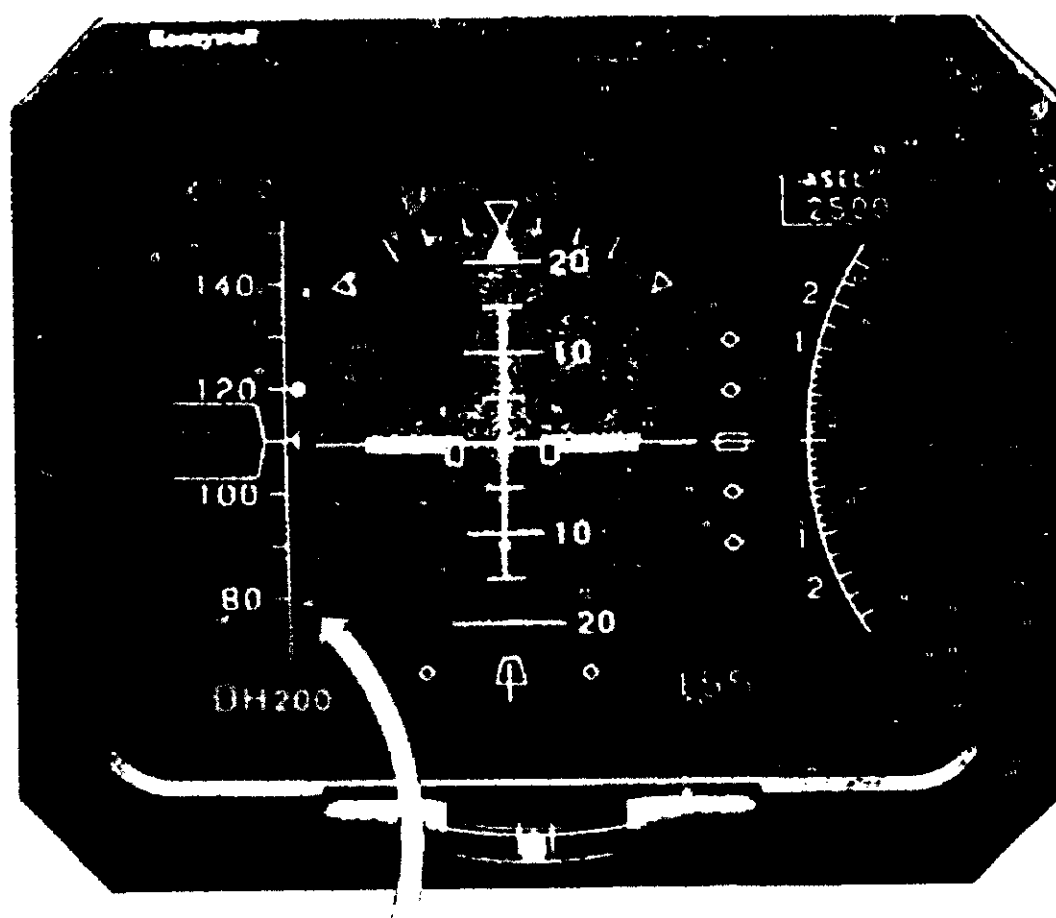
Figure 9.--Electronic attitude director indicator.

The Safety Board examined the display of airspeed within the airplane's electronic attitude director indicator, a cathode ray tube or CRT, to determine if the manner in which the information was presented could have hampered the ability of either pilot to perceive and integrate the critical information. Airspeed data on the J-4100 is presented digitally on a vertical moving display, with the airplane's indicated airspeed centered within the display. As the airspeed increases or decreases, the displayed airspeeds move up or down correspondingly. (See figure 9).

low airspeed  
awareness indicator [red color]
