# NATIONAL TRANSPORTATION SAFETY BOARD

## AIRCRAFT ACCIDENT REPORT

IN-FLIGHT LOSS OF PROPELLER BLADE  
FORCED LANDING, AND COLLISION WITH TERRAIN  
ATLANTIC SOUTHEAST AIRLINES, INC., FLIGHT 529  
EMBRAER EMB-120RT, N256AS  
CARROLLTON, GEORGIA  
AUGUST 21, 1995

**Adopted: November 26, 1996  
Notation 6609B**

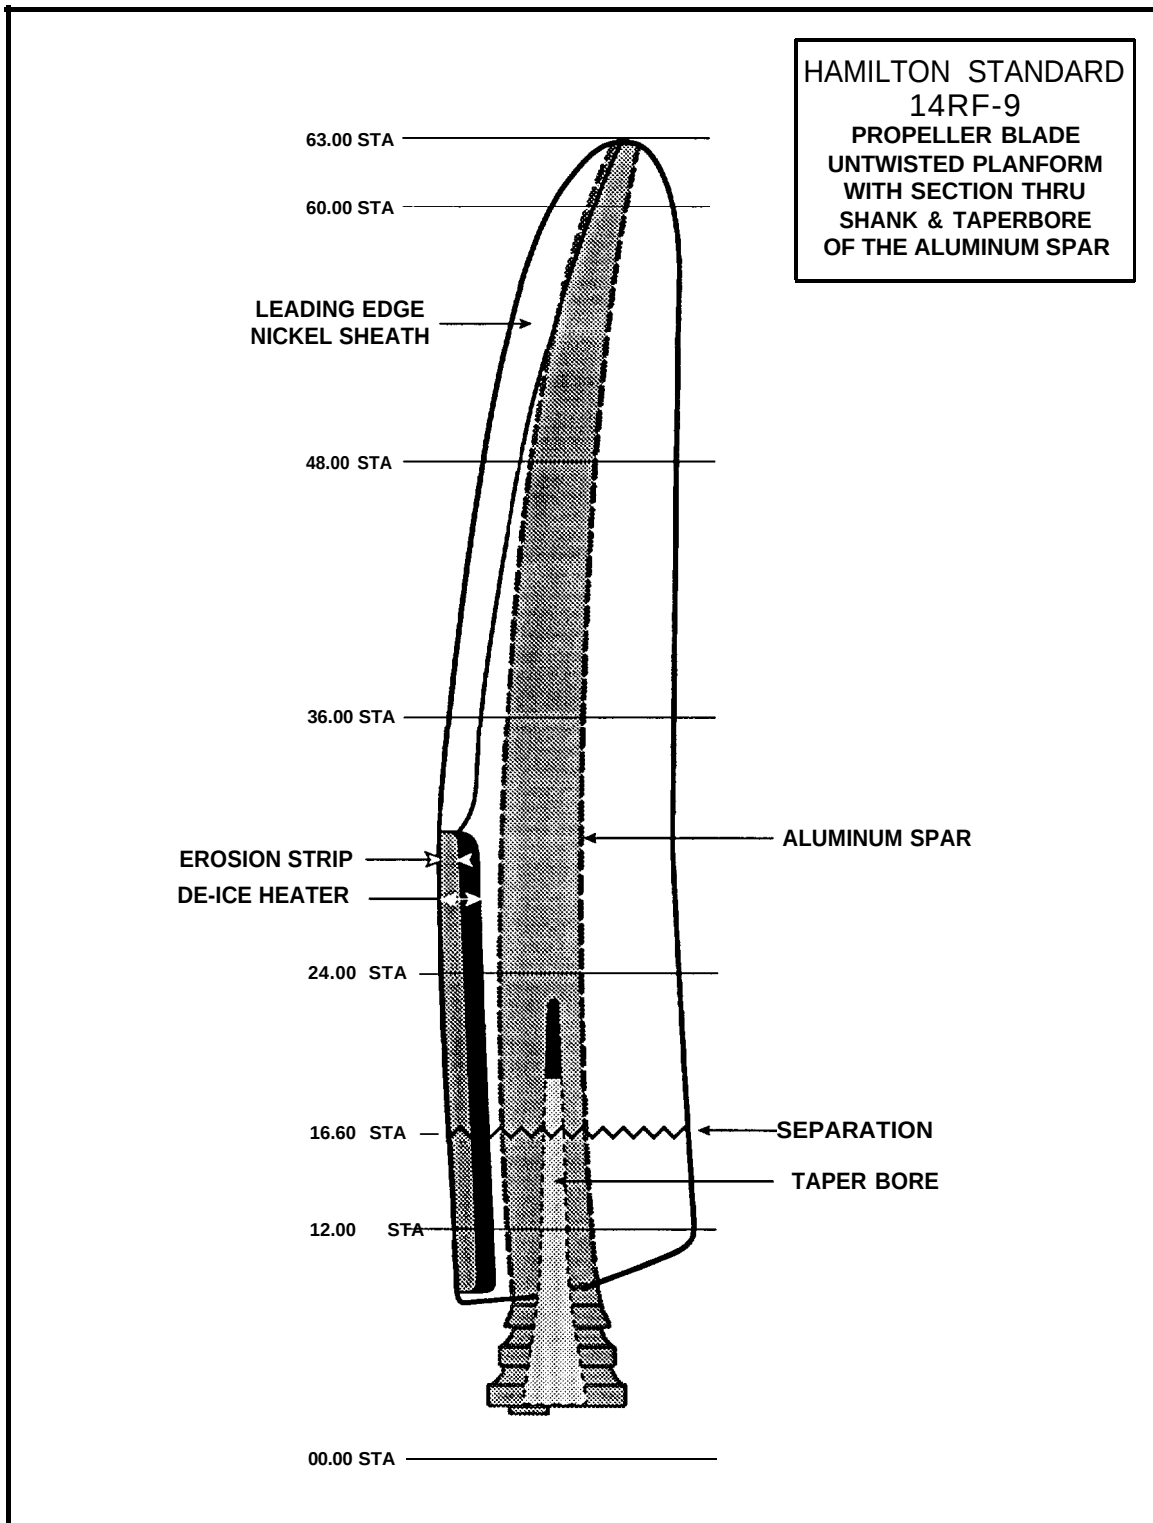
Figure 2.--Illustration of a 14RF-9 propeller blade.

Hamilton Standard manufactures a family of composite propeller blades, including the 14RF (the accident propeller blade), 14SF, and 6/5500/F, that are intended for use on turbopropeller commuter airplanes. The solid, forged 7075-T73 aluminum alloy spar is the main load-carrying member. The airfoil shape of the blade is formed by glass fiber-filled epoxy and foam adhesively bonded to the spar (see Figure 2). A conical hole (taper bore) is bored in the center of the spar from the inboard end to blade station 21,<sup>12</sup> for weight reduction and balance weight installation. The taper bore on the 14RF blade can be one of two different shaped designs: straight taper bore known as the “M” style<sup>13</sup>) and a

bellmouth shape (known as the “N” style). Also, during very early production, the taper bore was shotpeened.<sup>14</sup> However, early in the production run, Hamilton Standard reviewed the production process, deemed shotpeening unnecessary, and, with FAA approval, it was discontinued. The accident blade was originally an N style blade, but it was rebalanced on customer request for ASA fleet standardization to the M style and reidentified as an M blade. The accident blade taper bore was not shotpeened during production.

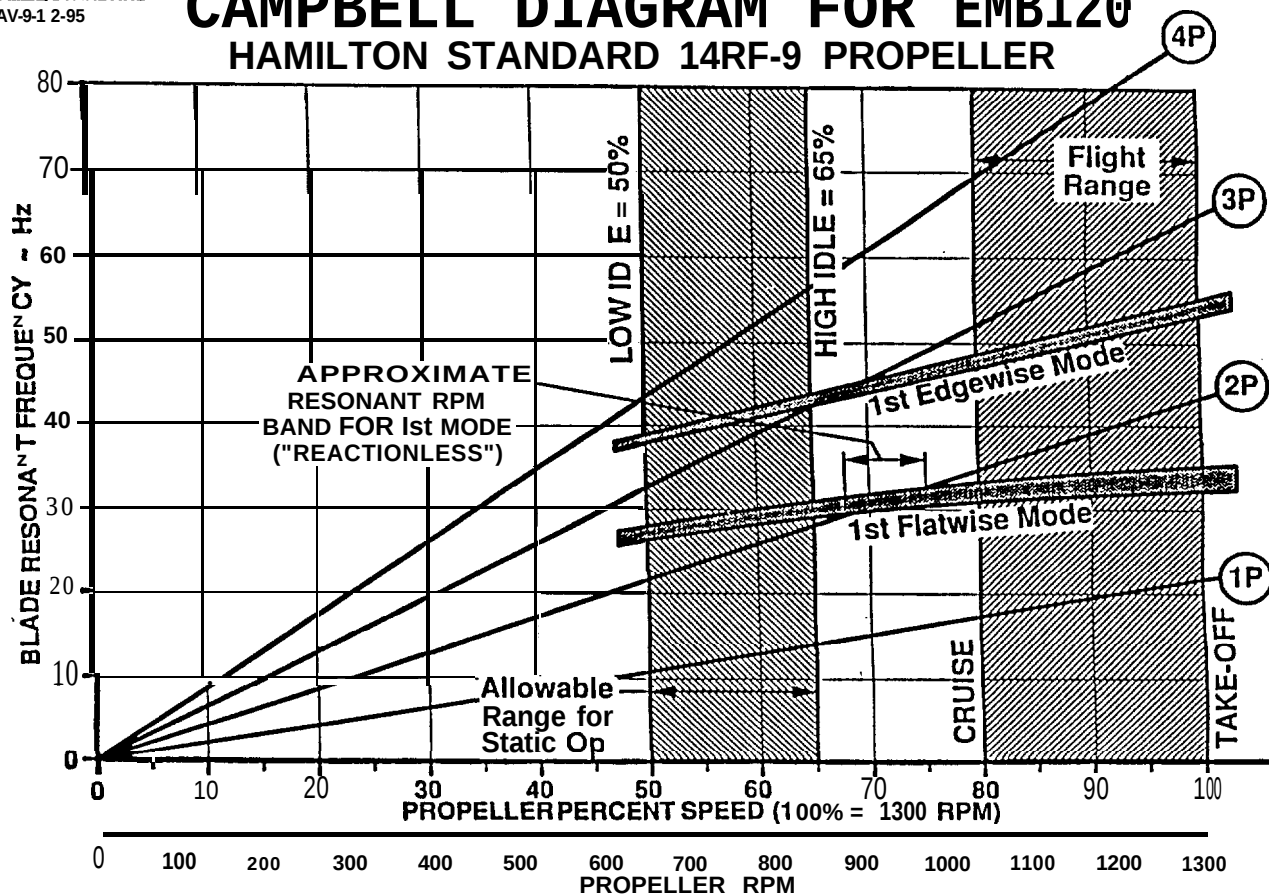
Figure 4.--Vibratory modes of the 14RF-9 propeller.

The Hamilton Standard 14RF-9 blade for the EMB-120 was designed so that its first flat-wise resonant frequency would not coincide with the 2P<sup>48</sup> excitation frequency during ground operation. However, the coincidence or close proximity of the ground rotational speed and the first flat-wise resonant frequency can place the propeller in a resonant condition and results in undesirable vibratory stress. (See Figure 4 for an illustration of the vibratory modes of the 14RF-9 propeller.)

When the first flat-wise vibration frequency and the 2P excitation frequency coincide, a four-bladed propeller, such as the 14RF-9, vibrates in the reactionless<sup>49</sup> mode. The reactionless mode of vibration is characterized as when two blades of a four-bladed, rotating propeller, 180 degrees apart, reach a negative stress peak at the same time that the other two blades reach their positive stress peak. This type of propeller vibration is called reactionless because the bending loads of the four blades are canceled at the propeller hub which consequently transmits little or no vibratory loading to the propeller mounting structure.
